# HIGHWAY RESEARCH RECORD

Number | Performance of Composite  
434 | Pavement, Overlays,  
and Shoulders

6 reports  
prepared for the  
52nd Annual Meeting

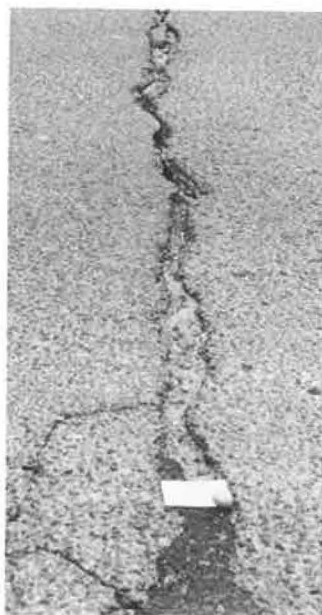
**Figure 4. Wide transverse crack in asphalt pavement on unreinforced concrete base (section A).**

Cracks are least frequent but widest in sections having an unreinforced base or a reinforced base with formed joints (A, B, and G). Those are shown in Figures 4 and 5. Cracks are most frequent and generally the narrowest on sections with concrete base or concrete pavement having the greatest weight of reinforcing mesh (C, D, and H). Several cracks in the concrete slab of section H are very wide and faulted (Fig. 6). The longitudinal steel area provided in that section (0.38 percent of concrete) is considerably less than that normally recommended (0.60 percent) for continuously reinforced concrete pavement (3).

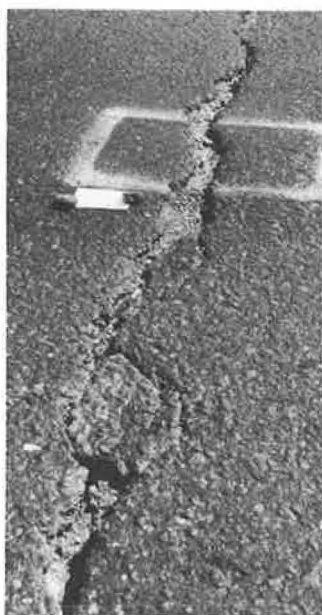
**Figure 5. Wide transverse crack in asphalt pavement over contraction joint in reinforced concrete base (section G).**

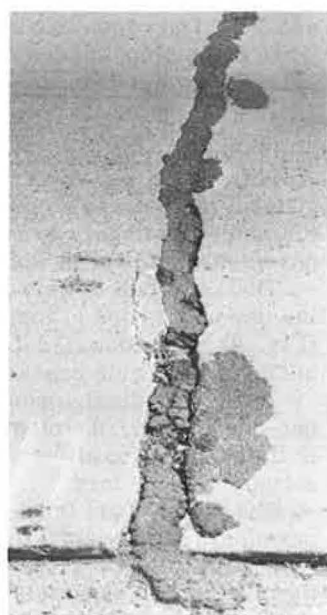
**Figure 6. Wide stepped transverse crack, about 3½ in. wide, in continuously reinforced concrete pavement (section H).**

6. The continuously reinforced concrete pavement (0.38 percent longitudinal steel) in section H had the poorest rideability characteristics of all the sections because of stepping at many of the transverse cracks.

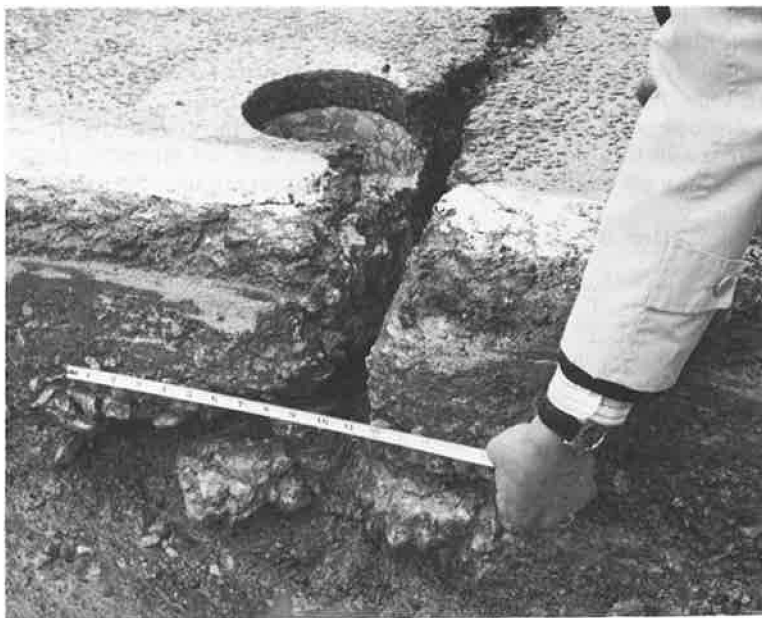
**Figure 7. Severe spalling in bottom half of concrete base slab at wide crack (section D).**

Transverse cracking in bituminous pavements placed directly on a granular base course has been identified as a serious problem in the northern parts of Ontario, where the freezing index is high (4). Such cracks permit the ingress of water and salt solutions, which lead to stripping of the bituminous mix, pumping of fine granular base material, and local weakening of the pavement structure. The transverse cracking occurring on the sections of composite pavement is seemingly less of a problem; if properly maintained, it will not seriously affect the riding qualities of the pavement, unless vertical faulting of the crack occurs. Many of the wider cracks in the pavement are faulted. In sections D and H, where about half of the transverse cracking exhibits faulting, it is undoubtedly a major cause of the relatively high R values as determined by the roughometer trailer. Most "steps" are in the range of  $\frac{1}{8}$  to  $\frac{1}{4}$  in.; the highest one measured was  $\frac{3}{4}$  in. at a wide crack in section D. Removal of the shoulder material adjacent to a wide faulted crack in section D indicated severe spalling of the bottom half of the 7-in. thick concrete slab (Fig. 7). The crack width in the concrete slab was  $1\frac{3}{4}$  in. The 4-0 gauge longitudinal wires of the reinforcing mesh were "necked" and broken at the crack. Less severe spalling was also observed at narrower cracks in the concrete base (Fig. 8).

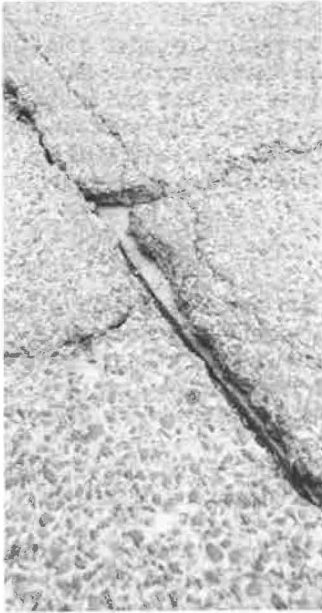
**Figure 9. Loss of asphalt pavement due to cracking at centerline joint (section D).**

The hook-bolt dowels in 3 of the 7 bituminous-covered sections had little effect on the severity of the cracking. Both doweled centerline joints with  $1\frac{1}{2}$ -in. thick asphalt (Fig. 9) and undoweled centerline joints with 8-in. thick asphalt (Fig. 10) are associated with wide cracks and loss of bituminous pavement.

It is apparent that the longitudinal joint in the concrete base is open (Fig. 9) and that the hook-bolt dowels ( $\frac{5}{8}$ -in. diameter at  $2\frac{1}{2}$ -ft centers) have not held the two 12-ft wide slabs together. A core taken through the pavement at the location of a hook-bolt

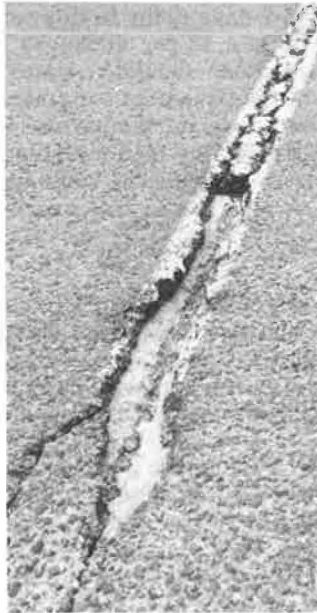
**Figure 10. Loss of asphalt pavement due to cracking at centerline joint (section F).**

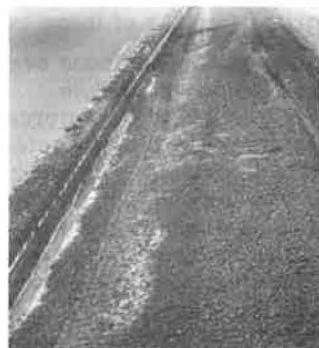
**Figure 13. Surface water in granular shoulder at edge of pavement.**

It is apparent that, in spite of a 12-in. thickness of granular material under both the concrete slab and the crushed-stone shoulder, water from the roadway surface is not drained from the structure of the pavement but collects readily in the base and subbase. Pavement damage to composite or concrete pavements from frost heave is not common in southern Ontario; nevertheless, the high moisture content of the subgrade with the possibility of ice-lense formation during the wintertime is potentially a cause of pavement faulting, particularly at wide transverse cracks.

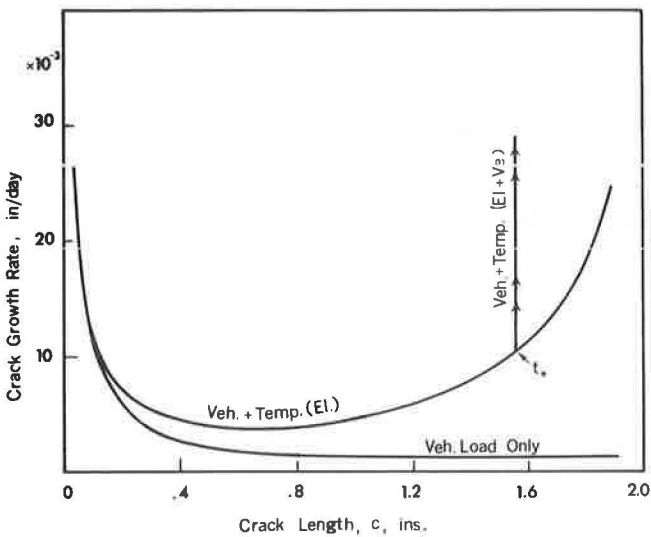
Figure 5. Growth rate of elastic and viscoelastic reflection crack.

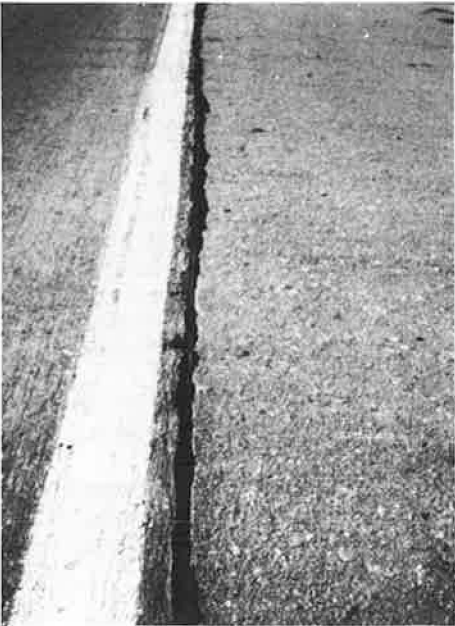
Figure 1. Sealed joint on I-80 in Illinois after 5 years of service.
