AN INSTRUMENT FOR DETECTING DELAMINATION IN CONCRETE BRIDGE DECKS

William M. Moore, Gilbert Swift, and Lionel J. Milberger,
Texas Transportation Institute, Texas A&M University

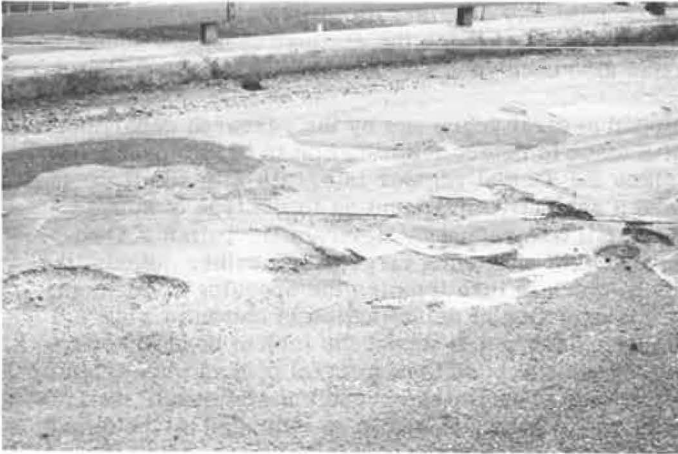
Figure 1. Delaminated area of a bridge deck in the last stages of deterioration.

•**DELAMINATION** is sometimes referred to as horizontal cracking. It occurs frequently at the elevation of the reinforcing steel and most often at the upper level of reinforcing steel. Delaminated areas may range in size from a few square inches to several square yards. After initial delamination occurs, additional rapid deterioration of the deck may be expected to follow, under the combined influences of weather and traffic. Figure 1 shows a delaminated bridge deck in the last stages of deterioration.

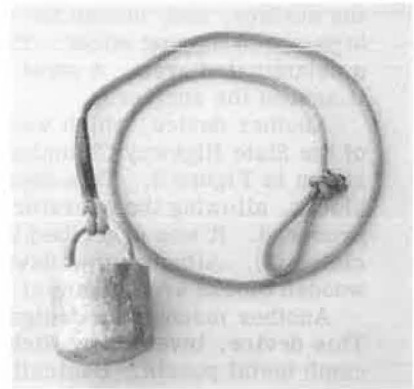
Figure 2. Tapping mass used for locating delaminated concrete in bridge decks.

The sound produced when the hammer strikes the concrete depends on the vibrational characteristics of the hammer itself as well as the concrete. If the hammer is highly resonant, its sound is confused with the sound from the slab. This makes the judgment by testing personnel much more difficult. Thus, claw hammers, steel rods, and the like do not make good striking objects. The best type of striking object has been found to be a steel mass tied at the end of a soft rope. This device, which is shown in Figure 2, was developed by an employee of the Texas Highway Department to facilitate bridge deck inspections. The steel mass, being essentially nonresonant, produces very little sound when hammered against a solid deck, but it causes a delaminated area to give forth a loud, distinctive hollow sound. Additionally, the mass may be dragged across

the surface, and, unless the surface is unusually smooth, its irregularities produce a high-speed tapping effect. This dragging also produces the distinctive hollow sound on a delaminated area. A steel chain has also been used for the same purpose by dragging it across the surface.

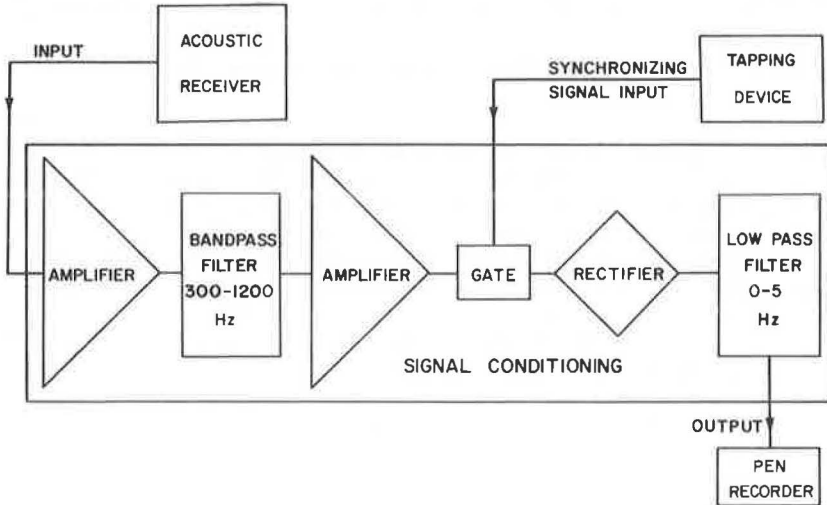
Figure 7. Block diagram of the signal conditioner.

The signal conditioner that accepts the electrical signals produced by the rolling receiver and processes them for recording is shown in Figure 7. The distinction between delaminated and solid concrete is enhanced by filtering and by time-interval gating. Specifically, the distinction between delaminated and nondelaminated zones is enhanced by selecting only those frequency components of the received sound that fall between 300 and 1,200 Hz. Also, the distinction is further improved by accepting only that portion of the received signal that occurs during the first 3 msec after a tap has been made. Taps, which are produced 60 times per second, occur at intervals of 16.7 msec; thus, there is a relatively short interval during which the recording system is allowed to accept signals from the rolling receivers.

The final signal conditioning is accomplished by rectifying and integrating the signal over a period of approximately $\frac{1}{4}$ sec. This provides a rapidly responding voltage suitable for display on a pen recorder. Delaminated areas extending over 1 ft² or 2 ft² ordinarily produce responses exceeding 1 V. Smaller areas result in lesser responses that can be interpreted usefully down to about 0.05 V. Unwanted responses, resulting from rolling over rough surfaces and other disturbances, are substantially less than 0.05 V.

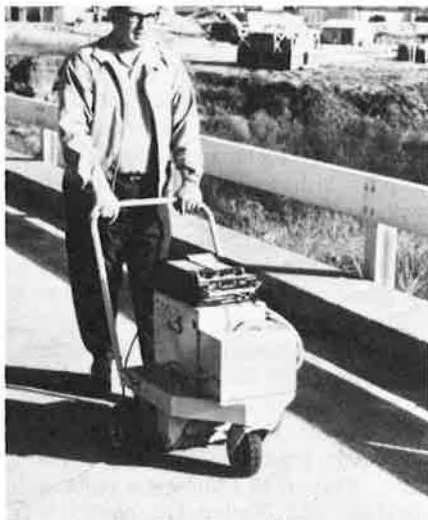
Figure 8. Delamination detector in operation.

The basic components developed in this study and described in the previous section have been incorporated into the delamination detector unit shown in Figure 8. This unit, in the form of a mobile cart, is roughly the size and shape of a push-type power lawn mower. It is equipped with two rolling acoustic receivers spaced 12 in. apart and with two tapping wheels spaced 6 in. apart, centered between the receivers (Fig. 9). Because the unit detects delamination only when a receiver and a tapping wheel are simultaneously over a delaminated area, the unit surveys two 3-in. wide parallel paths that are 6 in. apart.

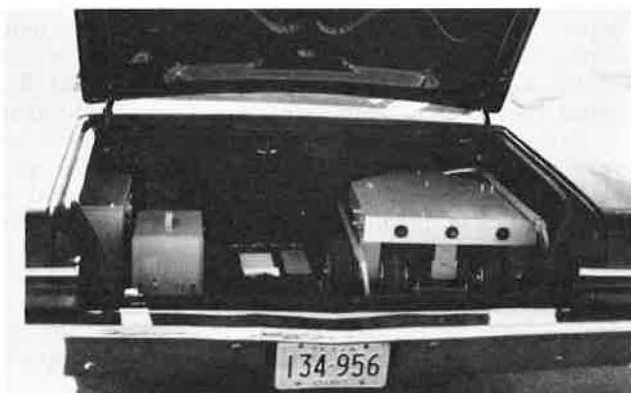
Figure 10. Delamination detector disassembled and stowed in an automobile trunk.

The unit consists of several separable components, each of suitable size and weight for one-man lifting and stowage in an automobile trunk. They are (a) a main frame that houses the tapping device and rolling receivers, (b) a two-channel pen recorder, (c) a control unit that contains two signal conditioning channels and an inverter for obtaining 120 Vac, and (d) a box that contains a 12-V storage battery. The disassembled unit is shown in Figure 10. Assembly or disassembly of the unit on site takes less than 1 min.
