MEASURING AND DEPICTING TROUBLE AREAS IN STEREOMODELS

Wayland Norell, Ohio Department of Highways

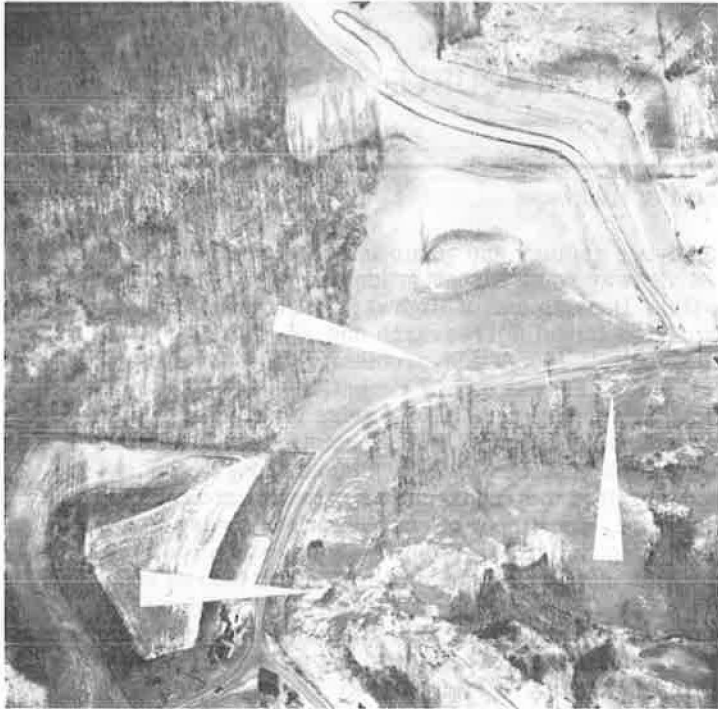
Figure 1. Evidence of slope instability (1 is uncultivated portion of slope, 2 is fence misalignment, and 3 is topographic position at headward end of drain).

In 1957, a state highway terrain analysis revealed a convergence of evidence that indicated a slope was not stable. The evidence included texture and photograph tones above the existing highway showing that the portion of the field is untillable, fence misalignment indicating slope movement, and topographic position at headward end of drain (Fig. 1).

Field investigation resulted in special highway design to treat this unstable condition. The treatment consisted of cutting a 20-ft wide trench into the existing slope and placing suitable embankment material to backfill to the proposed design grade.

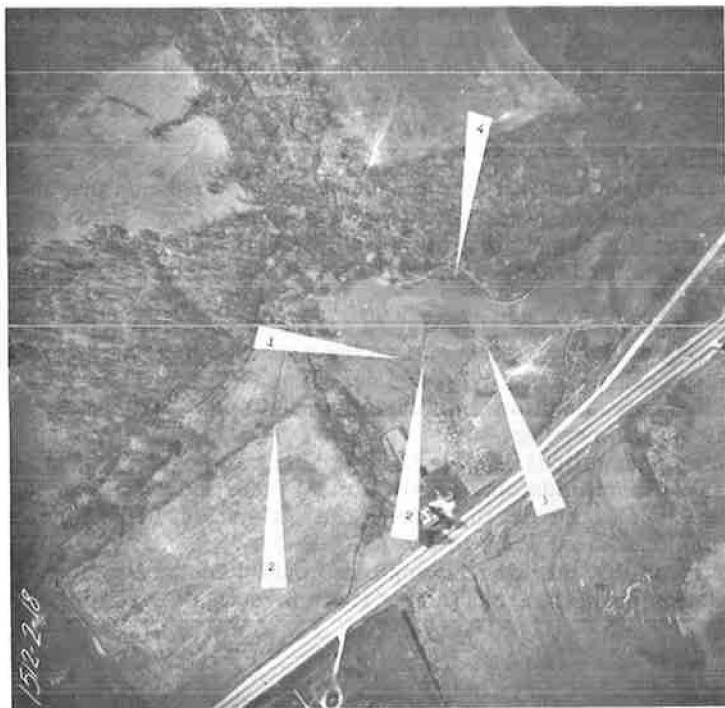
Figure 2. Unstable soil conditions (1 is soil slumping, 2 is springs, 3 is small alluvial fans, and 4 is wet, unfarmed meadow).

Convergent evidence of unstable conditions include light and dark photograph tones of slope slumping, springs issuing from midslope, small alluvial fans, and an unfarmed wet meadow from the toe of the slope to the run that drains the valley (Fig. 2). An embankment superimposed on this slope failed prior to paving (Fig. 3).

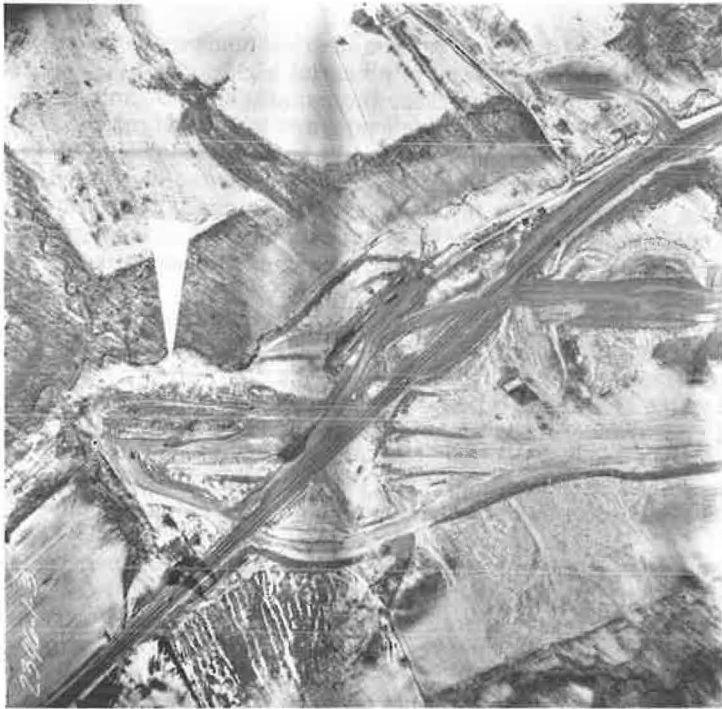
Figure 3. Embankment failure.

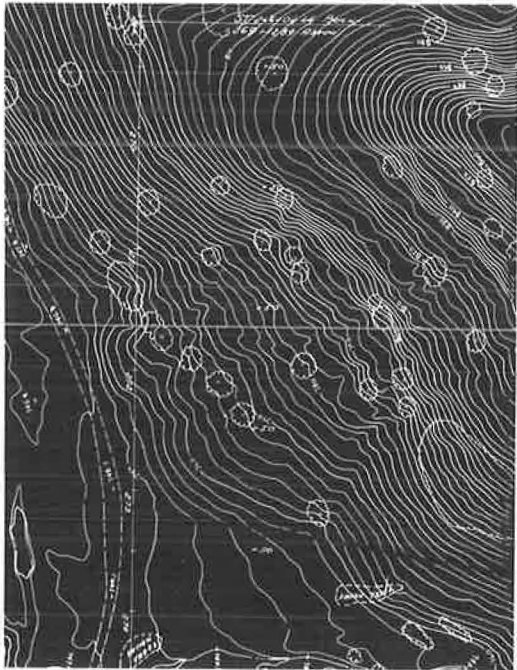
Figure 4. Highway design map.

Figure 4 shows a portion of a highway design map. It was produced prior to the landslide research. Disorientation of the contours on one area of the slope vividly contradicts the adjacent contours where the slope is stable.

A proposed highway centerline traverses the lower portion of the slide area.

To preserve the original appearance of the map no delineation has been done. This enables the viewer to judge the contour anomalies.

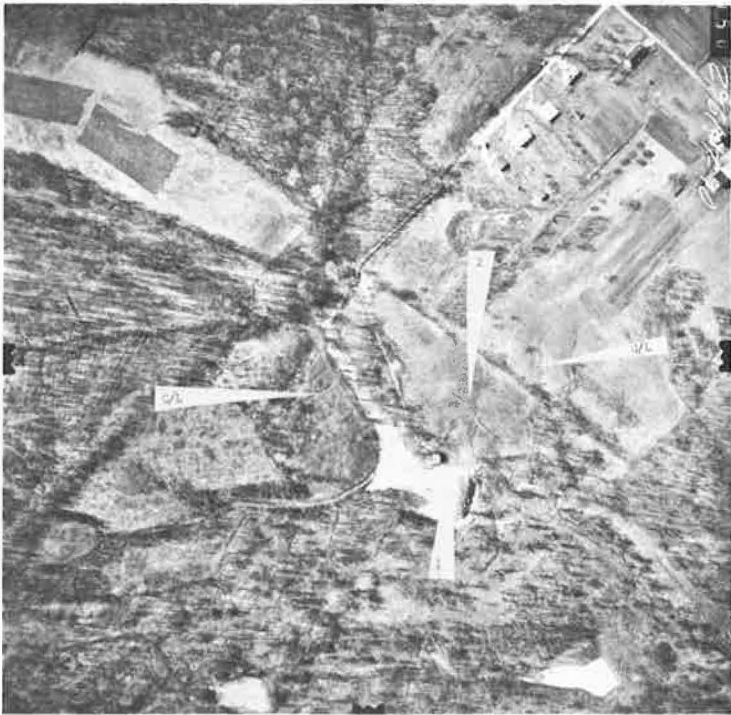
Figure 5. Landslide area (1 is landslide, 2 is interceptor ditch, and 3 is proposed centerline for highway).

After the landslide research had been completed and the compilers trained to recognize unstable conditions, a landslide was detected during highway design mapping (Fig. 5).

Apparently removal of the toe-of-slope material to construct the earthen dam and the associated saturation resulting from the ponded water conjoined to trigger the landslide.

The diagonal line above the landslide is an interceptor ditch that was apparently installed to divert upslope water away from the slide.

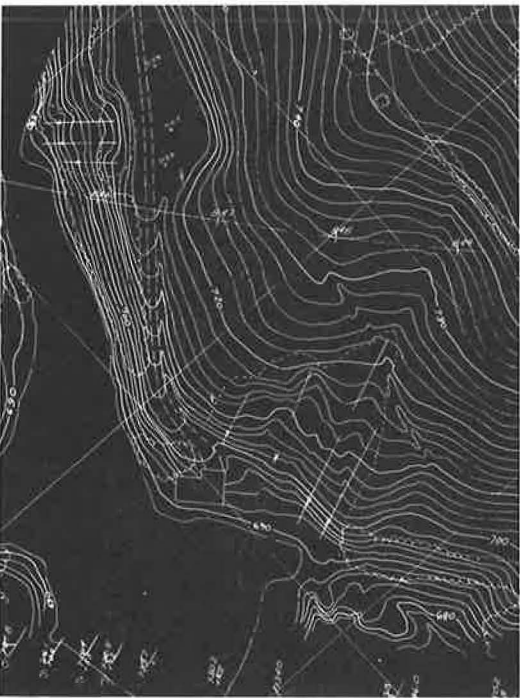
Figure 6. Highway design map produced from Figure 5.

Figure 6 shows a portion of the highway design map produced by a stereocompiler using the photography shown in Figure 5.

The limits of instability are indicated by the dashed line shown in Figure 6.

The arrows symbolize the slope movement and its direction.

Contour configuration is anomalous thereby delineating the unstable area and the interceptor ditch.

Special highway design to treat this instability was provided because part of an embankment was to be placed on the landslide.

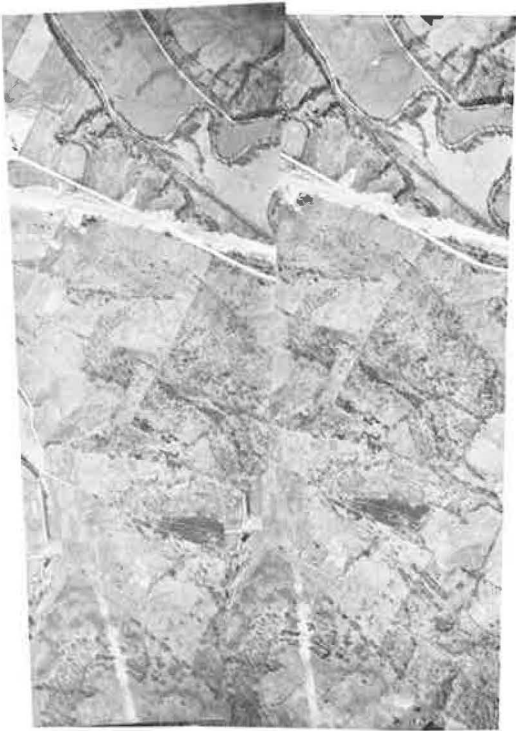
Figure 7. Stereopair showing gentle slope bracketed between resistant rocks.

At the northern boundary of this project, the gentle slope occupied a midslope position. The regional trend of the strata along the proposed highway is southward, descending about 30 ft per mile; therefore, at a point 6 miles south along the study area, the lower resistant rocks and the lower part of the softer strata had passed below the point to which erosion had progressed. Figure 7 shows the gentle, unstable slope bracketed between more resistant stratigraphic members.

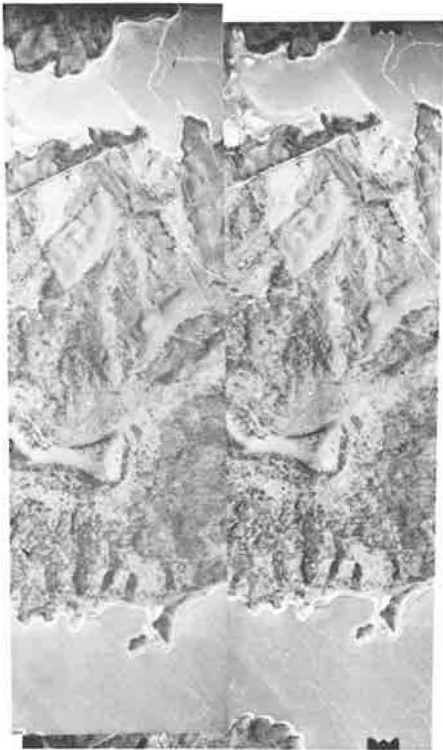
Figure 8. Stereopair showing drainage channels in lower resistant rocks and lack of channels on Upper Conemaugh red beds.

Figure 8 shows a classic Upper Conemaugh landform including the steeper Monongahela rocks capping the hill. Note that lower resistant rocks, from the reservoir shore to the Upper Conemaugh red beds, have drainage channels incised into them, but they tend to terminate at the base of the gentle slope.

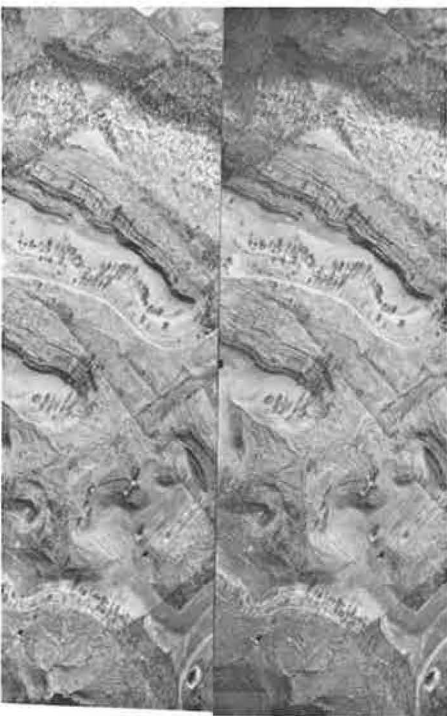
Figure 9. Stereopair showing sliding red bed gentle slopes.

Following detection of this regional photograph pattern, a section of the manual was devoted to examples from the counties where the Upper Conemaugh red beds outcrop. The slopes shown in Figure 9, photographed 35 miles southwest of the landform shown in Figure 8, make up one of the best stereopairs obtained. The text contained this statement: "Sliding is so prevalent that mapping the areas which are not sliding would greatly simplify the plotter operator's task."

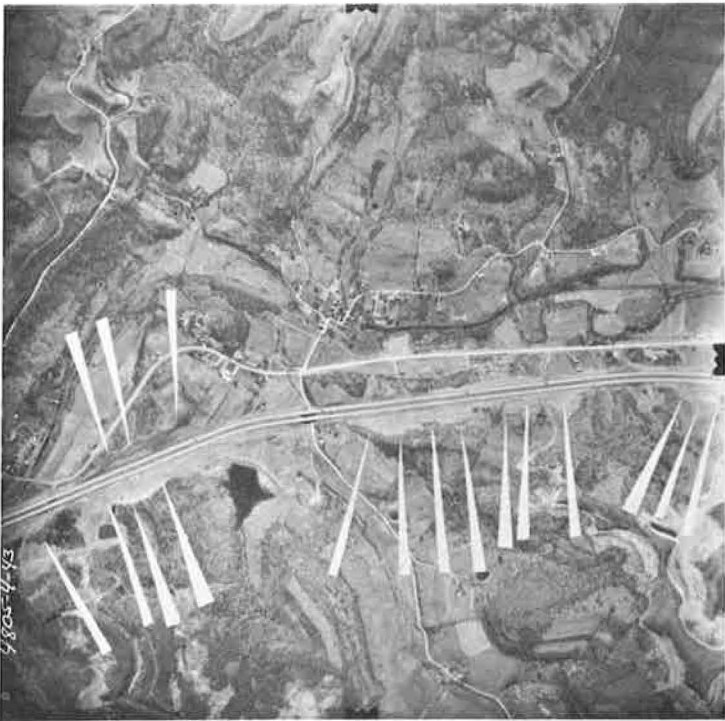
Figure 10. Back slope movements in red beds.

Although special highway design had been incorporated into the plans to minimize the problems associated with these strata, Figure 10 shows delineations of detectable backslope movements along approximately 9,000 ft of the new highway.

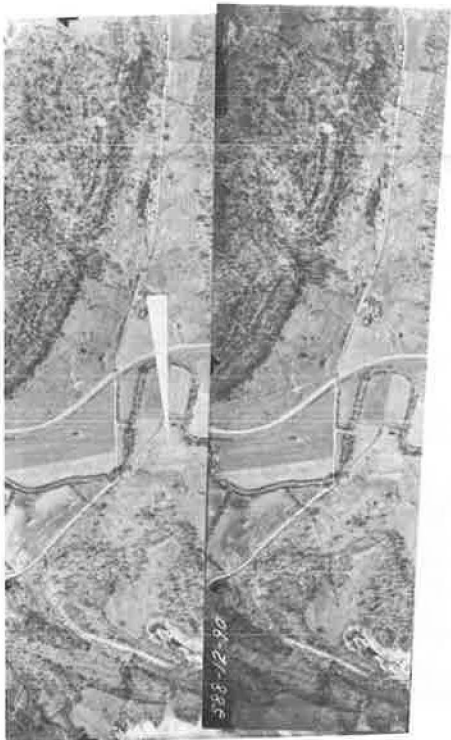
Figure 11. Occurrence of red beds.

Figure 11 shows that red beds occur from the floodplain up to the Monongahela caps. The lower resistant rocks have dipped below the point to which erosion has progressed. The delineator indicates a bulge that "appears to be stable."

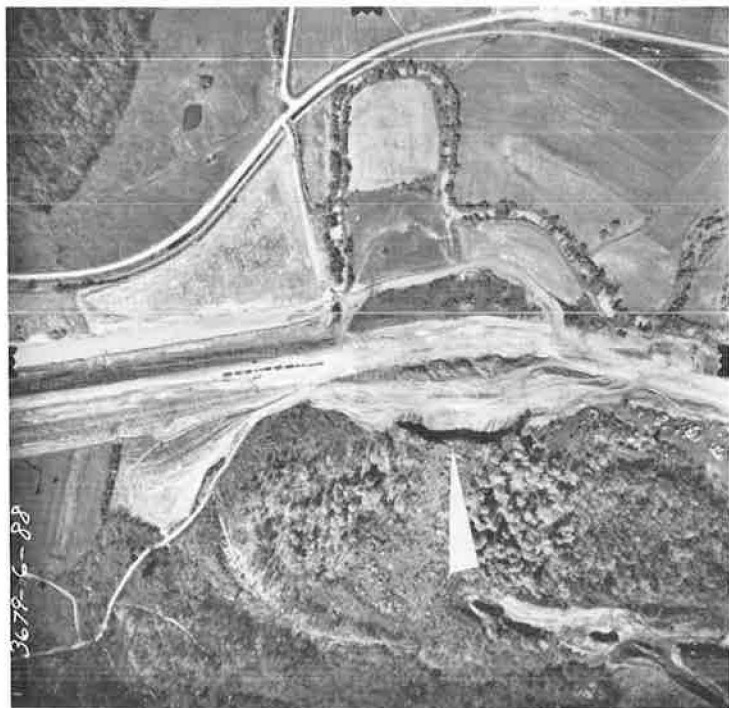
Figure 12. Bulge during highway construction.

Figure 12 shows the bulge during highway construction. The delineator indicates the scarp of the landslide involving the bulge.

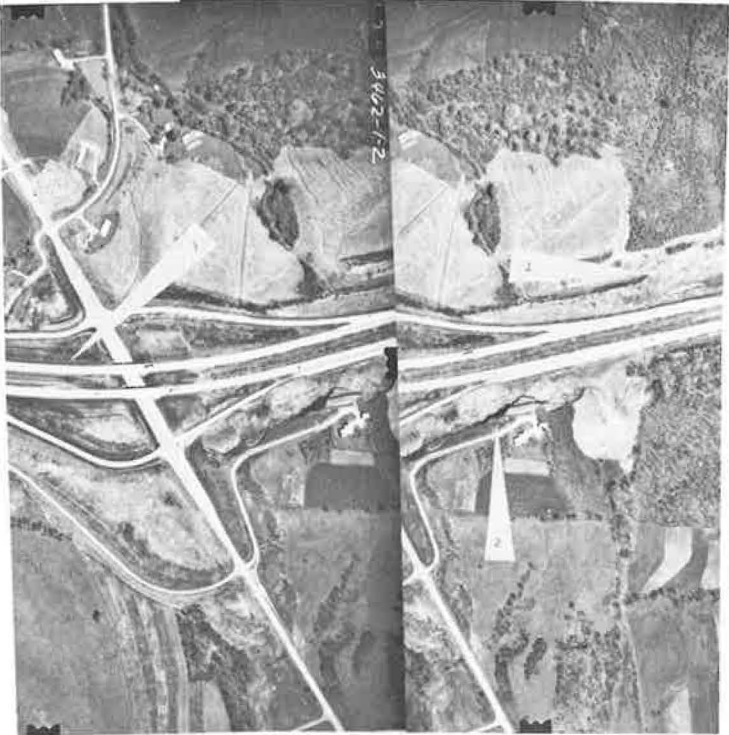
Figure 13. Red bed performance on east-west Interstate highway (1 is back slope slide during construction, 2 is closed ramp, and 3 is location where westbound lanes were closed).

Miles away the red beds also outcropped along this east-west Interstate highway (Fig. 13).

Figure 13 shows the location of back slope slides that occurred during highway construction and the location where the westbound lanes were closed during the summer of 1971 due to slope instability. Also shown is a closed on-ramp. Today the entire back slope has been flattened, and the residence has been moved.

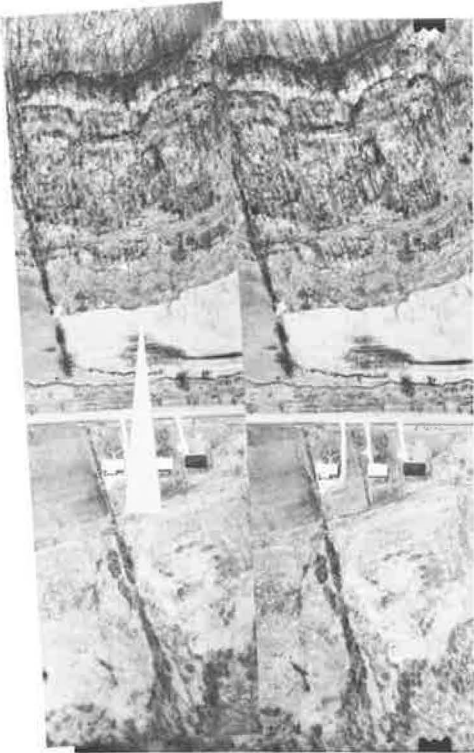
Figure 14. Spoil slide bulldozed to red bed slope.

Figure 14 shows a spoil slide that has carried with it trees and slope soil. It is encroaching into a portion of a cultivated field as delineated.
