HIGHWAY RESEARCH RECORD

Number | Highways and
479 | the Catastrophic Floods

| of 1972

11 reports
prepared for the
52nd Annual Meeting

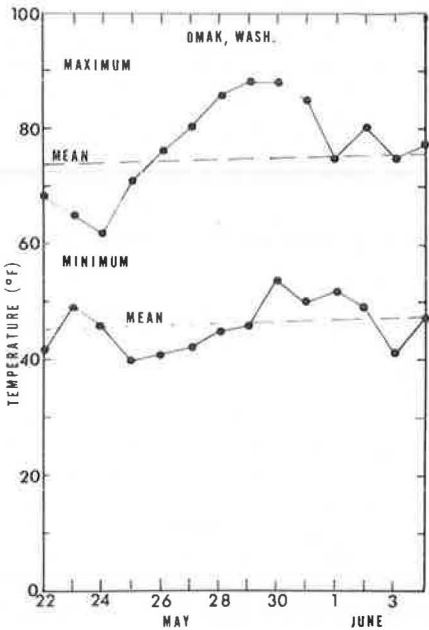
Figure 2. Maximum and minimum temperatures at Omak, Washington, during latter part of May and early June 1972.

The temperature conditions in the north-central part of Washington during the latter part of May and early June were more common for a period in mid to late summer. A high-pressure system off and along the Pacific coast brought a flow of air off the warm Pacific Ocean, across the Cascades, and down into the interior of the state. Through the Pacific Northwest, there were generally light winds and clear skies. These conditions were conducive to bright sunshine, which pushed the maximum temperatures into the 80s and low 90s over most of interior Washington and Oregon. Figure 2 shows the daily maximum and minimum temperatures at Omak, Washington. Such temperatures were not representative of this region for so early in the summer season and resulted in relatively rapid melting of heavy snowpack over the mountains of northern Washington, which was the primary cause of the heavy flooding through the Okanogan valley region.

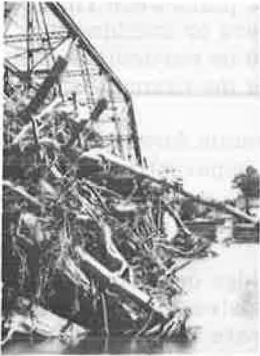
Figure 1. Debris deposited on bridge by floodwaters.

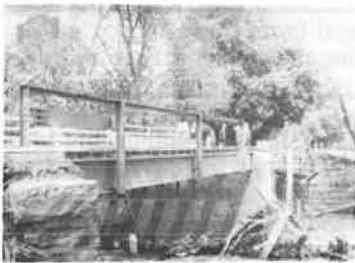
Figure 2. Cracked pier cap on Towanda Creek bridge in Powell, Penn.

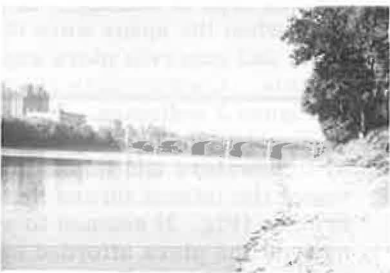
Figure 3. Arch bridges, such as the Market Street bridge in Wilkes Barre, Penn., were most damage-resistant.

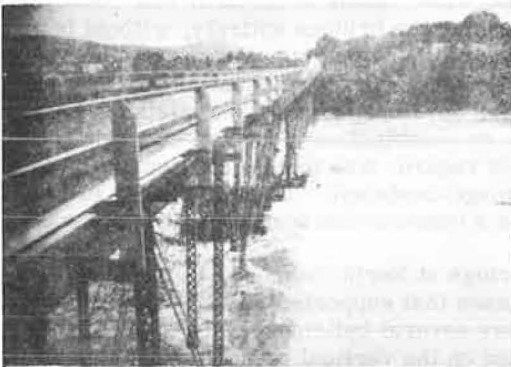
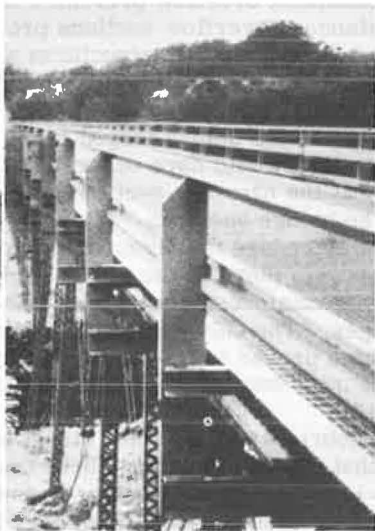
Figure 4. Large deflection of (a) the upstream truss and (b) the downstream truss of the James Street bridge in North Towanda, Penn.

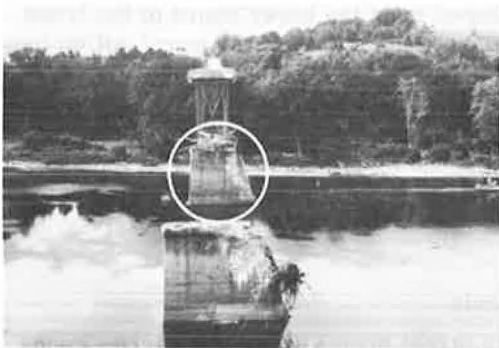
Figure 5. Post-flood remnants of the James Street bridge.

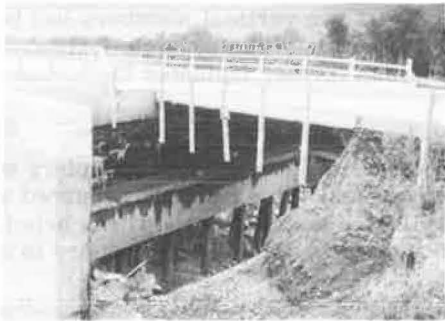
Figure 6. Exposed piling and undermined abutment of Chemung River bridge.

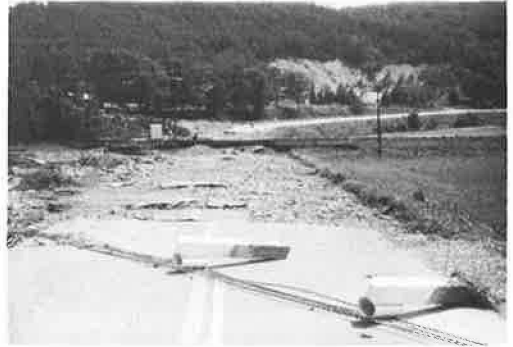
Figure 8. Approach damaged by overflow on Tioga River bridge.

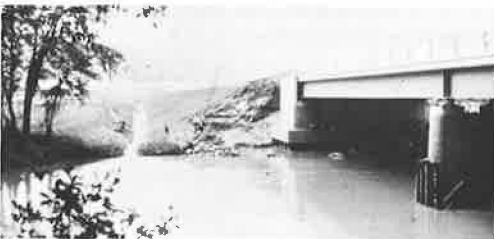
Figure 10. Upstream view of scoured bridge abutment and approximately 2 ft of exposed piling on Canisteo River bridge.

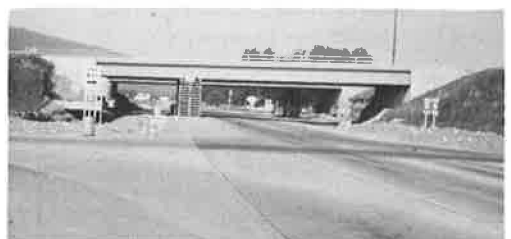
Figure 11. Timber cribbing supporting US-17 interchange bridge until abutments could be underpinned.

survived because the steel superstructure prevented collapse. The structure was closed to traffic and braced by timber cribbing until the footings could be underpinned.

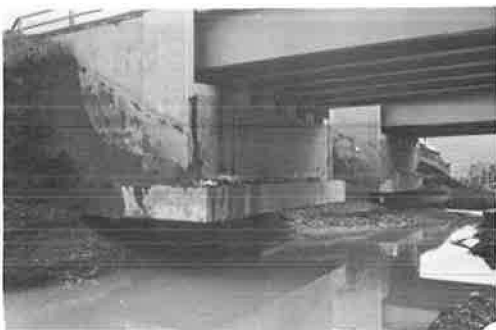
Figure 12. Scour beneath and behind abutments on US-15 interchange bridge.

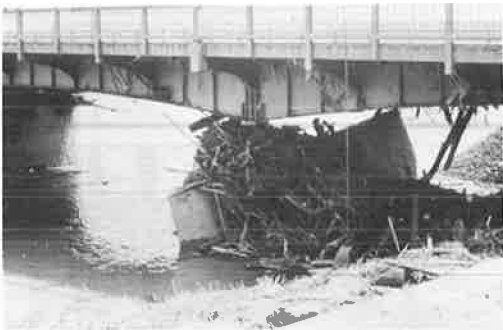
Figure 13. Settlement due to scour on Chemung River bridge in Elmira, N.Y.

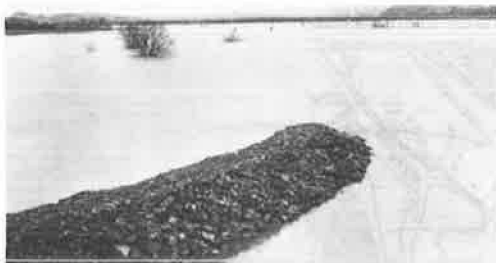
Figure 14. Rockfill spur dike near Susquehanna River bridge in Nanticoke, Penn., during 1964 flood.

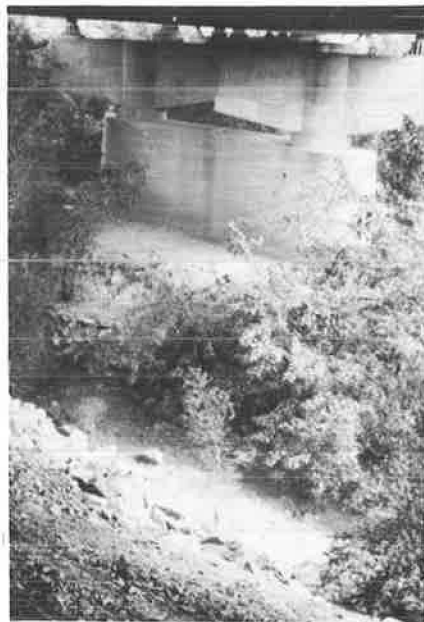
Figure 15. Post-flood condition of floodplain between abutment and adjacent pier of Susquehanna bridge.

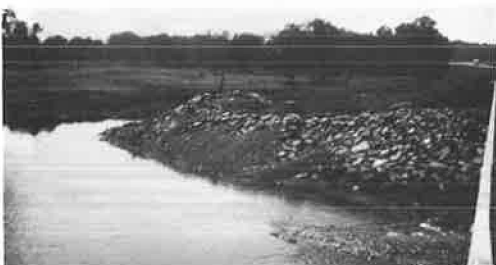
Figure 16. Remnants of earthfill spur dike near Chemung River bridge near Lowman, N.Y.

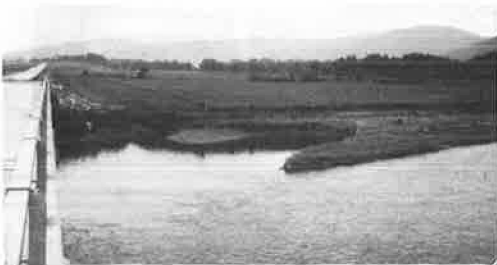
Figure 17. Enlarged scour hole upstream from Chemung River bridge in Waverly, N.Y.

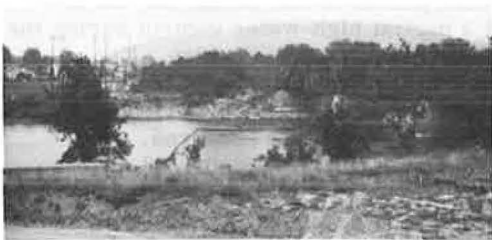
Figure 19. Upstream scour hole, eroded approach embankment, and damaged abutment of Lehigh Valley Railroad bridge.

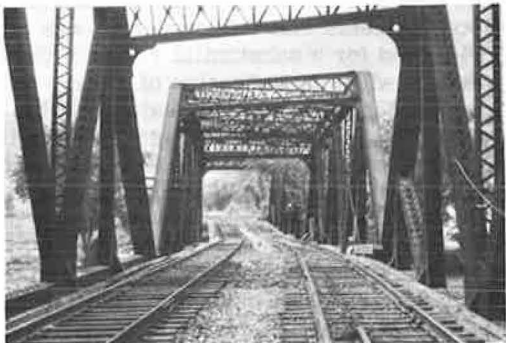
Figure 20. Downstream view of Lehigh Valley Railroad bridge showing pier settlement.

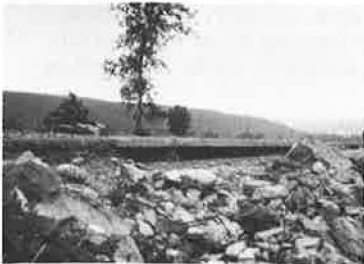
Figure 22. Undermined roadway slab and scoured embankment fill adjacent to Tioga River.

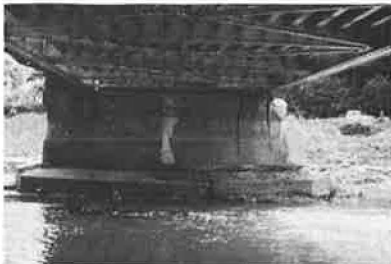
Figure 23. Cracked pier shaft supporting a county bridge on Schrader Branch of Towanda Creek.

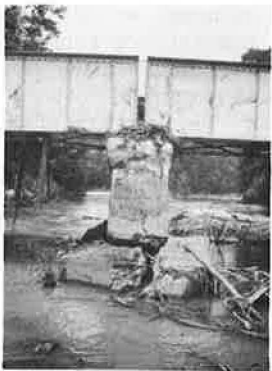
Figure 24. Front view of cracked pier shaft and broken pier footing.
