NATIONAL COOPERATIVE HIGHWAY RESEARCH PROGRAM  
REPORT

**101**

**EFFECT OF STRESS ON  
FREEZE-THAW DURABILITY OF  
CONCRETE BRIDGE DECKS**

HIGHWAY RESEARCH BOARD

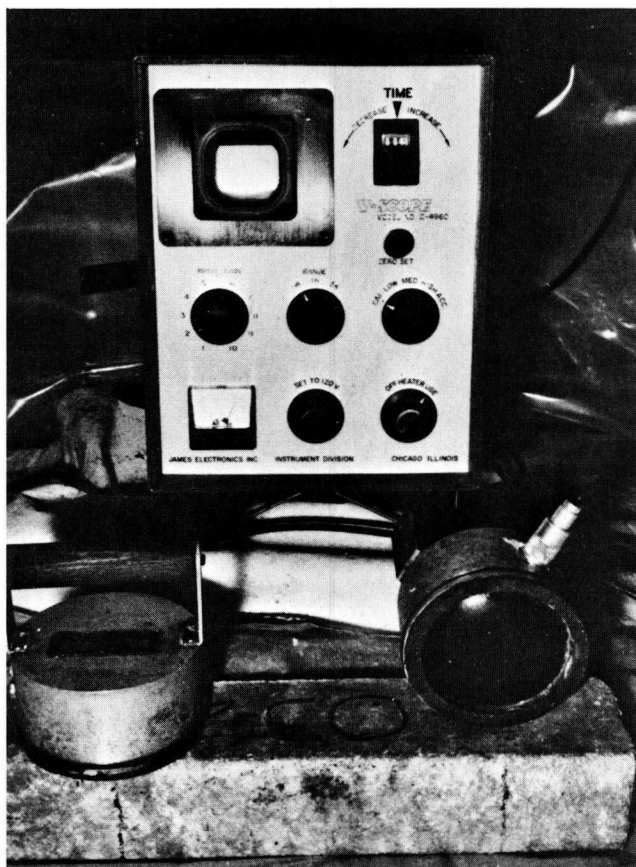
Figure 3. Sonic testing apparatus.

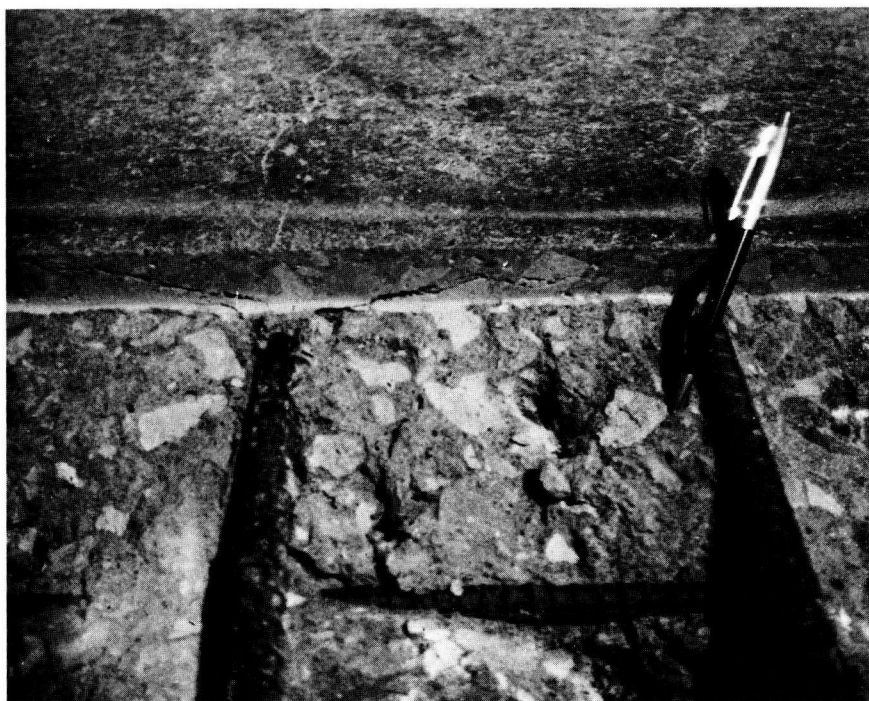
*Figure 143. Bridge deck deterioration resulting from reinforcement corrosion at transverse cracks.*
