NATIONAL COOPERATIVE HIGHWAY RESEARCH PROGRAM
REPORT

129

GUARDRAIL CRASH TEST EVALUATION

HIGHWAY RESEARCH BOARD 1972

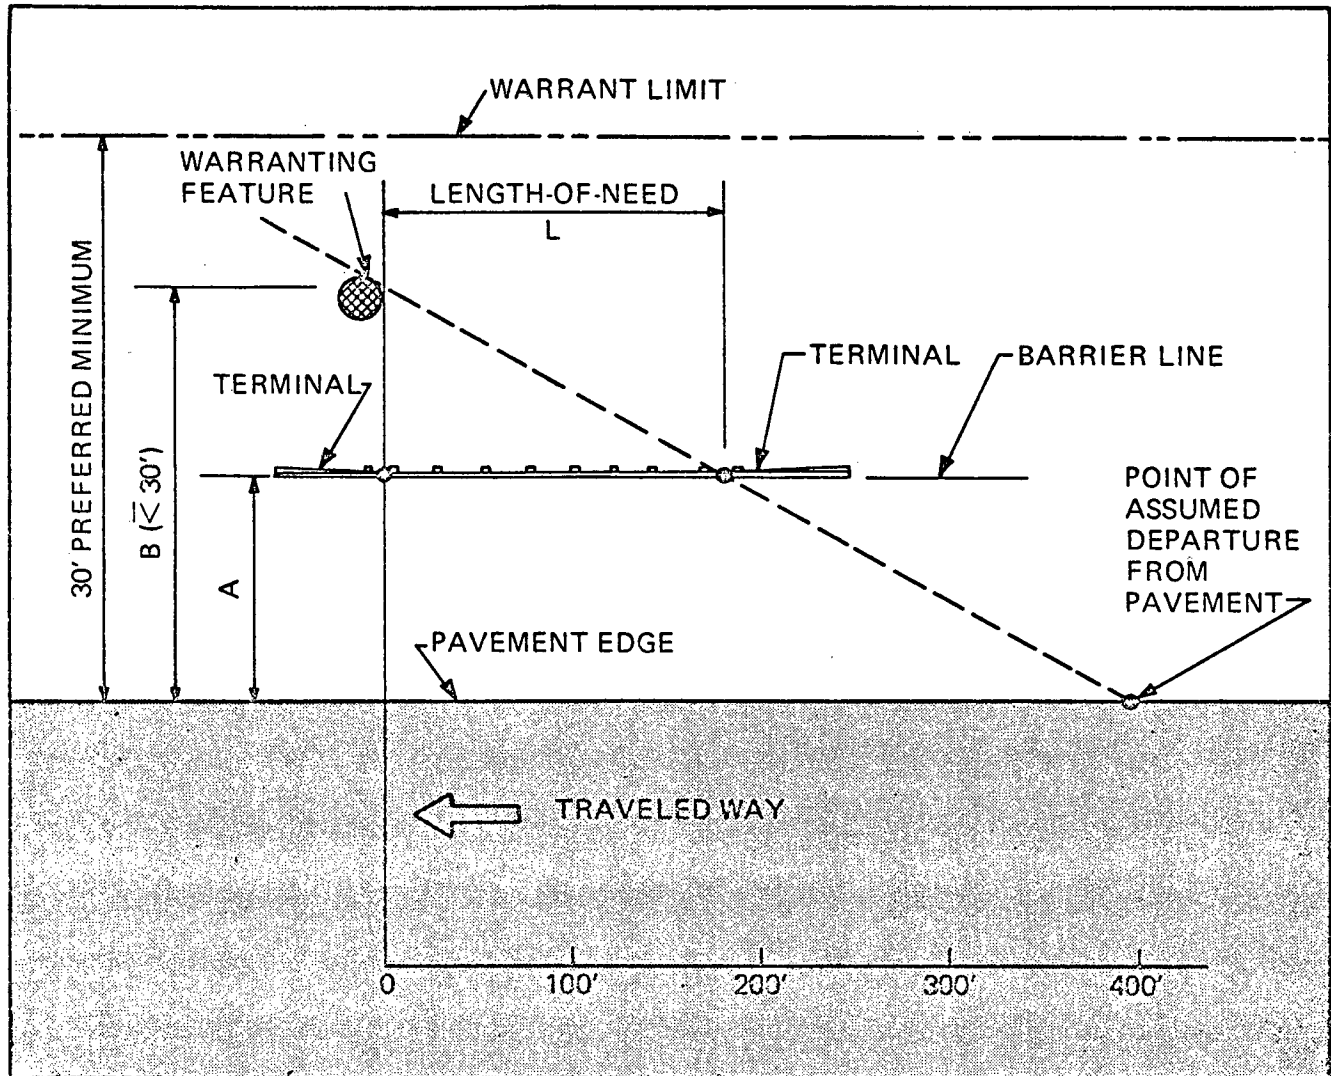
Figure 1. Barrier length-of-need determination.

where the terms are defined in Figure 1. As an example, for an installation to be located 12 ft from the pavement edge shielding a hazard that is 22 ft from the pavement edge, the length-of-need is $L = (1 - 12/22)400 = 180$ ft. Terminal lengths are added to develop the structural effectiveness of the system at the length-of-need extremities.

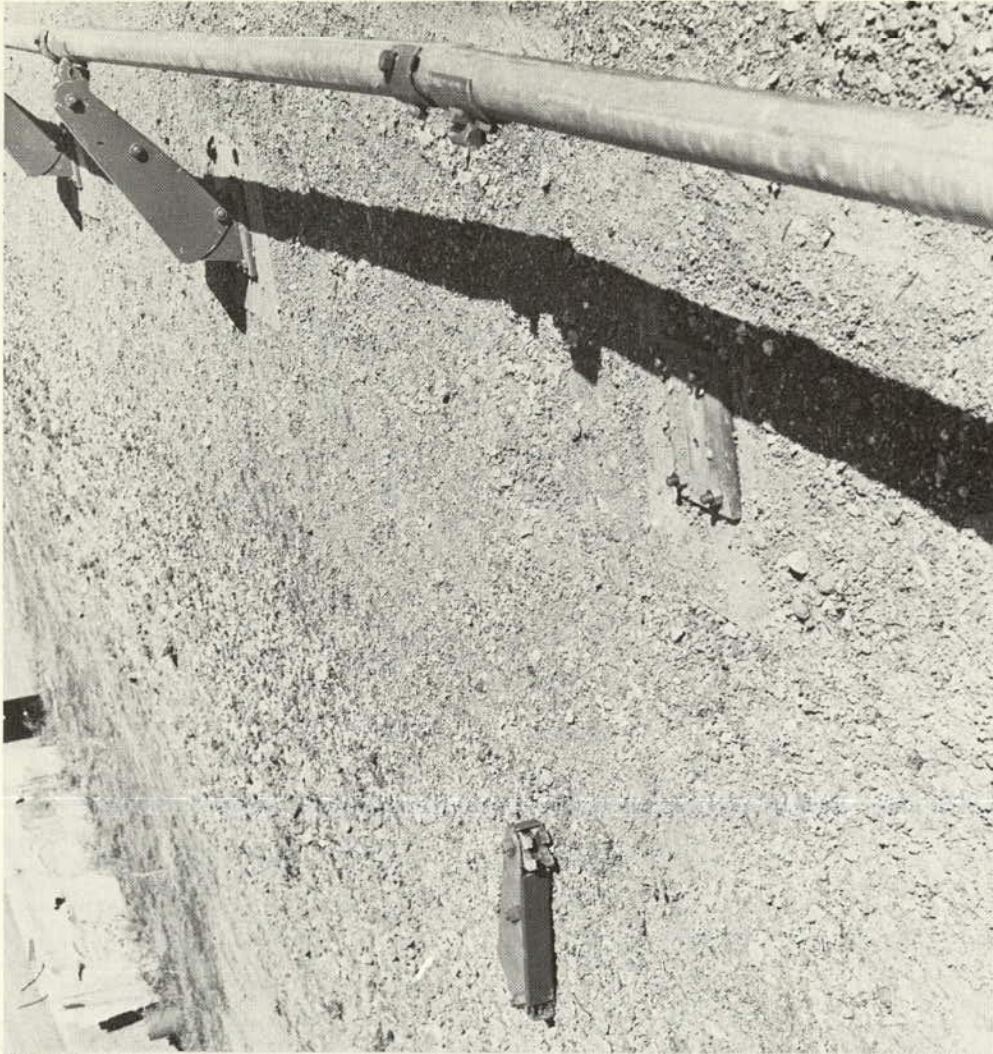
(b) Post 9

(a) Looking downstream

Figure A-3. Installation damage, Test 126.

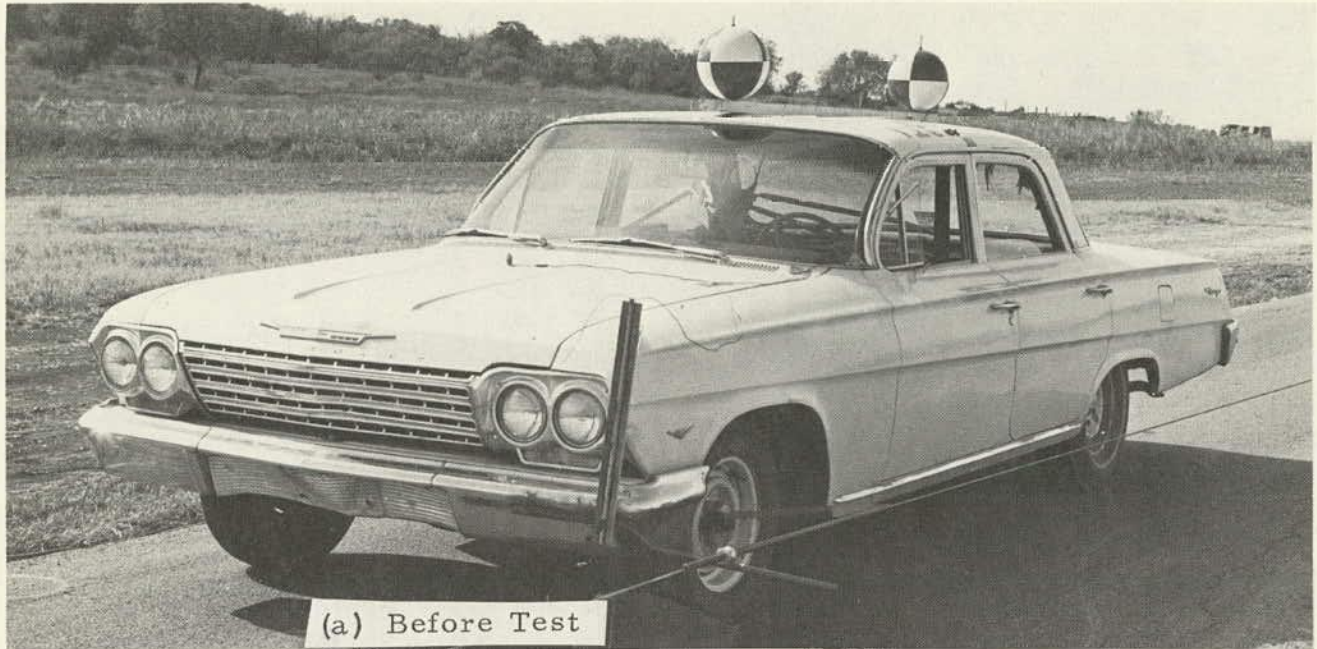
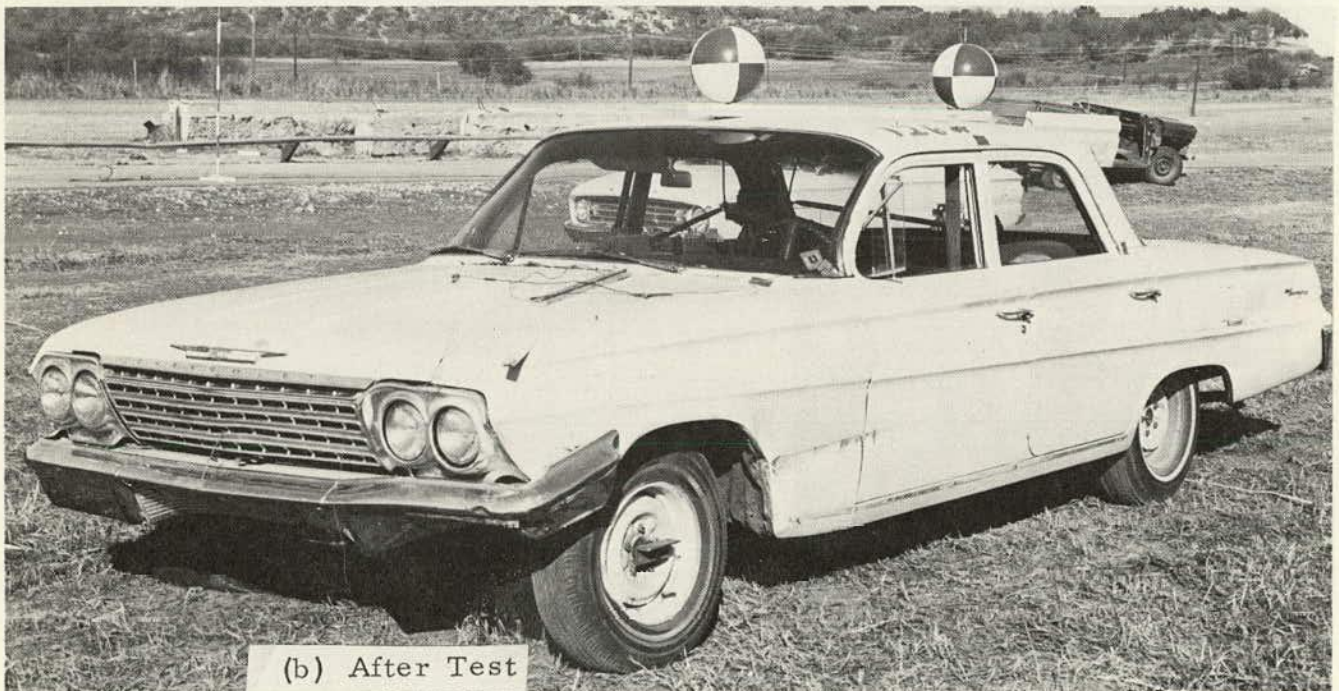
Figure A-4. Vehicle damage, Test 126.

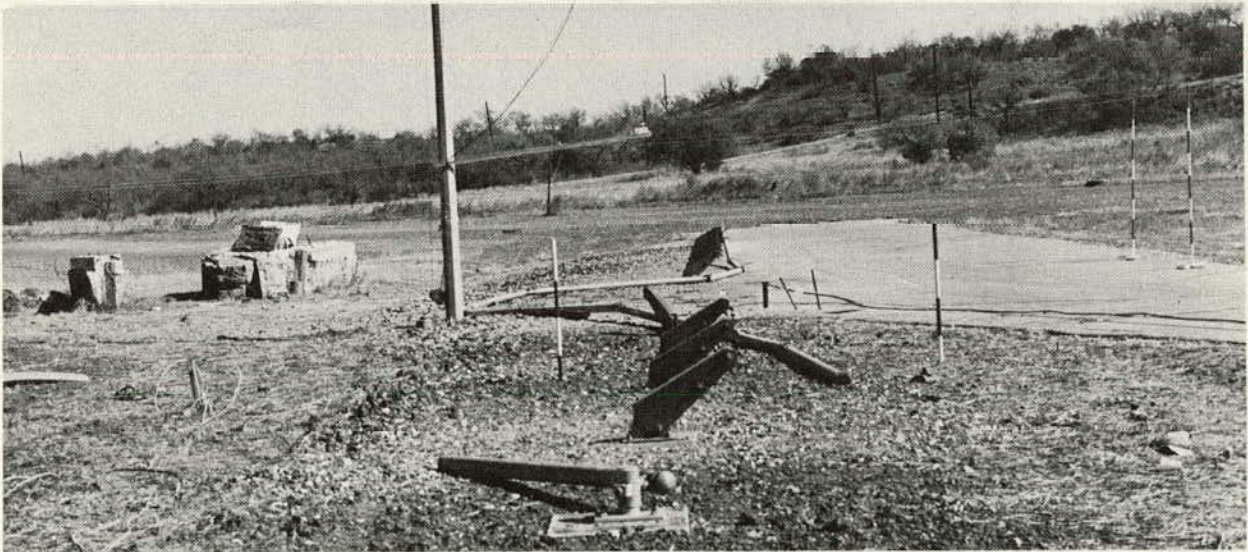
(b) Looking Downstream

Figure A-6. Installation damage and final vehicle position, Test 127.

Installation Damage.—Damage to the installation was confined to the impact area. Four posts were sheared (bolt shear) from the bases and displaced as follows:

POST NO.	FINAL LOCATION
8	10 ft behind Post 10
9	17 ft behind Post 12
10	9 ft behind Post 17
11	12 ft behind Post 14

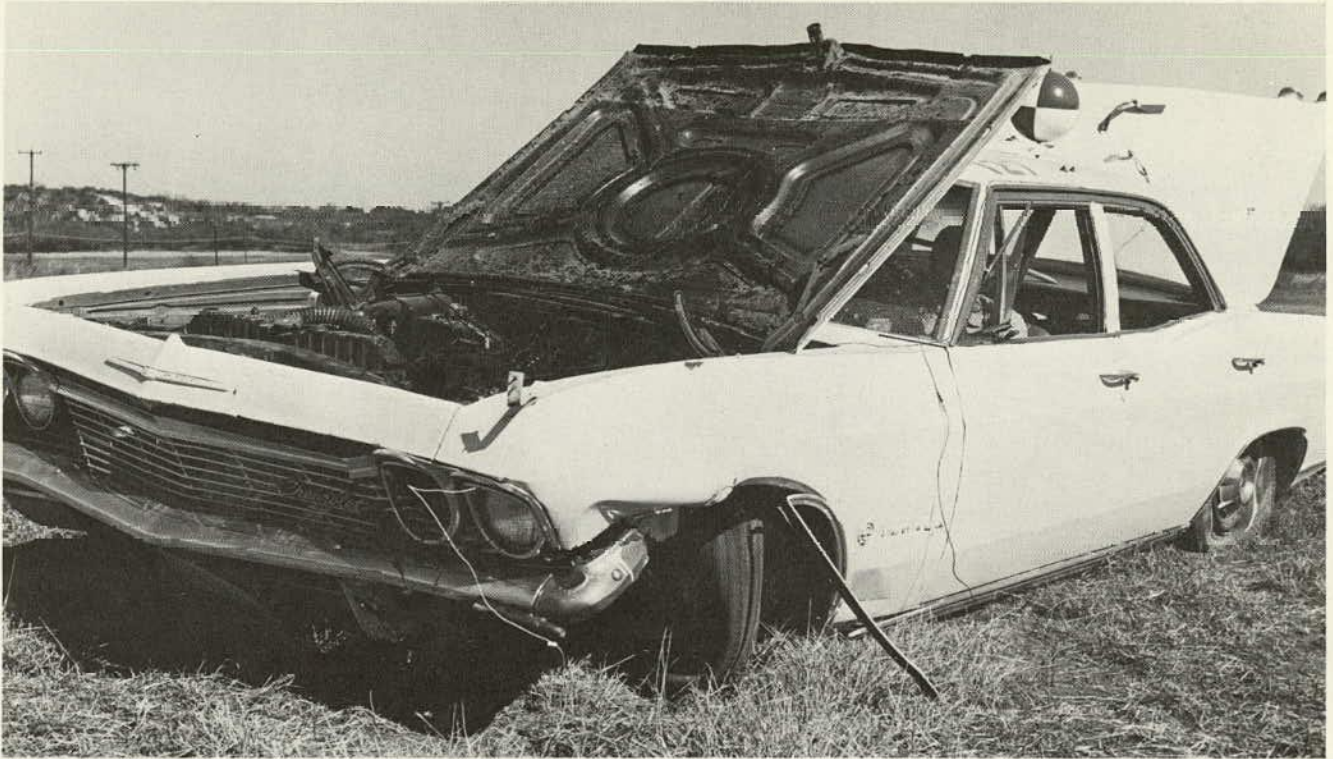
Figure A-7. Vehicle damage, Test 127.

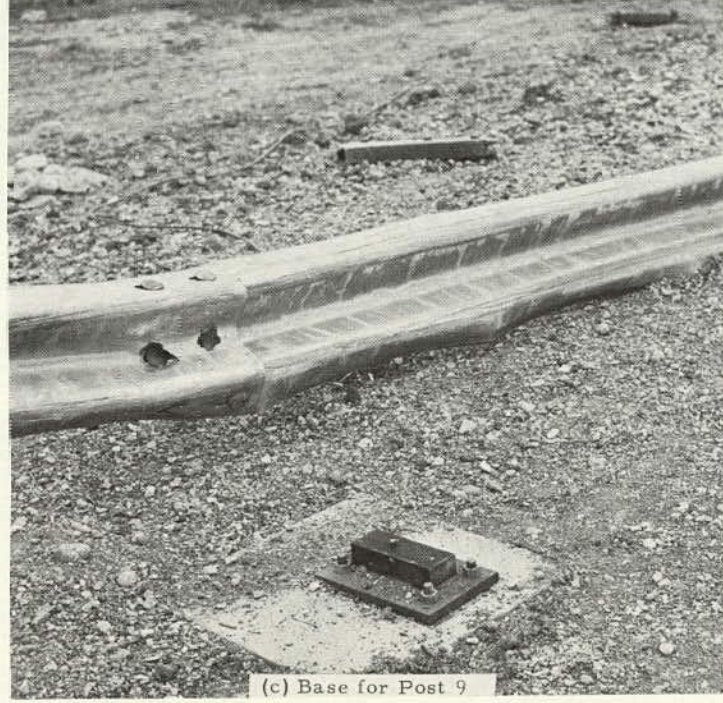
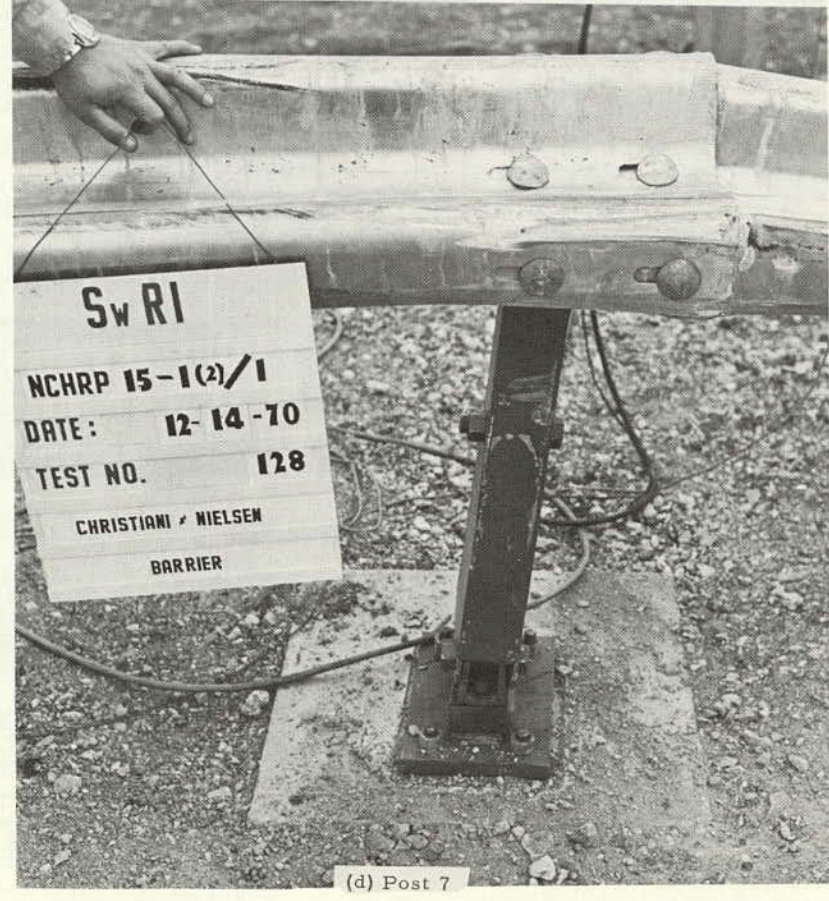
Figure A-10. Installation damage, Test 128.

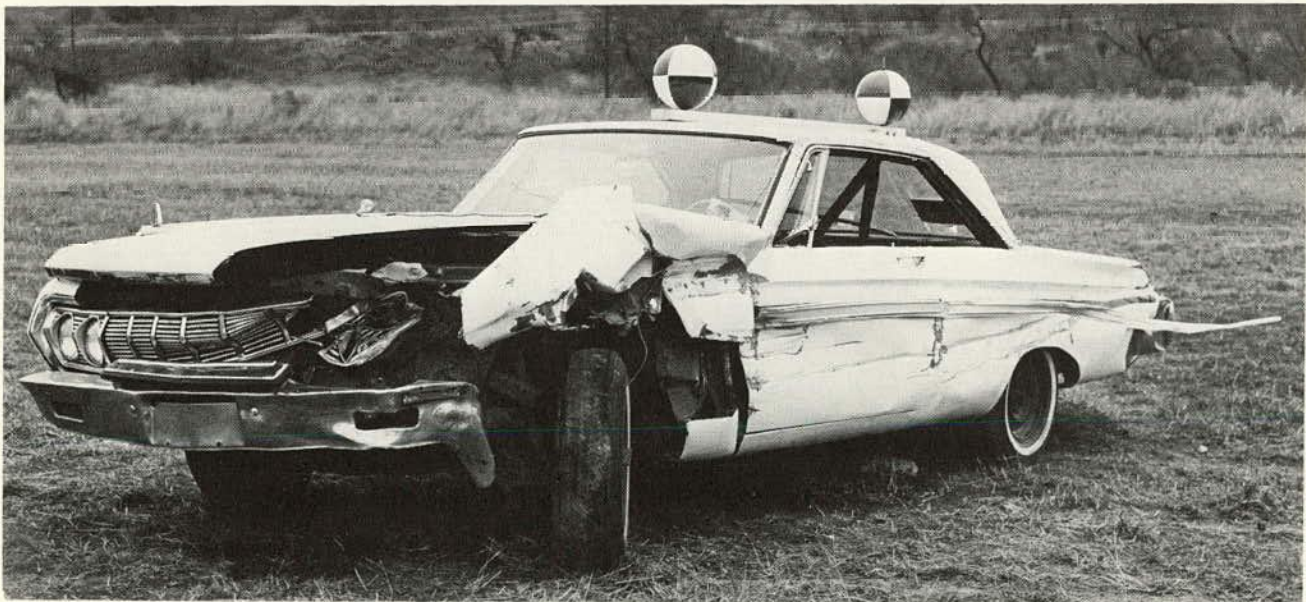
Figure A-11. Vehicle damage, Test 128.

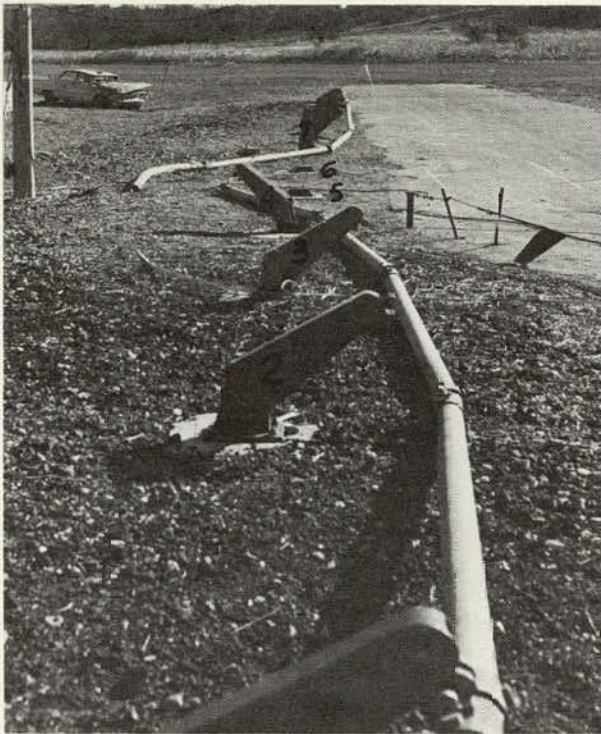
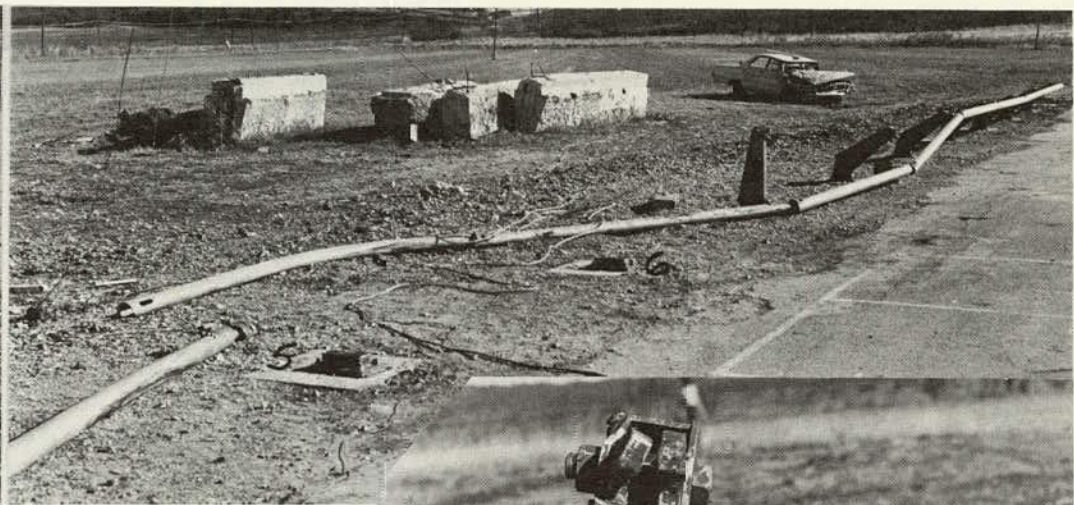
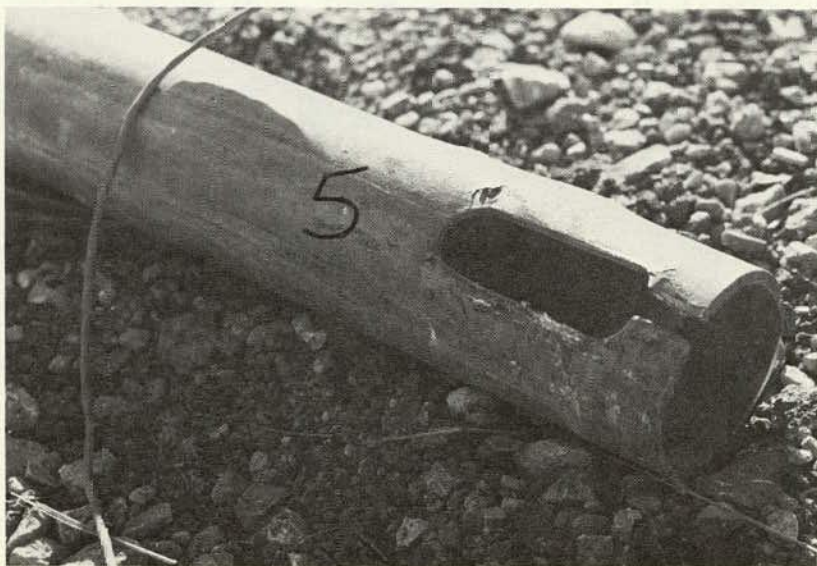
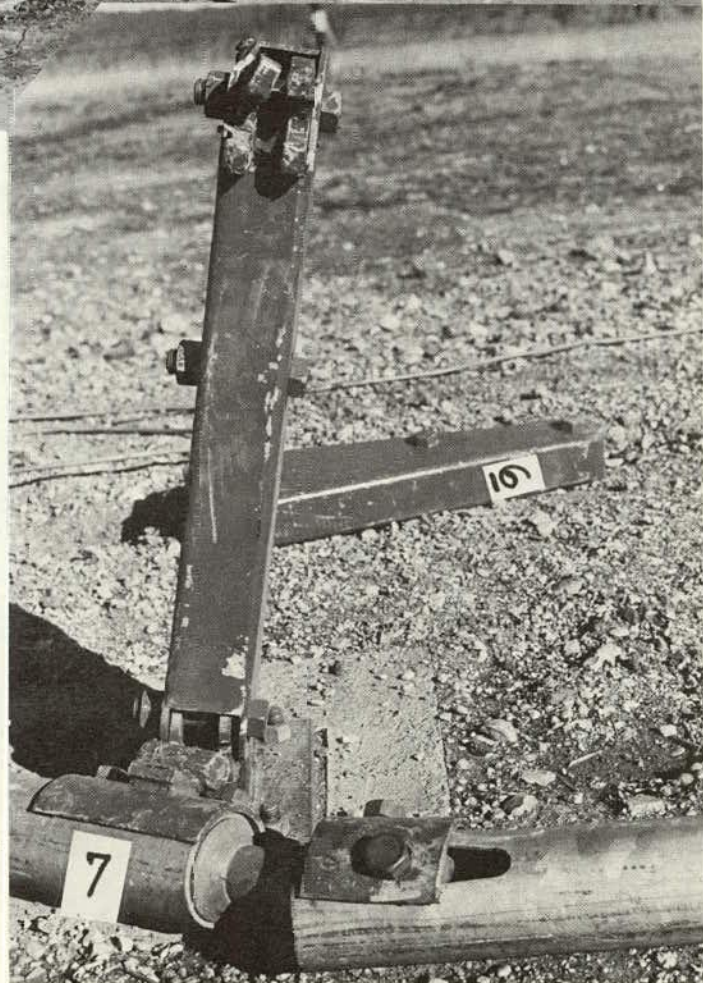
Figure A-15. Installation damage, Test 129.

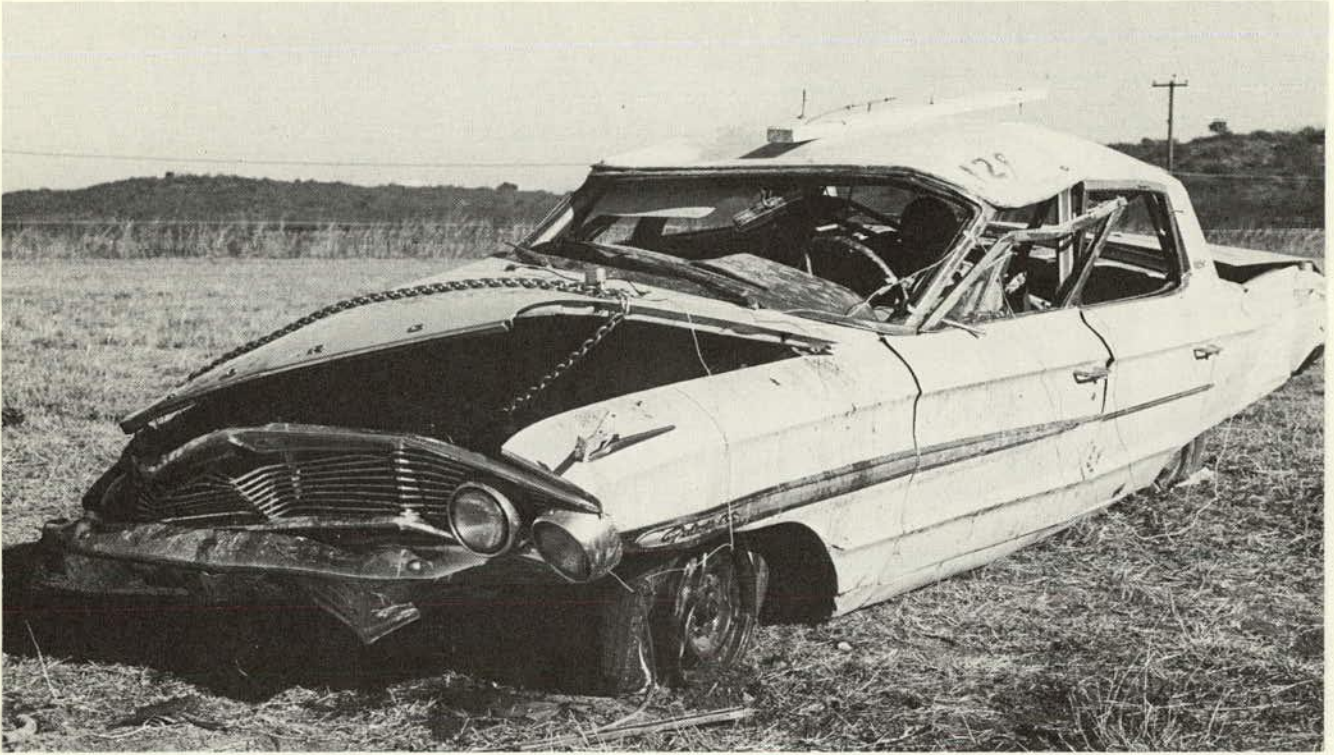
Figure A-16. Vehicle damage, Test 129.

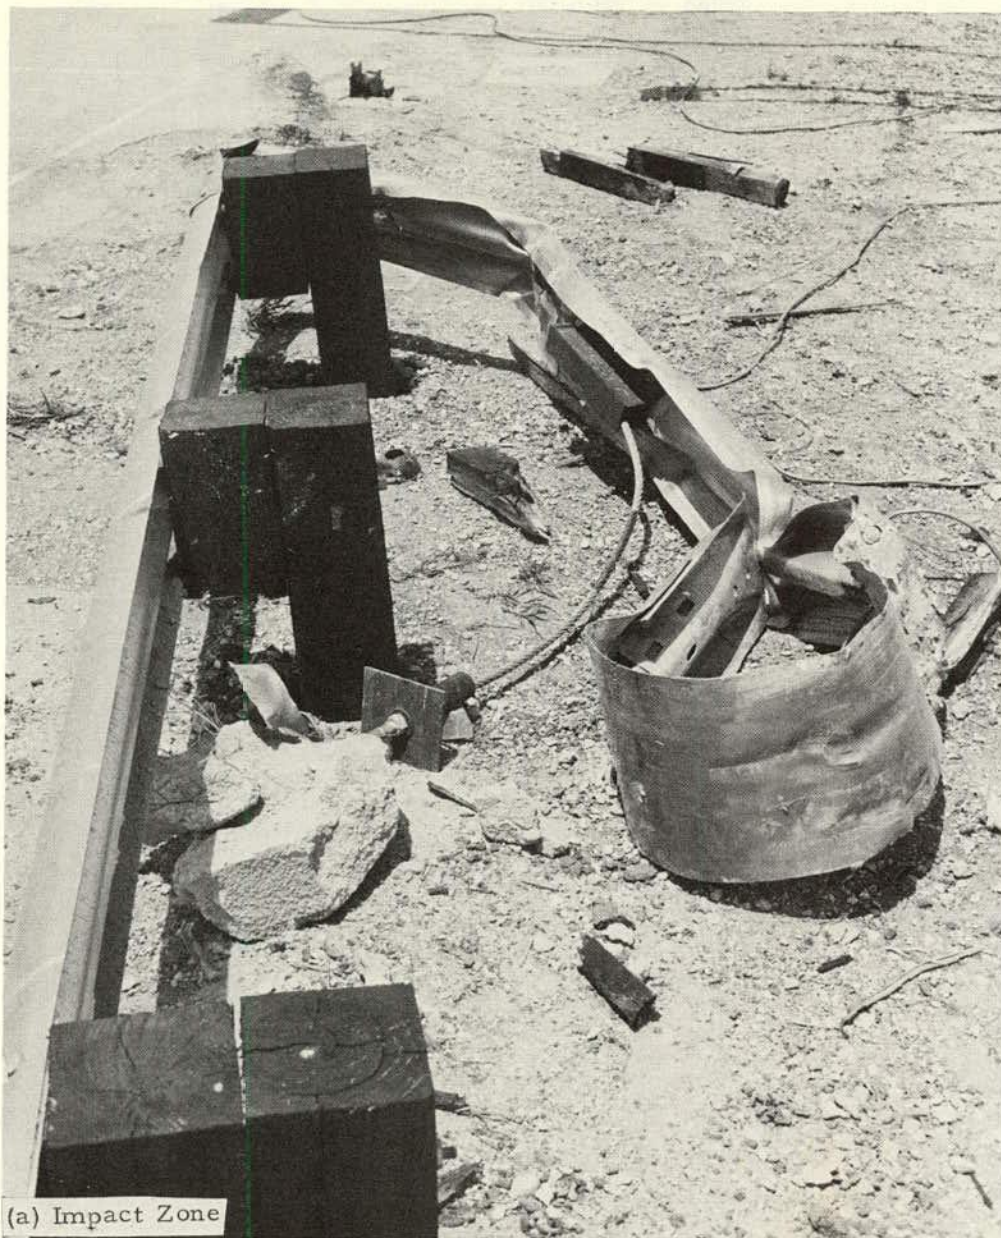
(a) Impact Zone

(c) Post No. 1 Fragments

Figure A-24. Installation damage, Test 130.

Installation Damage.—The first two posts fractured near grade level (Fig. A-23), and the first two 6.25-ft beam panels bent and pivoted about the third post to the rear of the barrier system. The lightweight concrete separated

from the circular end piece and fractured into several large parts. The circular end piece was only partially deformed during impact. Posts 3 and 4 deformed slightly in the soil (less than 2-in. gap at grade); otherwise the installation

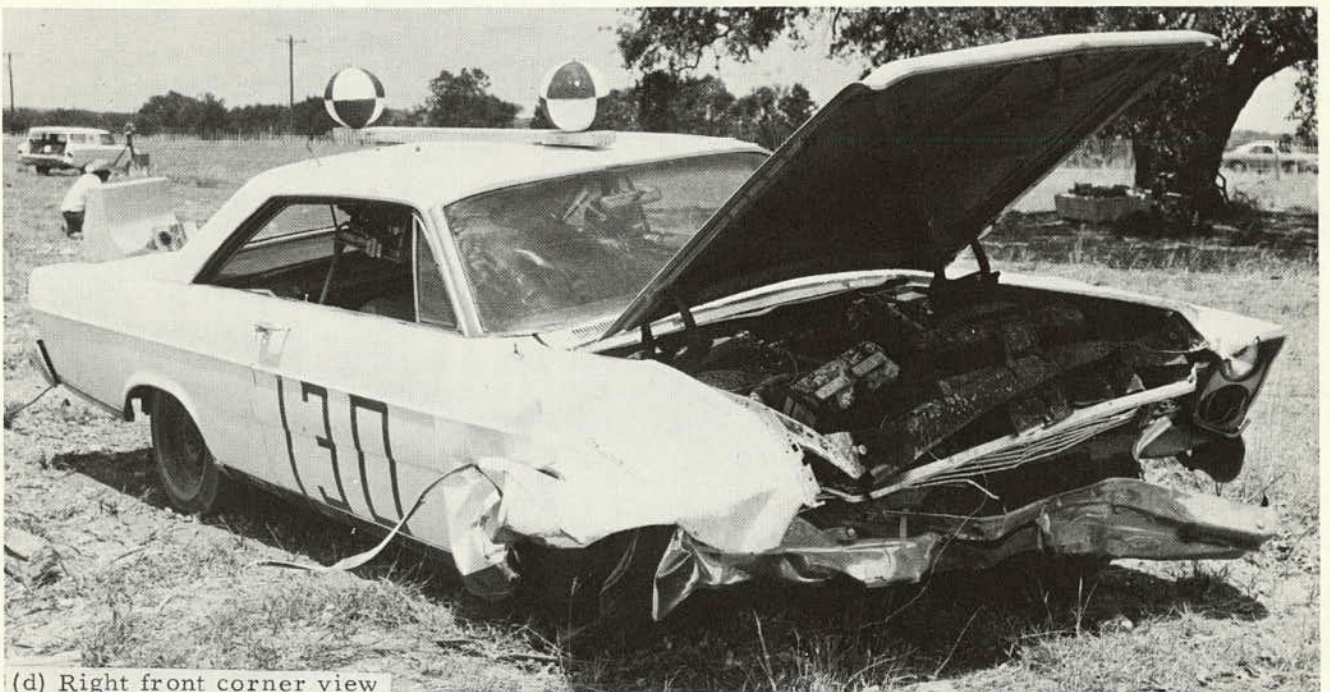
(d) Right front corner view

Figure A-25. Vehicle damage, Test 130.

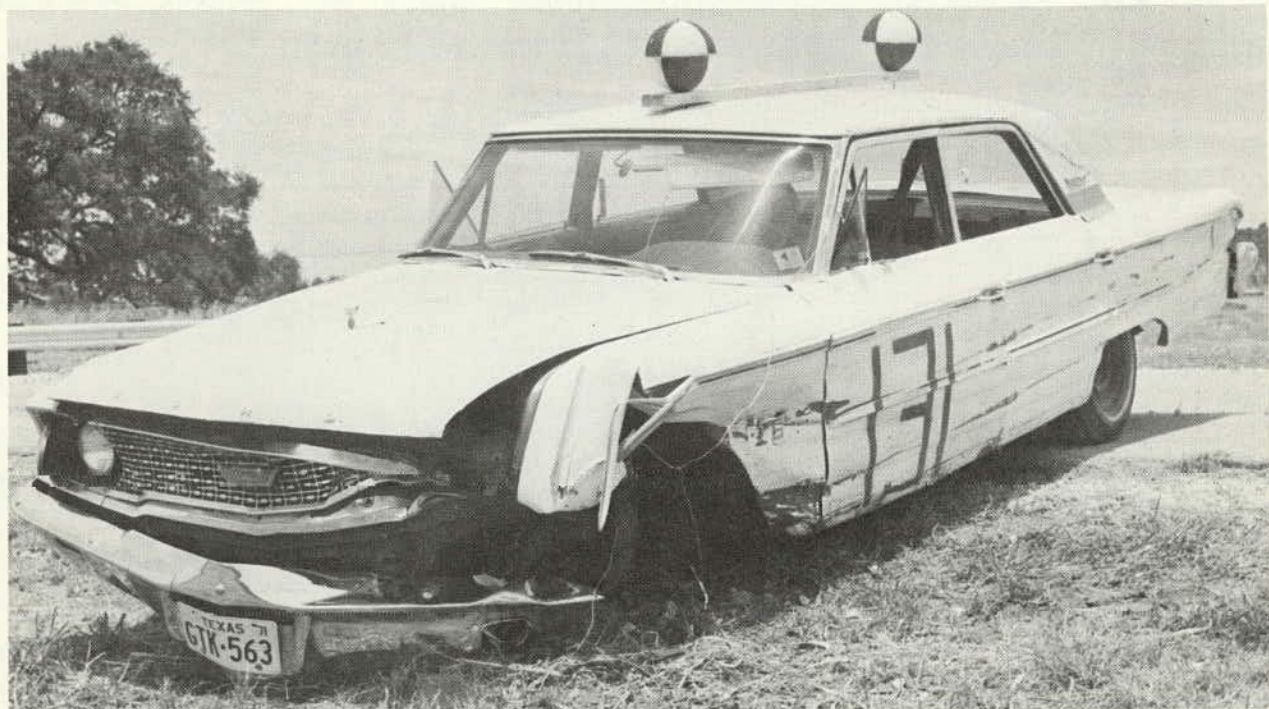
(c) Vehicle damage

Figure A-28. Installation and vehicle damage, Test 131.

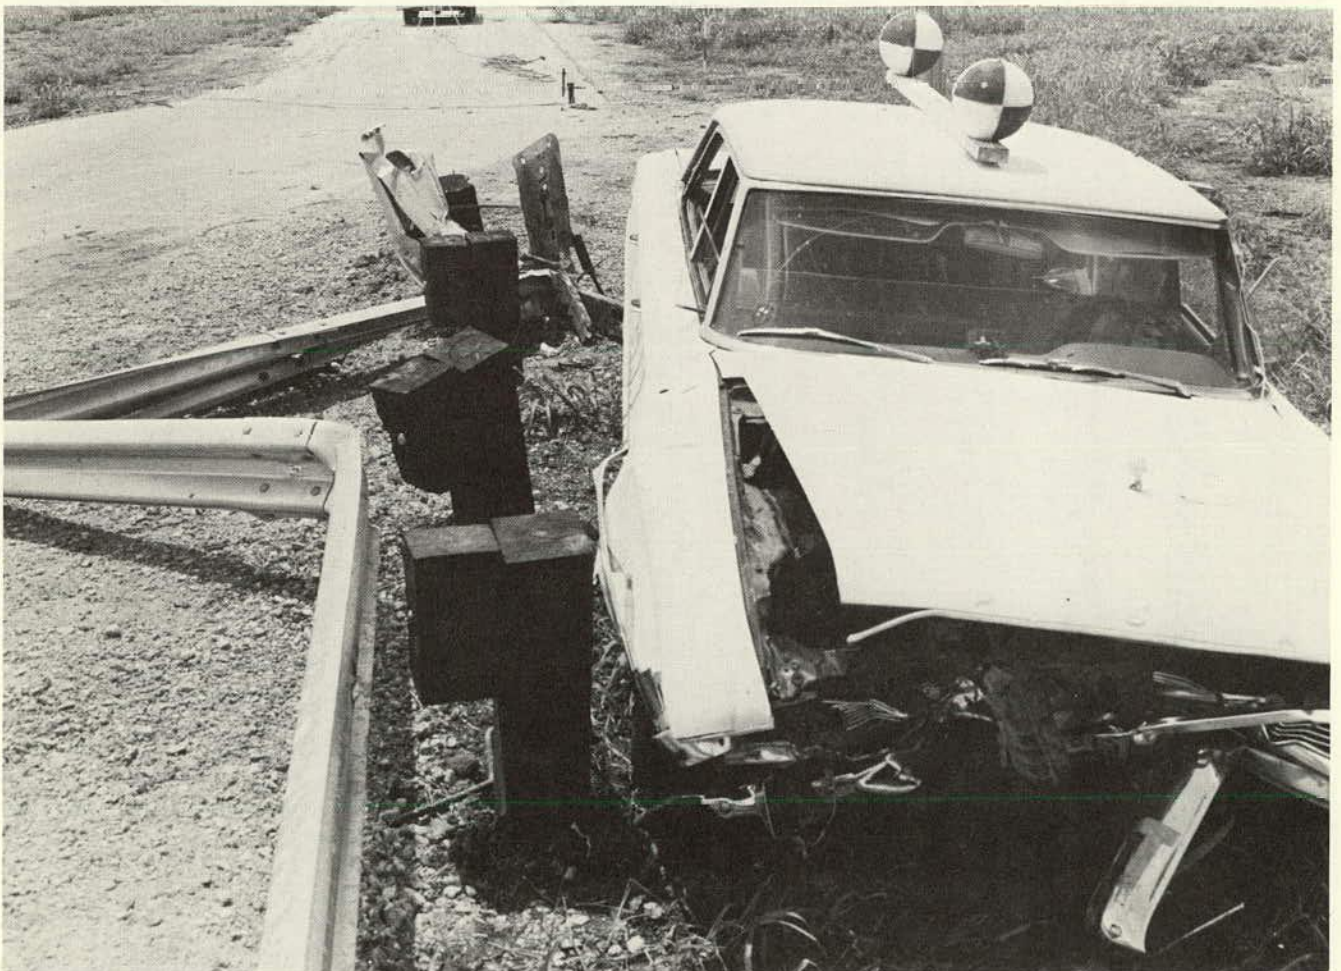
Figure A-31. Vehicle and installation damage, Test 132.

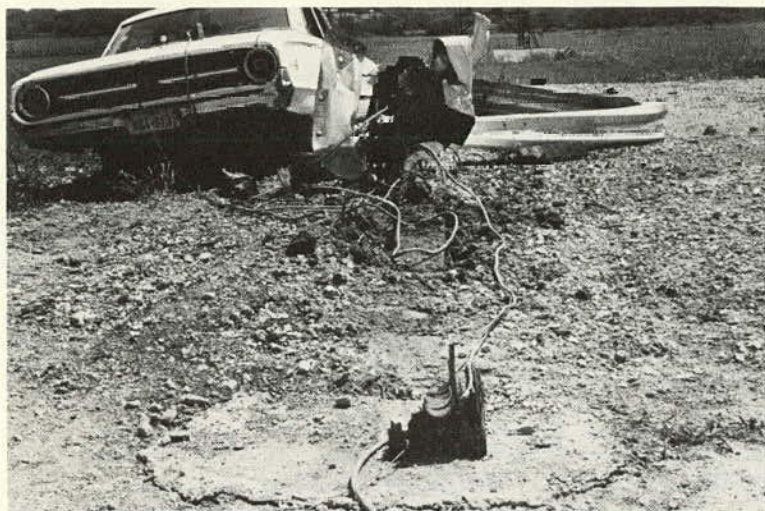
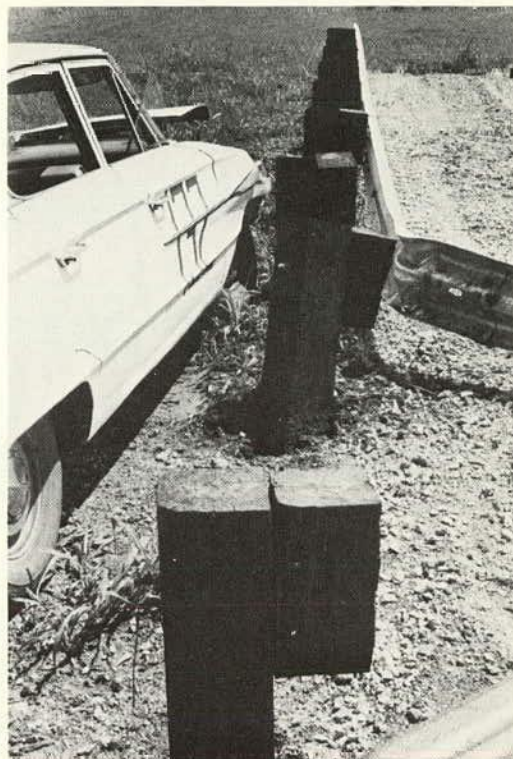
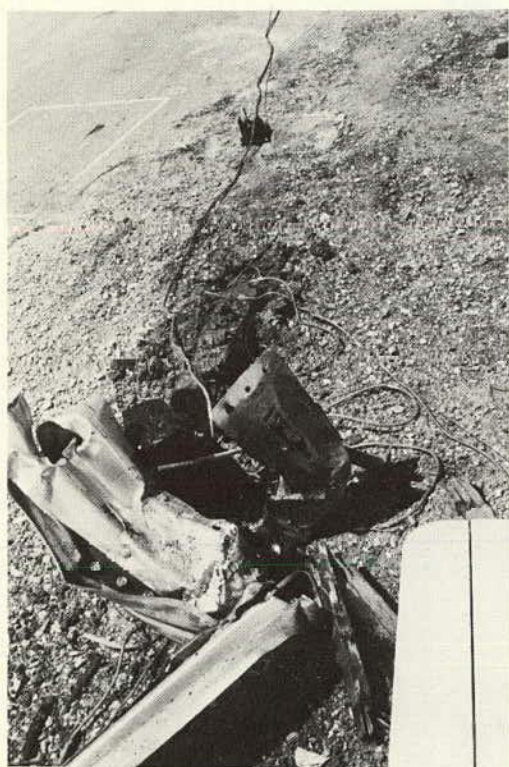
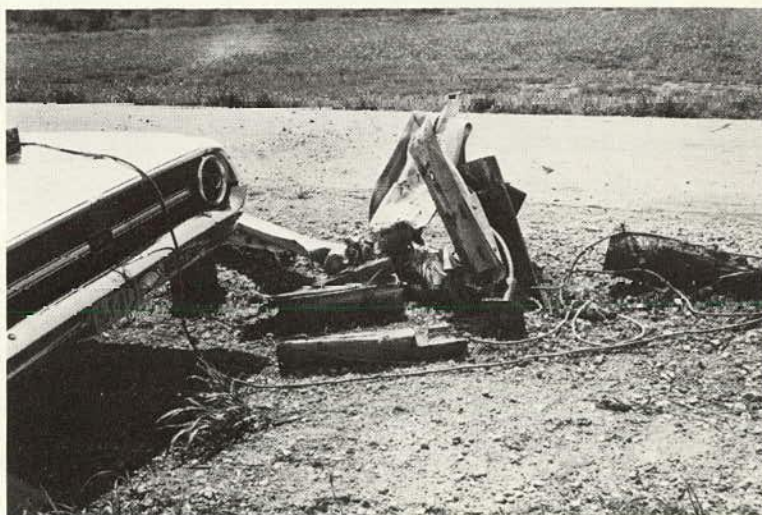
Figure A-32. Installation damage, Test 132.
