✓ NATIONAL COOPERATIVE
HIGHWAY RESEARCH PROGRAM REPORT

278

CATHODIC PROTECTION OF CONCRETE BRIDGE SUBSTRUCTURES

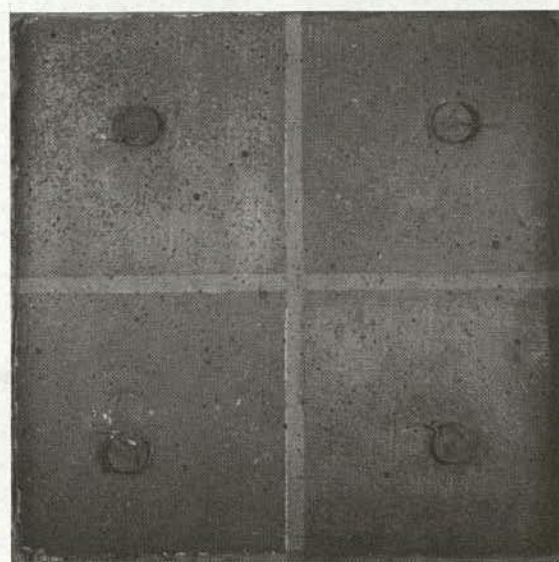
COATING C

COATING B

COATING A

Figure A-2. Freeze-thaw slabs after 100 cycles of freezing and thawing.

2. Coating B deteriorated rapidly during freeze/thaw testing. Early loss of bond occurred between the two layers of the conductive coating material and between the conductive coating and the decorative paint overcoat. After 100 cycles of freeze/thaw very little conductive coating B remained bonded to the concrete, except for the material which had penetrated into the concrete pores.

3. From 5 to 30 percent of the slab areas coated with conductive coating C had spalled away from the concrete surface after 100 cycles of freeze/thaw testing. The freeze/thaw durability of this material was significantly improved when it was covered with 1 coat of decorative latex paint, although such covered areas still experienced limited bond loss, particularly at the edges of the painted sections.

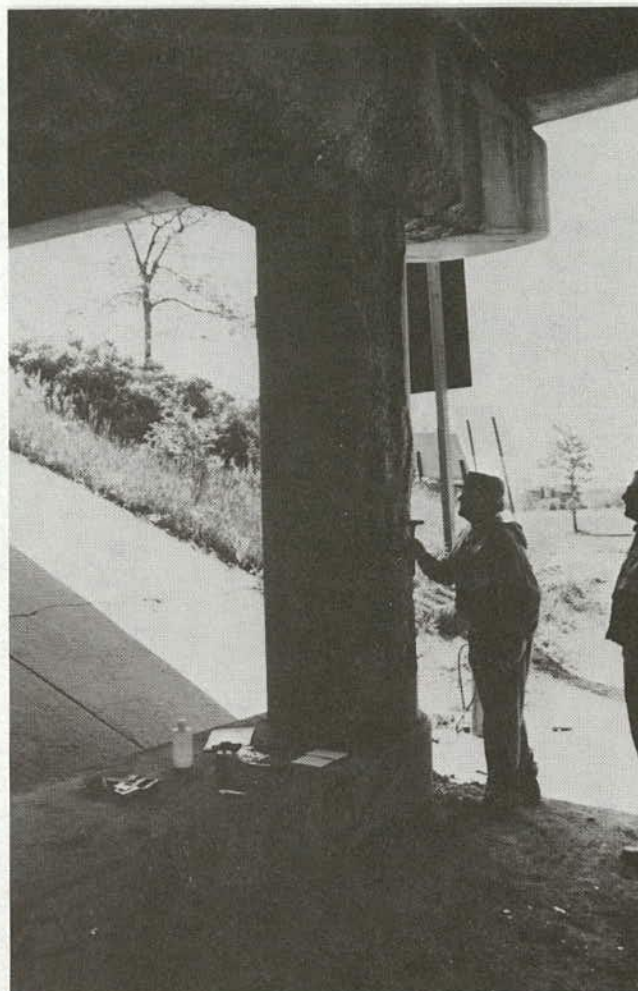
Figure C-1. General deterioration of pier base, column and cap (south end).

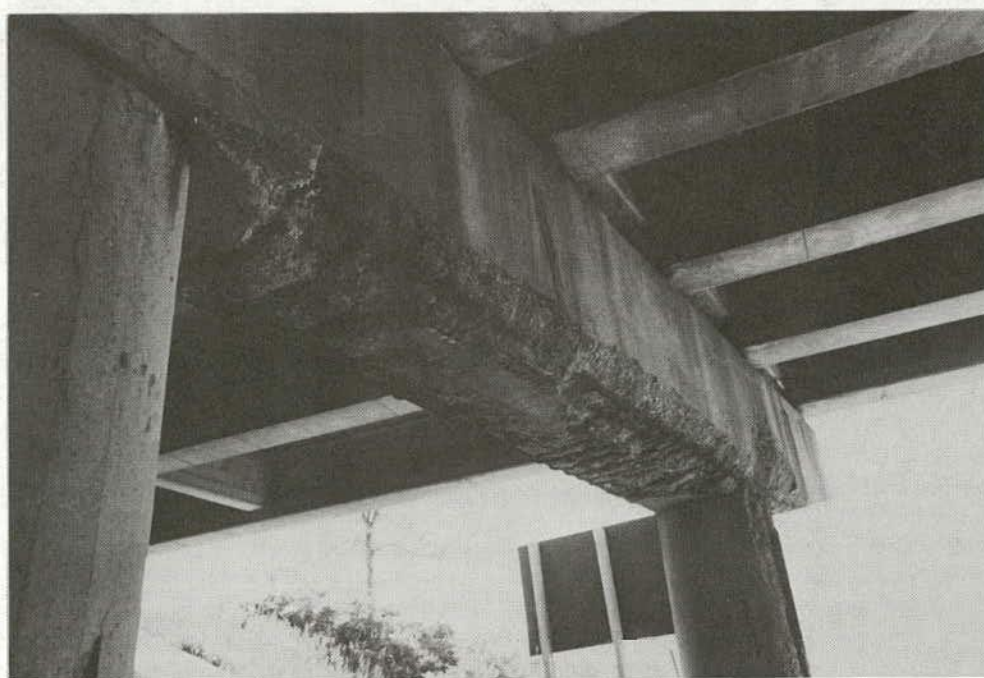
Figure C-2. Spalled base of pier cap.

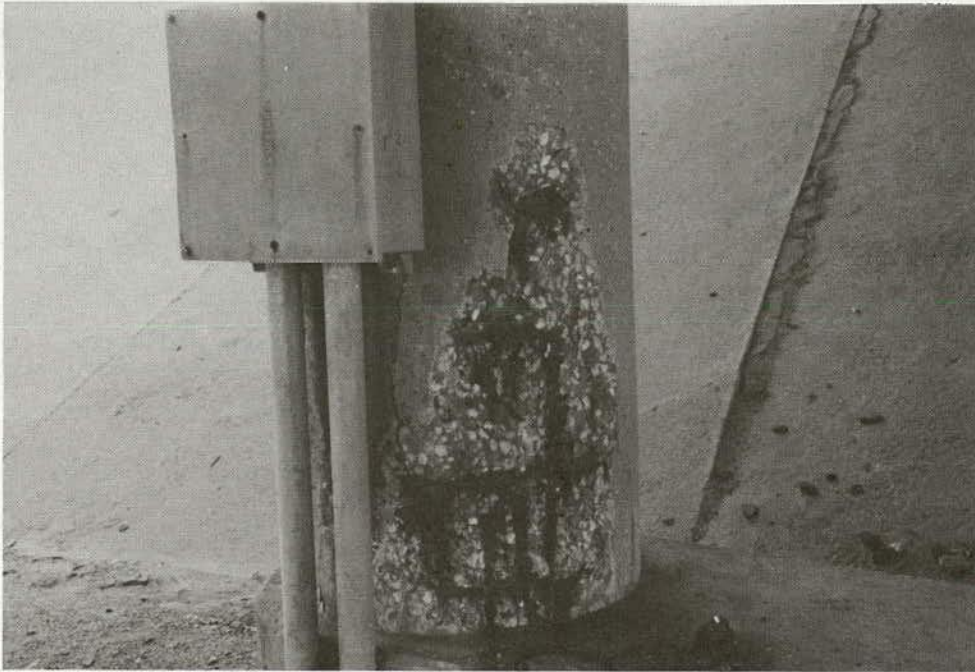
Figure C-3. Deteriorated base of north column.

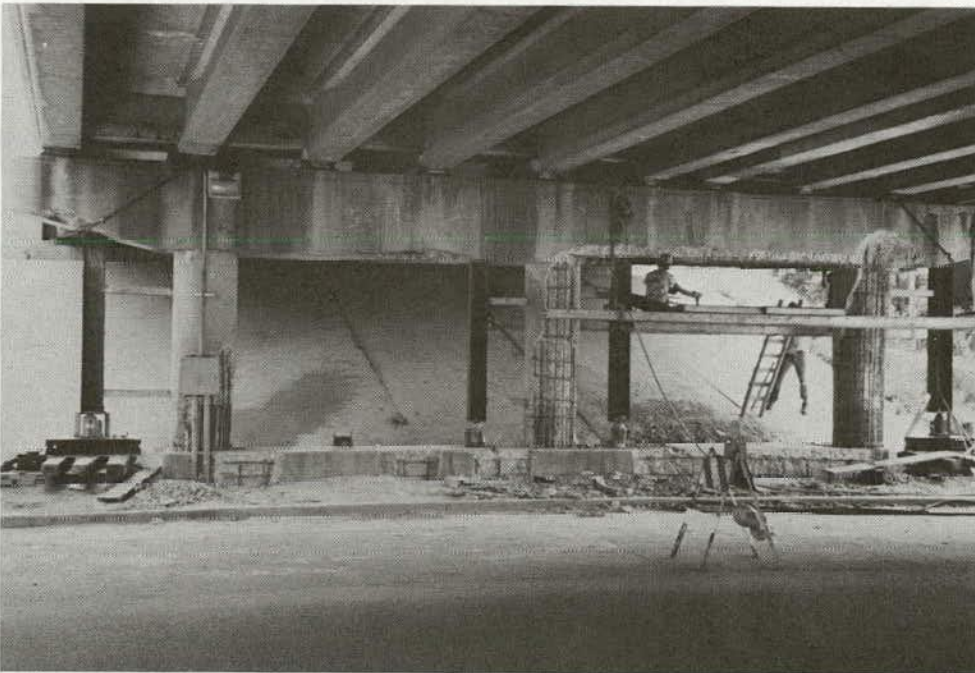
Figure C-4. Bridge pier after removal of majority of delaminated and unsound concrete.

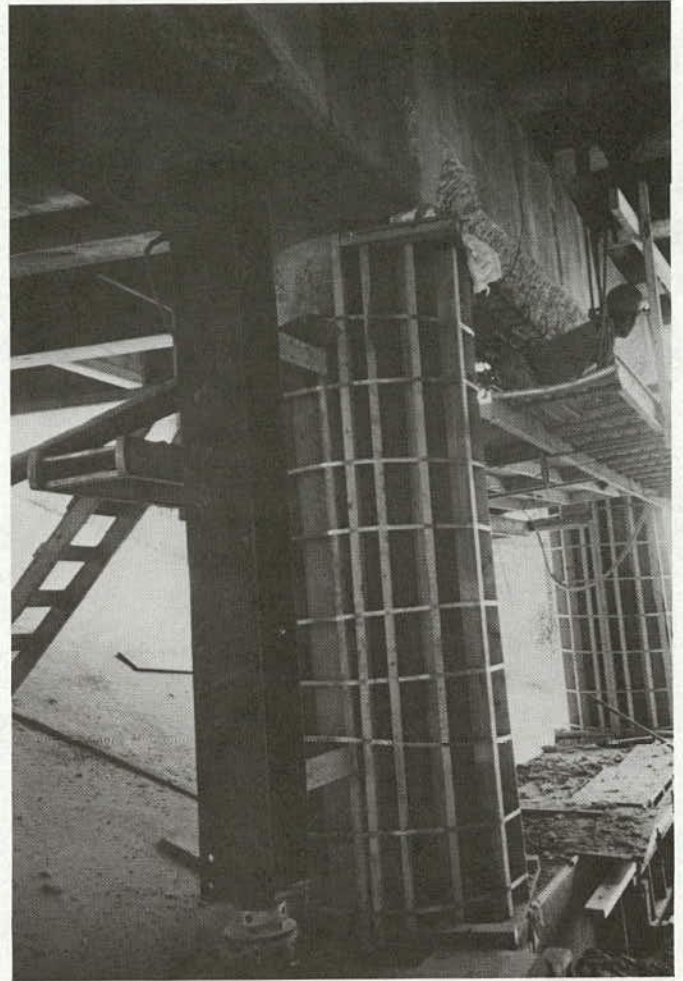
Figure C-5. Wood form details for column repair.

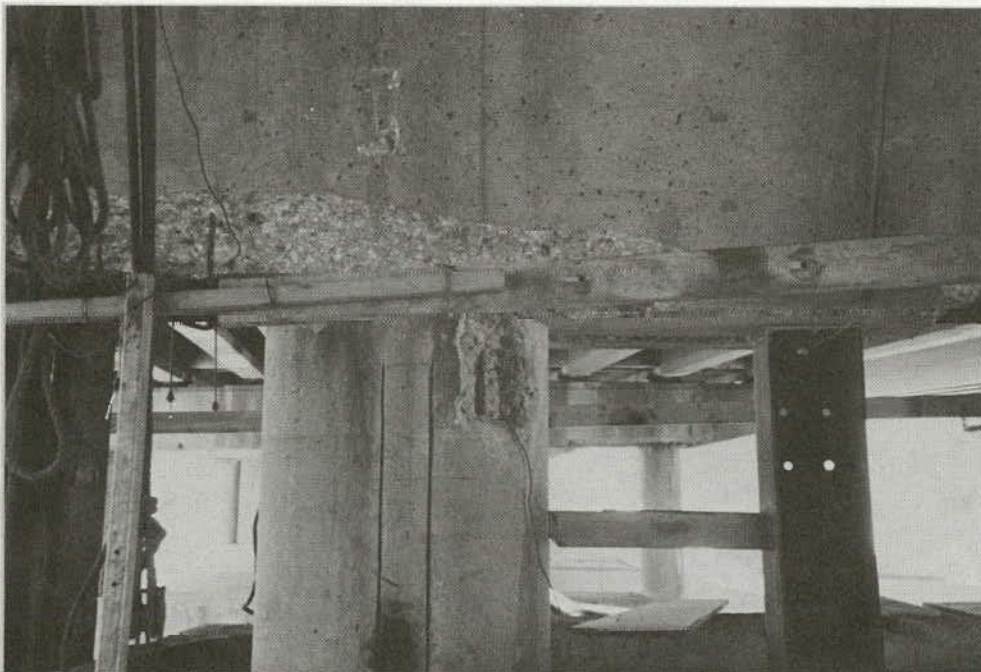
Figure C-7. Ground wire attached to exposed reinforcing bar of column.

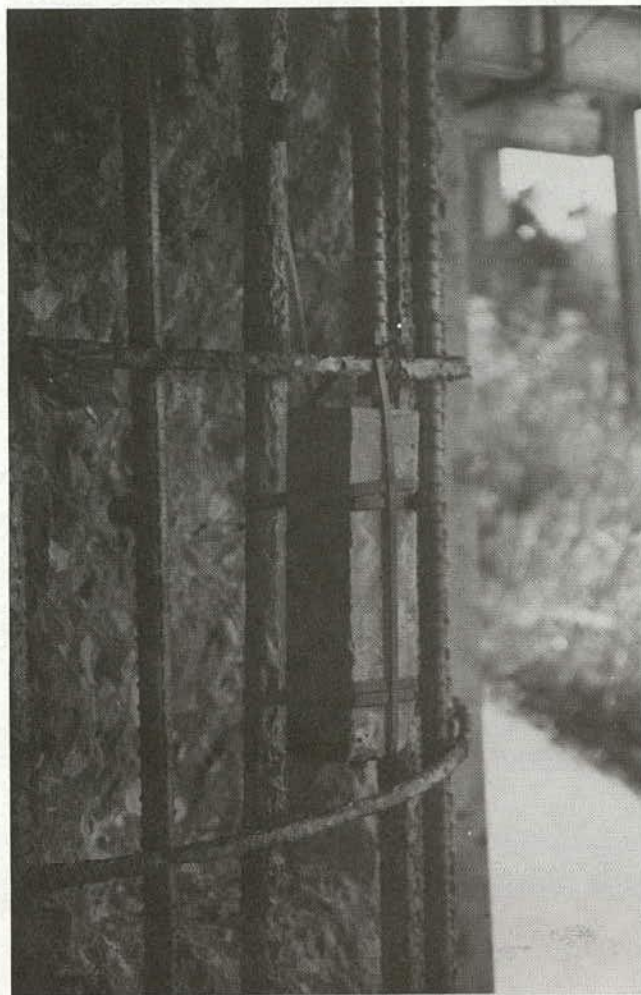
Figure C-8. Precast maroccell assembly suspended between reinforcing bars with plastic ties prior to casting repair concrete.

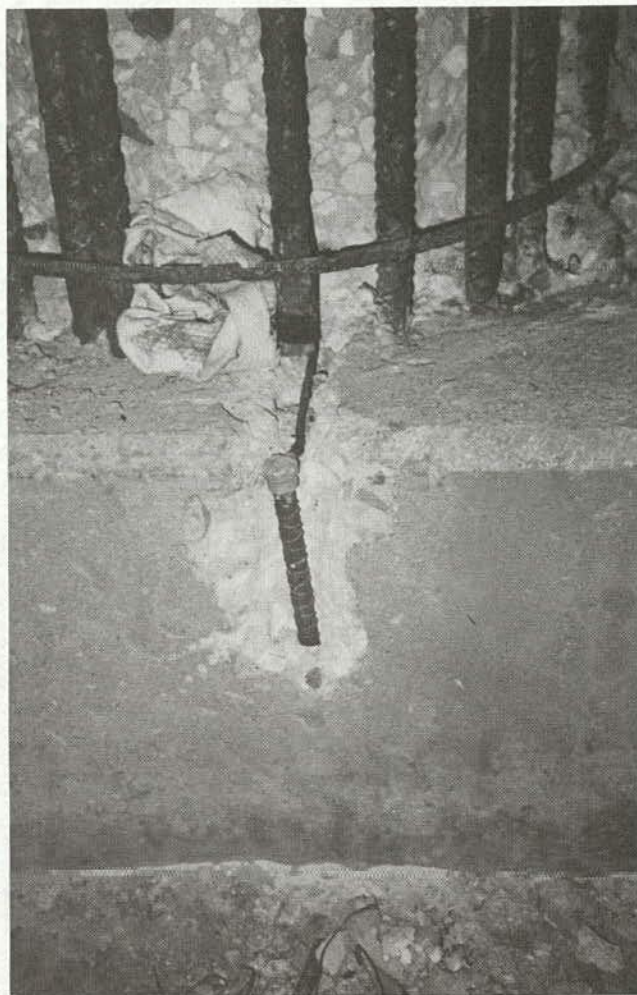
Figure C-9. Rebar current pickup probe in place.

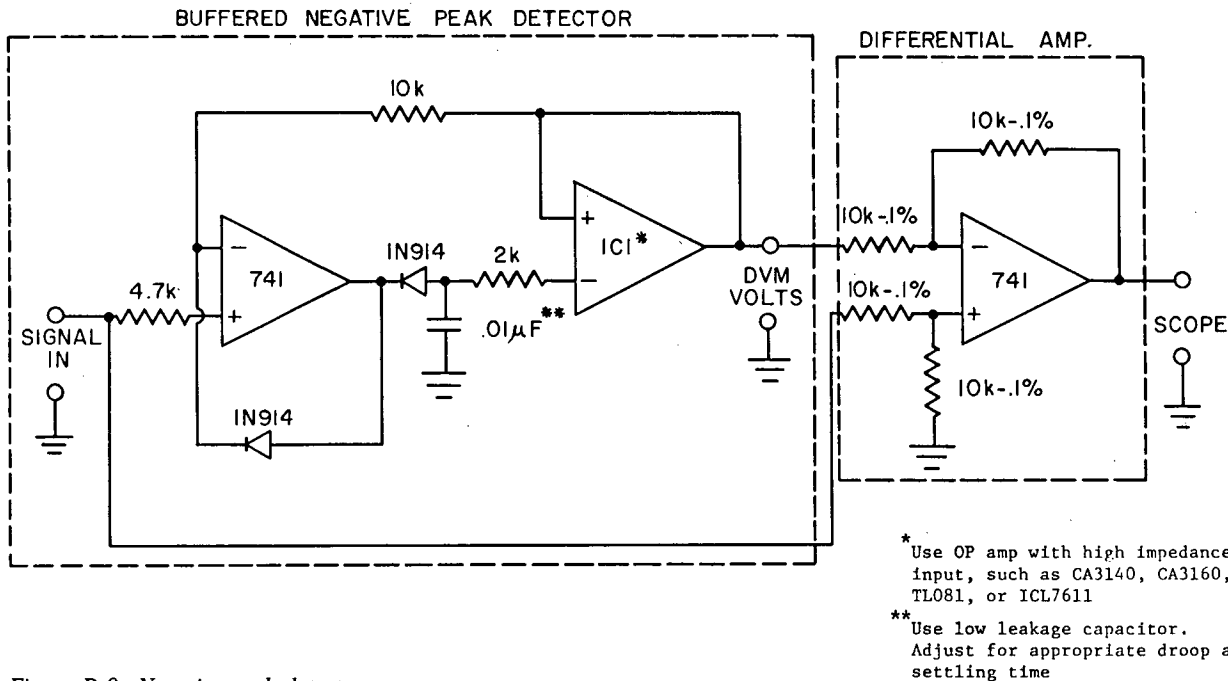
Figure D-9. Negative peak detector.

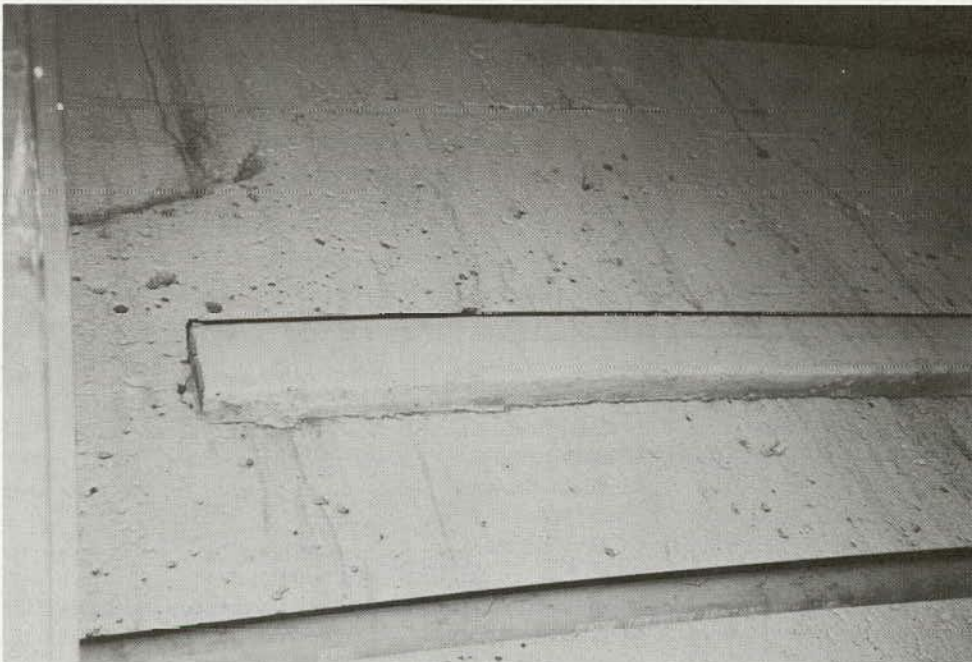
Figure E-1. Loss of bond between the concrete and the precast anode.

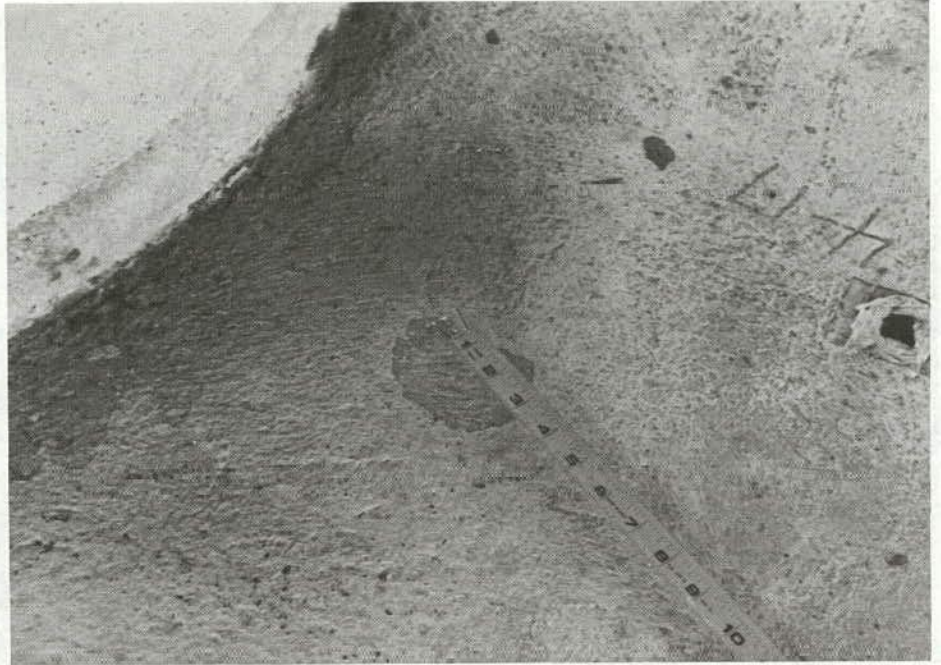
Figure E-2. Small scaled areas on top of the base.

Several factors may be responsible for the scaling of the conductive coating over the original concrete of the structure. Some possible reasons are the following:

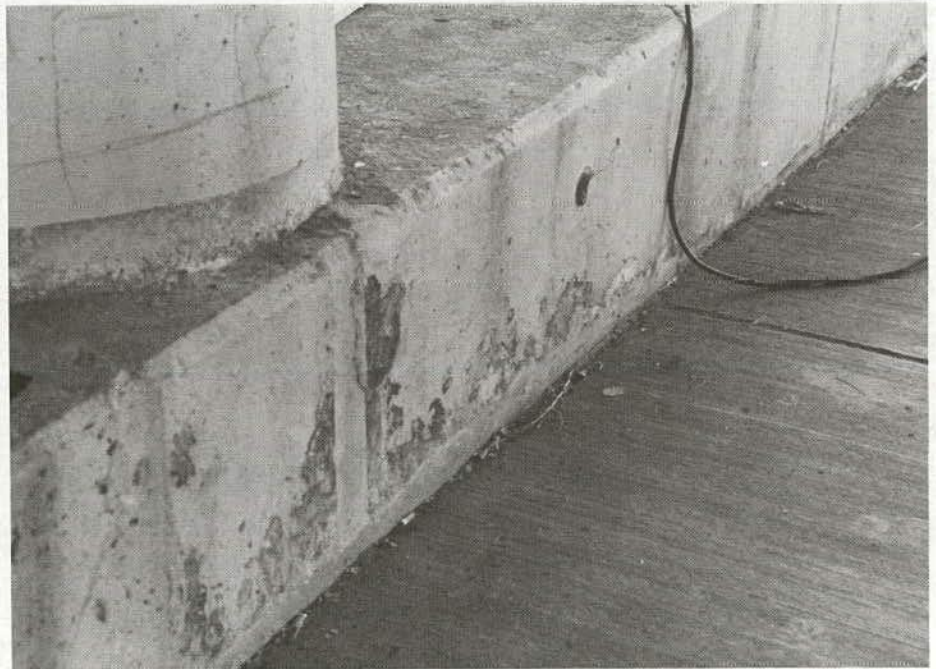
Figure E-3. Scaled coating on the side of the base.

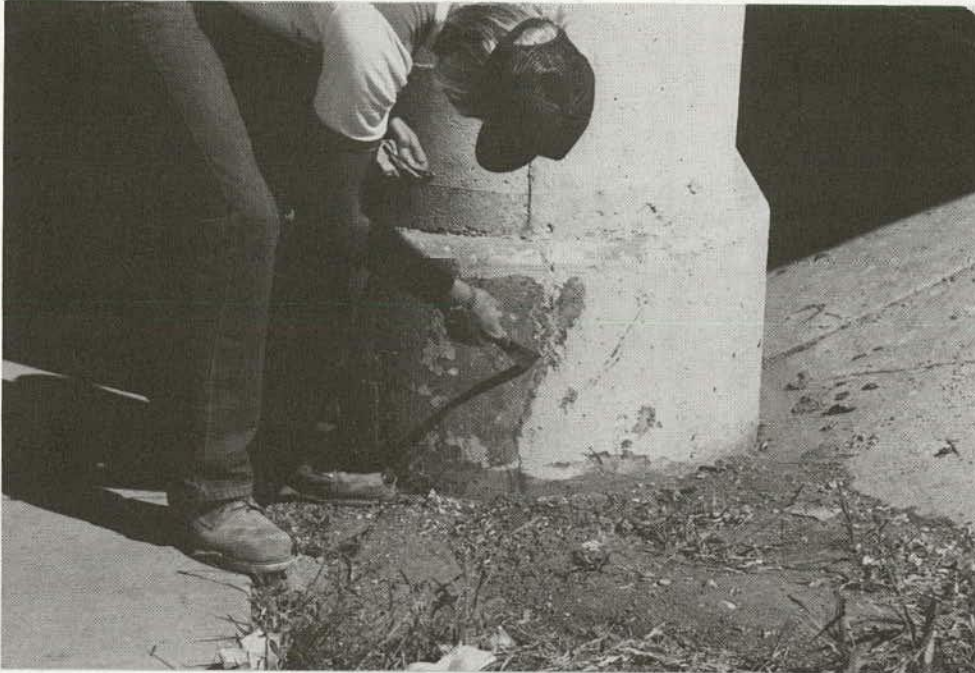
A. Scraping coating off a scaled area of the base.

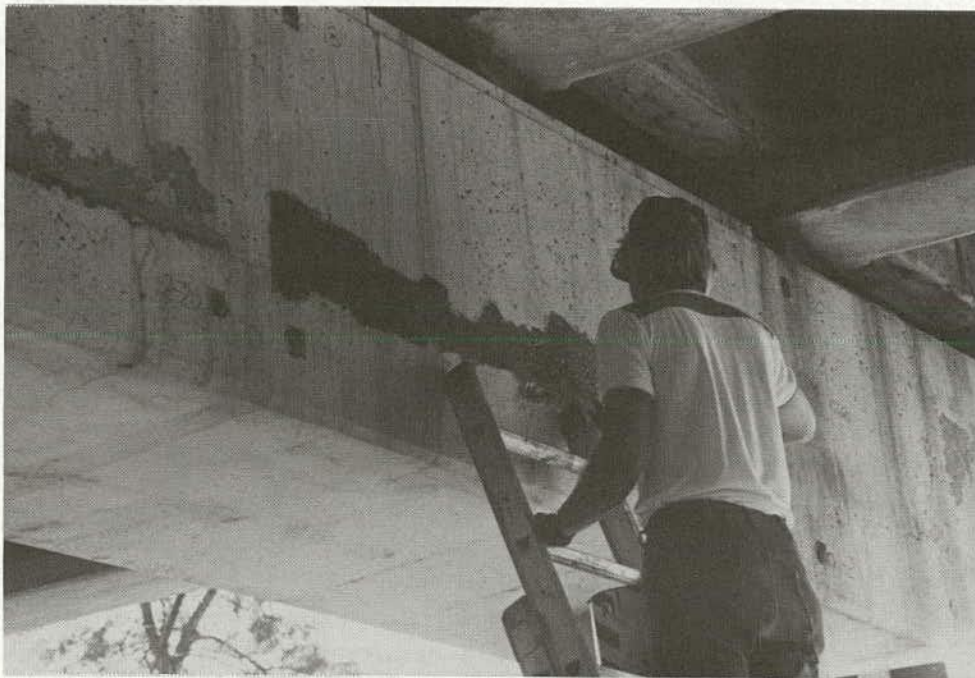
B. Reapplying the conductive coating.
