NATIONAL COOPERATIVE
HIGHWAY RESEARCH PROGRAM REPORT

289

**PERFORMANCE OF LONGITUDINAL
TRAFFIC BARRIERS**

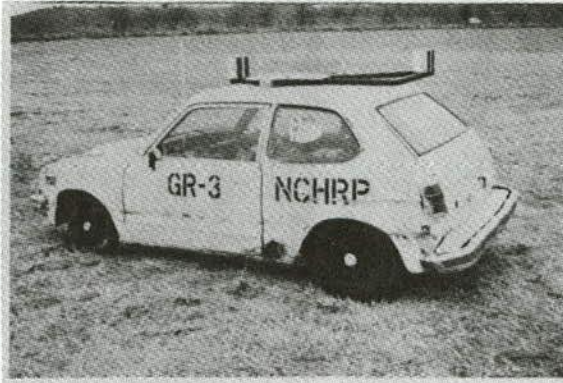
This test evaluated the G2 W-beam on weak steel post guardrail system. The vehicle was smoothly redirected with a maximum dynamic barrier deflection of 16.0 in. (41.0 cm) as shown in Figure 13. Contact with the posts caused the rear of the vehicle to yaw away from the barrier as it left the rail. Damage to the vehicle consisted of sheet metal and left front wheel/tire damage resulting from contact with the posts. Damage to the barrier was sufficient to reduce the serviceability (as shown in Figure 11). One post was completely out of service. Measured test values indicated compliance with *NCHRP Report 230*.

(c) Test GR-3, System G2

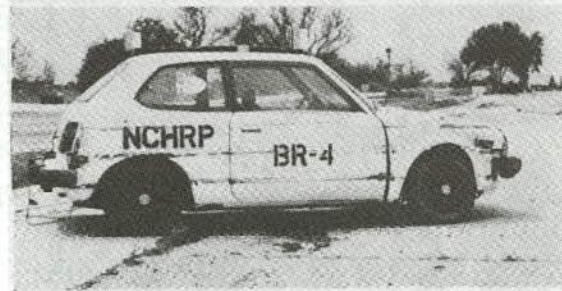
Figure 20. Barrier and vehicle damage after bridge rail tests.

(d) Test BR-4, Service Level 1 Bridge Rail
