NATIONAL COOPERATIVE
HIGHWAY RESEARCH PROGRAM REPORT

**PLANNING AND IMPLEMENTING
PEDESTRIAN FACILITIES IN
SUBURBAN AND DEVELOPING RURAL AREAS**
State-of-the-Art Report

TRANSPORTATION RESEARCH BOARD
NATIONAL RESEARCH COUNCIL

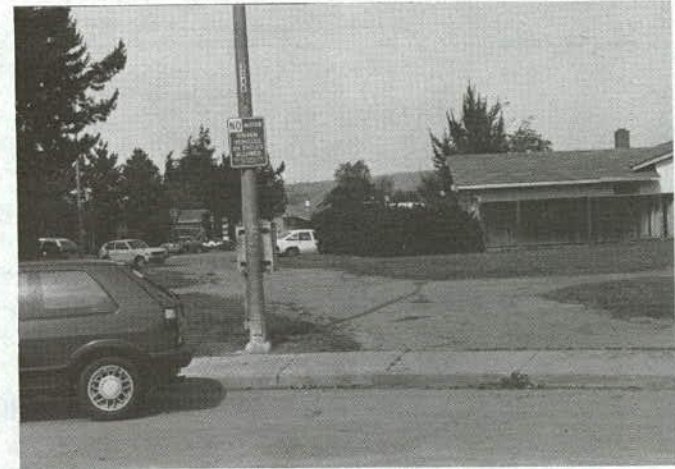
Pathway cut through between blocks.

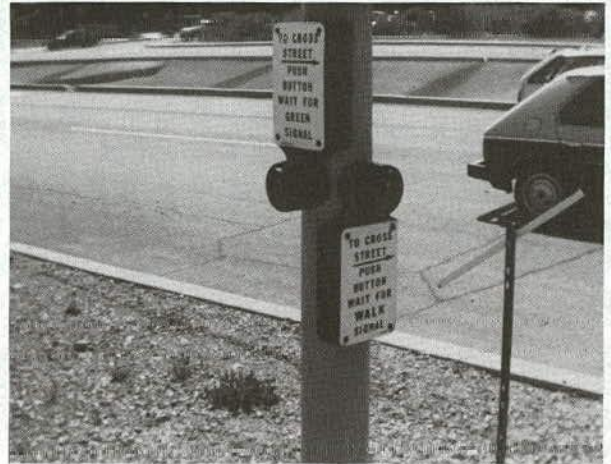
Most signalized intersections have pedestrian actuation. Note arrows indicating direction corresponding to each button. This is often neglected in some cities.

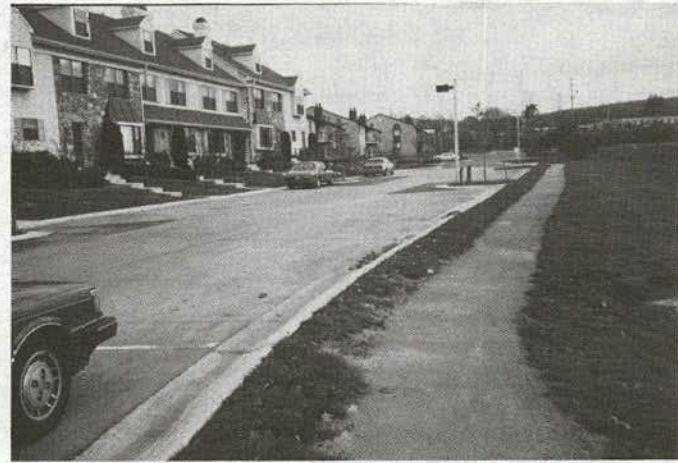
Pathway across from housing units. Note how street lighting is also used to illuminate the pathway.

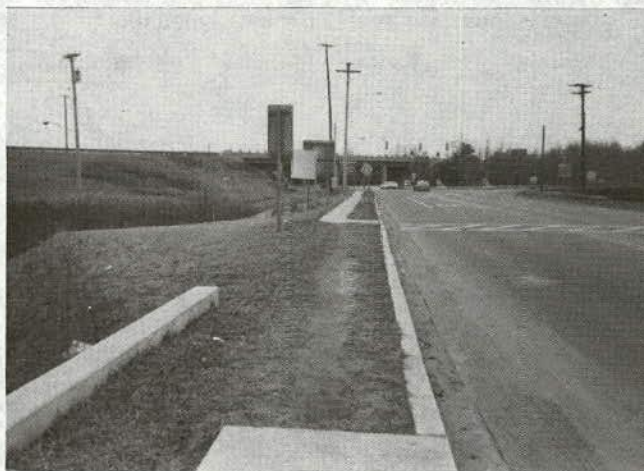
Sidewalk entering the area from U.S. 50 with crossing of Garden City Drive. Note worn path after the sidewalk ends.

Garden City Drive acts as a major pedestrian barrier between the office park and the Metro station. The straight alignment contributes toward unnecessarily high vehicular speeds. The lack of a median makes crossing difficult and dangerous at locations other than the traffic signal. Although it is probably too late for a median, carefully placed and marked refuge islands would add substantially to the convenience

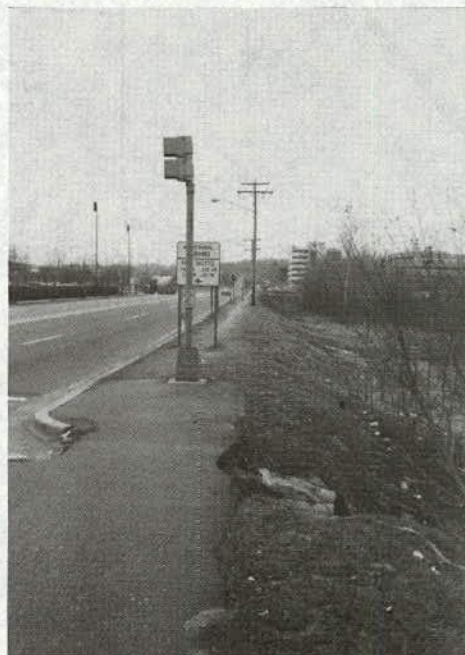
Sidewalk from Amtrak parking area to the crossing of Garden City Drive. Note worn path up the east side of Garden City Drive.

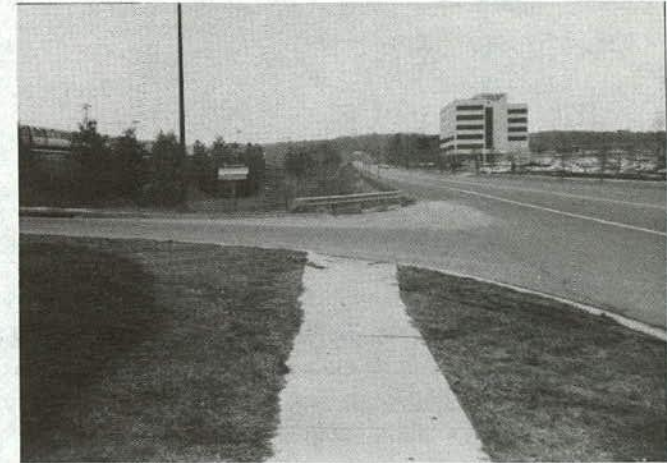
Sidewalk ends along west side of Garden City Drive.

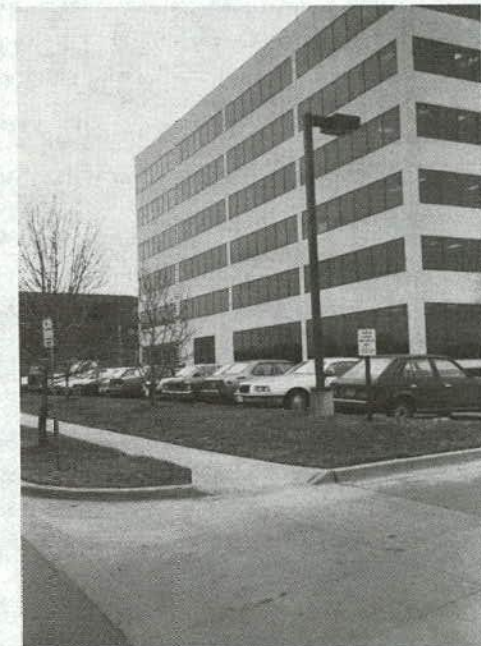
Buildings can be accessed from the sidewalk only through the parking lot.

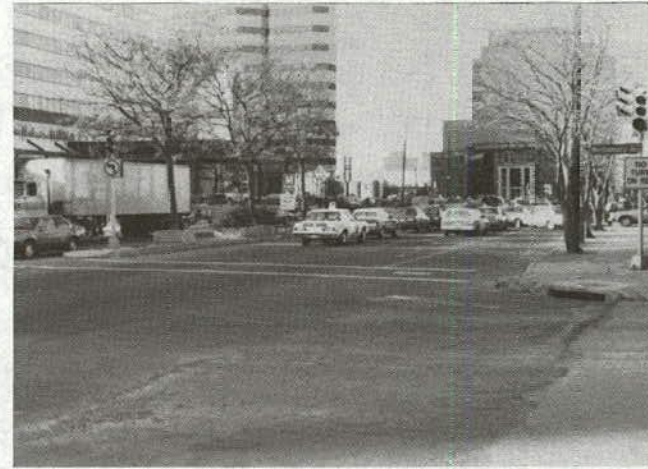
Wisconsin Avenue - the major north-south artery. The median and trees make it a less hostile environment. The traffic itself tends to keep speeds slower than might be expected for an arterial.

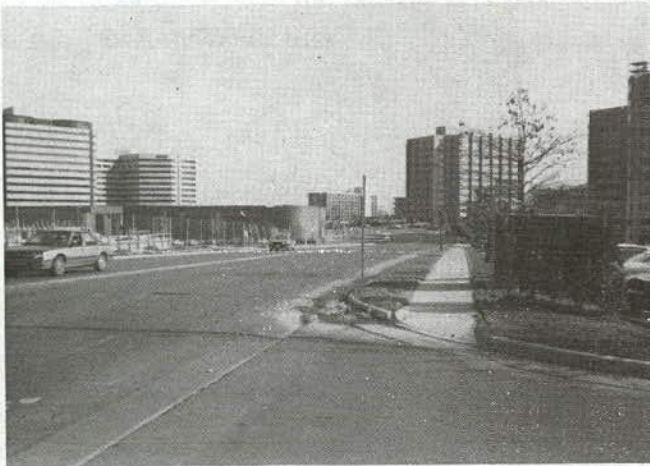
Sidewalks are being provided in some of the newer areas. A median or refuge island would have helped the pedestrian crossing situation here.

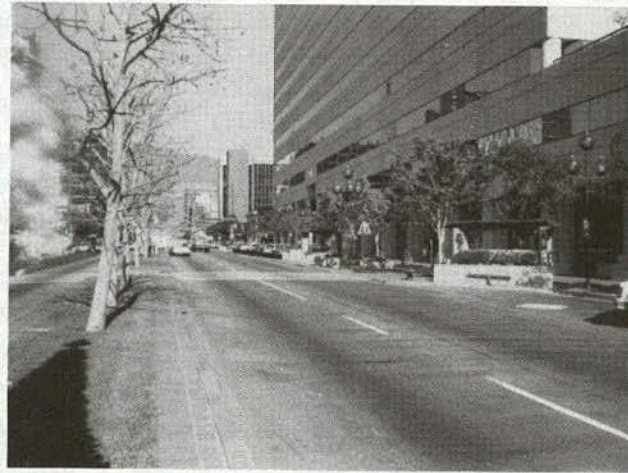
Brand Boulevard, a wide arterial, has been redesigned to better accommodate the pedestrian. A median equipped with curb cuts, landscaping and brick pathways has been provided.

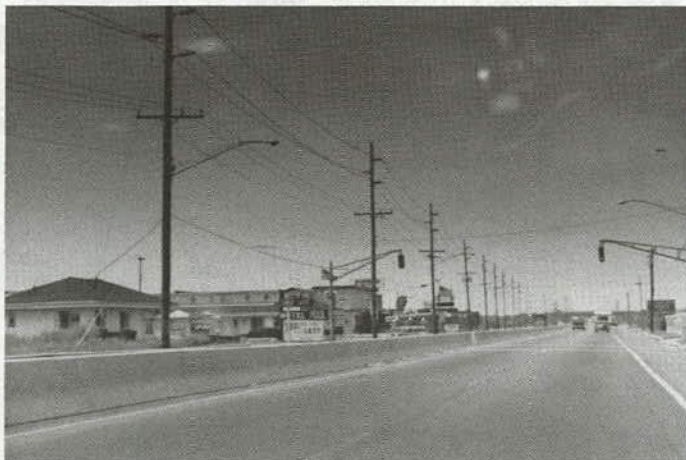
The pedestrian crossing signal and opening in the barrier are provided for access between two commercial establishments on this arterial.

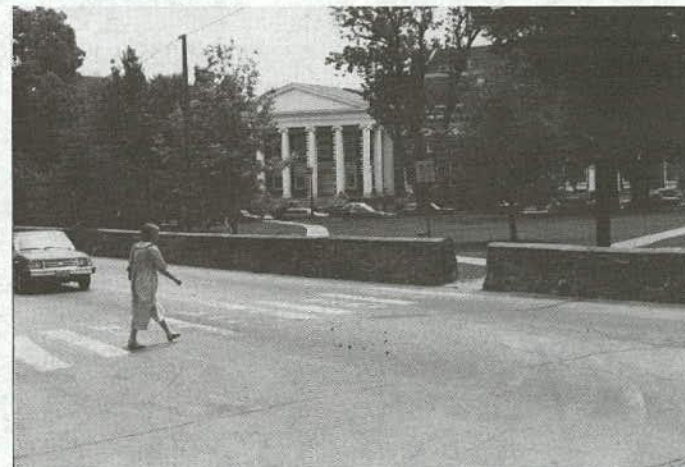
Simple openings in walls can shorten walking distance.
