NATIONAL COOPERATIVE  
HIGHWAY RESEARCH PROGRAM REPORT

**314**

# **GUIDELINES FOR THE USE OF WEATHERING STEEL IN BRIDGES**

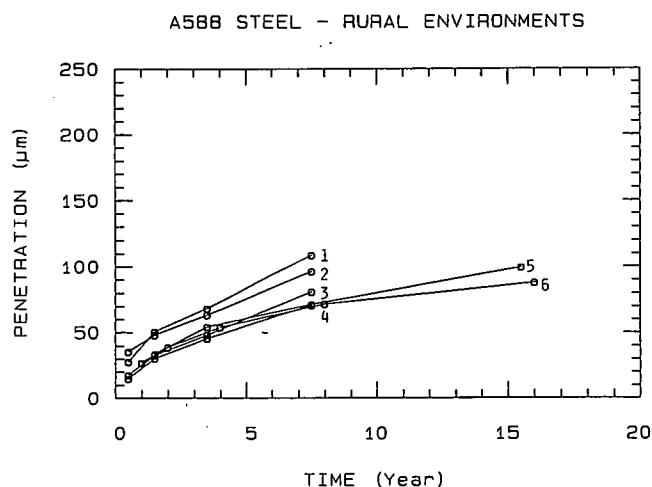
**Figure 3. Corrosion penetration of A588 steel exposed in rural environments. See also Table 2.**

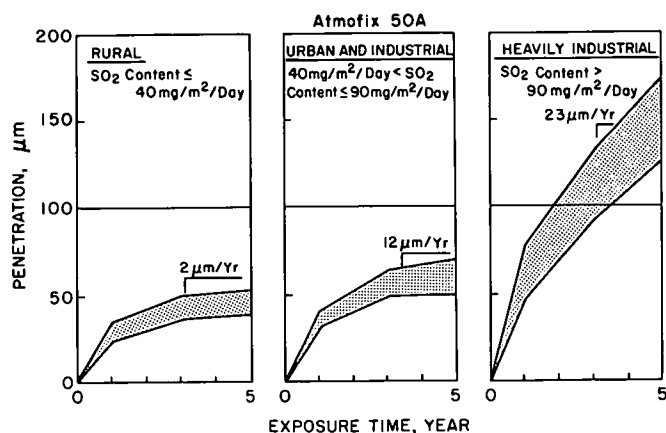
Figure 7. Effect of sulfur dioxide content on corrosion of weathering steel exposed to various atmospheres in Czechoslovakia [Knotkova 1982].

(Note:  $1.0 \text{ mg SO}_2/\text{m}^2/\text{day}$  deposition rate  $\approx 0.8 \text{ } \mu\text{g SO}_2/\text{m}^3$  volumetric concentration. [International Standards Organization 1988])

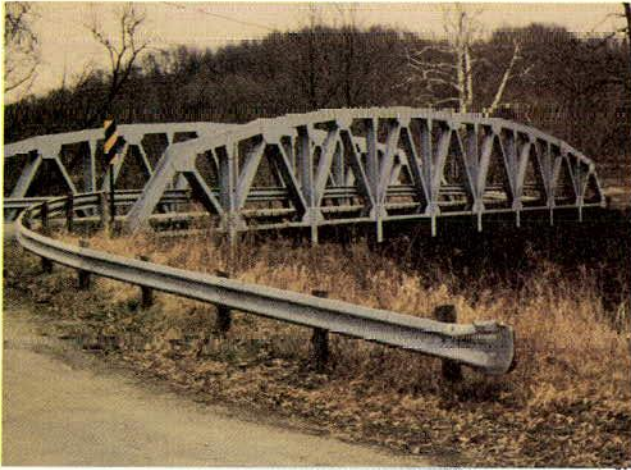
Figure F-1. Truss bridge over slow moving, shallow stream surrounded by trees (County Road 37 Bridge over Little Still Water Creek, Tuscarawas County, Ohio).

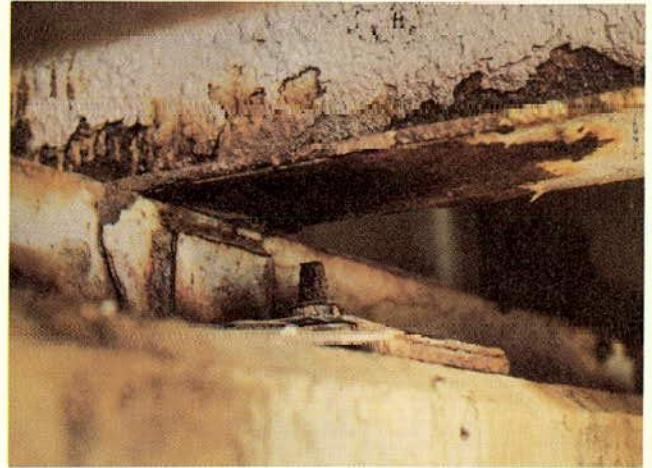
Figure F-3. Paint failure and severe corrosion of weathering steel stringers near abutment (County Road 37 Bridge).

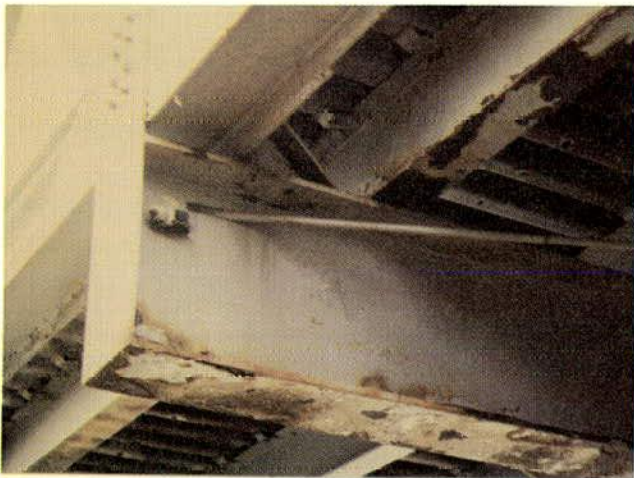
Figure F-2. Paint failure and severe corrosion of weathering steel floor beam and stringers of remedially painted truss bridge (County Road 37 Bridge).

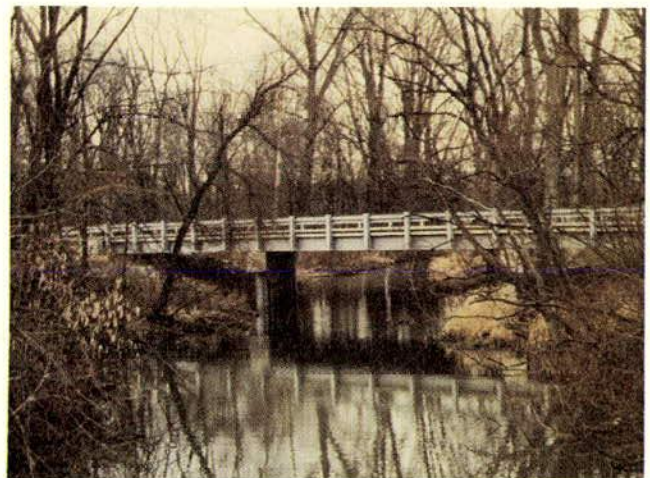
Figure F-4. Three-span continuous bridge with low clearance over creek in forested rural areas (Brand Road Bridge over North Fork of Indian Run, Franklin County, Ohio).

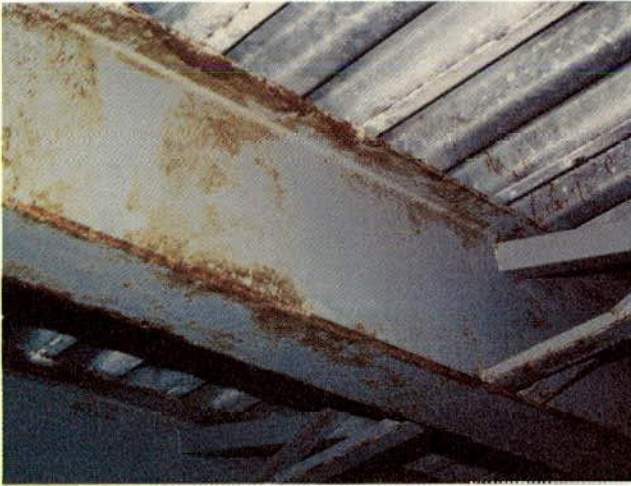
Figure F-5. Paint failure of beams one year after remedial painting (Brand Road Bridge).

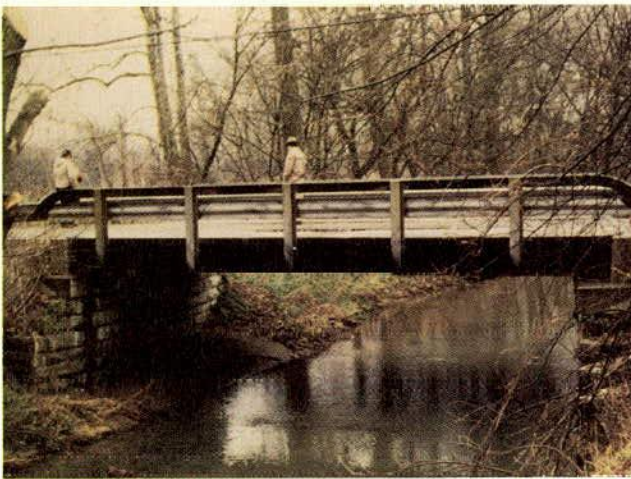
Figure F-6. Simple-span bridge with clearance over creek in forested rural area (Howard Road Bridge, Butler County, Ohio).

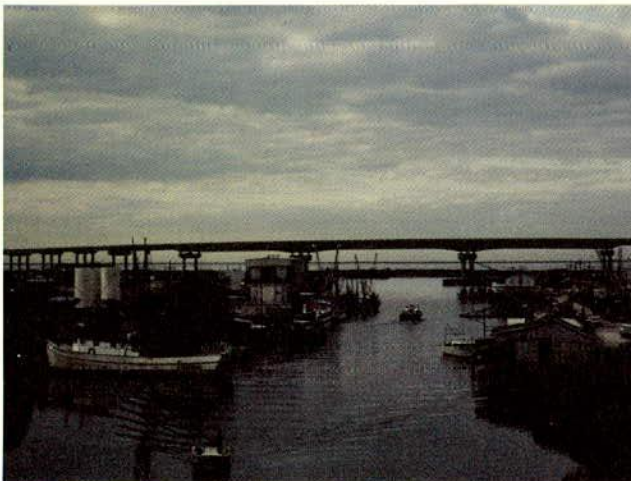
Figure F-7. Five-span, continuous plate girder bridge over open marsh country in Mississippi Delta (Doullut Canal Bridge, Empire, Louisiana).

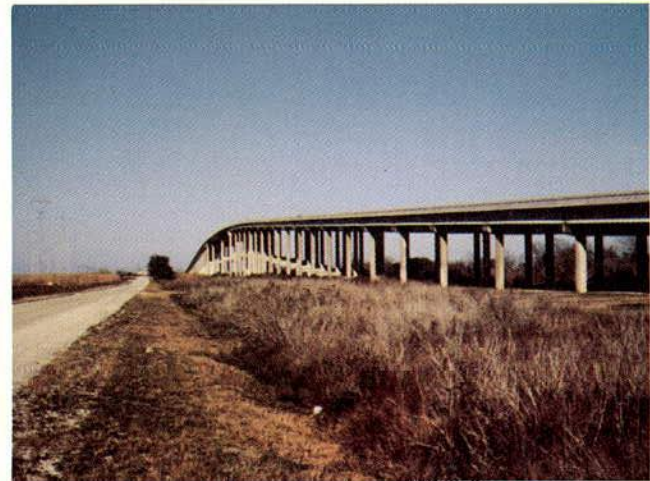
Figure F-10. Plate girder bridge located 8 km (5 miles) from Gulf Coast (Route 127 Bridge over Intercoastal Waterway, High Island, Texas).

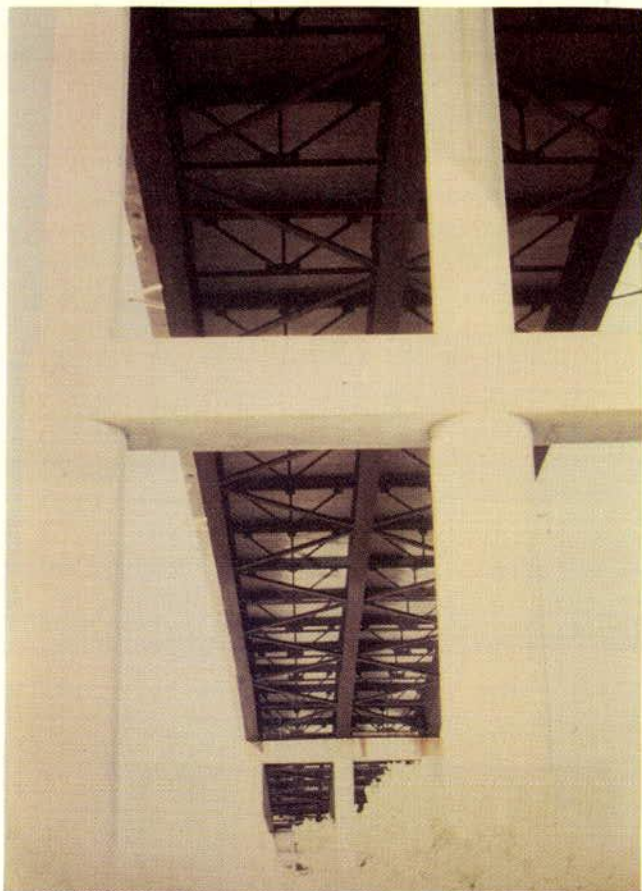
Figure F-11. Substructure of High Island bridge

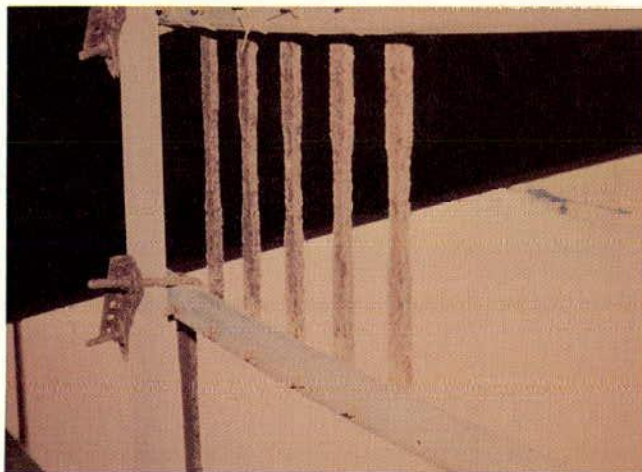
Figure F-12. Rust flakes forming on tensile specimens mounted on rack attached to substructure of High Island bridge.

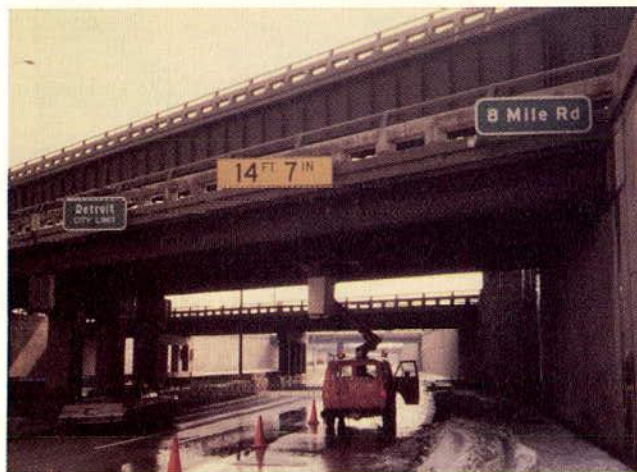
Figure F-14. Grade separation structure with low clearance, lateral retaining walls, and salt-laden melting snow draining across roadway (8 Mile Road Bridge over US 10, Detroit, Michigan).

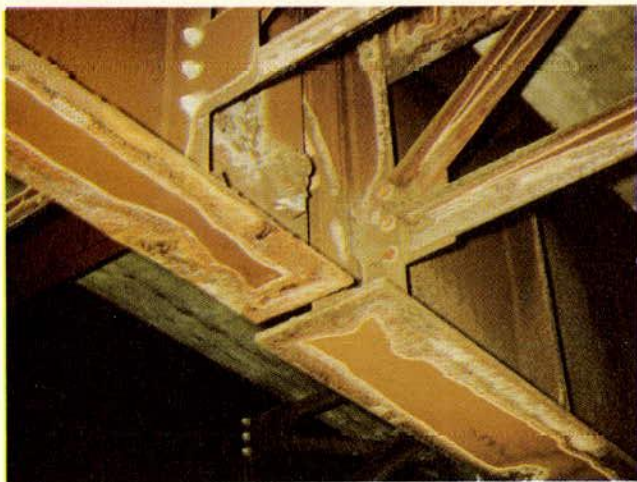
Figure F-15. Salt residue from leakage through expansion joint (175 Bridge over Fort Street, Detroit, Michigan). [Culp 1980].

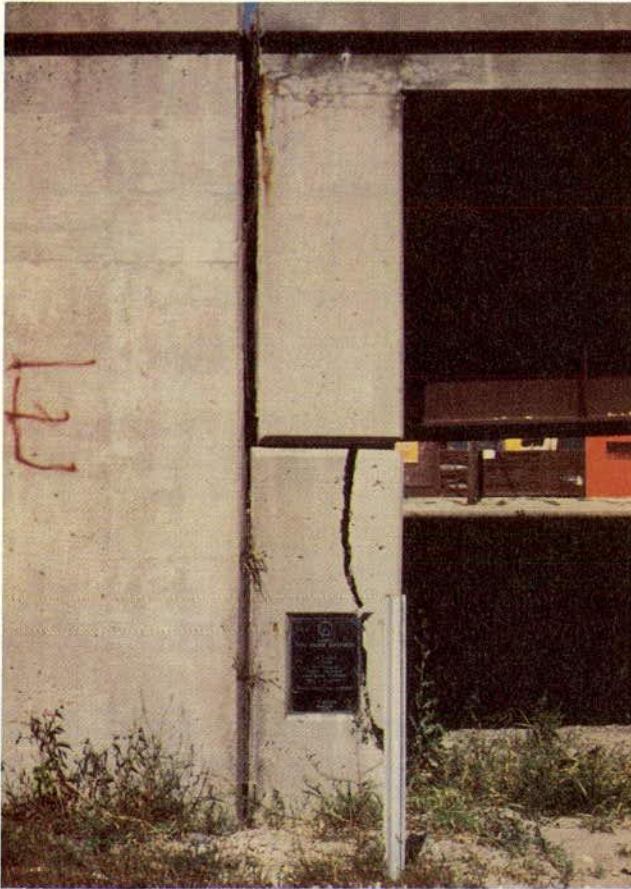
Figure F-18. Headwall separation and concrete fracture resulting from rust-frozen, cantilevered expansion joint (8 Mile Road Bridge over US 10, Detroit, Michigan). [Michigan Department of Transportation]

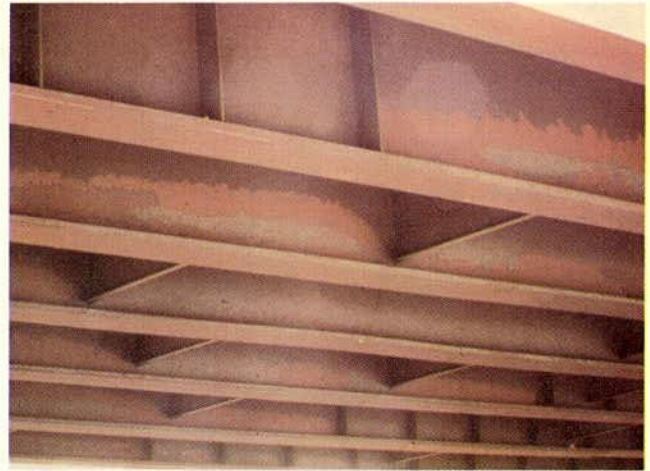
Figure F-20. Corrosion of beams subjected to traffic spray. [Michigan Department of Transportation]

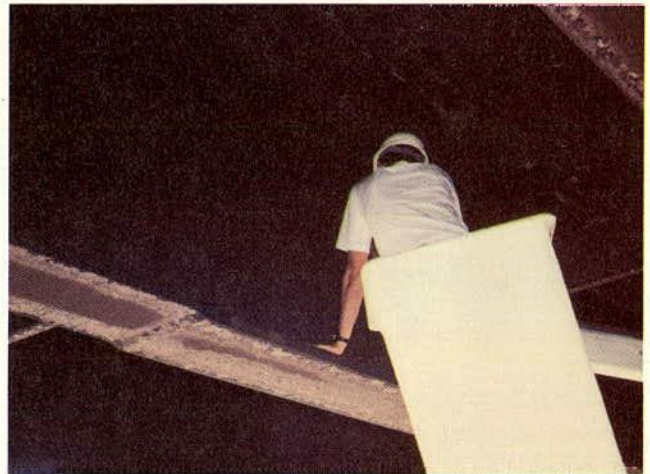
Figure F-21. Accumulation of salt from traffic spray.

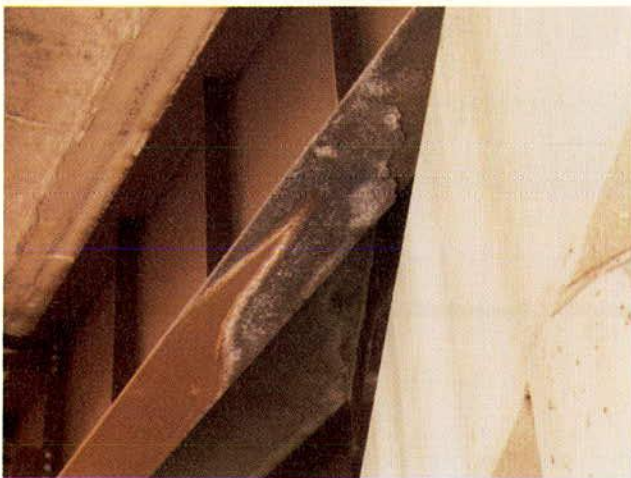
Figure F-19. Corrosion of steel below leaking joint at bearing (I75 Bridge over Fort Street, Detroit, Michigan).
