NCHRP Report 354

**Resistance of Welded Details
Under Variable Amplitude
Long-Life Fatigue Loading**

**Transportation Research Board
National Research Council**

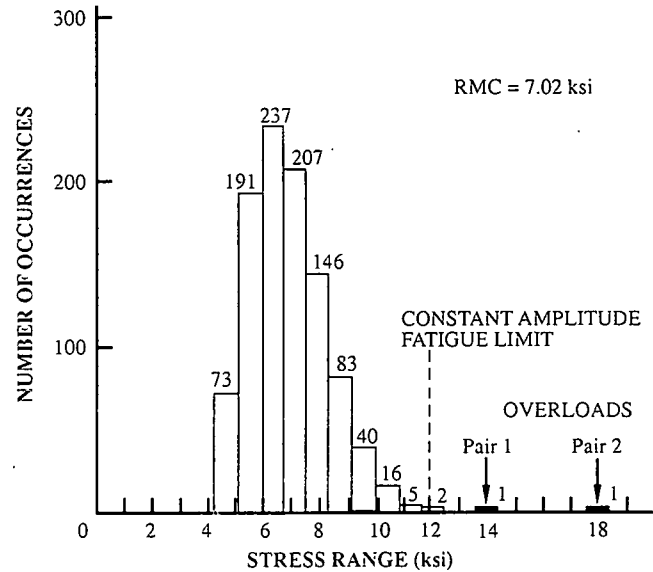
Figure 2. Stress range spectrum at stiffener details 8 and 10 for Girder Pairs 1 and 2, $\gamma = 0.001$.

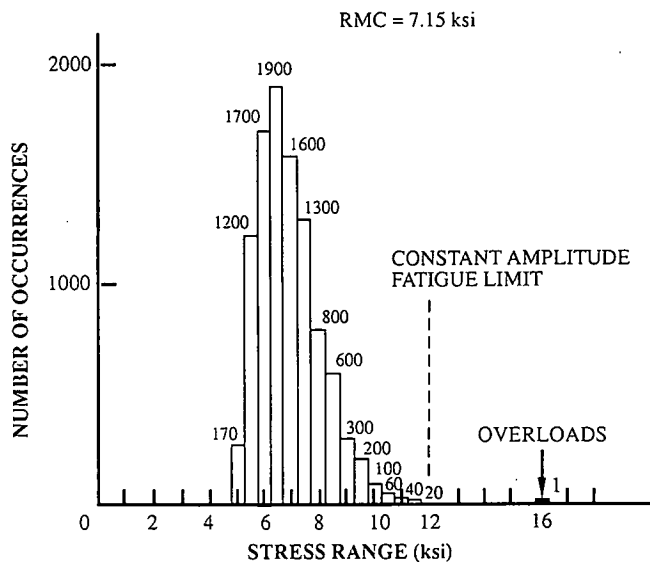
Figure 3. Stress range spectrum at stiffeners 8, 9, and 10 for Girder 3, $\gamma = 0.0001$.

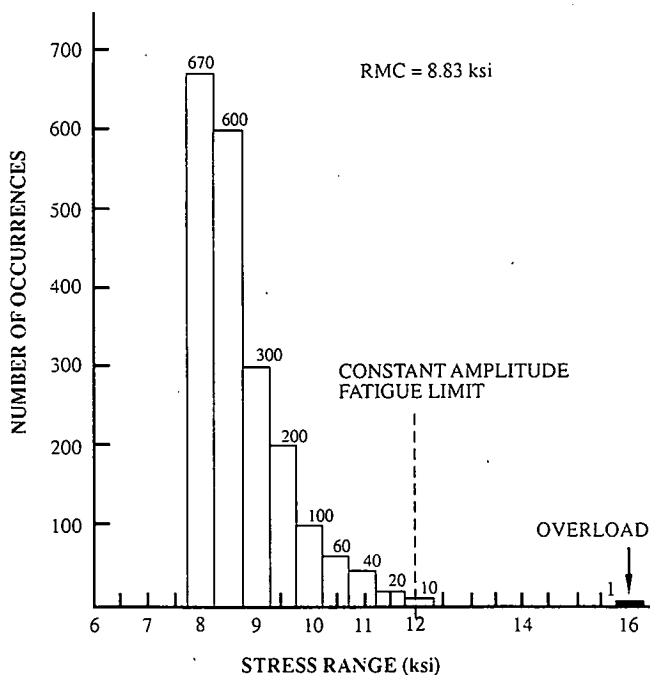
Figure 4. Stress range spectrum at stiffeners 8, 9, and 10 for Girder Pair 4, $\gamma = 0.0005$.

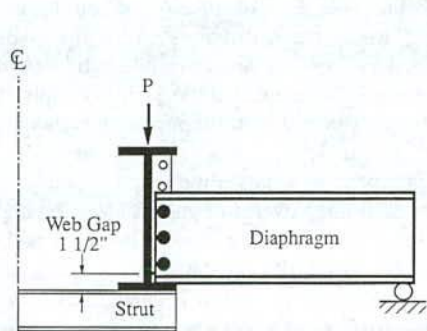
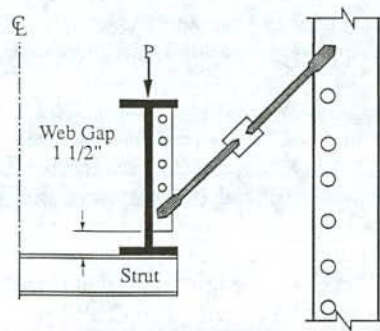
Test Setup for Distortion in Girder Pair 1

Test Setup for Distortion in Girder Pair 2

Figure 7. Test setup for distortion induced web gap cracking for Girder Pairs 1 and 2.

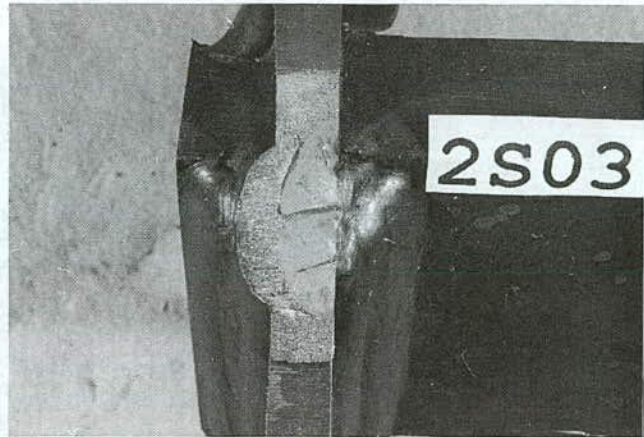
Figure 13. Semielliptical crack at web gusset. (Note crack can exceed web thickness as a result of weld on back surface.)

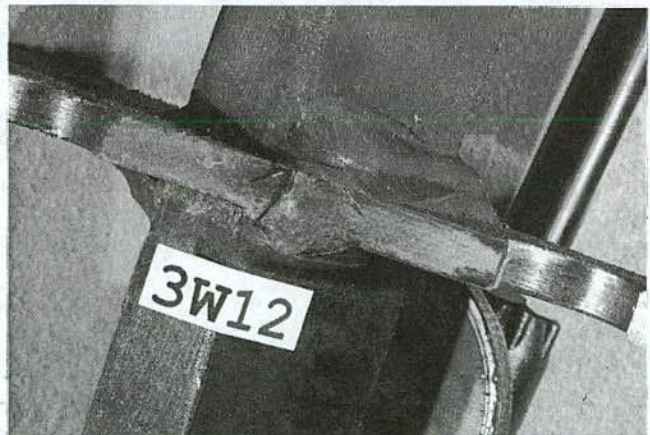
Figure 14. Typical through thickness crack arrested by retrofit holes.

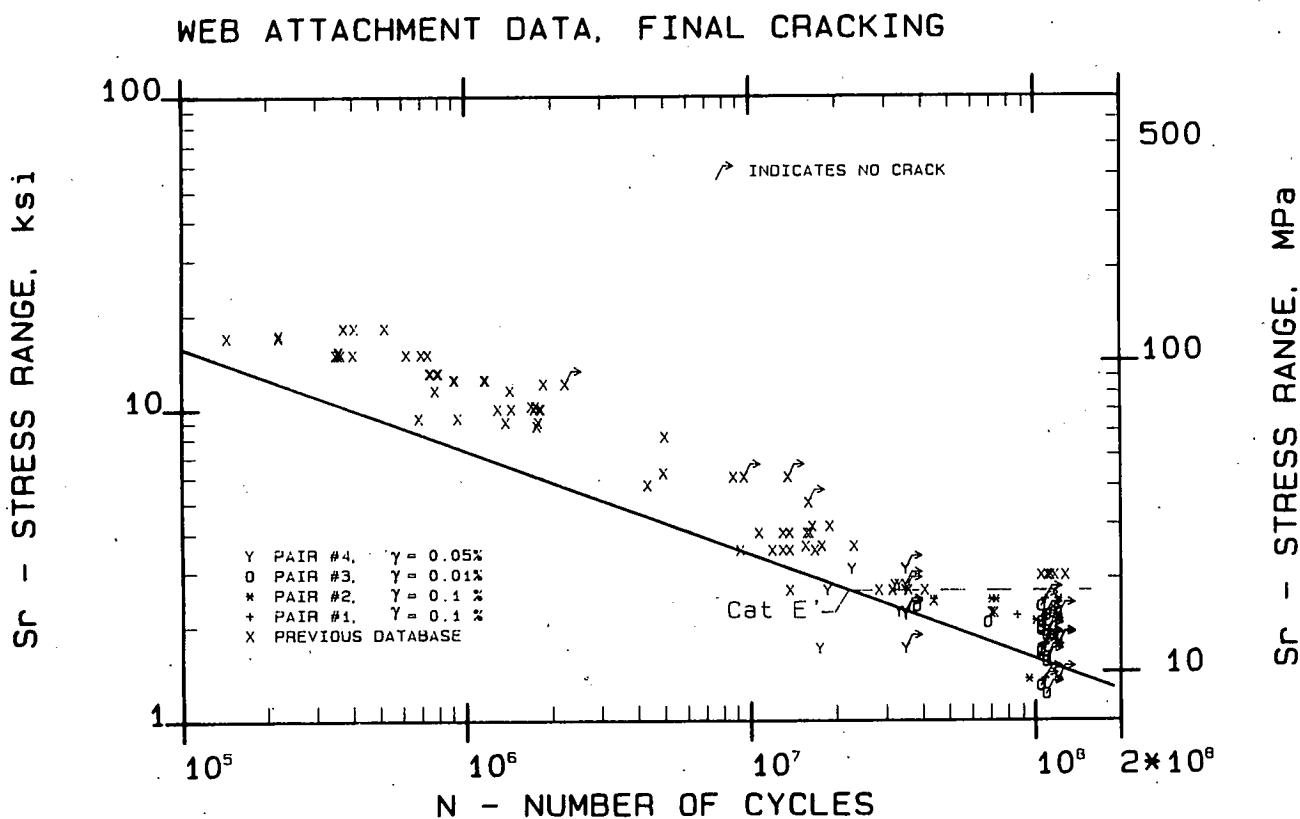
Figure 18. Comparison of the web attachment test data at failure or test termination with Category E' fatigue resistance curve.

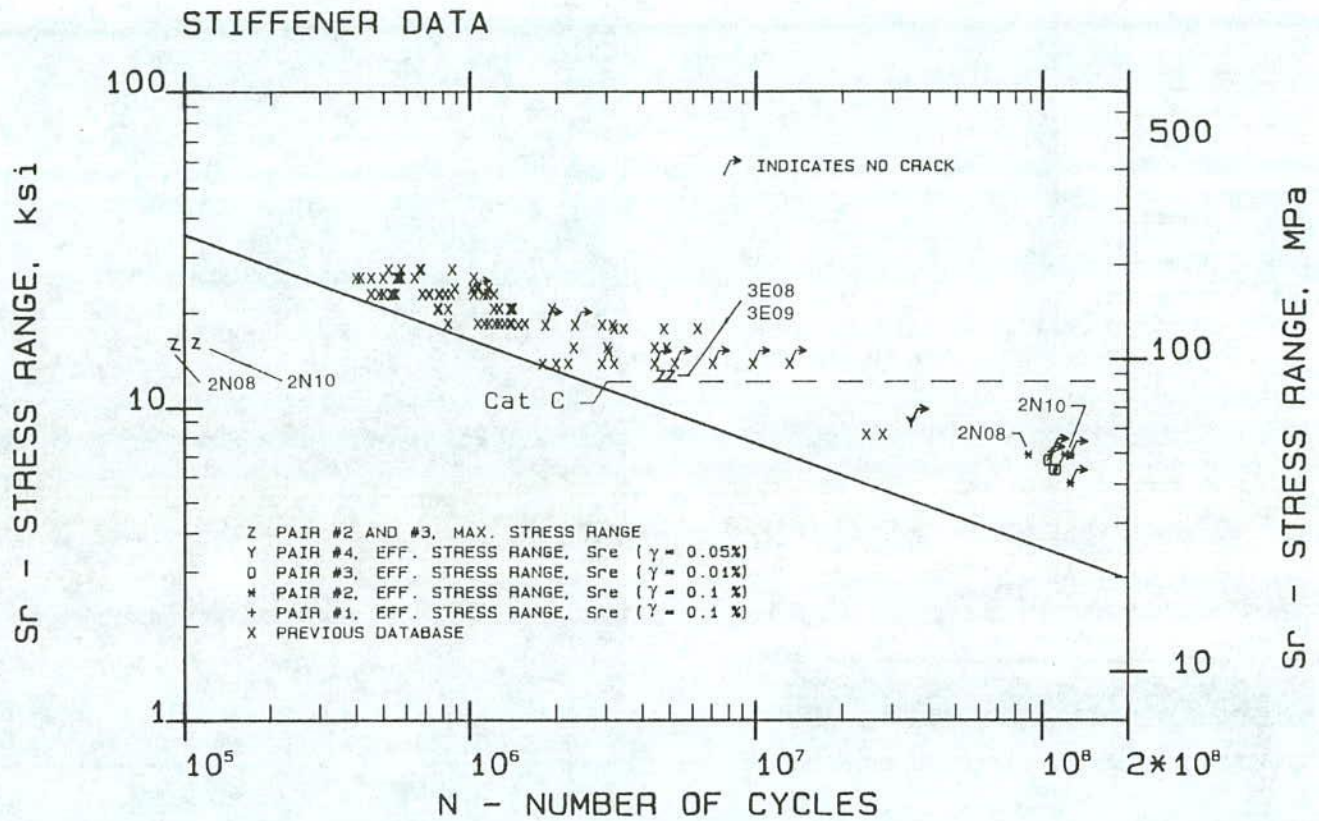
Figure 28. Comparison of test data with fatigue resistance curve for Category C.

The test results are summarized in Figure 28. The test data for the four details that developed cracks are plotted two ways. The data are plotted as "z" symbol considering only the maximum stress cycle in the variable spectrum. For details 3E08 and 3E09, the test result is in good agreement with the constant cycle data.

However, for details 2N08 and 2N10, there is no correlation with the constant cycle test data. All stress cycles in the variable load spectrum when plotted at the effective stress range are in reasonable agreement with the extension of the fatigue resistance curve for Category C. The test data for all test points below the assumed constant cycle stress range of 12 ksi (84 MPa), are all well beyond the lower bound fatigue resistance curve.

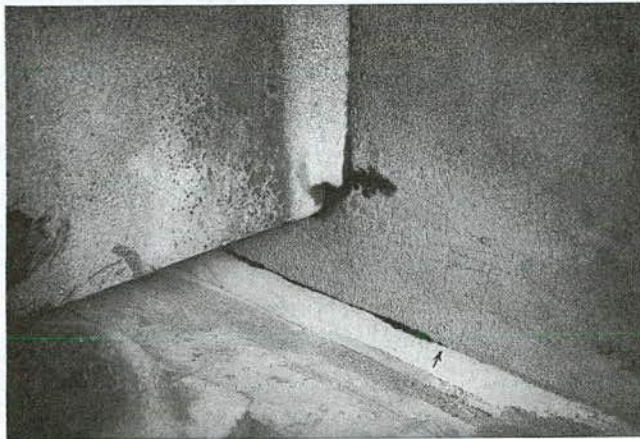
Figure 29. Fatigue cracks at web gap of 1N09.

Variable amplitude loading fatigue cracks developed quickly in the web gaps. The initial cracking was first detected at approximately 50,000 cycles, with extensive cracking at 100,000 cycles. The distortion-induced fatigue cracks developed at both the toe of the web-to-flange fillet weld and at the connection plates end, as shown in Figure 29.

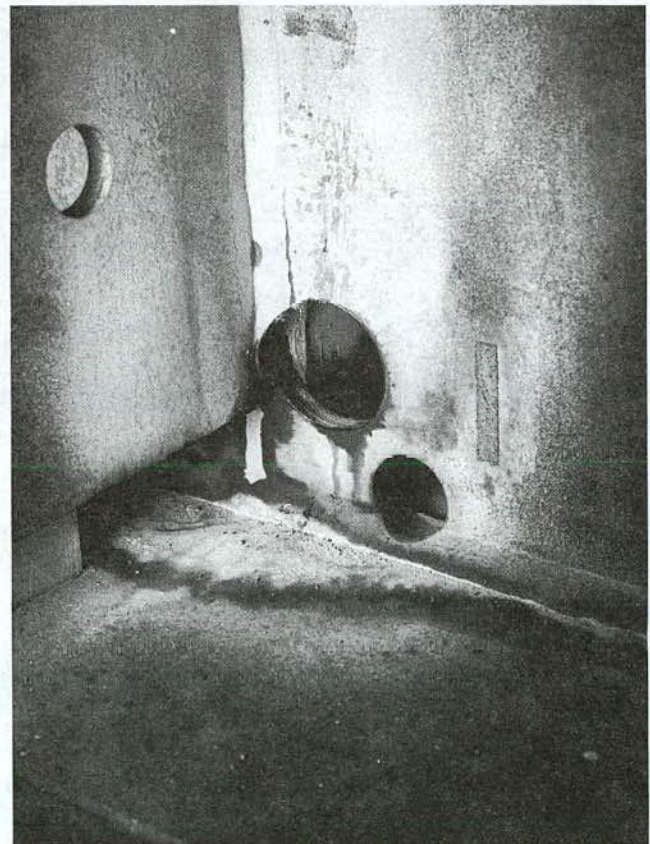
Figure 30. (Right) Retrofitted distortion cracks at detail 1N09.

At approximately 1 million random variable load cycles, the web gap cracking was retrofitted by means of drilled holes at the crack tips. Figure 30 shows the progression of fatigue cracking in stages at one of the web gap details. One and one-half-in. diameter holes were used to core out the cracking at the connection plate end, and $\frac{3}{4}$ -in. diameter drilled holes were used at the tips of the web-to-flange cracks (Stage I). Within 500,000 cycles, crack reinitiation occurred at the toe of both the connection plate weld and the web-to-flange weld. The crack tips were again arrested by drilling holes, as shown in Figure 31 and testing resumed (Stage II). At 2.1×10^6 cycles (Stage III) and again at 2.9×10^6 cycles (Stage IV) a crack reinitiated at the drilled hole along the stiffener fillet weld toe.
