NCHRP Report 370

Performance of Epoxy-Coated Reinforcing Steel in Highway Bridges

Transportation Research Board
National Research Council

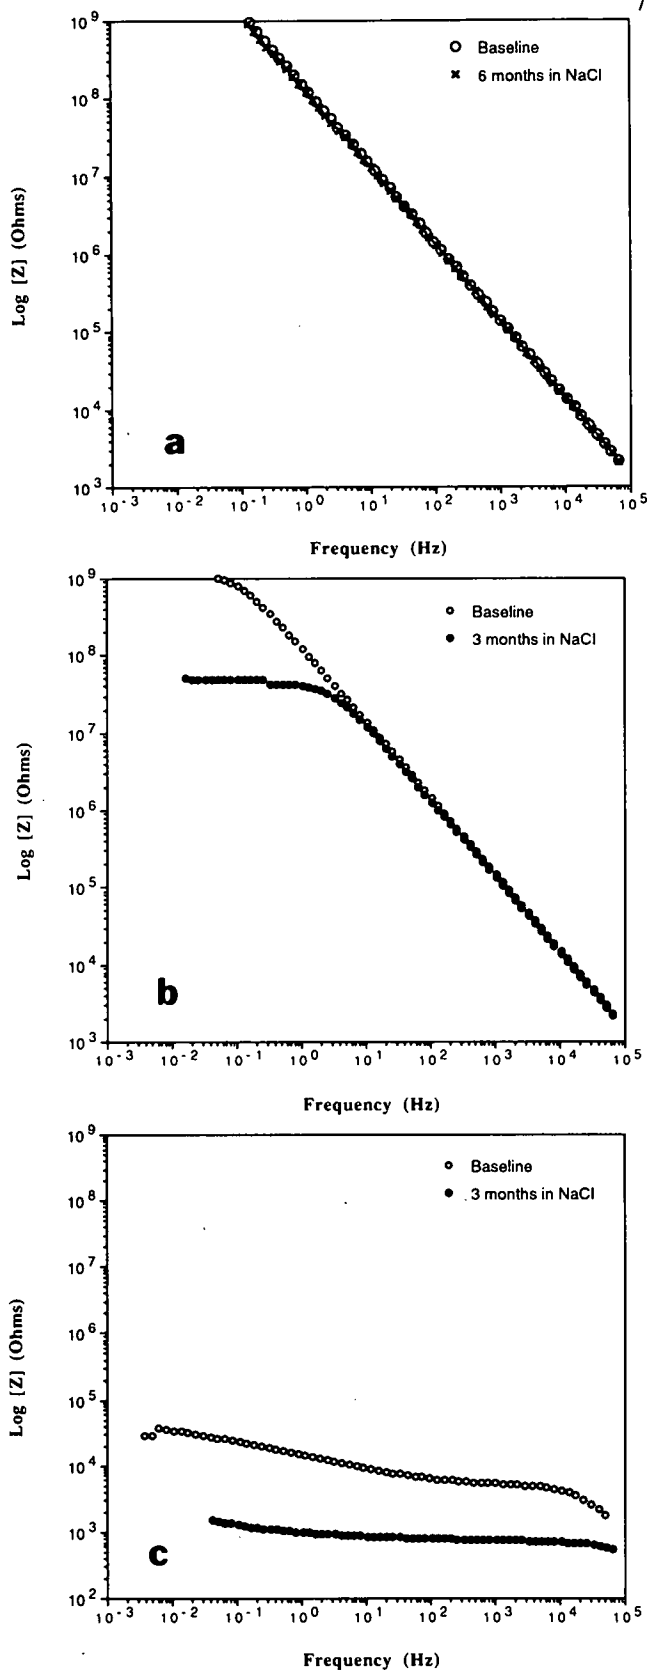
Figure 6. (a) Example of EIS scans where capacitive behavior was retained. (b) Example of an ECR that exhibited reduced pore resistance with exposure time. (c) Example of modest impedance reduction as typically occurred for coatings that were of low initial impedance.

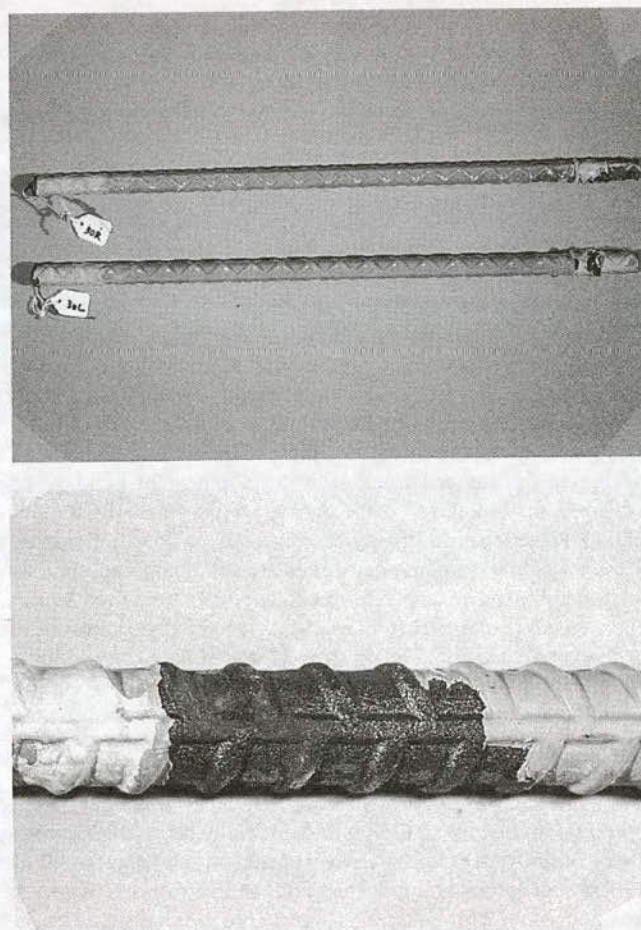
Figure 9. (Top) Photograph of the two ECRs recovered from Slab 30. ECR (30R) performed well with negligible macrocell current and relatively high impedance. (Bottom) Close-up of debonded area of a poorly performed ECR. Bright substrate next to rust area at left indicates cathodic disbondment.

and cathodic disbonding for up to approximately 1 in. (2.5 cm) away from defects. An example of this is illustrated by Figure 9 (bottom). Progressive corrosion beginning at the defect and working its way underneath the coating was apparent. A debonded coating such as this cannot be expected to afford corrosion protection in the long term. A ranking from good to bad of the ECR in the slab specimens according to impedance measurements, macrocell current, and visual appearance was A,D,U > N,J > T. (Note: Because of material quantity limitations on acquisition schedule, slab specimen fabrication included ECR from only 6 of the 11 sources).

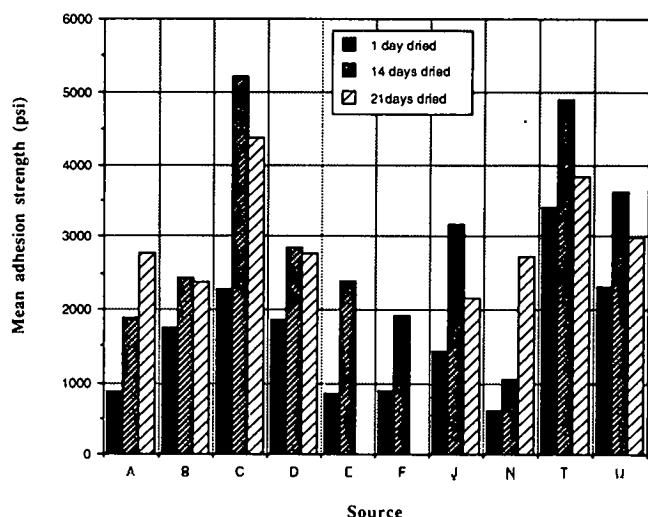
Figure 10. Average adhesion strength of different source ECRs after 14-day 80 C DW HWT.

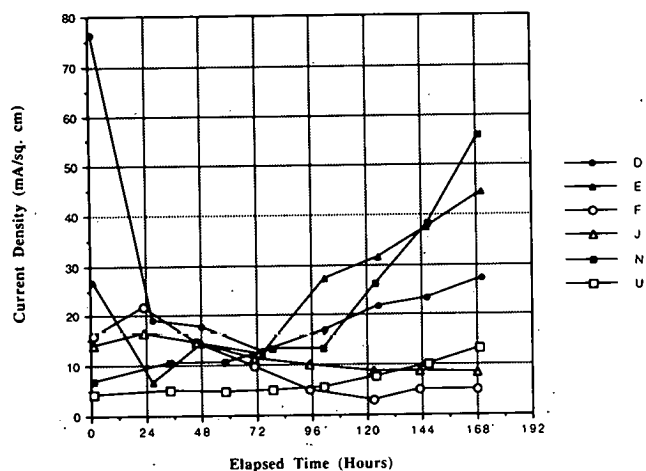
Figure 13. Results of ACT with ECRs from six sources.

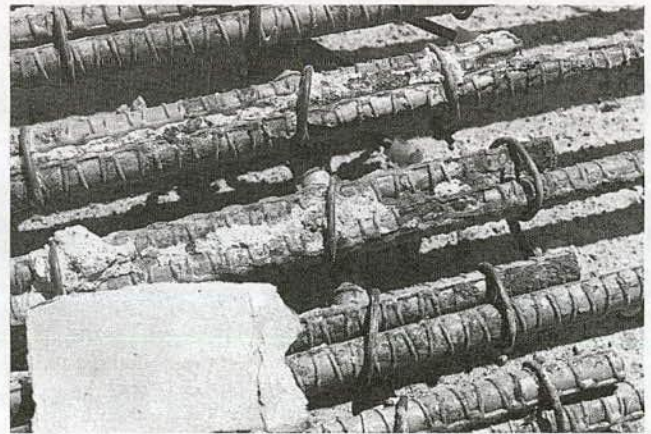
Figure A-1. Fall 1981 condition of top rebar. FHWA 1974 Slab 14—Flintflex 6080 coating with excessive holidays, spliced bars and bare bar ends.

these data and photographs. Figure A-1 shows the condition of the top mat reinforcing in the Flintflex 6080 coated rebar slab number 14 case, which was characterized by excessive holidays (more than 25 per foot), spliced bars and uncoated bar ends (total bare area of approximately 1.1 percent). Note the severe corrosion and the appearance of undercutting. There were numerous cracks in the concrete that extended from the rebar trace, and the coating was easily removed from more than half of the coated rebar area using a knife. While Flintflex 6080 was prequalified for highway application, subsequent evaluation has shown that this coating developed a high holiday density and might be inappropriate for this type of service.

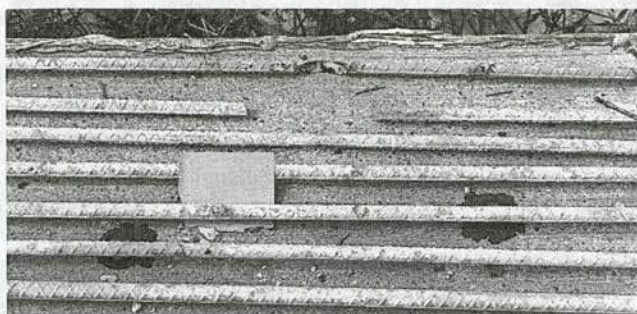
Figure A-4. Fall 1981 condition of top rebar. FHWA 1974 Slab 16—Scotchkote 202 coating with excessive holidays and bare bar ends.

6 in. (15.2 cm) centers to simulate field damage, and the bar ends were uncoated. This rebar was found to be in excellent condition with most of the bare areas showing slight corrosion damage, and no undercutting was apparent. Figure A-4 shows a photograph of the top rebar in slab 16 (Scotchkote 202), which had excessive holidays (more than 25 per foot) and bare bar ends. It exhibited greater corrosion damage than the slabs in Figures A-2 and A-3 but much less damage than exhibited by slab 14 (see Figure A-1). A small amount of undercutting was noticed. The lower rebar in this slab is an uncoated bottom mat that had been positioned along one edge, and it exhibited much more corrosion than the coated steel. However, the concrete around the uncoated bar had become chloride contaminated due to salt solution runoff during rainy weather.

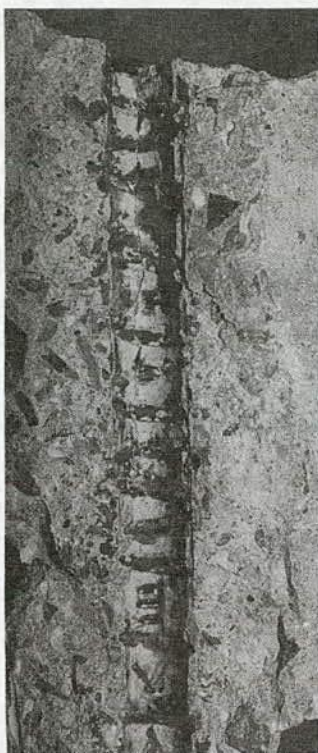
Figure A-5. FHWA September 1989 autopsy of non-spec epoxy-coated rebar Slab 235 (see *time to corrosion, Volume 5 Report*).

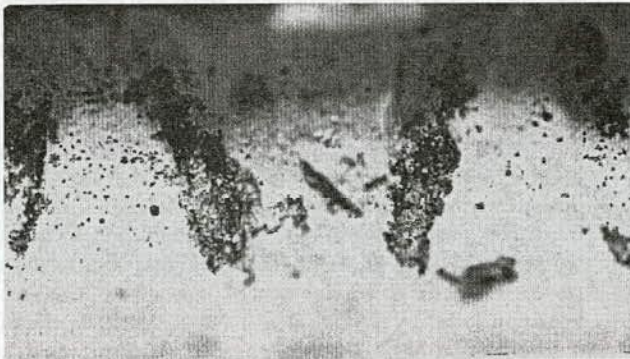
Closeup of the Trace of ECR #2 with Rust

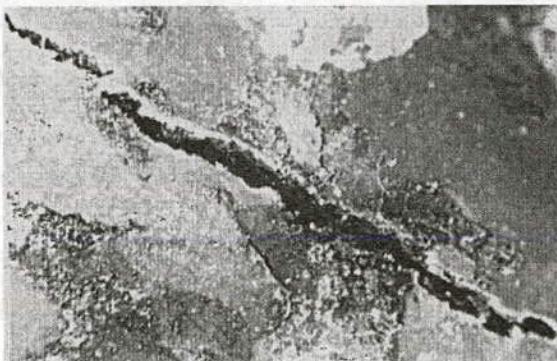
Closeup of Crack in ECR #2

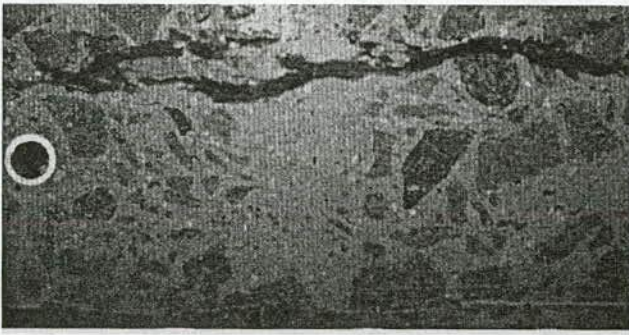
Delam in N2-SE1

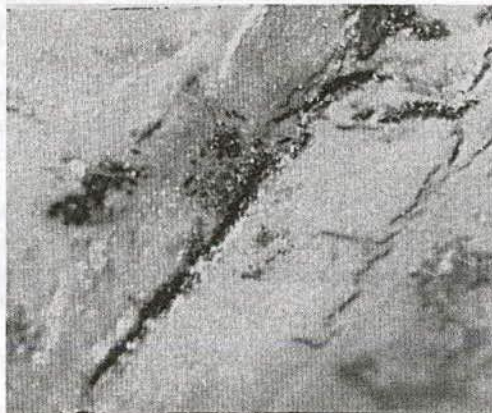
Typical Cracking of Coating N2-SE1

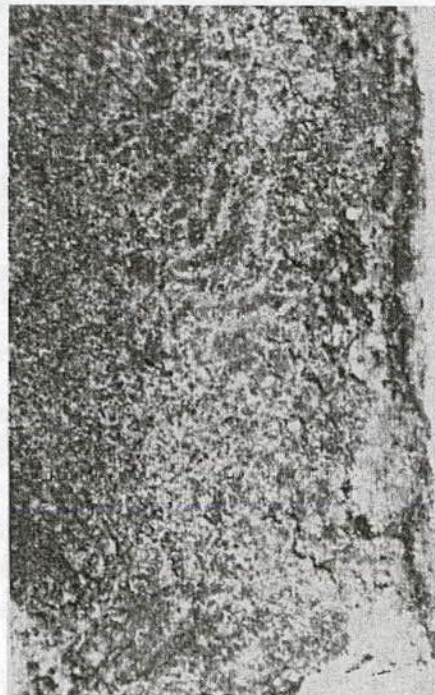
Underside of Epoxy from Bent Bar N7-SE2

Figure A-7. Autopsy findings—specification epoxy-coated rebars after 3.25 years of exposure to intermittent saltwater ponding, tap water ponding, and outdoor exposure.

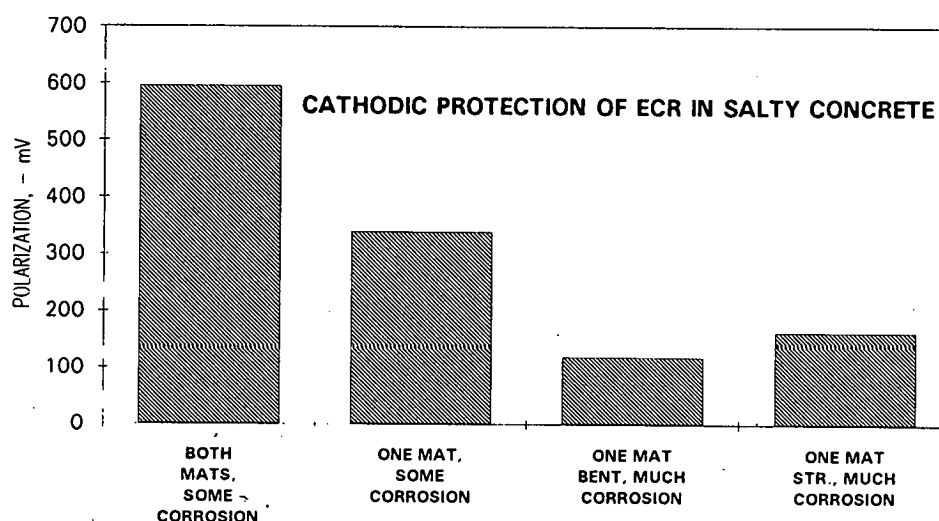
Figure A-9. Polarization at 1 mA/sq. ft. of rebar.

In all cases the cathodic protection anode was installed on the top slab surface, and the top and bottom mats remained interconnected. The CP systems for slabs 1 and 2 were activated in October 1991; and those for slabs 3 and 4 were activated in mid-November 1991. The slabs were initially powered at the KCC INC outdoor exposure facility, moved into the laboratory to allow continued testing during the winter of 1991-92, and subsequently returned to the outdoor test facility. Testing continues today. While in the laboratory they were subjected to a weekly wet-dry cycle by covering them with wet burlap and plastic for three days each week. After a short period at 0.5 mA TRMS/ft² of total rebar, all systems were adjusted to 1 mA/ft². Cathodic protection system voltages were in the range 1.5 to 3.5 volts to maintain the constant current. Half cell potentials were monitored at three to five locations per slab, including via wells drilled close to the top mat rebar. On all four slabs, the corrosion macrocell was reversed by the cathodic protection, thus indicating that the top mat rebar had been cathodically polarized, rather than being anodic and corroding as was the case prior to CP. Polarization (7 days for slab 1 and 24 hours for the other slabs) exceeded -100 mV at all sites monitored. Average values are presented in Figure A-9, and the data through December 1991 were listed in the Appendix of the Interim Report (69). Note that the polarization was greatest for the slab with epoxy-coated rebar in both mats and least for the slab exhibiting the highest corrosion rate (bent top mat epoxy-coated rebar, uncoated bottom rebar). Figure A-10 presents the percent of the total cathodic protection current received by the top mat epoxy-coated rebar in each slab. Note that more current was received by the uncoated rebar in the bottom mat for slabs 2 to 4 than in the case of the epoxy-coated bottom mat rebar in slab 1. However, this did not create difficulties in protecting the top mat rebar in any of the slabs. Depolarization at all measurement locations on all slabs exceeded 100 mV (average 24 hour depolarizations varied from 160 to 842 mV).

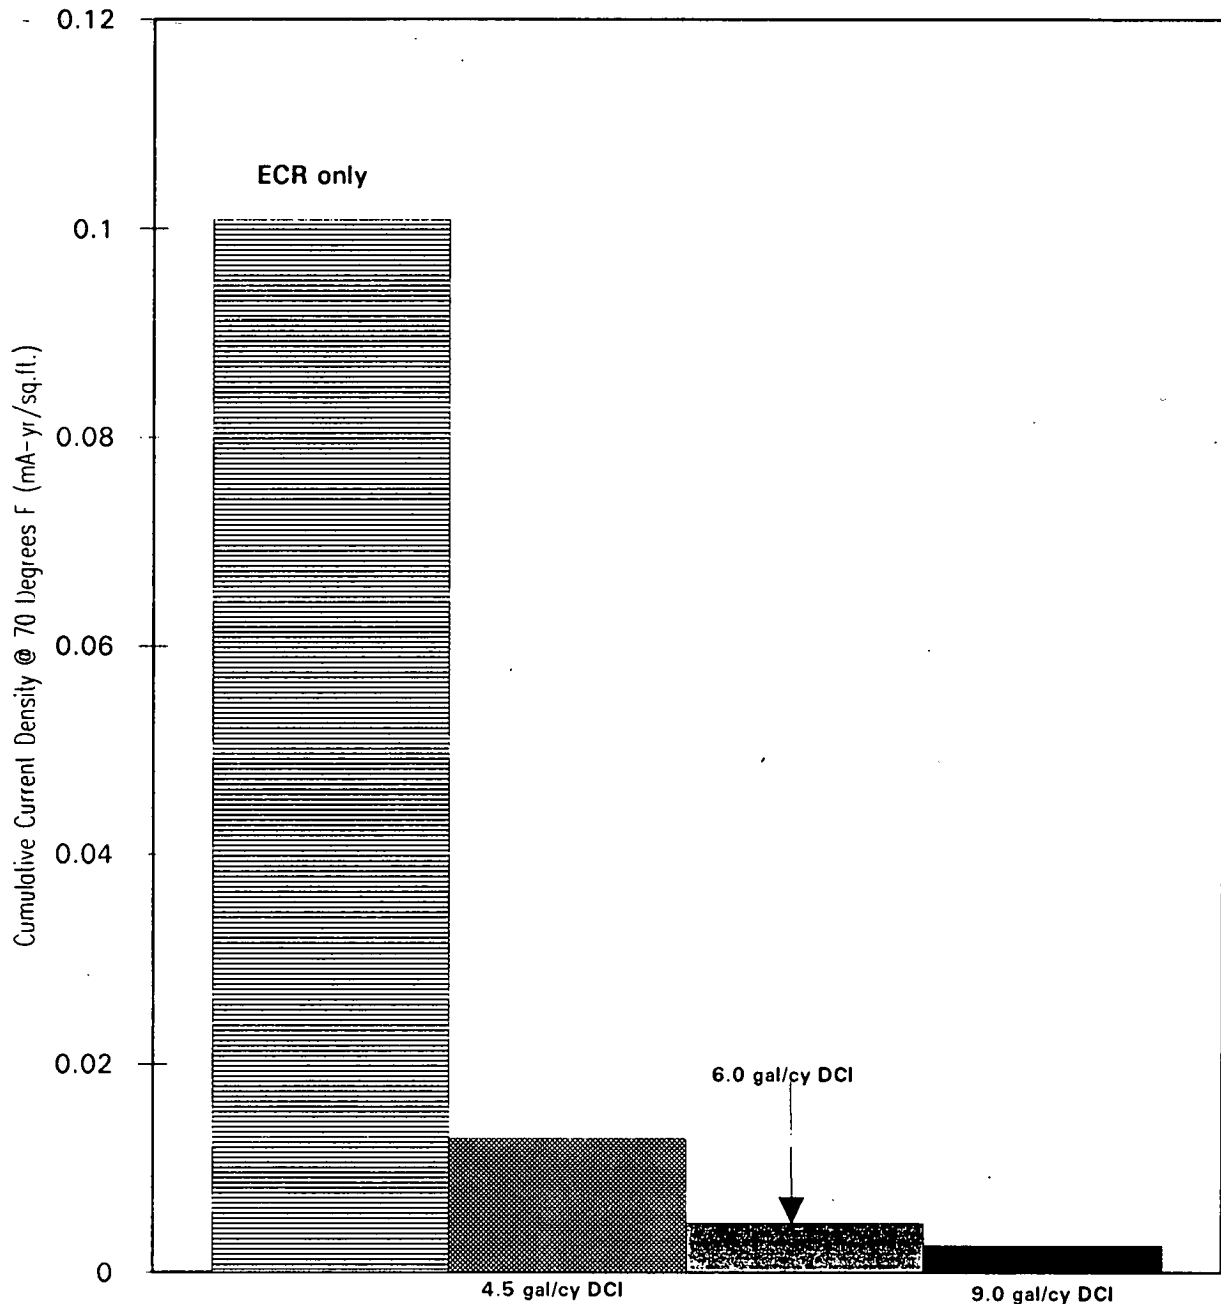
Figure A-12. Effect of calcium nitrite addition on macrocell current density.

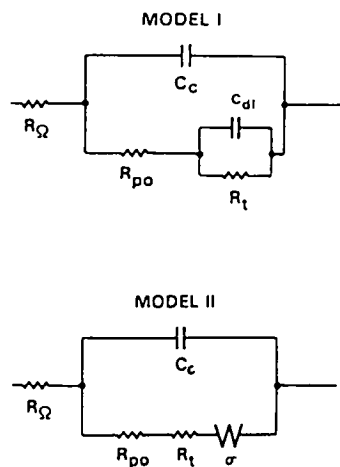
Figure B-6. Equivalent Circuit Analogs for Modeling Behavior of Organic Coating Systems, where R_Ω is the Bulk Solution Resistance, C_c is the Coating Capacitance, R_{po} is the Coating Pore Resistance, C_{dl} is the Pseudo Capacitance at the Coating/Substrate Interface, R_t is the Charge Transfer Resistance and W is the Warburg Diffusional Impedance.

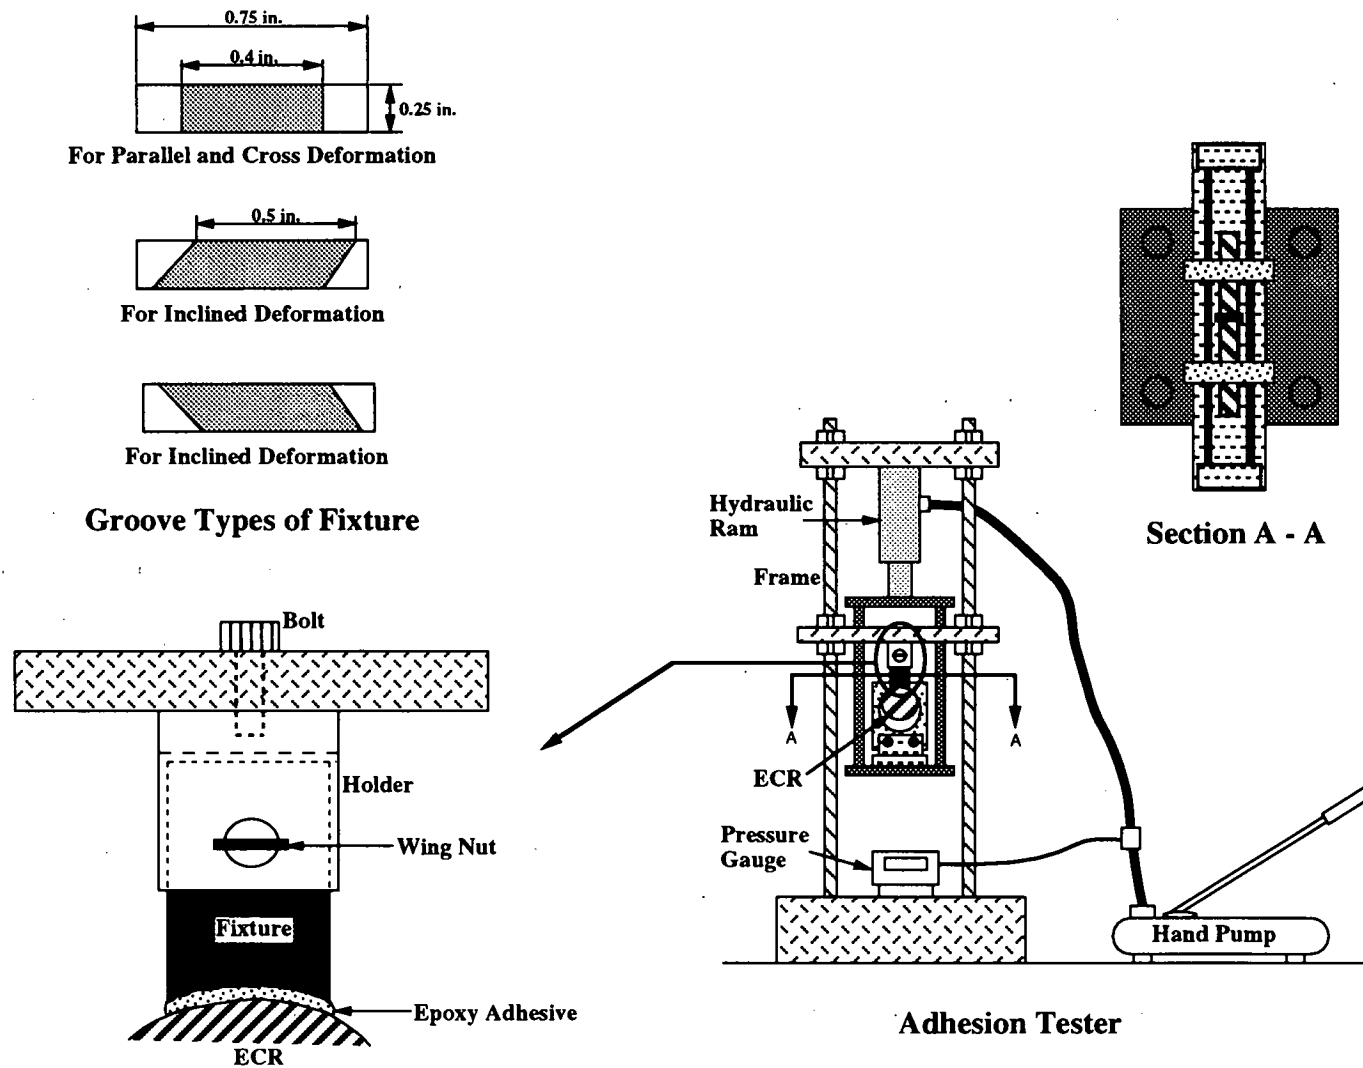
Figure C-1. Schematic of Adhesion Testing System.

1. The required equipment for conducting this procedure includes a temperature controlled bath preferably capable of multi-specimen immersion, electrochemical impedance measuring instrumentation and adhesion pull-off tester.
2. Schematics of the adhesion pull-off instrumentation and aluminum pull-stubs are shown in Figure C-1.

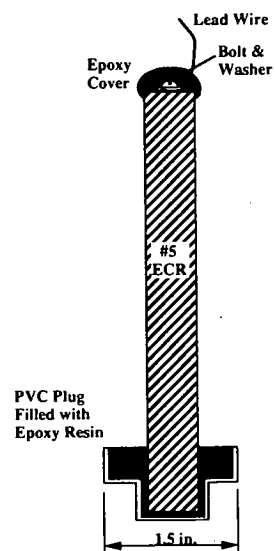
Figure C-2. Schematic of ECR Specimen.

1. Cut ECR specimens into lengths of 6 to 8 inches (15.25 to 20.5 cm).
2. Drill and tap one end of the ECR specimen and attach an electrical lead wire using an appropriately sized screw.
3. Seal both ends of the specimen using a room temperature curing (two-part) epoxy. Place the end opposite to end with electrical connection in plastic cap and fill with epoxy resin. Refer to Figure C-2.
4. Allow epoxy to cure according to the manufacturer's specifications.

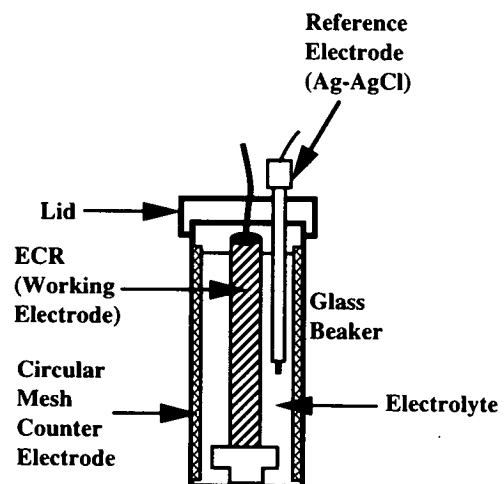
Figure C-3. Schematic of Immersion Test Cell.

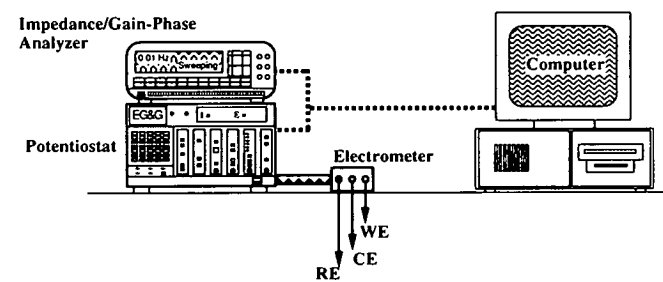
Figure C-4. Schematic of Electrochemical Impedance Instrumentation.

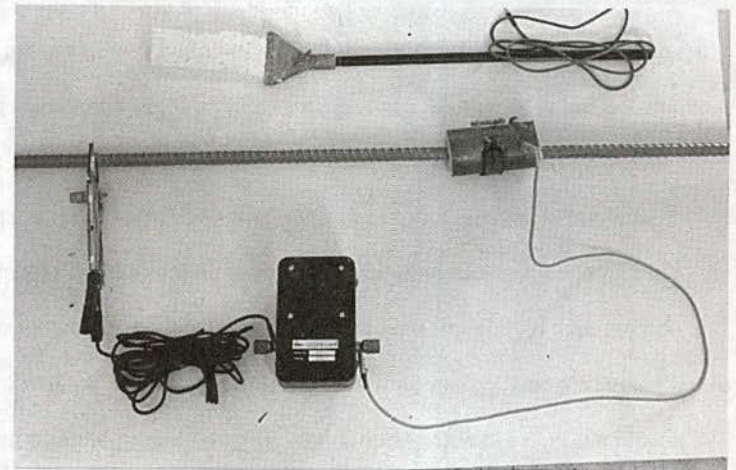
Modified Holiday Detector Test.

Figure D-3. Single Probe Test Setups.

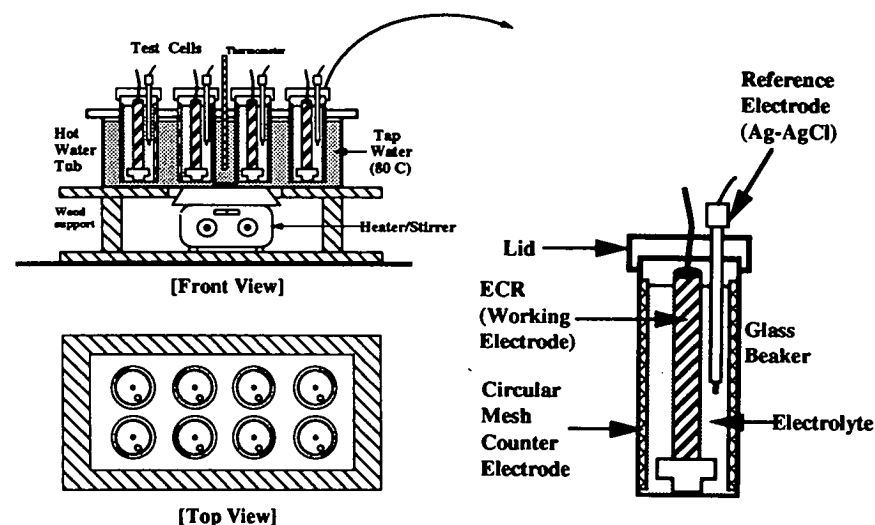
Figure G-4. Schematic of Hot Water Test Apparatus and Test Cell.

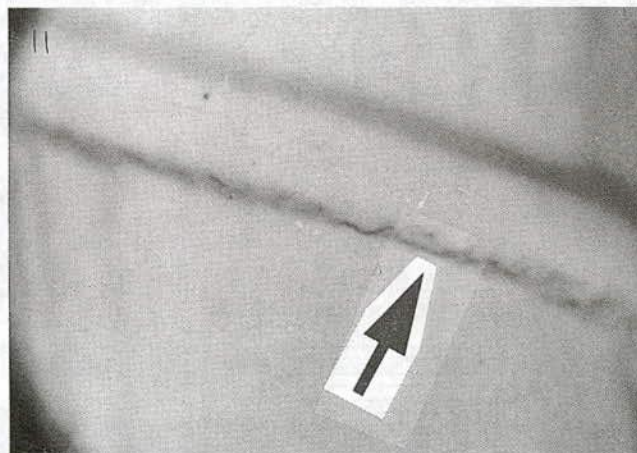
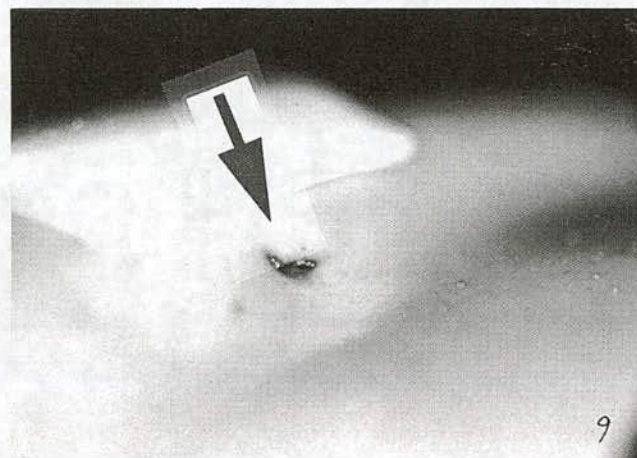
Figure H-2. (Top) Hairline crack along the base of a lug. (Bottom) Short crack at a valley.

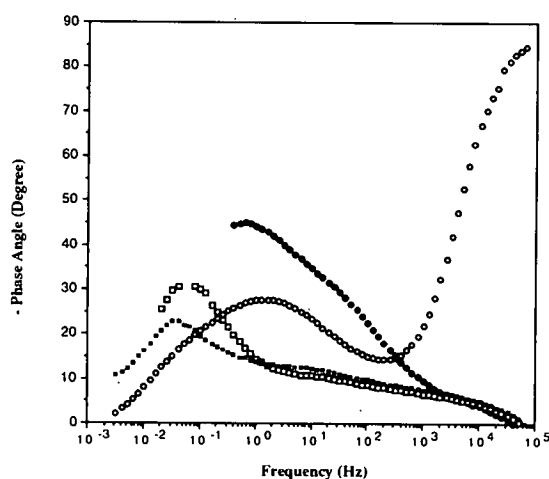
(ii) Bode Phase Angle Plots

Figure H-6. (b) Bode plots for specimen T12 with five initial defects exposed to aqueous 3.5 w/o NaCl solution for 14 days at 80°C.

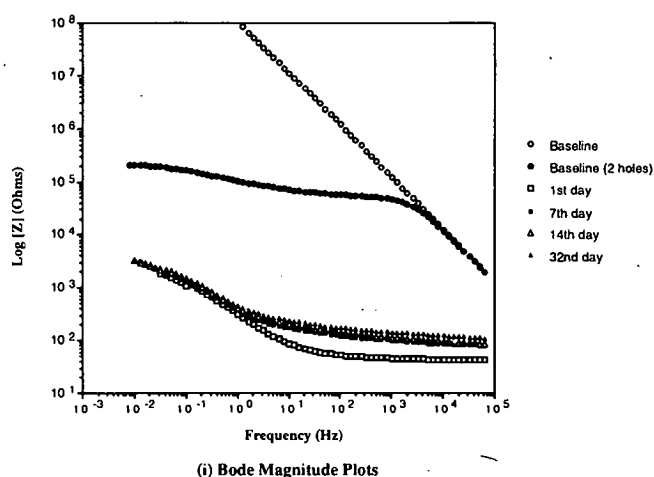
Figure H-16. (b) Bode plots for specimen B17 containing two artificial defects exposed to aqueous 3.5 w/o NaCl solution at 80°C.

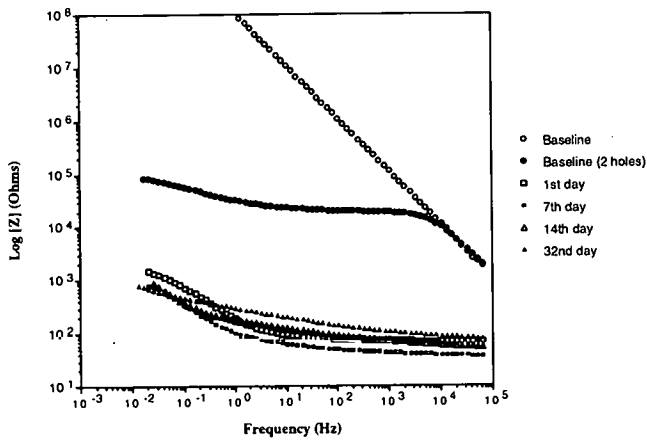
(i) Bode Magnitude Plots

Figure H-17. (a) Bode plots for specimen D13 containing two artificial defects exposed to aqueous 3.5 w/o NaCl solution at 80°C.

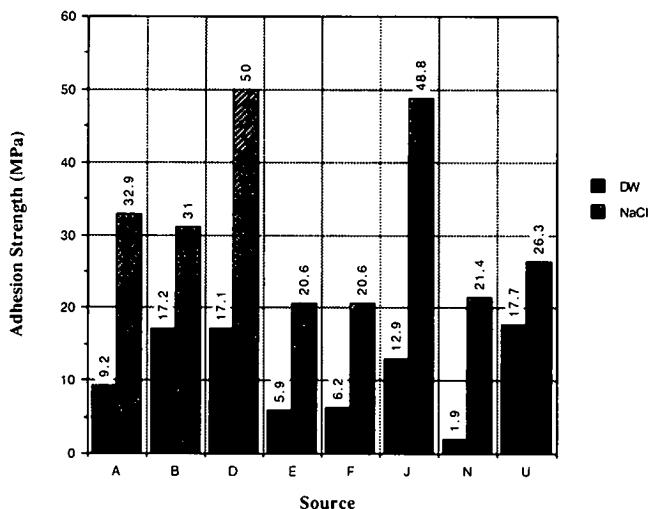
Figure H-20. Average adhesion strength after 1 day of drying for defect-free ECR specimens previously exposed for 14 days to either DW or aqueous 3.5 w/o NaCl solution to 80°C.

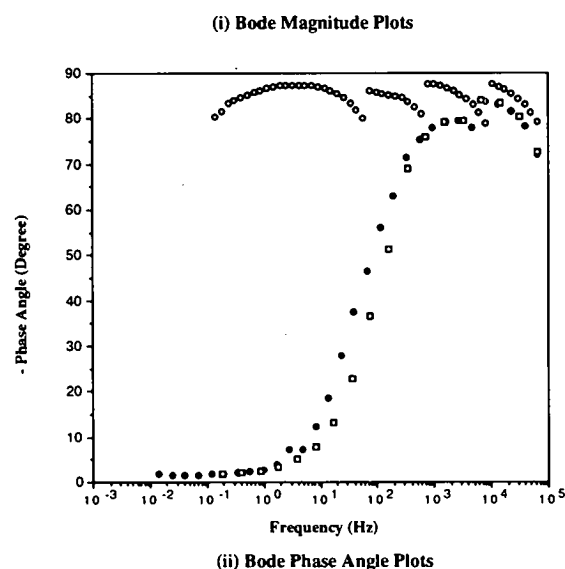
Figure H-24. (b) Bode plots for specimen BUCJ2 preweathered (uncovered) at the marine site for two months and tested in aqueous 3.5 w/o NaCl solution at 80°C.

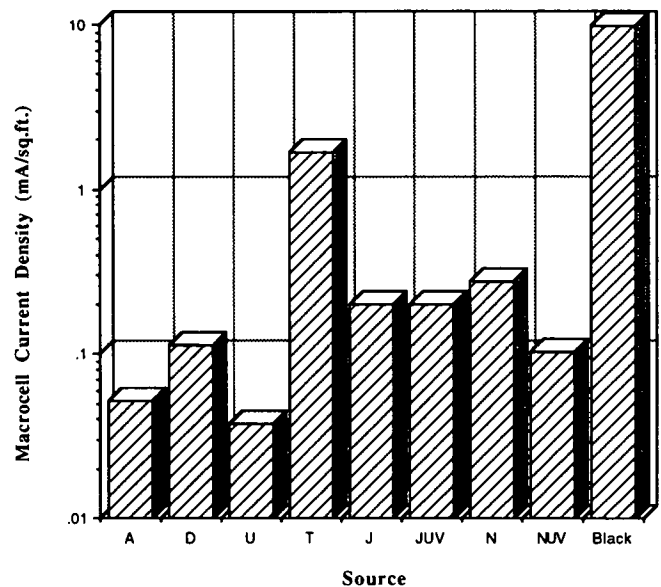
Figure H-31. Summary of initial macrocell current densities for concrete slab specimens as a function of ECR source.

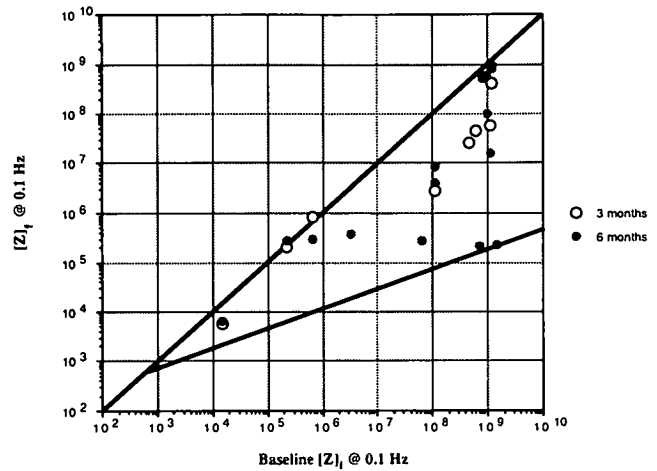
Figure H-36. Change of impedance at 0.1 Hz for all specimen sources exposed to distilled water at room temperature.

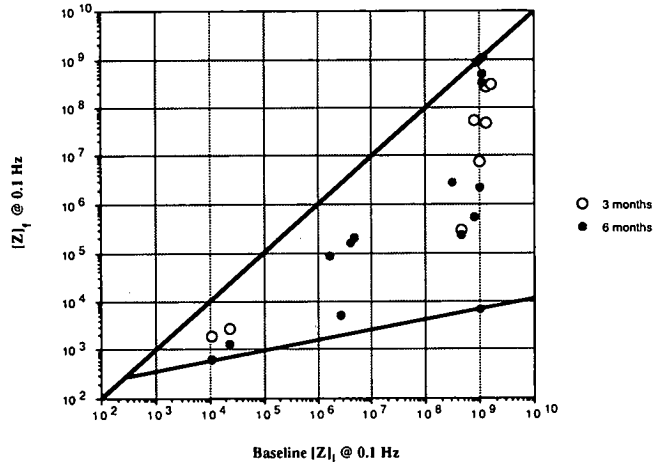
Figure H-37. Change of impedance at 0.1 Hz for all specimen sources exposed to aqueous 3.5 w/o NaCl solution at room temperature.

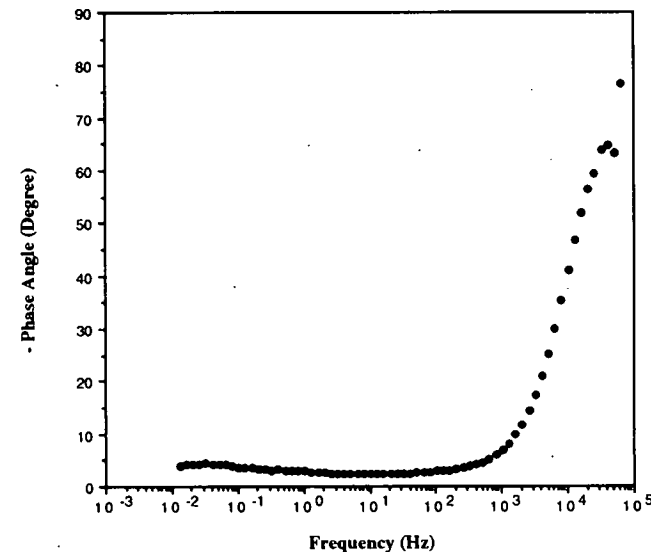
(ii) Bode Phase Angle Plot

Figure H-41. (b) EIS scan of A15 after 14-day ACT.

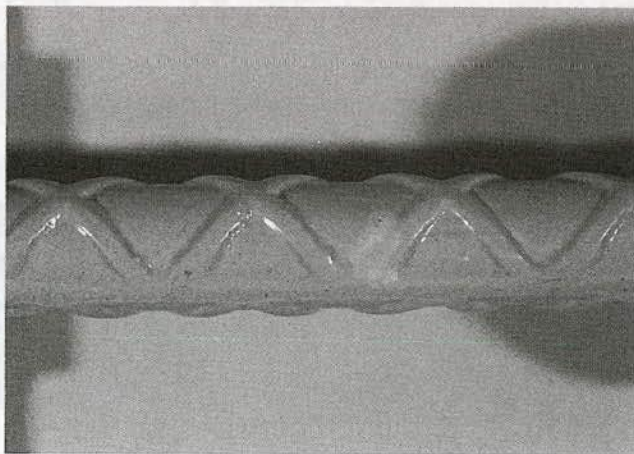
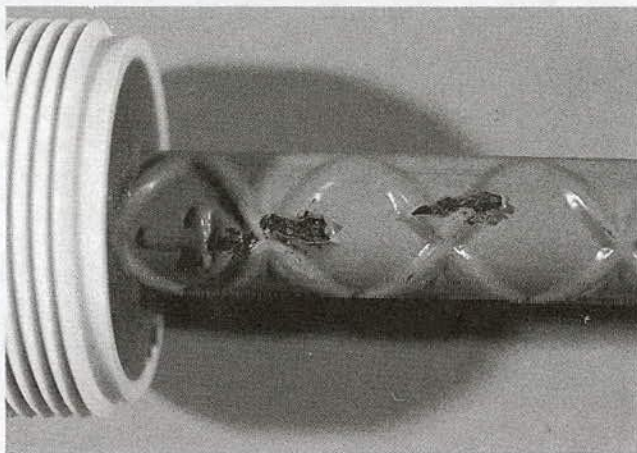
Figure H-43. (Top) Photograph of A15 after ACT.
(Bottom) Photograph of B14 after ACT.

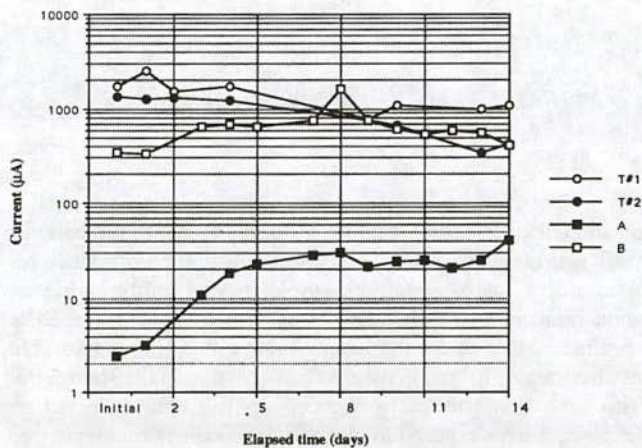
Figure H-44. Results of preliminary ACTs for three defect-containing ECR source bars.

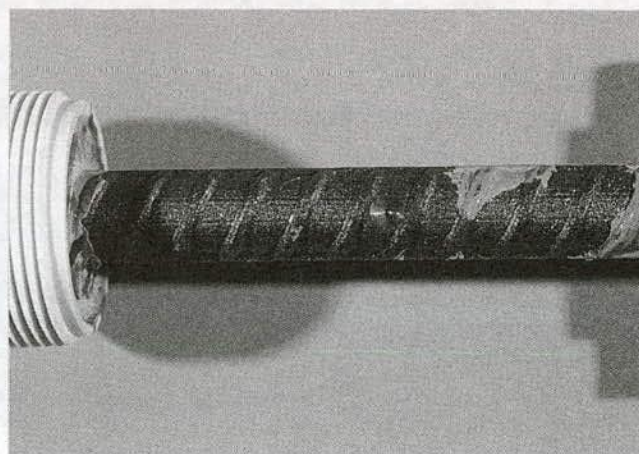
Figure H-45. Photograph of T18 after ACT.

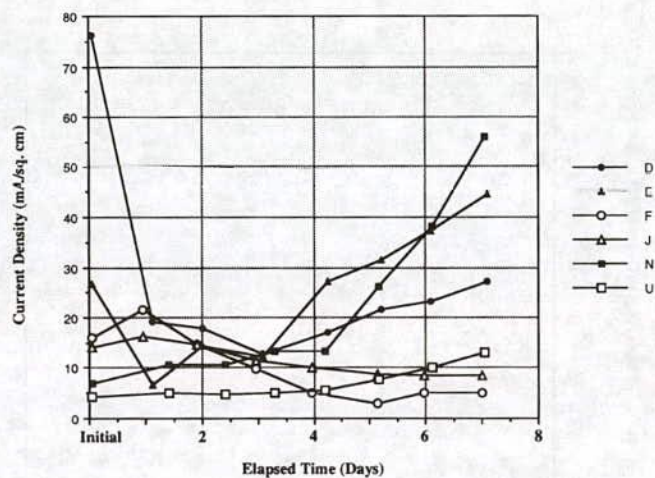
Figure H-46. Results of ACT with ECRs containing same size defects.

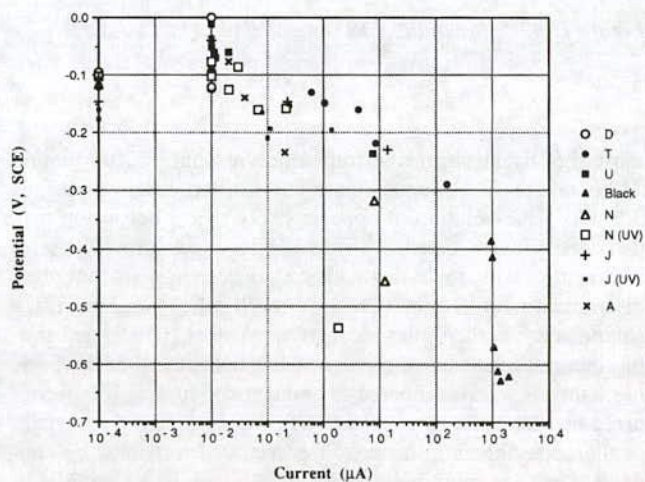
Figure H-47. Potential versus current of uncoupled condition ('A' Exposure).

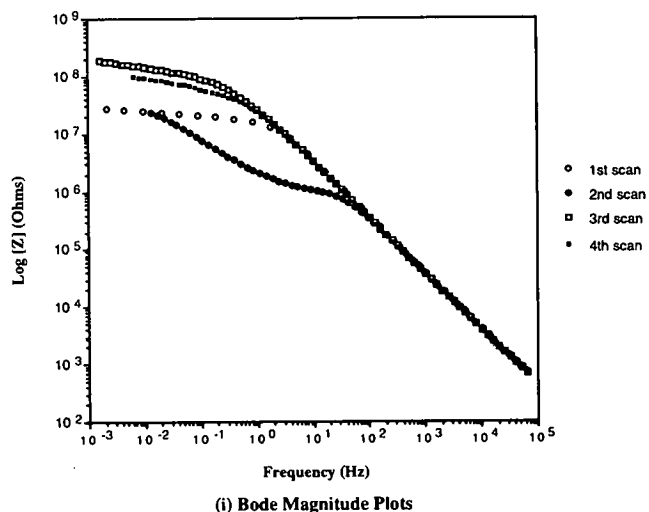
Figure H-53. Bode plots for slab specimen 50L (D Source) exhibiting high overall impedances during 8 months of exposure.
