NCHRP Report 396

Instrumentation for Measuring Scour at
Bridge Piers and Abutments

Transportation Research Board
National Research Council

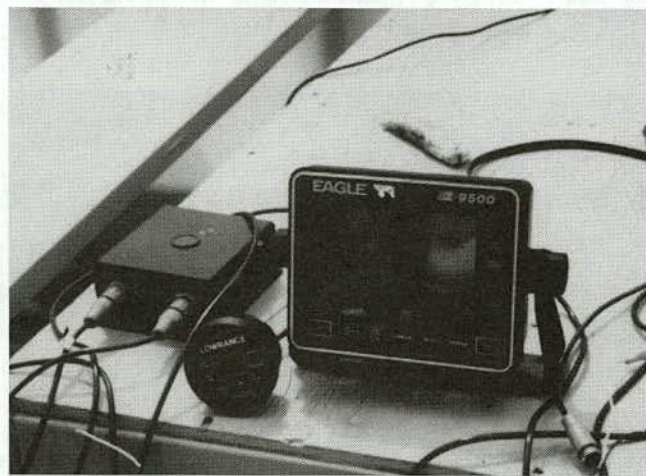
Figure 12b. Sonic fathometers in outdoor (near-prototype) flume.

A preformed scour hole was excavated in the outdoor flume for the second near-prototype test. For this test, a minimum of 0.9 m (3 ft) of water was maintained at the location in front of the pier where the transducers were to measure the scour depth. Both instruments were checked thoroughly and tested in calm water before and during the test to ensure that the instruments were functioning properly. Both instruments functioned properly as the discharge increased to approximately $0.71 \text{ m}^3/\text{s}$ (25 cfs). When the discharge was increased beyond that point, both fathometers once again lost signal. Upon reducing the discharge, signal was re-established. At no time was any flow separation observed at the transducer heads during this test. Observations of the functioning of the flume head box and energy dissipator (see Figure B-2) as the flow was increased through $0.71 \text{ m}^3/\text{s}$ (25 cfs) and then

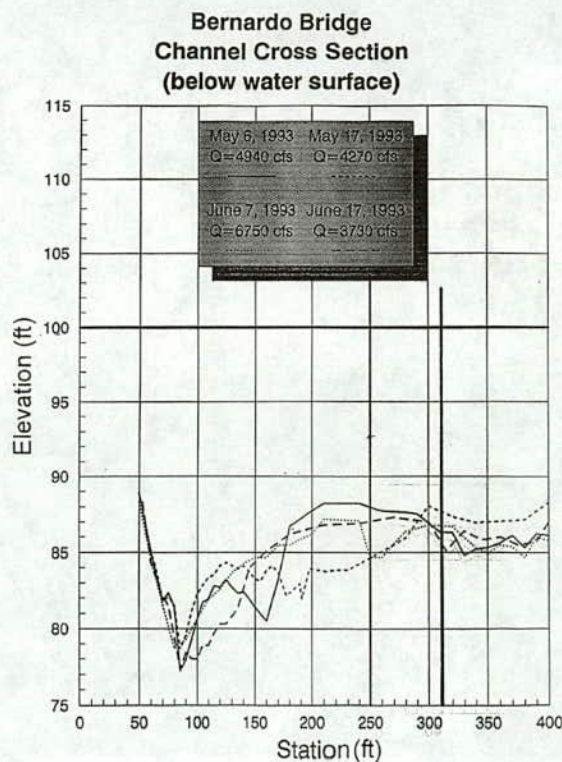
Figure 23. U.S. 60 bridge over Rio Grande near Bernardo (Site NM1) channel cross sections.

The sliding collar instrument was not in the portion of the cross section showing the most change, but did encounter some scour and fill. Because of the overhang of the bridge deck, the ground truth cross-sectional data developed from stream gaging results represent conditions as much as 0.9

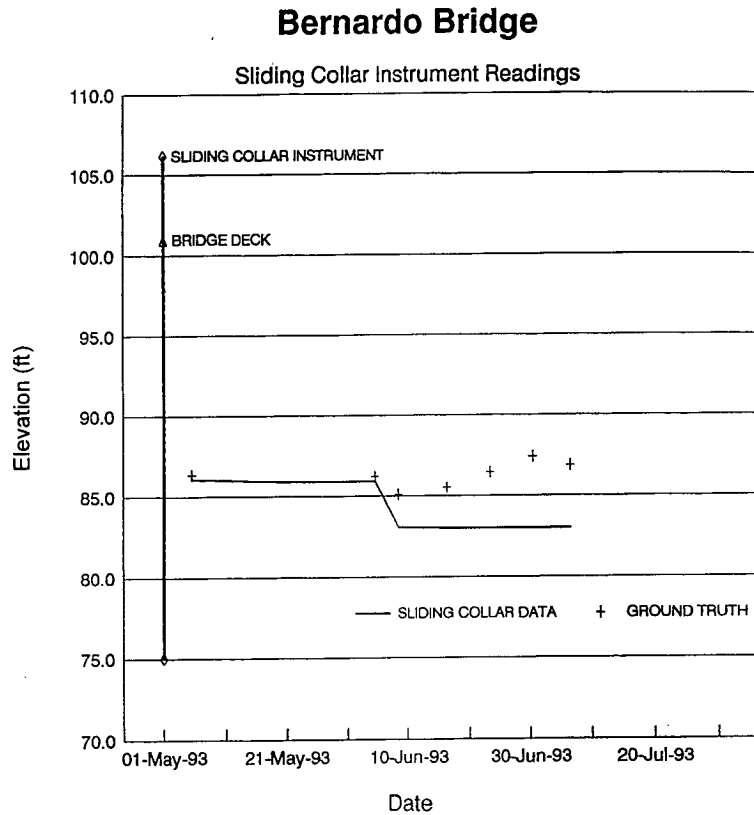
Figure 24. Site NM1 magnetic sliding collar readings.

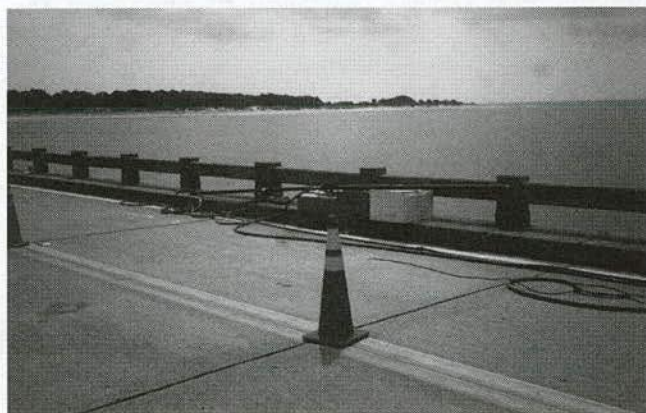
Figure 27. Overview of Nassau Sound automated sliding collar with driving extension (Site FL2).

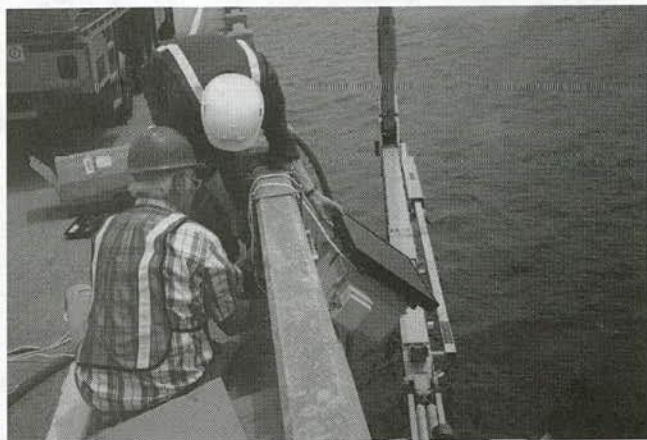
Figure 31. Nassau Sound sliding collar—datalogger housing and solar panel (Site FL2).

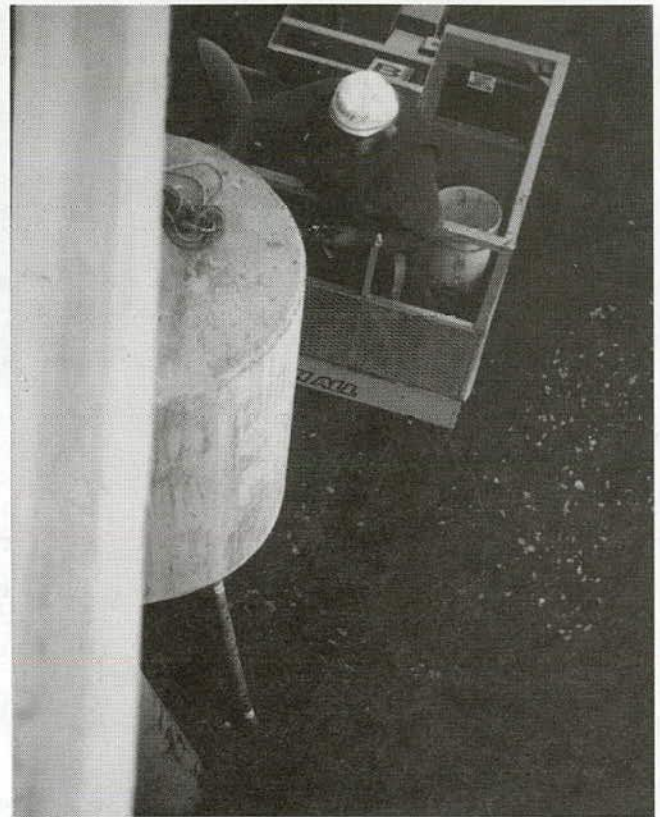
Figure 40. Installation of sliding collar device at Minnesota bridge no. 23015 (Site MN2).

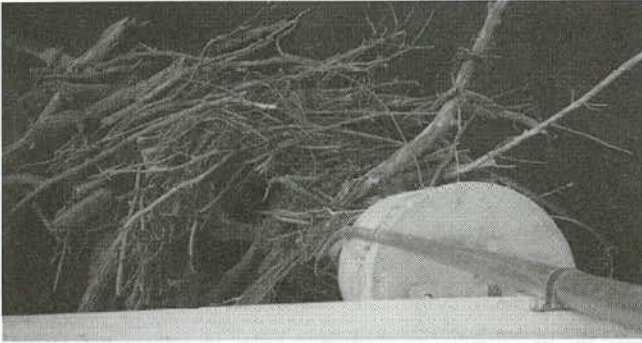
Figure 42. Debris accumulation on sliding collar device at Minnesota bridge no. 23015 (Site MN2).

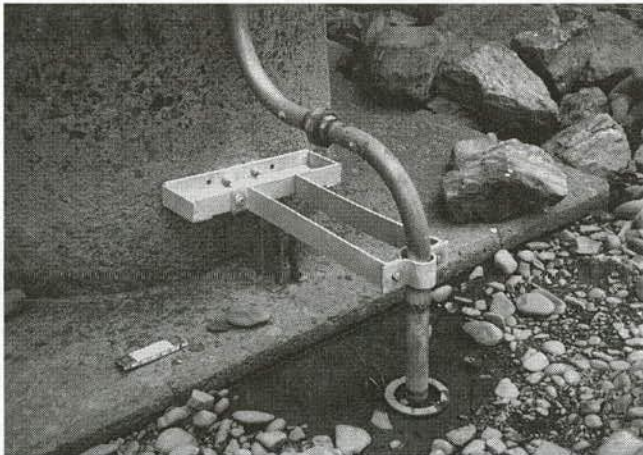
Figure 45. Sliding collar installed upstream of bridge pier at State Route 30/145 over Schoharie Creek at Middleburg, NY.

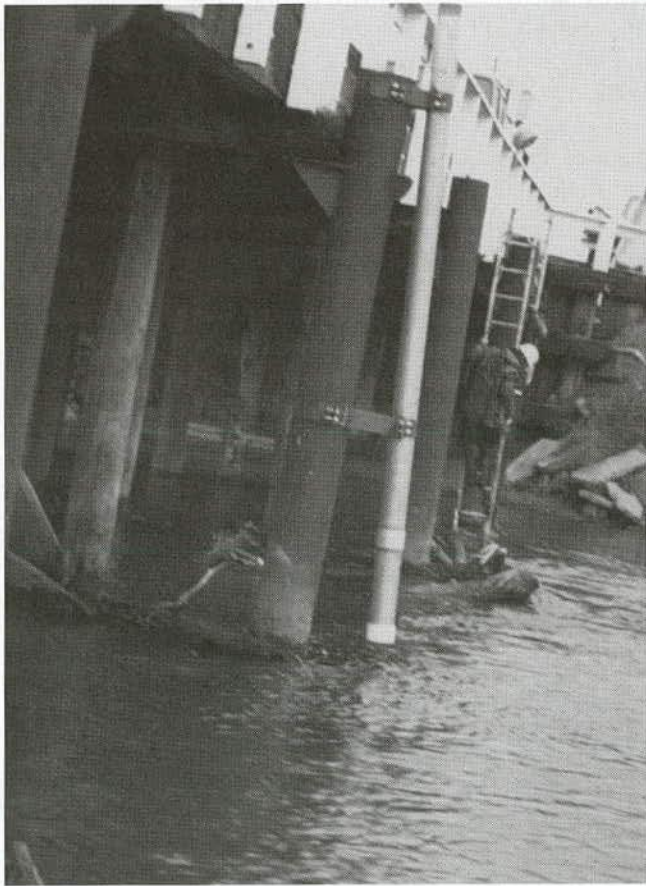
Figure 47. Sonic device support installation at State Highway 144 bridge near Orchard, CO (CO1).

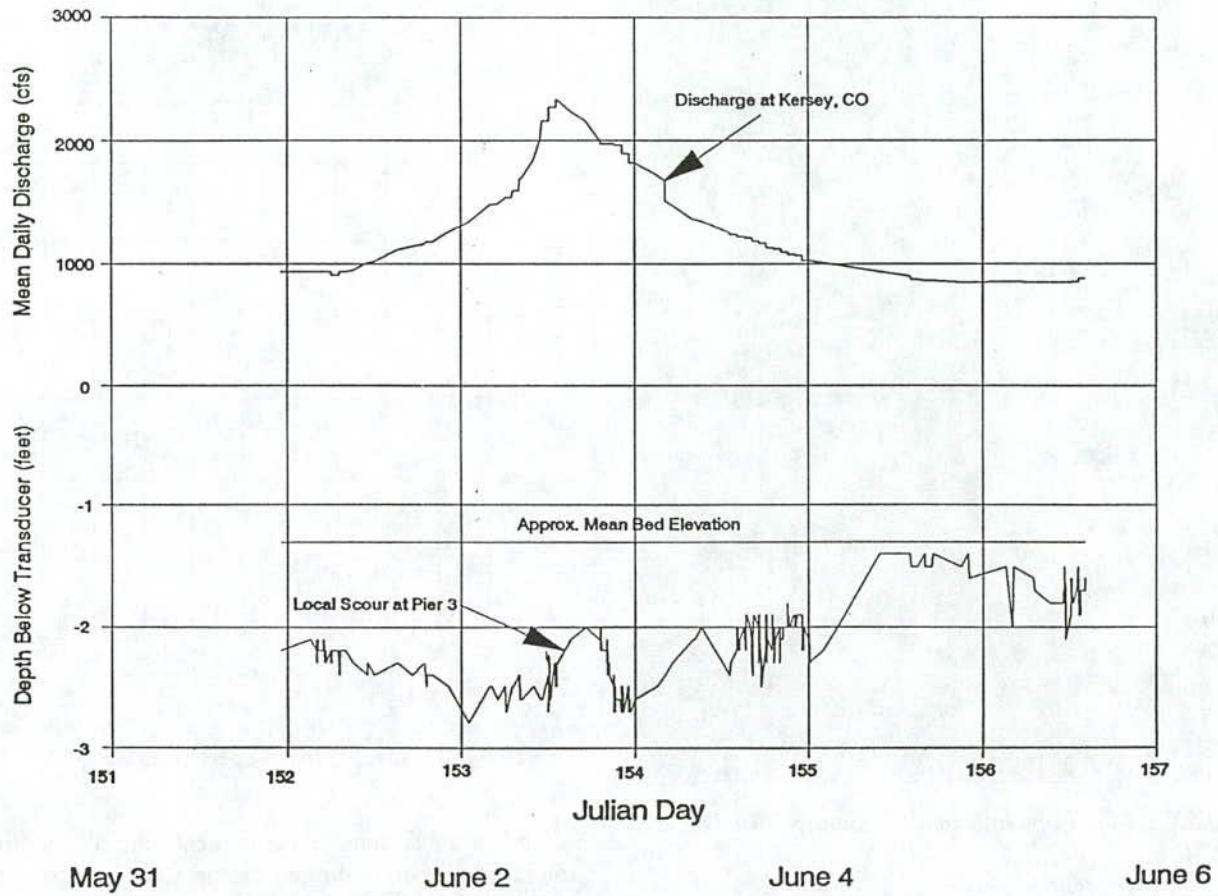
Figure 49. Plot of depth reading versus time from sonic fathometer at Orchard bridge site (CO1), 1992 field season.

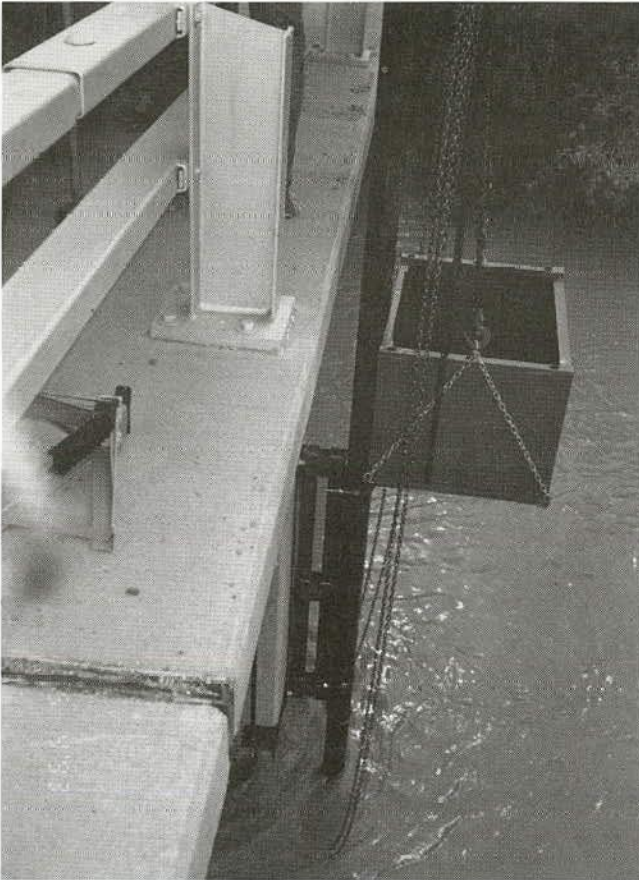
Figure 52. Sonar pipe attached to mounting bracket (Site NM2).

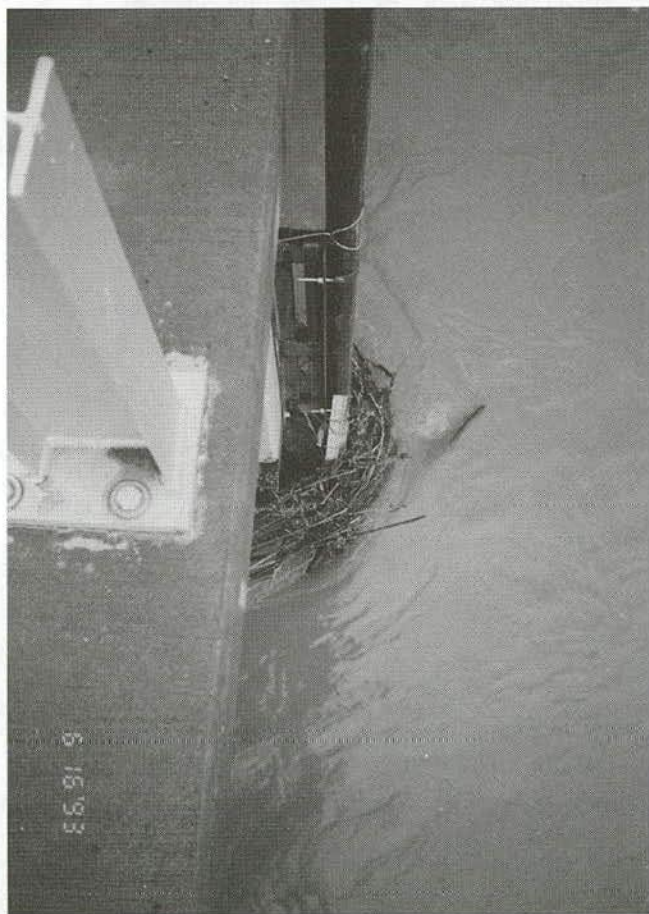
Figure 55. Debris collection at San Antonio sonar site (Site NM2).

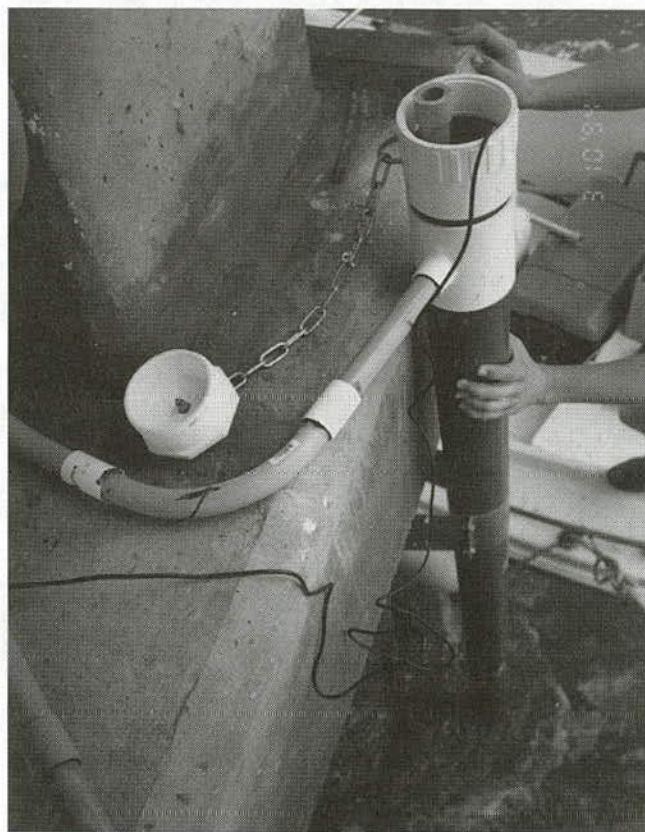
Figure 60. Transducer housing at Johns Pass bridge (Site FL1).

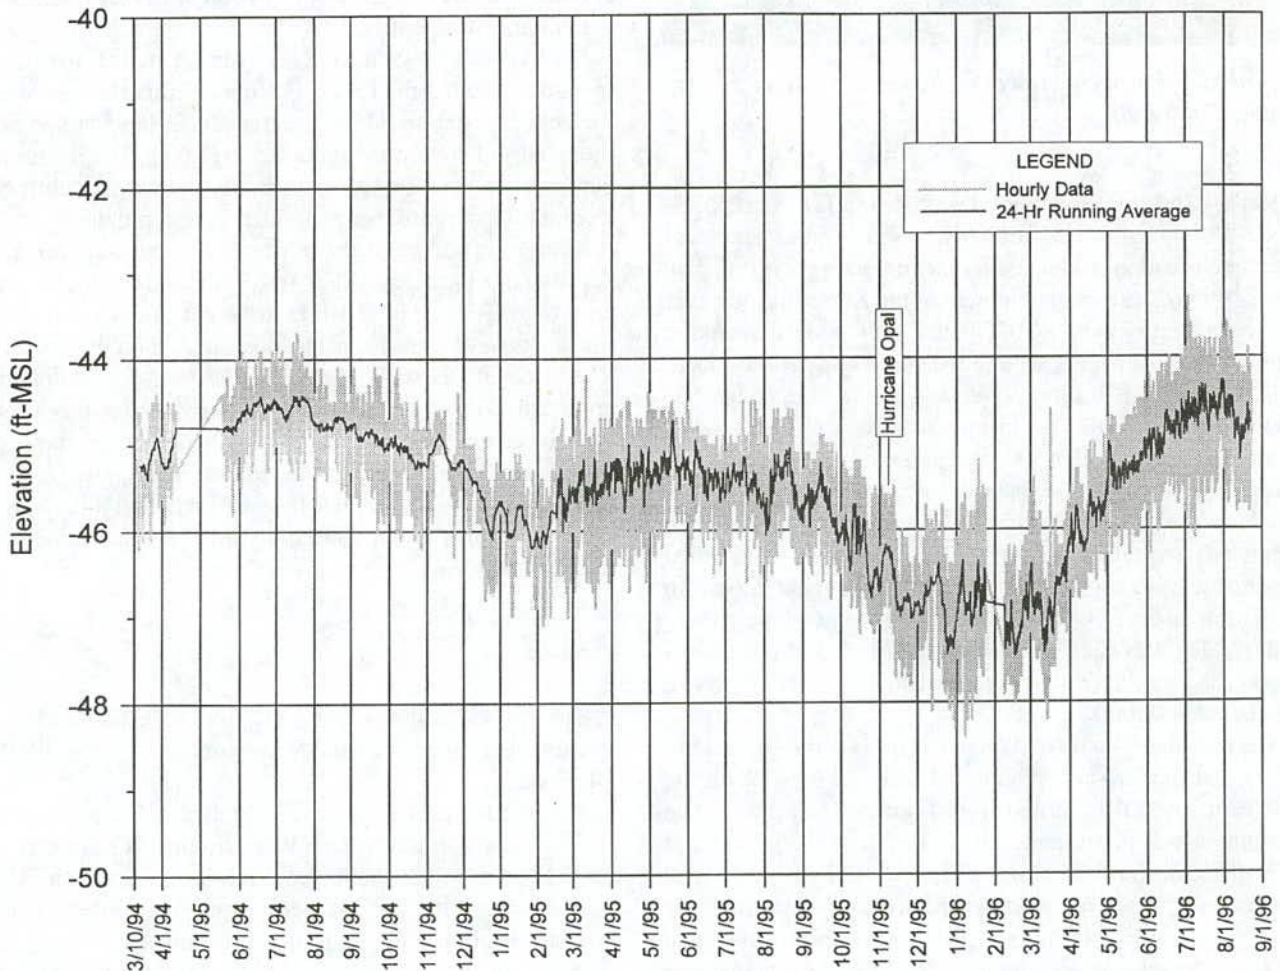
Figure 62. Uncorrected sounding data, Johns Pass bridge (Site FL1).

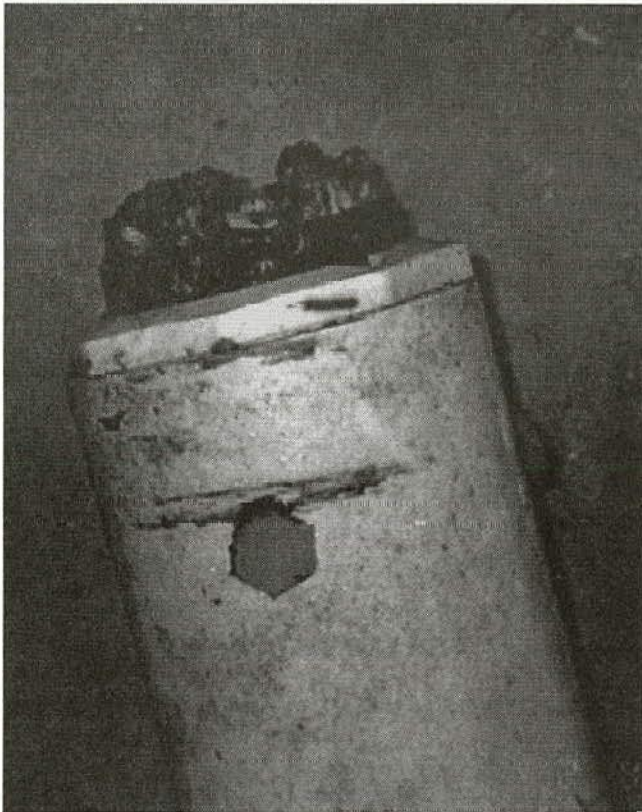
Figure 63. Barnacle growth on transducer—John's Pass bridge (Site FL1).

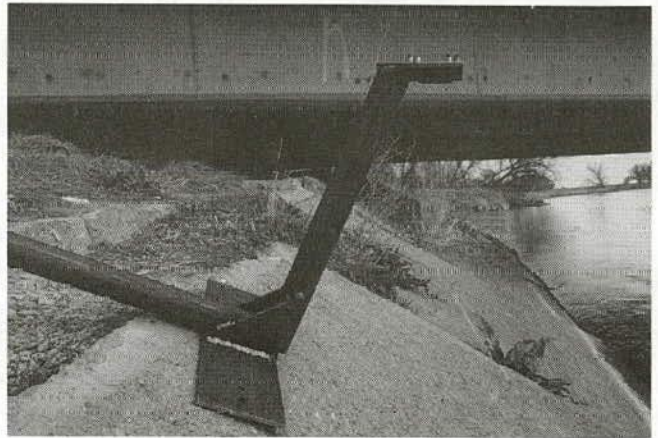
Figure 64. Close up of sonic device support bracket—Kersey bridge abutment installation (Site CO2).

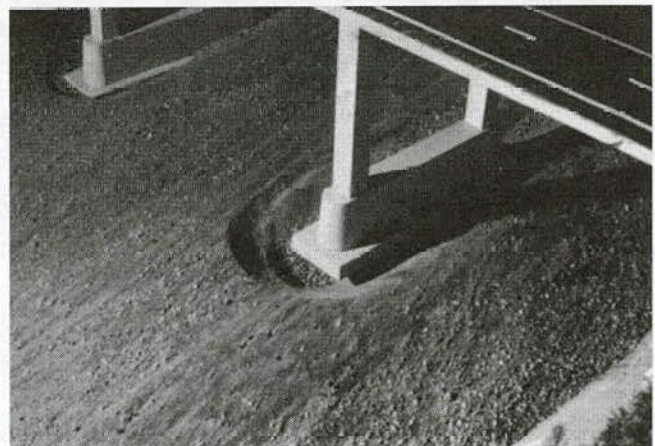
Figure 74. Schoharie Creek Pier 3 from the right bank showing the scour hole in the dry channel for 1987 flood conditions.

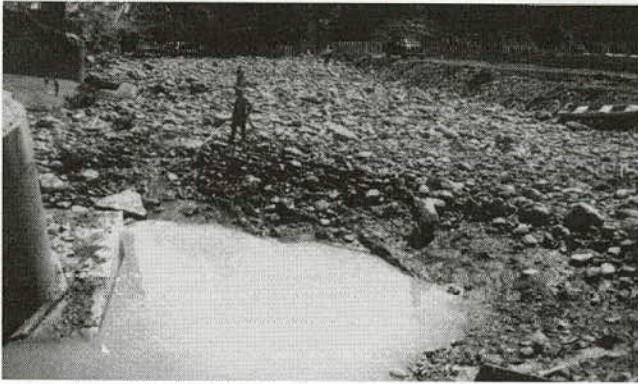
Figure 75. Configuration of the local scour hole at Pier 2, Schoharie Creek, NY, 1987.

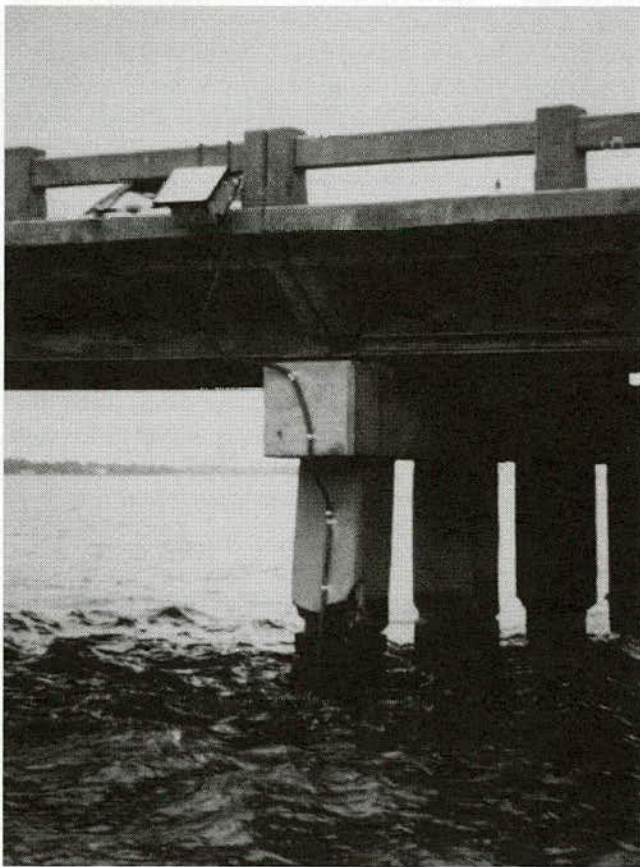
Figure 81. Nassau Sound (Site FL2) sliding collar instrument.

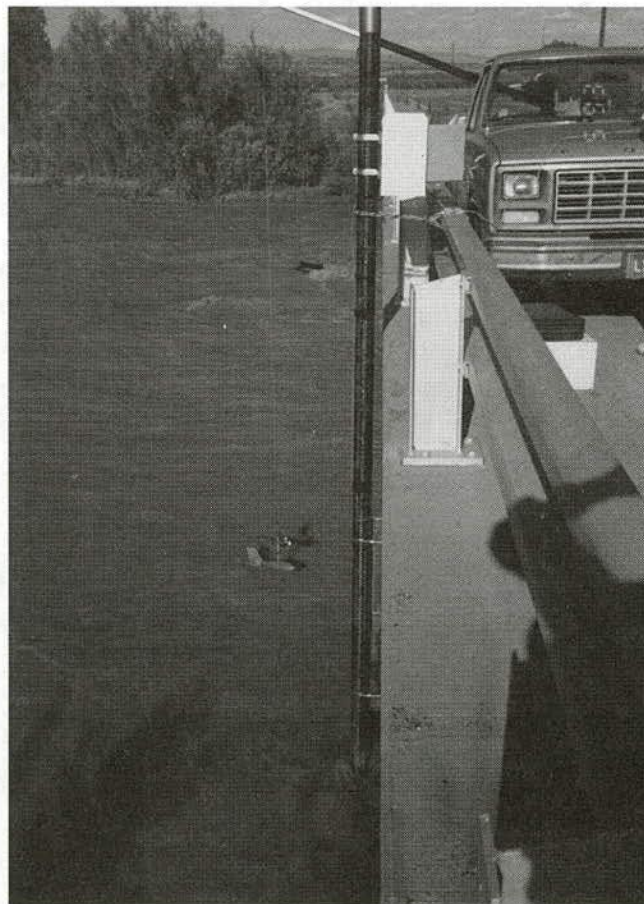
Figure 82. Stream-gaging and ground truth measurements at the San Antonio bridge (Site NM2).

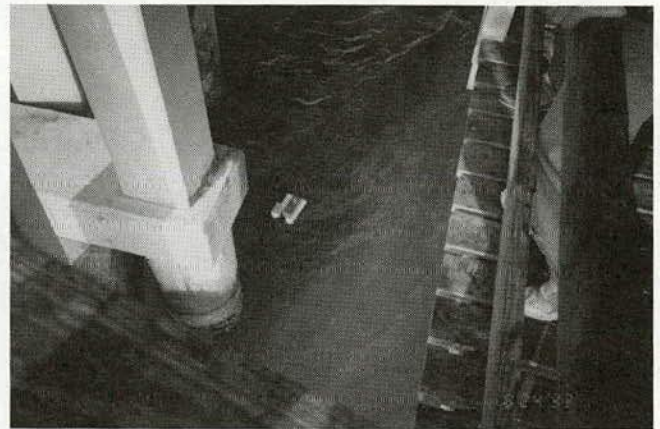
Figure C-3. Float-mounted sonic transducer sounding in 14.6 m (48 ft) of water, Johns Pass bridge near Clearwater, FL.
