NATIONAL COOPERATIVE HIGHWAY RESEARCH PROGRAM

NCHRP Report 408

Corrosion of Steel Piling
in Nonmarine Applications

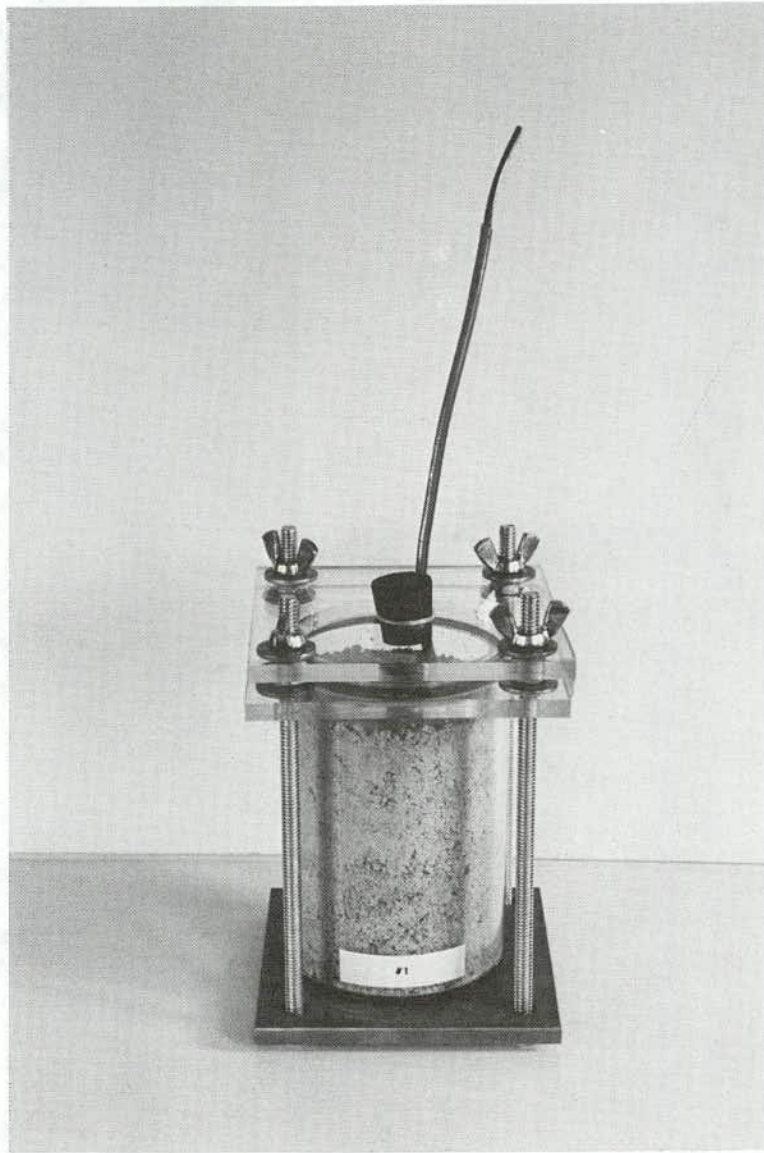
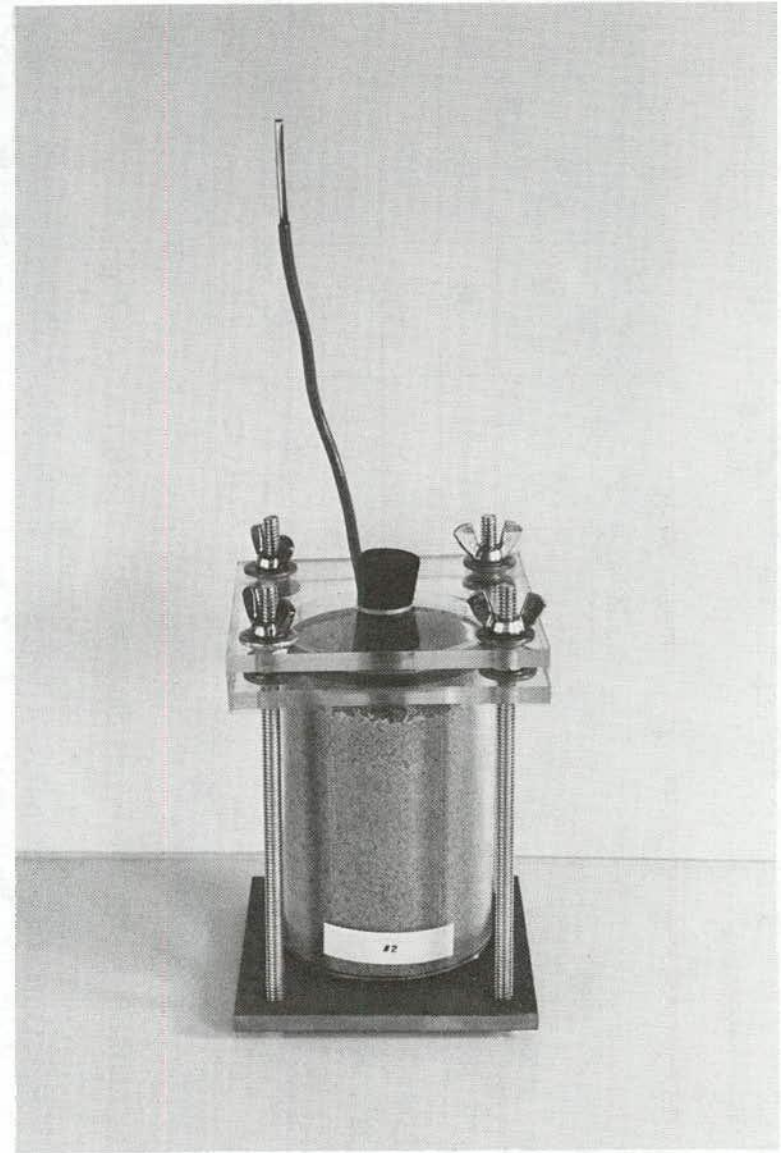
Figure E-1. Photographs of Soil Test Cells Containing Bentonite (Left) and Sand (Right) Used for Polarization Resistance Measurements.

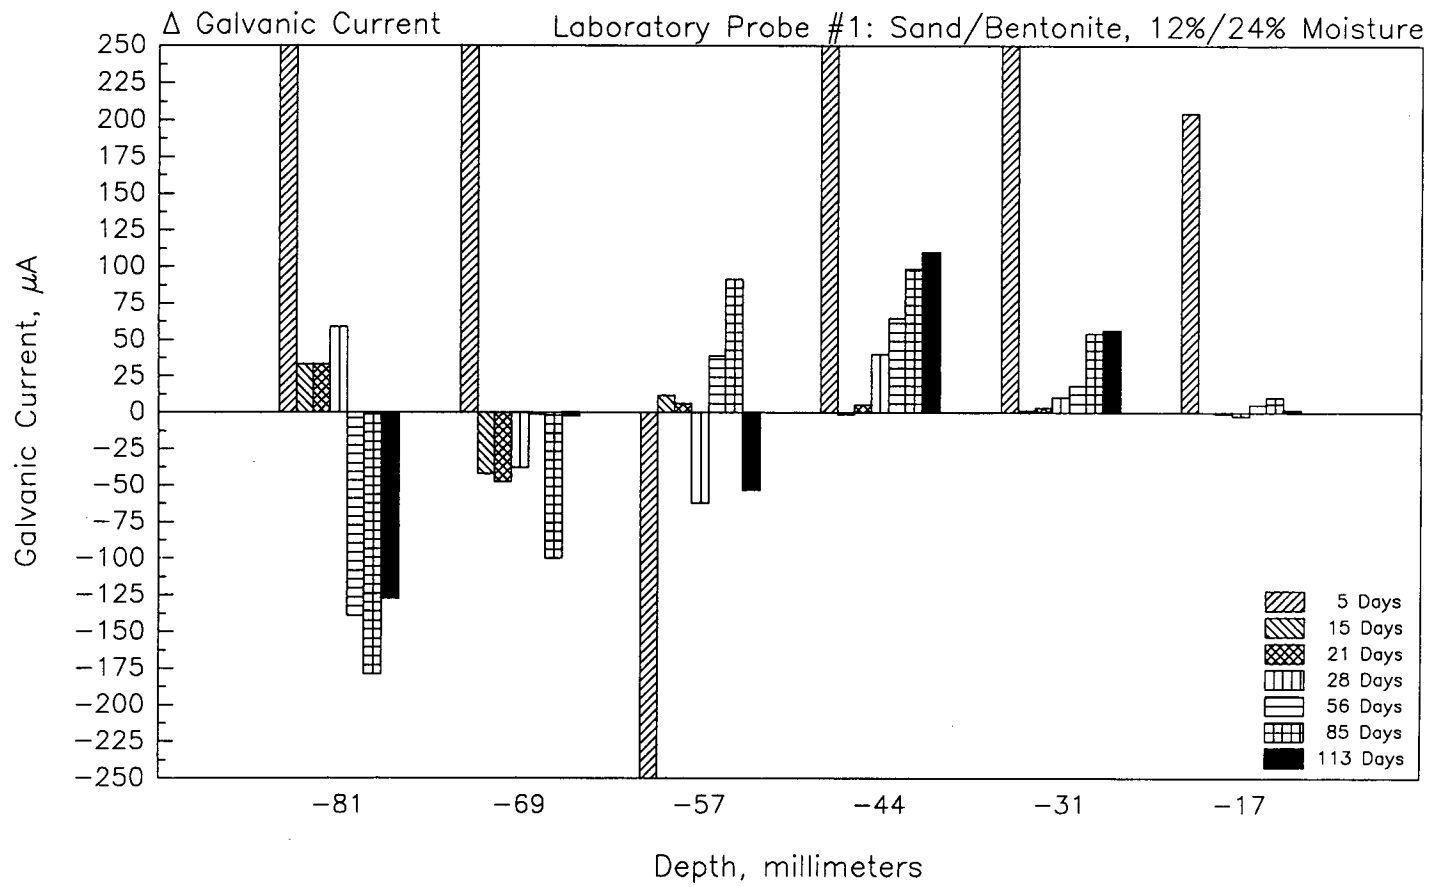
Figure E-6. Galvanic Currents as a Function of Depth and Time, for Coupled Laboratory Corrosion Probe Rings, in Sand and Bentonite.

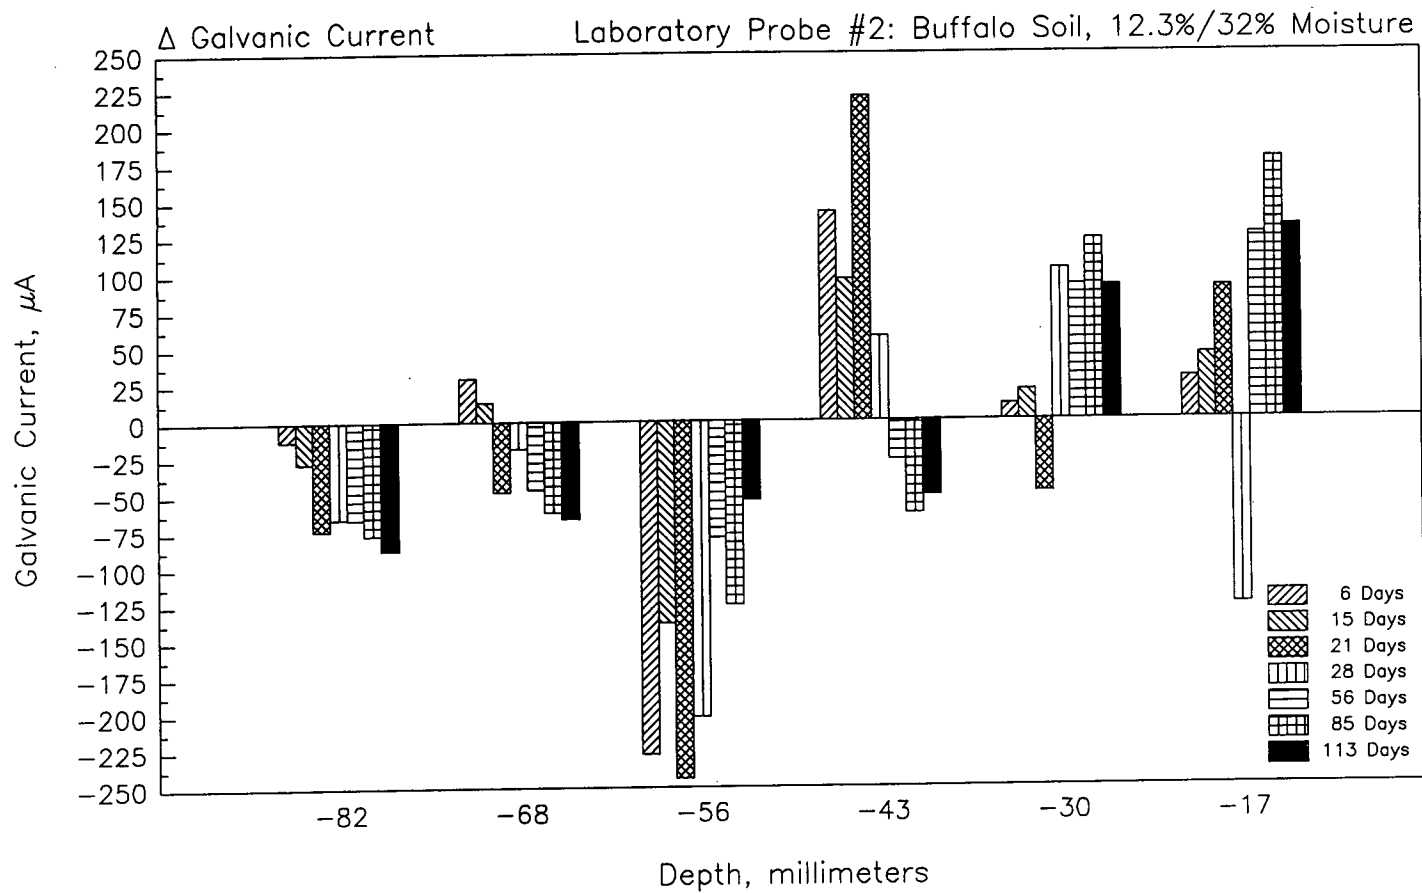
Figure E-7. Galvanic Currents as a Function of Depth and Time, for Coupled Laboratory Corrosion Probe Rings, in Soil Sampled from the Buffalo Site (Soil Samples #8 and #9).

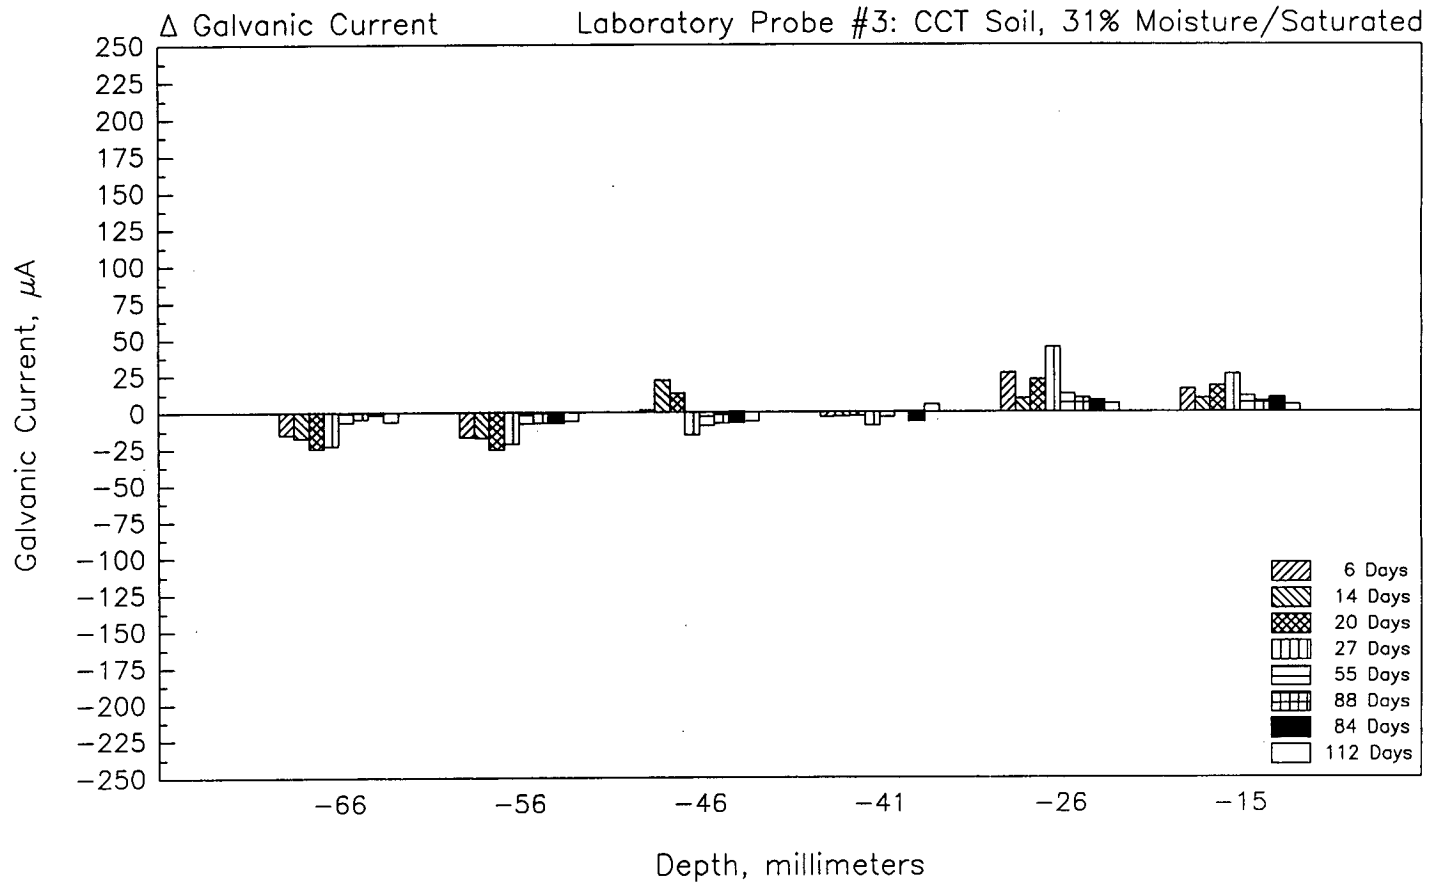
Figure E-8. Galvanic Currents as a Function of Depth and Time, for Coupled Laboratory Corrosion Probe Rings, in Soil Sampled from the CCT Site (Soil Sample #3).

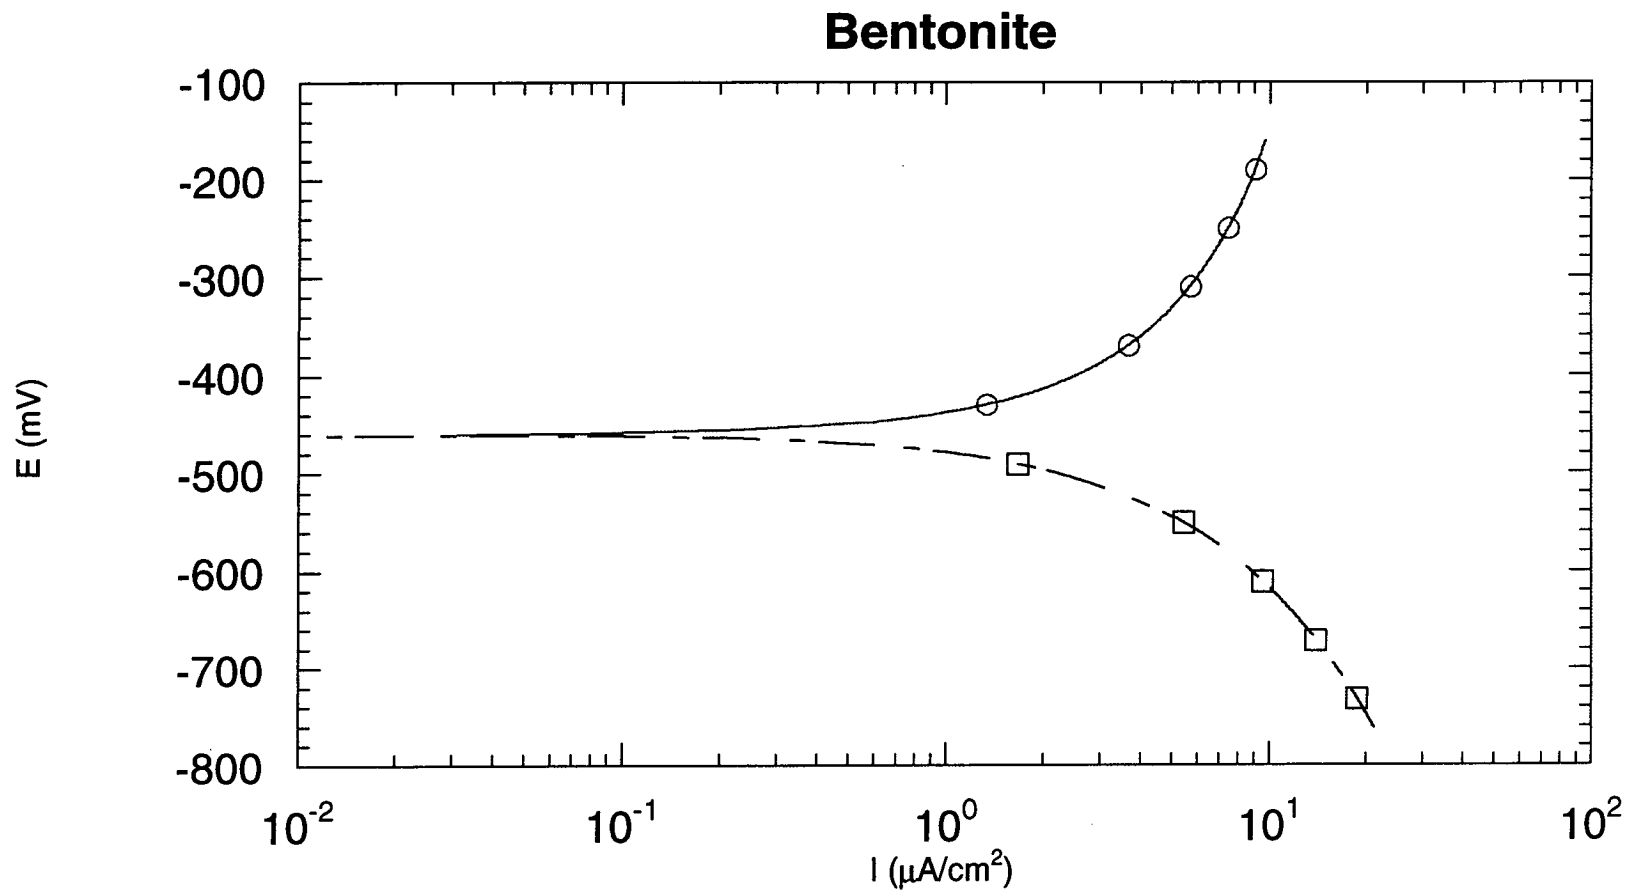
Figure E-13. Potentiodynamic Polarization Curves for Bentonite Containing 24% Moisture.

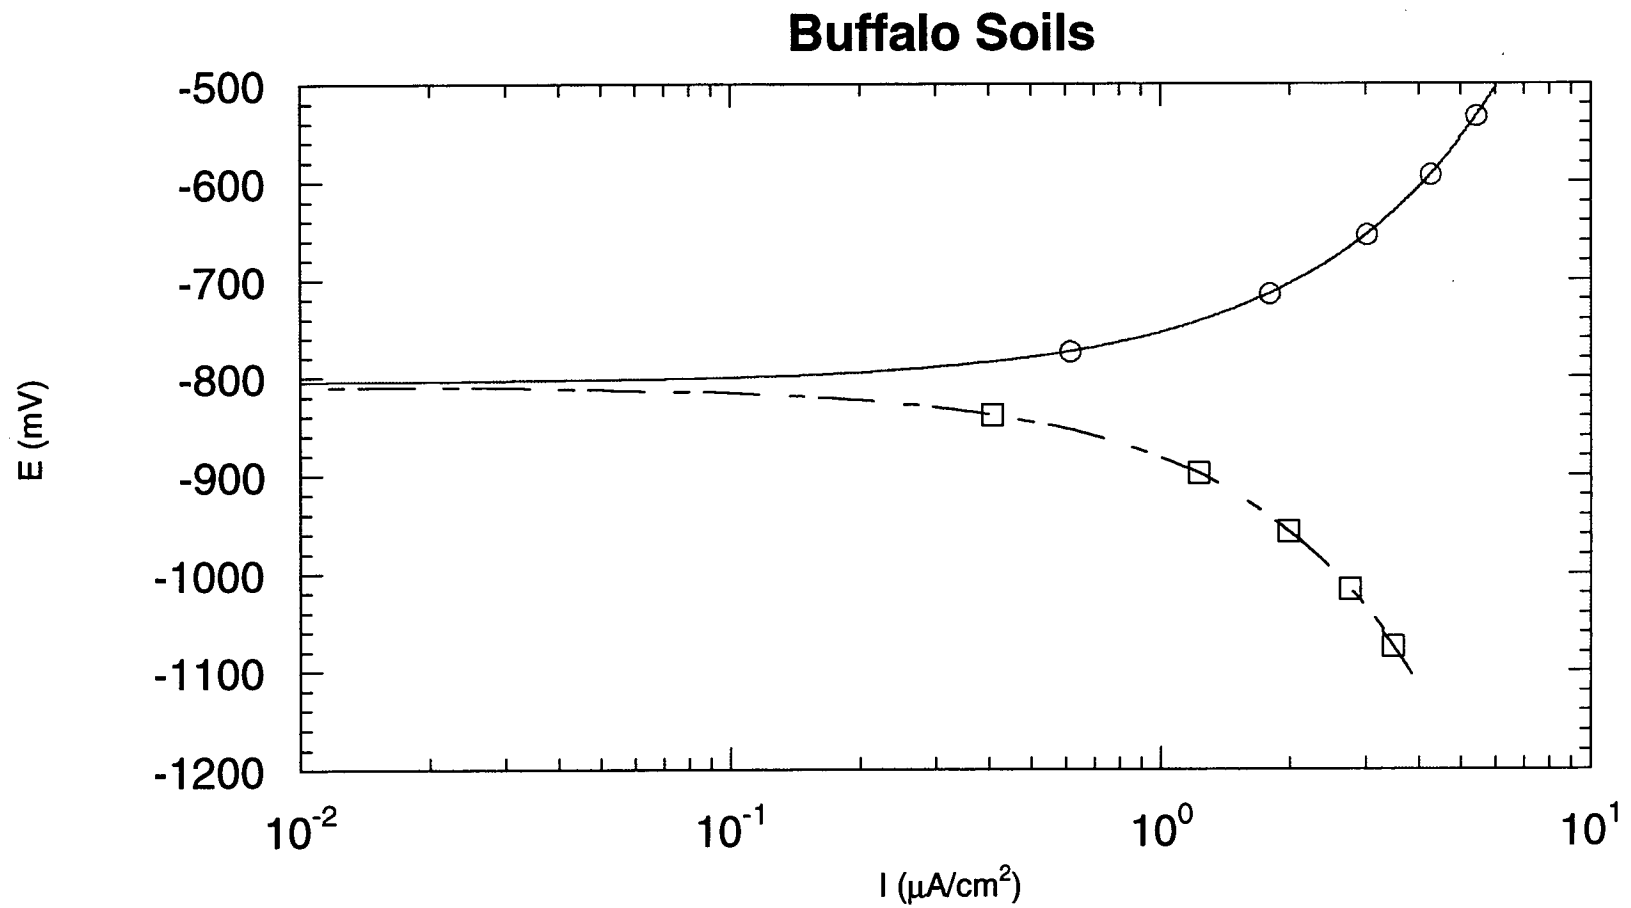
Figure E-14. Potentiodynamic Polarization Curves for Soil Sampled at the Buffalo Site (Sample #6) Containing 12% Moisture.

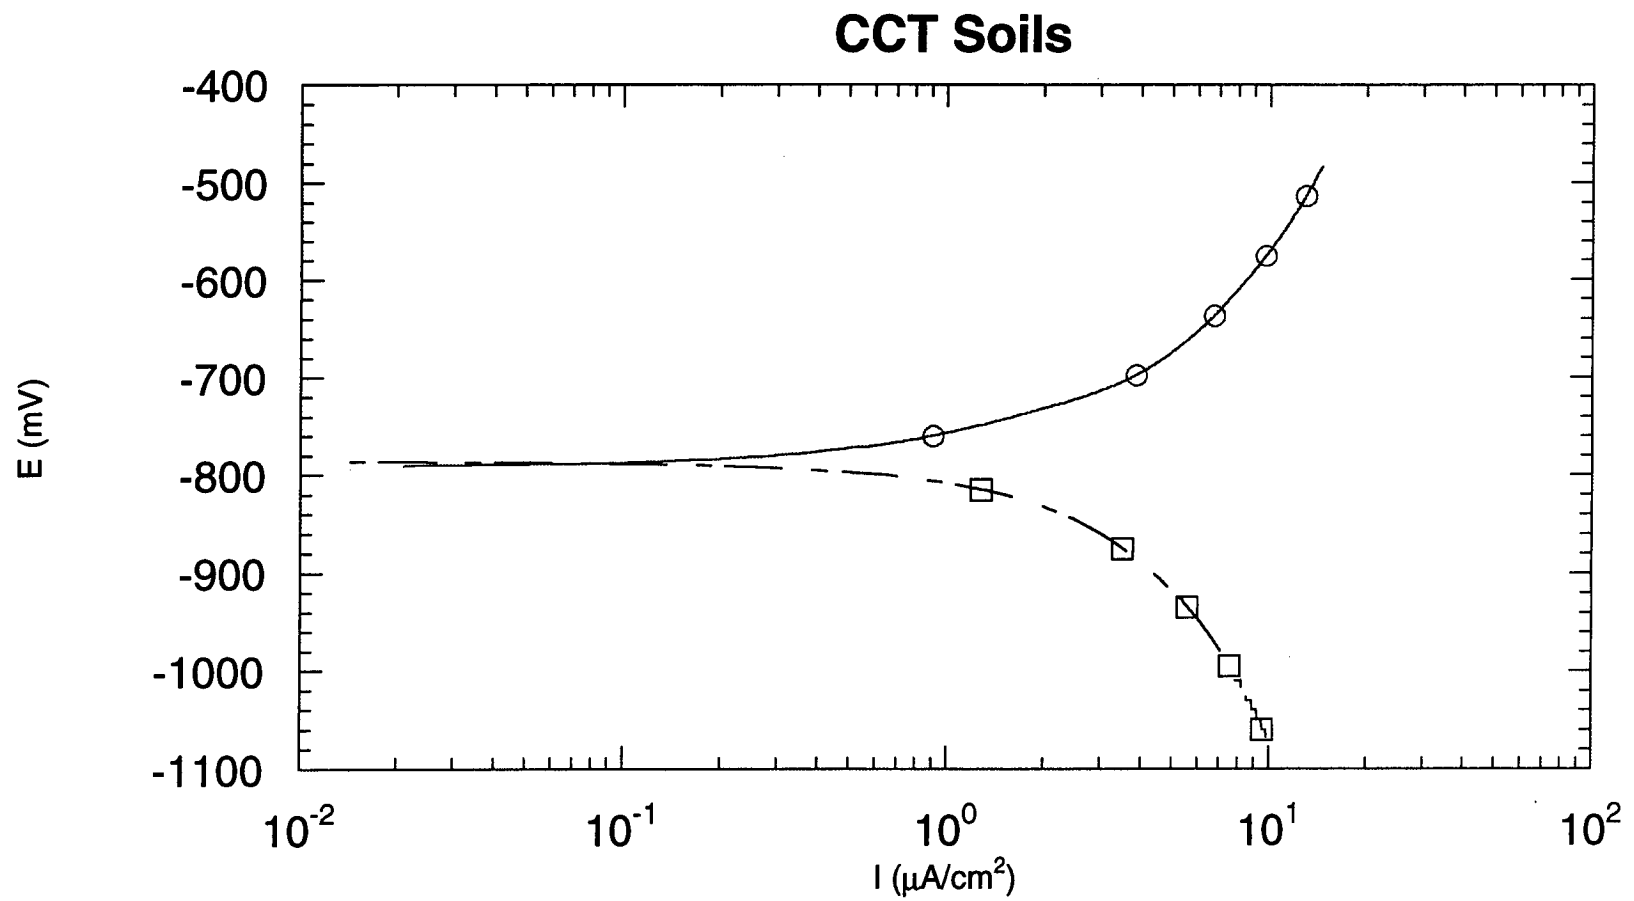
Figure E-15. Potentiodynamic Polarization Curves for Soil Sampled at the CCT Site (Sample #2) Containing 30.8% Moisture.

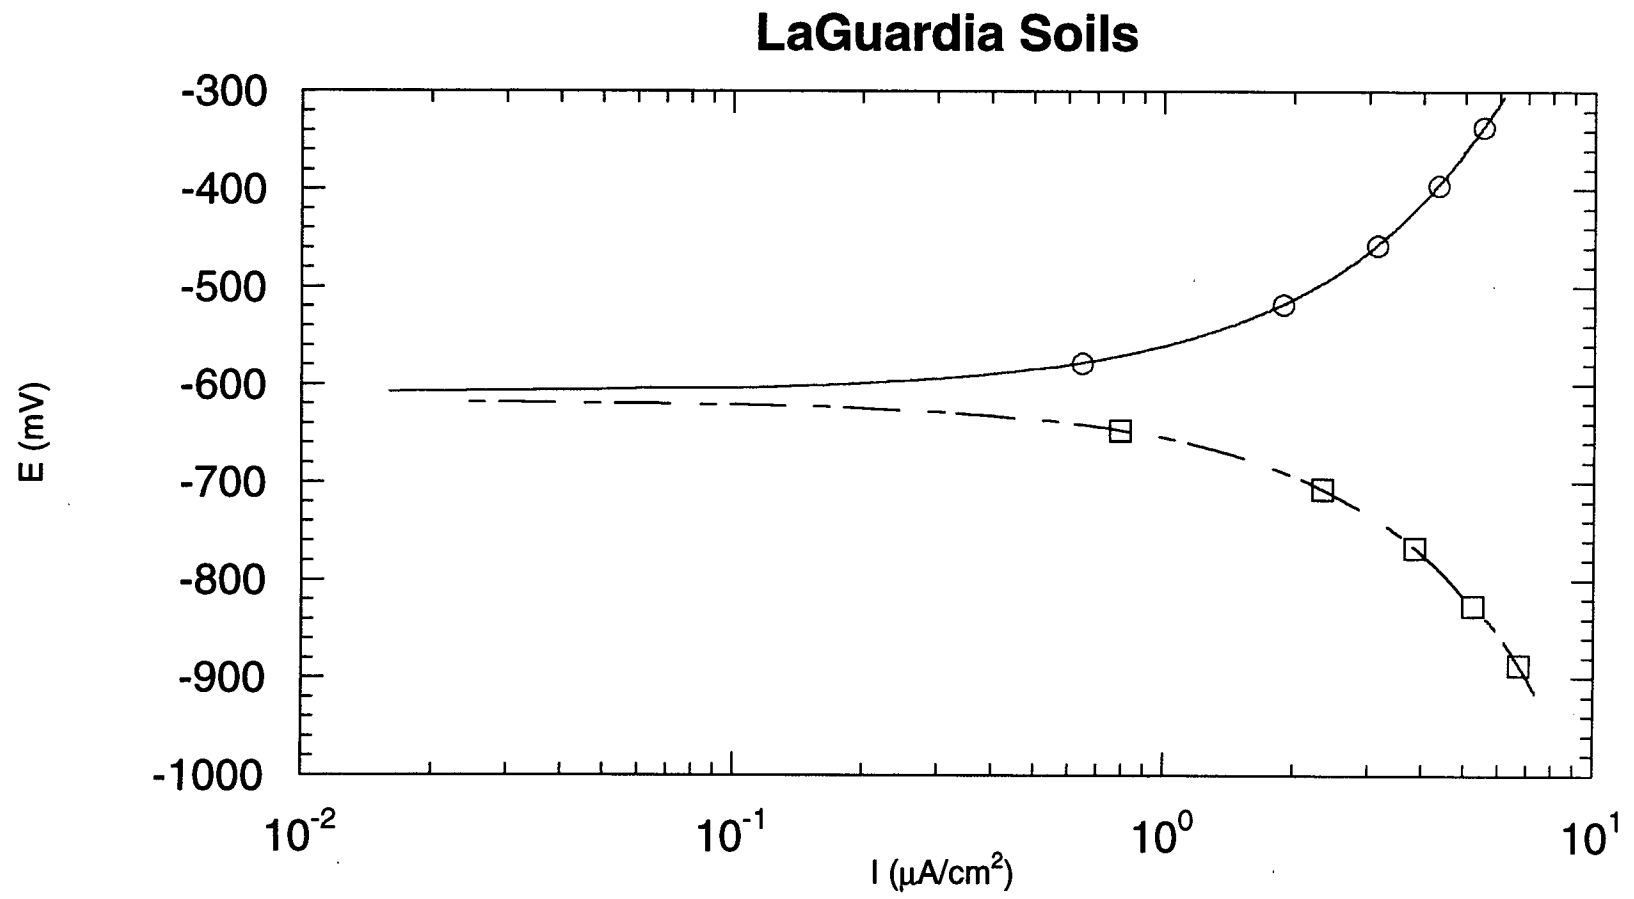
Figure E-16. Potentiodynamic Polarization Curves for Soil Sampled at the LaGuardia Site (Sample #8) Containing 17.6% Moisture.
