**NATIONAL COOPERATIVE HIGHWAY RESEARCH PROGRAM
 REPORT**

77

**DEVELOPMENT OF
 DESIGN CRITERIA FOR
 SAFER LUMINAIRE SUPPORTS**

HIGHWAY RESEARCH BOARD 1969

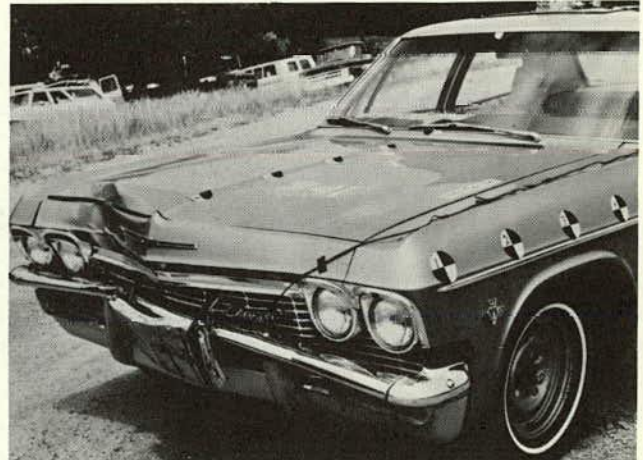
(a) BASE DETAILS

(b) VEHICLE DAMAGE

Figure 4. General Motors slip base. (Photos courtesy General Motors Proving Grounds.)

The basic concept developed in the Cambridge joint has been applied by the General Motors Proving Grounds. Figure 4(a) shows the General Motors design. The basic difference in this design is in the washers, the elimination of the retaining ring, and the use of a bolt-on bottom flange for modification of existing supports. Full-scale collision tests have been conducted to demonstrate the safe behavior of both steel and aluminum supports mounted on this slip base. Figure 4(b) shows the damage to the vehicle in a full-scale collision test on a steel support. The vehicle velocity at impact was approximately 40 mph.

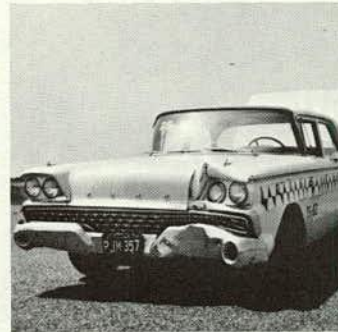
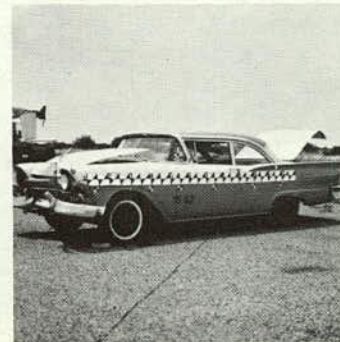
(a) 0° ANGLE OF APPROACH

(b) 30° ANGLE OF APPROACH

Figure 6. Test of triangular slip base (5).

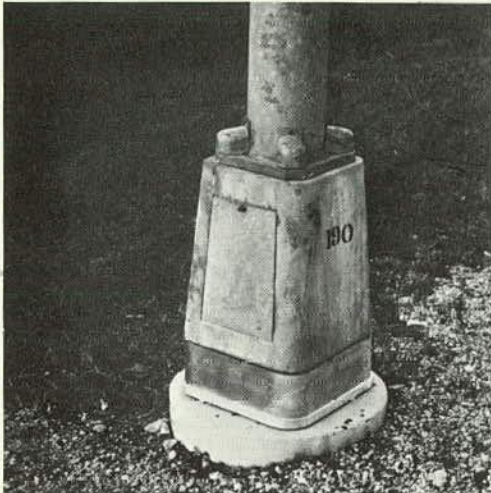
Figure 8. Cast aluminum insert with steel T-base.

Two tests were conducted to evaluate the cast aluminum insert (Fig. 8) which was designed as a remedial measure to be used in conjunction with steel transformer bases already in service. Test results are given in Table 1. In both tests the failure was initiated by a tensile crack forming in the top surface of the insert. As the collision progressed, the crack propagated diagonally toward the anchor bolts and the rear portion of the insert broke away, freeing the shaft and attached steel transformer base. In the 53 mph test, the

support cleared the vehicle; in the slow-speed test the shaft fell on the vehicle. It was concluded from these tests that a cast aluminum insert placed between the foundation and a steel transformer base appeared to be a satisfactory remedial design; however, it did not appear to be feasible for new designs (6, p. 26).

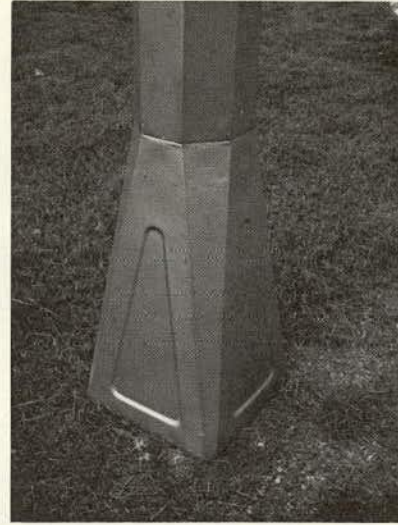
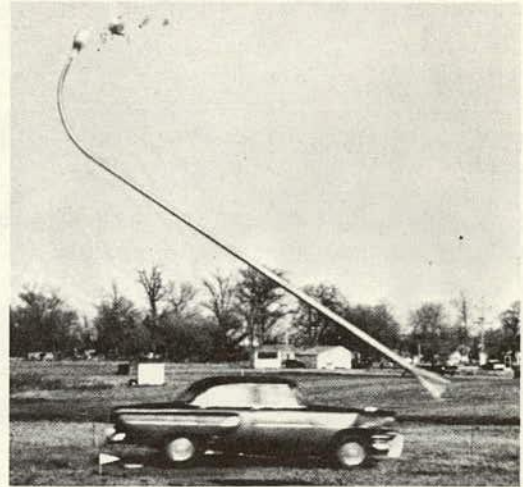
(a) BASE

(b) TEST

Figure 11. Stainless steel progressive-shear base. (Photos courtesy Millerbernd Manufacturing Company.)

Figure 11 shows this base in the first configuration subjected to full-scale tests. The base has since undergone several design modifications. The complete assembly, base and shaft, was fabricated from stainless steel (a 30-ft-high version weighs only 165 lb). The transformer base is riveted to a base plate with stainless steel rivets. The rivets act as shear pins which allow the shearing strength of the base to be controlled. In later designs, the rivets have been replaced with button welds.

Full-scale collision tests on this support were conducted by the Millerbernd Manufacturing Company (8, p. 5). The tests consisted of having an automobile, traveling at 20 mph, collide with a 30-ft mounting height, 15-ft davit arm pole. A 50-lb simulated luminaire was used. As the vehicle struck the pole, the transformer base sheared from the base plate, releasing the shaft. The shaft fell on the

vehicle roof, doing negligible damage (slight indentation). There was no damage to the bumper or hood. A new transformer base was attached to the undamaged shaft, and the assembly was erected for a second test. The driver of the test vehicle reported that he thought the impact was minor and similar to that felt when driving through a puddle of water.

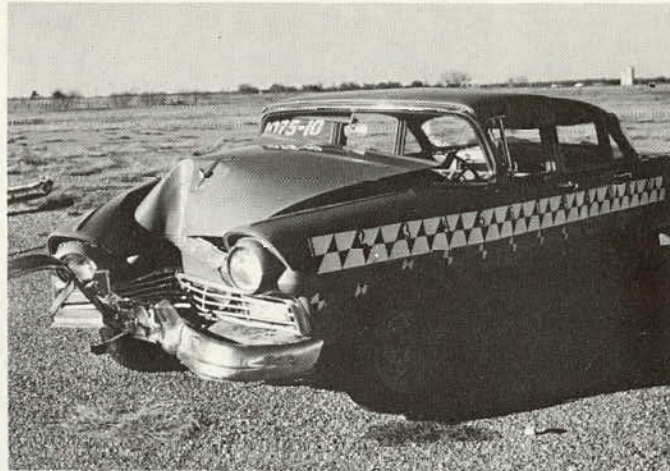
Figure 13. Aluminum shoe base (6).

Table 1 gives the results of the Texas tests on one support. Failure occurred by the crushing of the shaft on the impact side at the vehicle bumper height and subsequent fracture of the cast aluminum flange (Fig. 13). When the shaft crushed, a hook was formed which caught on the front bumper, which gave the support a forward and a downward motion so that it struck the vehicle top. The pole stayed in contact with the vehicle for approximately 45 ft beyond the point of initial contact (6, p. 26). It appears from this one test that although a survivable accident occurred, the severity was the highest of all the accidents occurring with the "safe" supports tested in the TTI series.

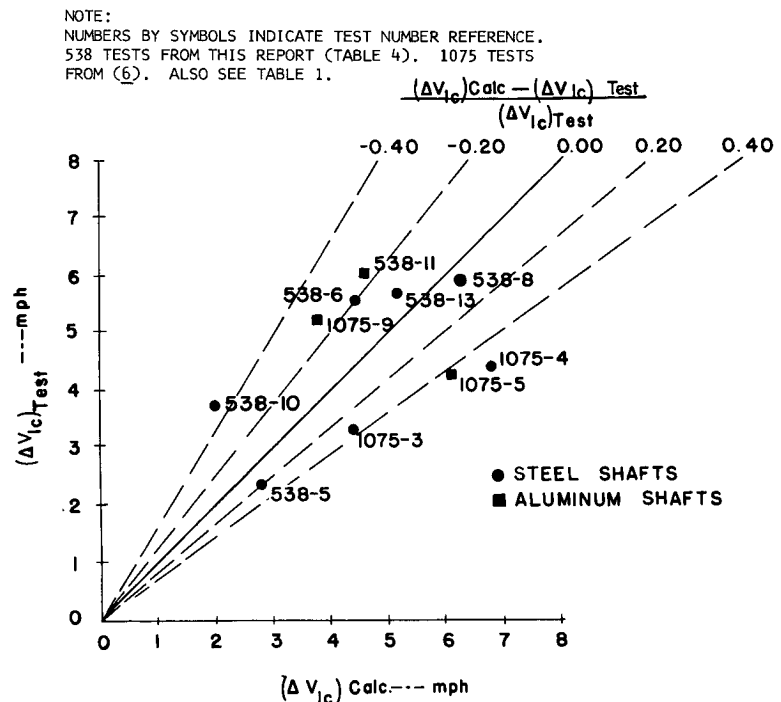
Figure 22. Correlation of parameter study with full-scale test data.

Curves of the type shown in Figure 21 (see Figs. 24 through 27) were used to correlate the mathematical model with the results of 10 full-scale tests. Figure 22 shows the comparison of the calculated velocity change with those observed. Note that four tests fall within 10% prediction accuracy, three fall within 40%, and the remaining three are slightly greater than 40%.

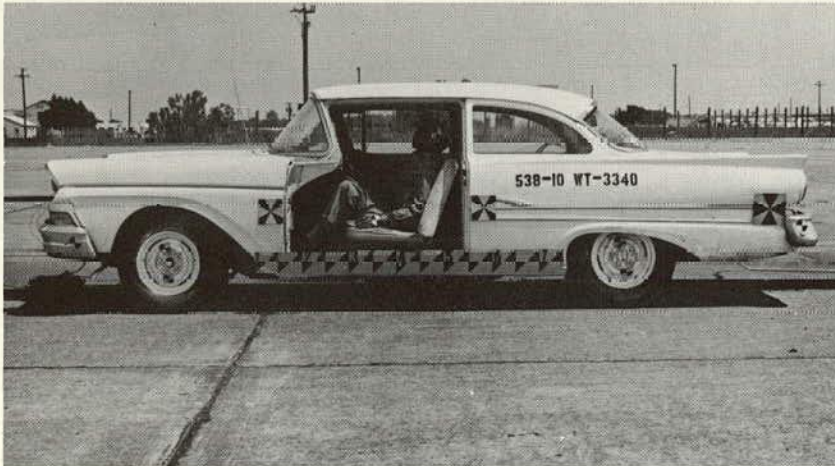
(a) TYPICAL VEHICLE

Figure A-6. Typical test vehicle.

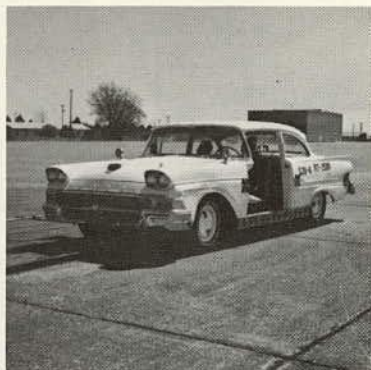
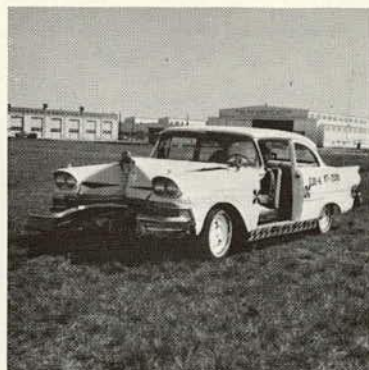
VEHICLE : 1958 FORD
 WEIGHT : 3580 LB
 DEFORMATION: 14 IN.
 DAMAGE EST.: \$397

Figure A-10. Test 538-6: post-collision vehicle damage.

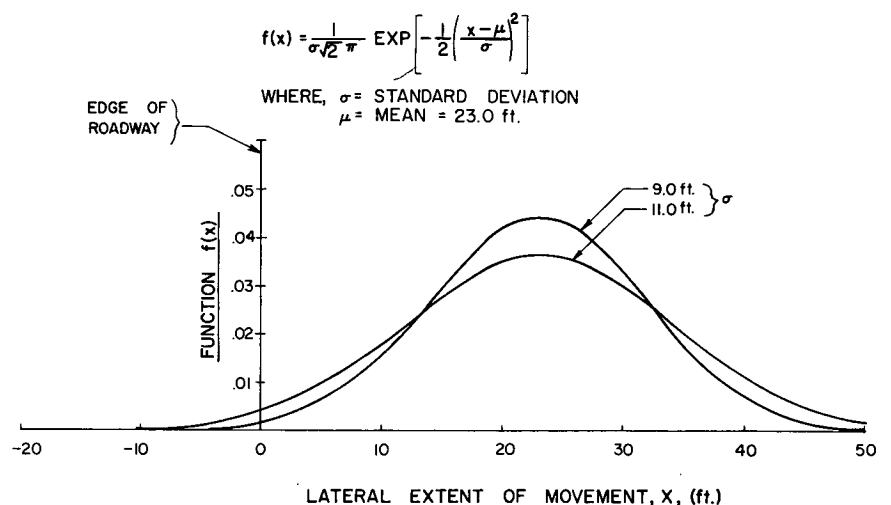
Figure C-2. Normal distribution function of lateral movements.
