NATIONAL COOPERATIVE HIGHWAY RESEARCH PROGRAM
REPORT

85

DEVELOPMENT OF FORMED-IN-PLACE WET REFLECTIVE PAVEMENT MARKERS

HIGHWAY RESEARCH BOARD 1970

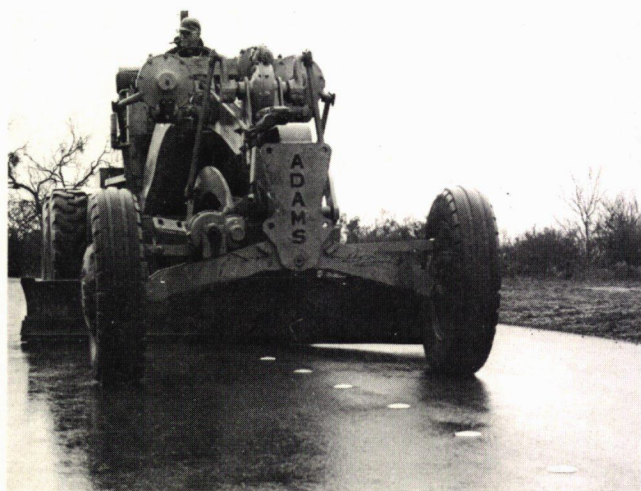
Figure 3. Rubber snowplow blade over conventional raised marker.

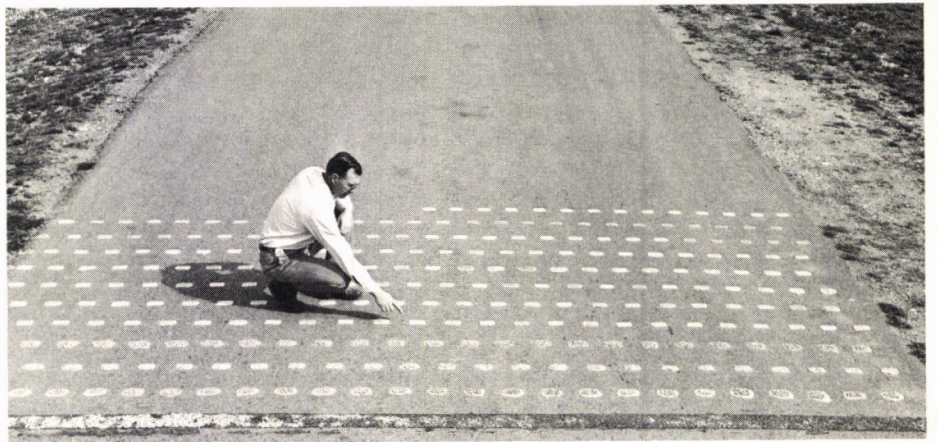
Figure 5. Field test site on research agency road.

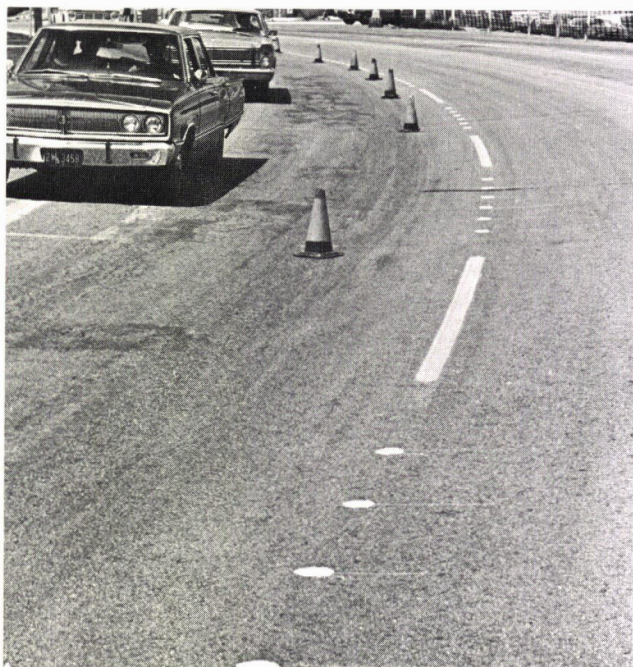
Figure 11. Test Site No. 6, East Lincoln Way, Cheyenne, Wyoming, July 1968.

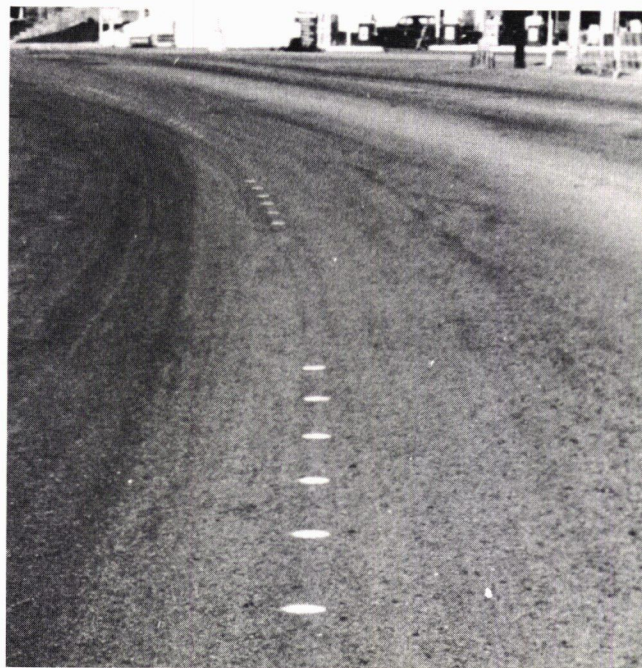
Figure 12. Test Site No. 6, East Lincoln Way, Cheyenne, Wyoming, May 1969.

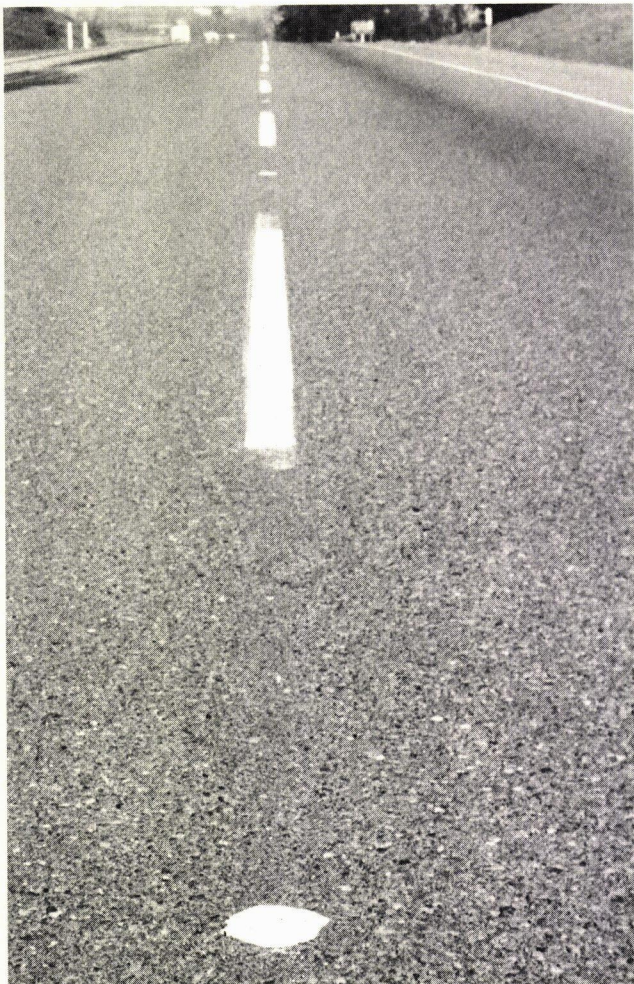
Figure 14. Test Site No. 4, Oregon, on final inspection, May 1969.
