NATIONAL COOPERATIVE HIGHWAY RESEARCH PROGRAM  
REPORT

**90**

**PROTECTION OF STEEL IN  
PRESTRESSED CONCRETE BRIDGES**

HIGHWAY RESEARCH BOARD  
NATIONAL RESEARCH COUNCIL  
NATIONAL ACADEMY OF SCIENCES—NATIONAL ACADEMY OF ENGINEERING

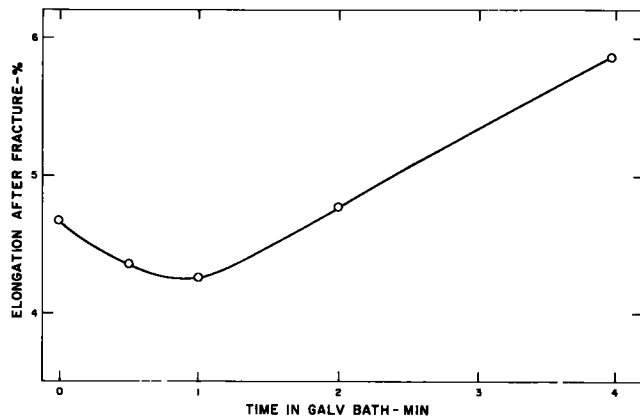
Figure E-3. Elongation after fracture for 0.25-in.-diameter galvanized prestressing wire.

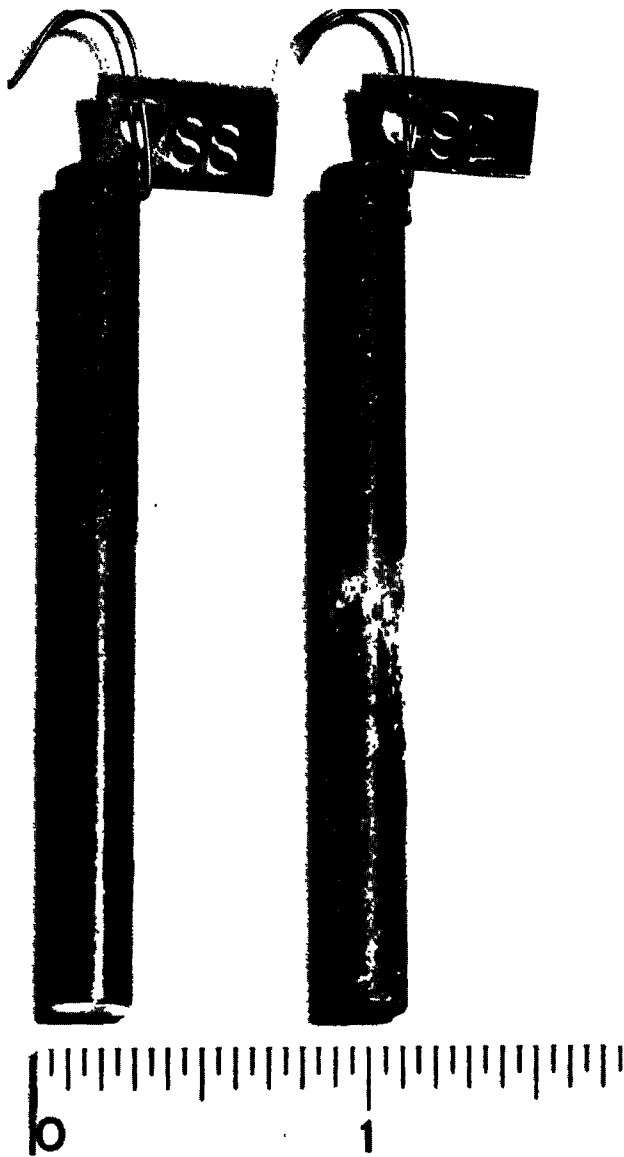
Figure E-14. Specimens after 800 hr in moisture condensation test. Lower half of Specimen 88 is coated with Shell water-soluble oil; lower half of Specimen 92, with sodium silicate-sodium nitrite coating, S-65.

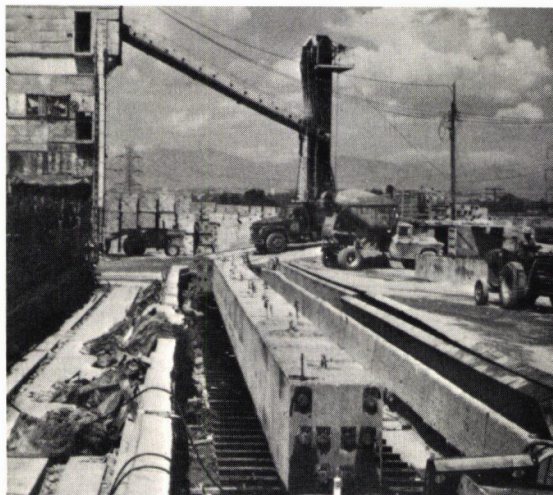
Figure G-14. Girder after removal of forms.

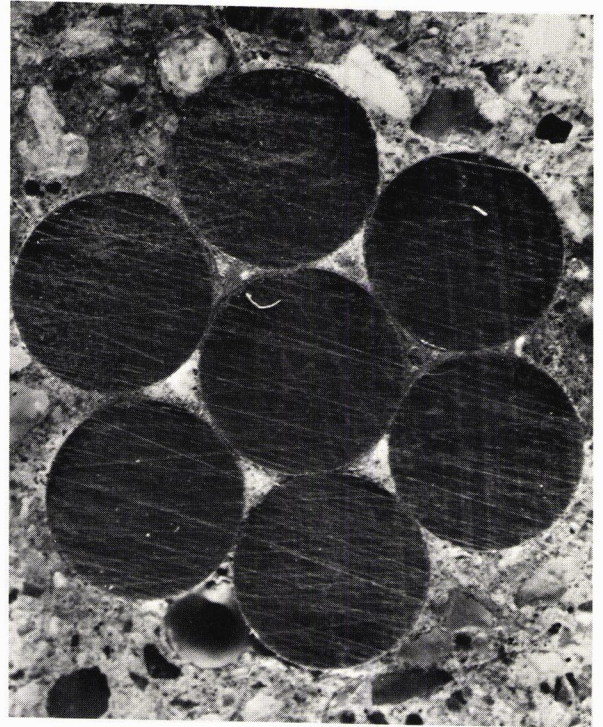
Figure H-1. Section of 0.5-in. strand in pretensioned girder fragment after 1½ years on bank of South Platte River, Ft. Morgan, Colo. Note cement paste in strand interstices.

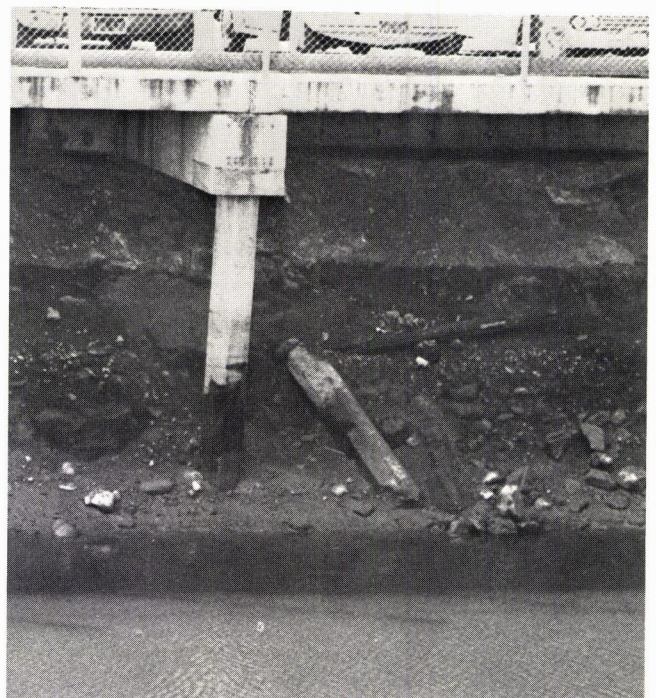
Figure H-2. Exposure site of 10-ft pretensioned pile section on Petaluma River bank, California.

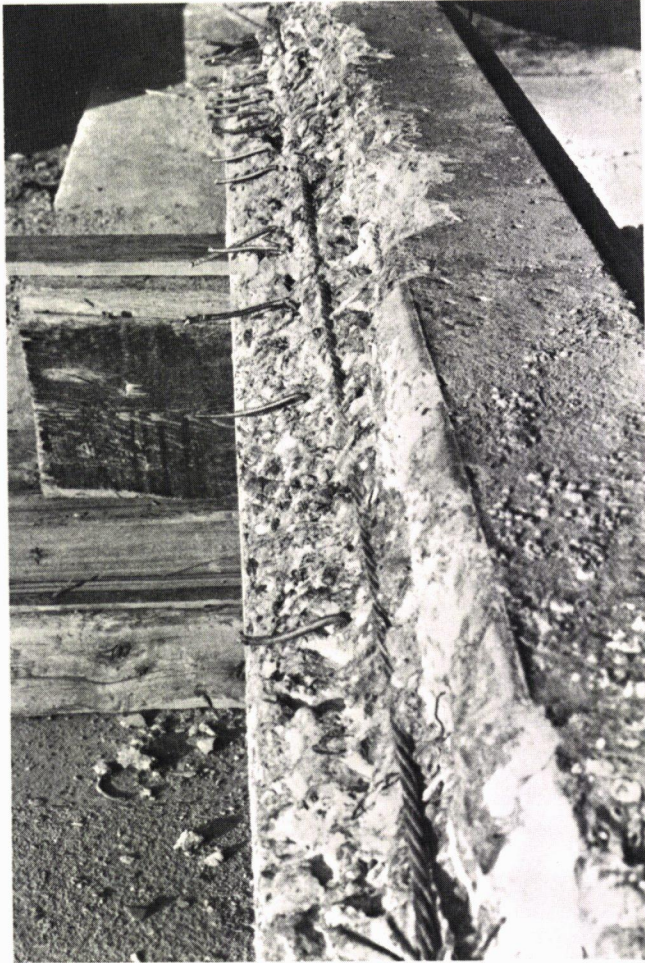
Figure H-3. Appearance of steel strand after chipping away concrete cover.
