**National Cooperative Highway Research Program**

**NCHRP Synthesis 204**

**Portland Cement Concrete Resurfacing**

**A Synthesis of Highway Practice**

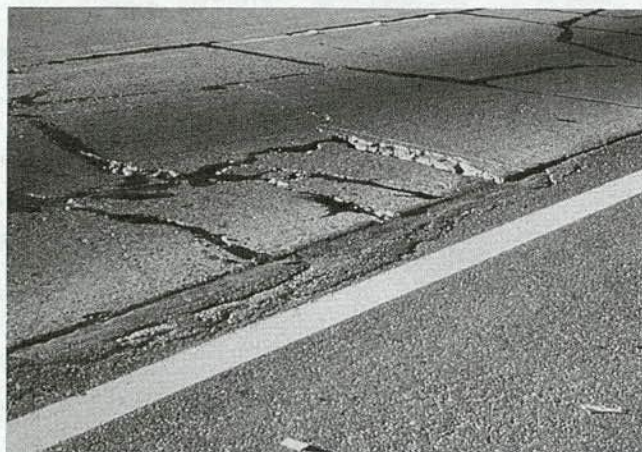
FIGURE 11 Shattered slabs.

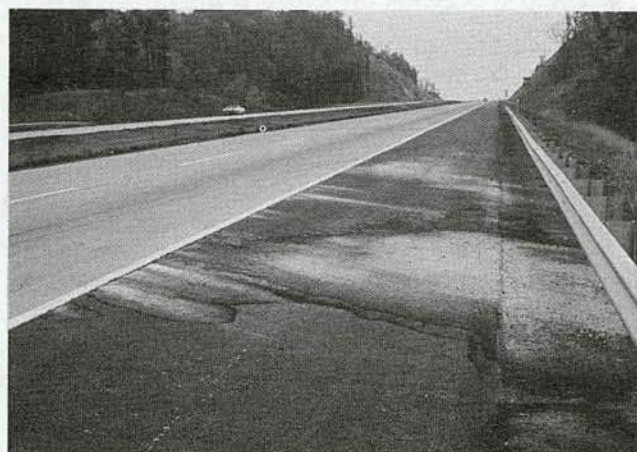
FIGURE 12 Pumping slabs.

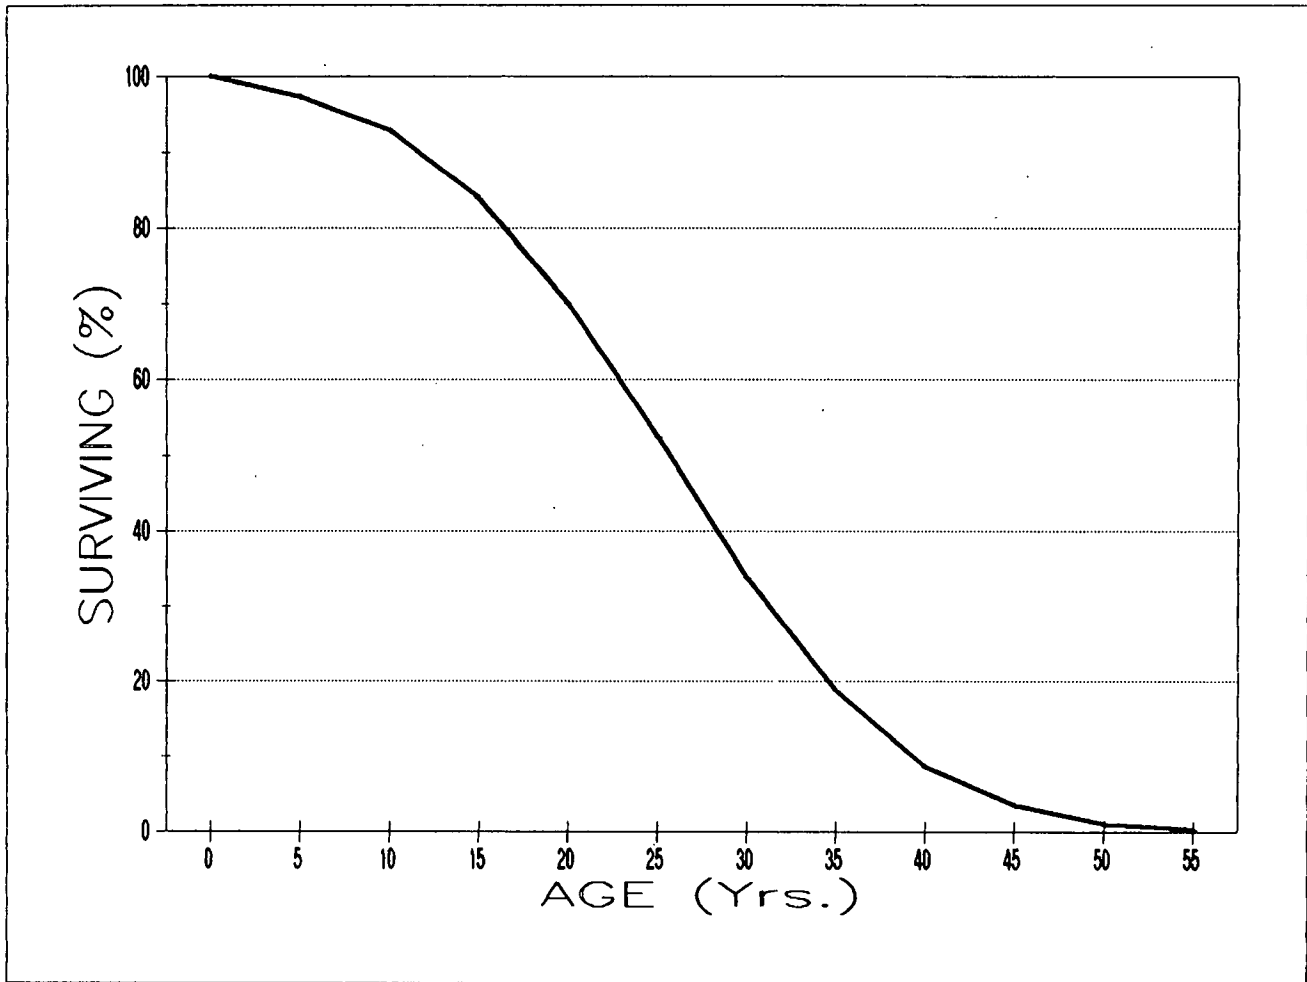
FIGURE 32 Survivor Curve for bonded and unbonded overlays no longer in service in 1993.
