Use of a Rumble Stripe to Reduce Maintenance and Increase Driving Safety

ROGER CAHOON, Materials and Tests Division, Utah Department of Highways

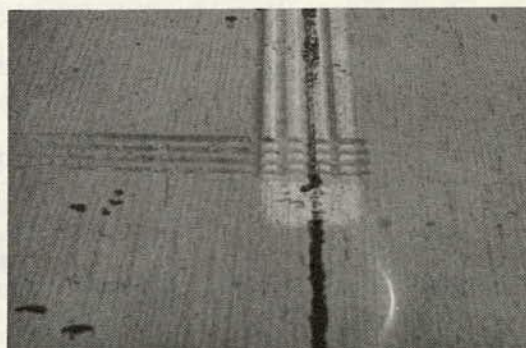
Figure 6. Textured pattern 4 in. wide.

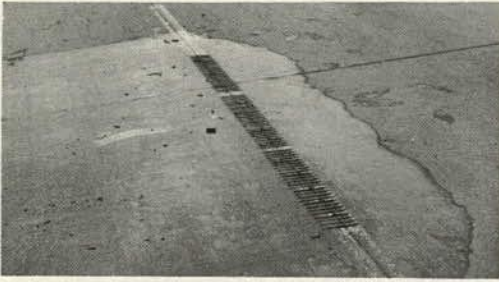
Figure 7. Type B rumble stripe 5 in. wide and 7½ ft long.

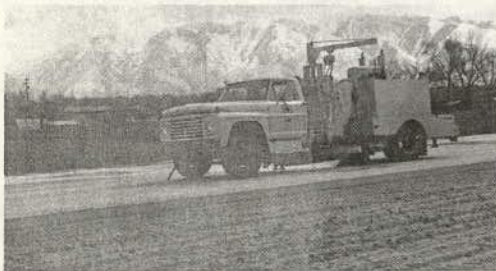
Figure 12. Transverse cutter.

Type B rumble stripes were cut in April 1969 by the same equipment but the cutters were mounted to cut 90 deg to the flow of traffic instead of parallel to it (Fig. 12). Stripes were painted in the test area about 6 months prior to the cutting of the transverse stripes. Twenty-three of the stripes were textured $7\frac{1}{2}$ ft long and 5 in. wide, and 2 stripes were cut 8 in. wide over the entire 15-ft length. These 2 stripes were added because it was thought that a wider cut would drain better and a longer stripe would be more visible. After the stripes were cut, they were thoroughly cleaned and painted the next day.

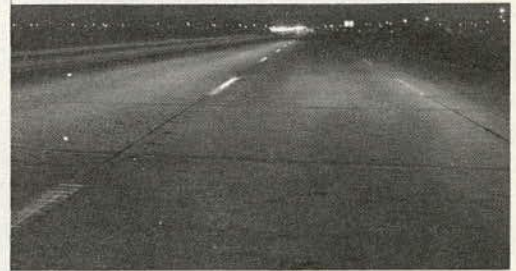
Figure 13. Rumble stripe (left) at night.

Until the cutting of the type B stripes, the only means of evaluation was by visual inspection and by photographs (1). Photographs and visual comparison showed that 4 to 5 rumble stripes could be seen during wet night conditions when only one standard painted stripe could be seen (Fig. 13). During a storm a film of water covers the road and eliminates the reflective qualities of a painted stripe. Texturing breaks this surface film and allows the beads in the paint to reflect light as shown in Figure 14.

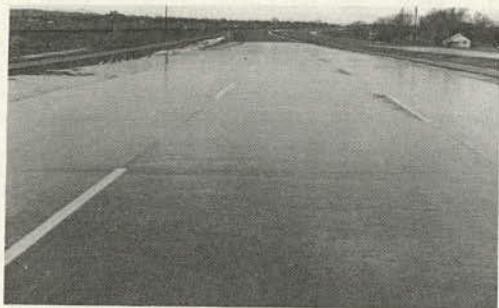
Figure 14. Rumble stripe (right) in rain during day.

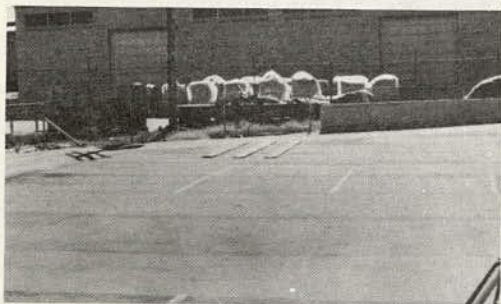
Sun on left, type B on left, type A on right.

Sun on right, type B in center, type A on right.

Figure 15. Standard painted strip, type B rumble stripe, and type A rumble stripe during day.

stripes. They are bright enough, however, to be seen adequately (Fig. 15). At night-time the textured stripes are almost always more visible than are the standard stripes (Fig. 16). The visual inspection and photographs show that the advantage of texturing a painted stripe is greatest during very critical times such as at night during wet weather.

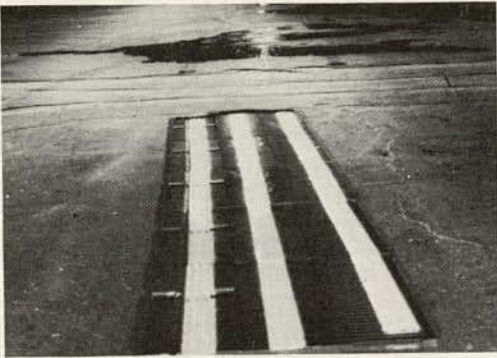
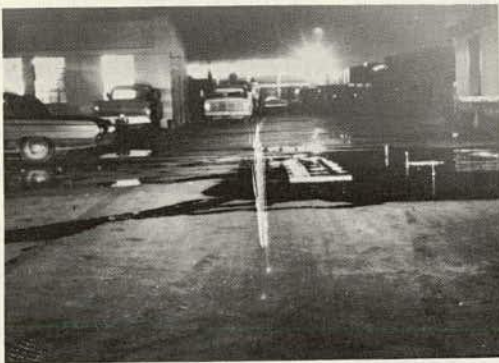
Dry

Wet

Figure 16. Standard painted and rumble stripes at night during dry and wet conditions (type B on right, type A on left, and standard in center).

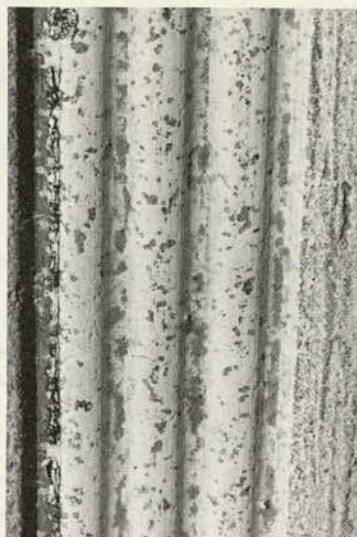
Standard painted

Type A rumble

Figure 17. Standard painted stripe and type A rumble stripe after 5 months of wear.

Figure 17 shows a comparison of a standard painted stripe and a type A rumble stripe after 5 months of wear. Because of the addition of more test stripes and re-painting of the test sections, no determination has been made of exactly how much paint life can be obtained from any of the textured stripes. Type A and B stripes cut in March 1969 were still in good condition in August, and so were standard stripes painted at the same time. It was expected that winter use would indicate a bigger difference in the stripes. Visual observations, photographs, and readings of the photocell indicate that the paint on the textured stripes will last much longer, but exactly how much will not be known until further research is completed.

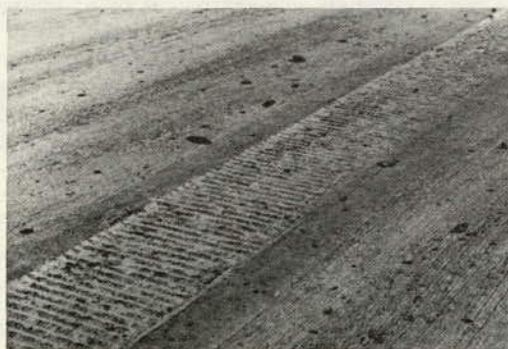
Figure 18. Continuous type B rumble stripe cut in plastic concrete near Ogden.

Little or no rumble noise was obtained from any of the drain ditches cut into the type A stripes. Type B stripes produce a zip or buzz that is noticeable in most passenger automobiles that traverse it. Figure 18 shows a continuous type B stripe that was cut in fresh concrete near Ogden, Utah. The sound effect of this stripe is good.

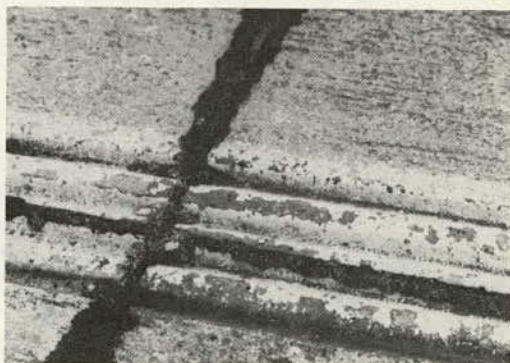
Figure 19. Joint filler being forced out of seam.

Where the longitudinal joints in the concrete have been filled with joint filler and a stripe is painted over it, as shown in Figure 19, some of the filler is forced out of the joint during the summer months, reducing the effectiveness of the stripe. This can be avoided by offsetting the seam or joint at the time of construction.

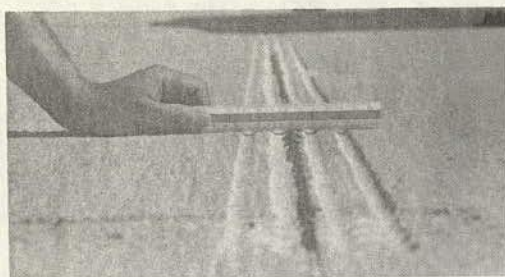
Level

Recessed

Figure 20. Top of grooves of type A rumble stripe level with road surface and recessed slightly.

Some of the grooves of the type A stripes were cut so that the tops were actually a slight distance below the top of the road surface (Fig. 20). The slightly recessed stripes seem to be wearing longer.
