One-Way Guardrail Vehicle Arresting System

DON L. IVEY and T. J. HIRSCH, Texas Transportation Institute,
Texas A&M University

The one-way guardrail vehicle arresting system was subjected to 4 full-scale vehicle crash tests. The system consists of 2 continuous parallel lengths of guardrail installed approximately 12 ft apart on a highway median. Each guardrail is constructed so that a vehicle that is out of control will lay down the first guardrail it encounters when traveling into the median. Once the vehicle crosses the first guardrail, it is trapped between the rigid faces of guardrail on both sides and cannot reenter the highway it has left or cross the median strip into the opposing traffic. The purpose of this program was to determine if the one-way guardrail could arrest errant vehicles traveling at velocities of approximately 60 mph and impacting at angles of 10 to 30 deg. The one-way guardrail vehicle arresting system performed as designed in 3 of the 4 tests conducted. From the test results, this system would seem to be an adequate device for containing vehicles with velocities somewhat less than 60 mph or angles of attack slightly less than 30 deg. All tests in which th

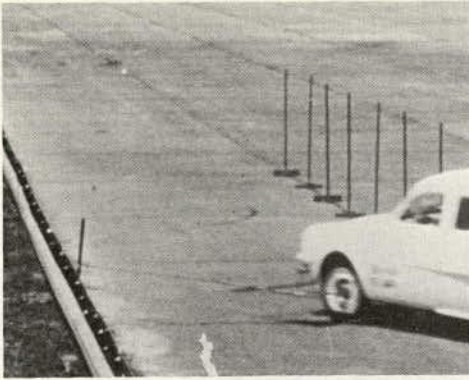
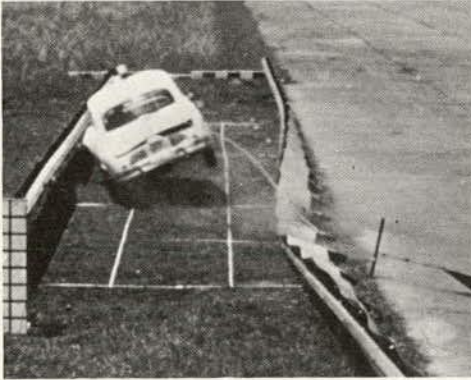
Figure 4. Sequential photographs during test 1.

A small vehicle weighing 1,600 lb was directed into the guardrail arresting system at an attack angle of 30 deg and velocity of 47 mph. The arresting system performed as designed, redirecting and containing the vehicle (Fig. 4). A comparison of the vehicle and guardrail before and after the test indicates that the damage to both was minor (Figs. 5 and 6). Figure 7 shows the point of impact with the first guardrail and demonstrates proper performance of the one-way design. Calculated average decelerations

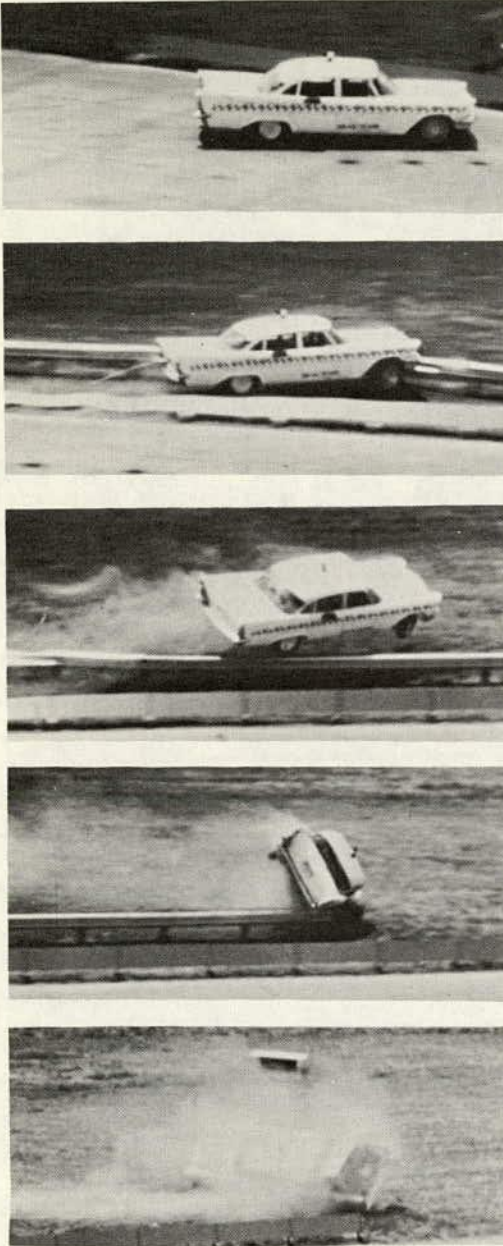
Figure 9. Sequential photographs by overhead camera during test 2.

deforming it severely (Fig. 9). As shown in Figure 10, the rail suffered heavy local damage. After striking the second guardrail, the automobile became airborne for approximately 36 ft and came to rest upside down after rolling over $1\frac{1}{2}$ times. The deceleration levels were moderate while the vehicle was in contact with the guardrails, but the vehicle sustained heavy damage while rolling after the impact with the second rail. The test summary is shown in Figure 11.
