# **effect of construction equipment vibration on nearby buildings**

L. M. Brown

Ontario Department of Transporta-  
tion and Communications

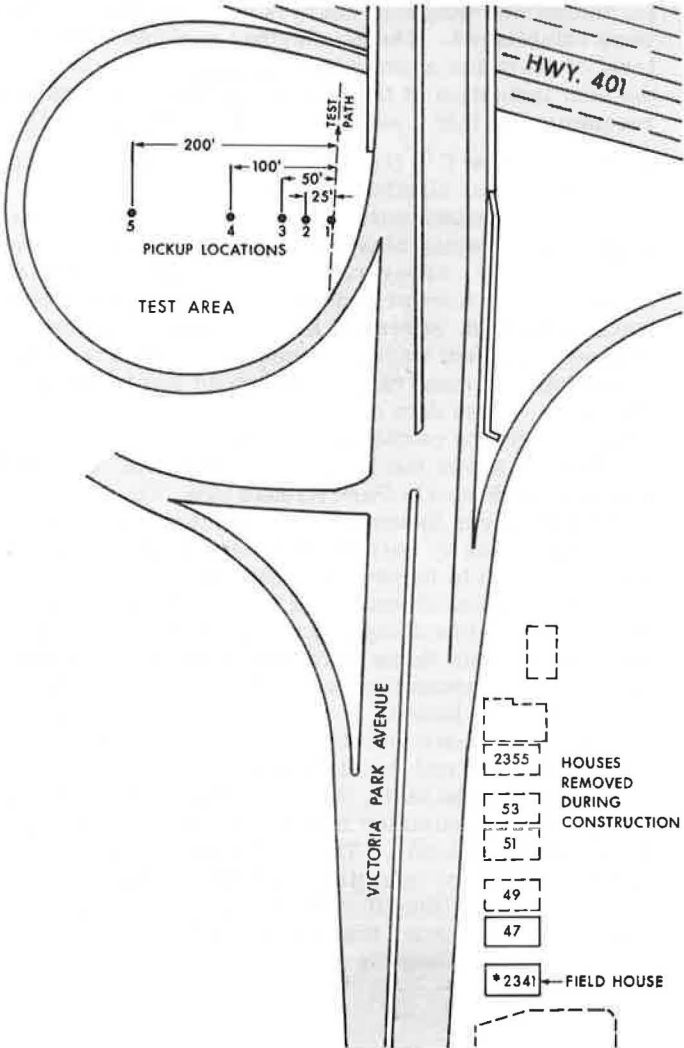
Figure 3. Field house and test area.

Figure 3 shows the layout of the test site, a partially completed interchange at Highway 401 and Victoria Park Avenue (Fig. 1). Velocity pickups were mounted in pairs on aluminum blocks (nonmagnetic), which were located at specific distances apart and oriented to pick up vertical and longitudinal vibrations (the transverse or shear wave has been found to be usually less than those two).

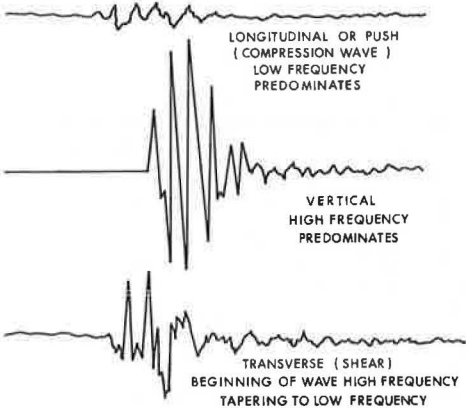
Figure 2. Ground waves resulting from vibrations and recorded simultaneously by seismograph.

Establishing a value of ground vibration at which damage occurs to nearby structures is not entirely a simple matter because there are 3 distinct types of ground waves that are generated (Fig. 2): longitudinal or compression waves in which low frequencies predominate; vertical waves in which high frequencies predominate; and transverse or shear waves that begin with high frequencies and taper off to low frequencies. Furthermore, knowledge of which is the important vibration parameter—displacement, velocity, or acceleration—had to be determined.

A major difficulty in establishing the energy ratio is in determining the frequency because, as Figure 2 shows, the ground wave frequency varies with time. Also, because the maximum acceleration occurs at a different time from the minimum frequency, ER is not useful in determining gradations of damage.

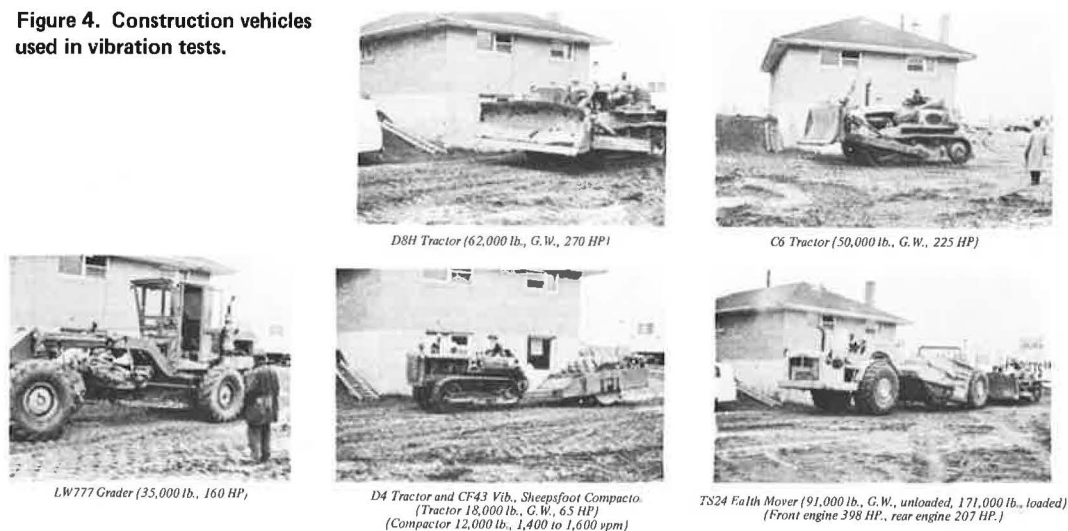
**Figure 4. Construction vehicles used in vibration tests.**

Various types of equipment (Fig. 4) were run on a test path perpendicular to the line of pickups, and oscillograph recordings were made of the resulting vibrations. The data curves from those tests are shown in Figures 5 to 33. The equipment was also run at various distances from a field house, and vibration levels were measured at different locations in the house. Reference to those data curves and records enables the prediction of approximate vibration levels for almost any situation. The tabulated house vibration levels and the method of using the data are given in another report (1).

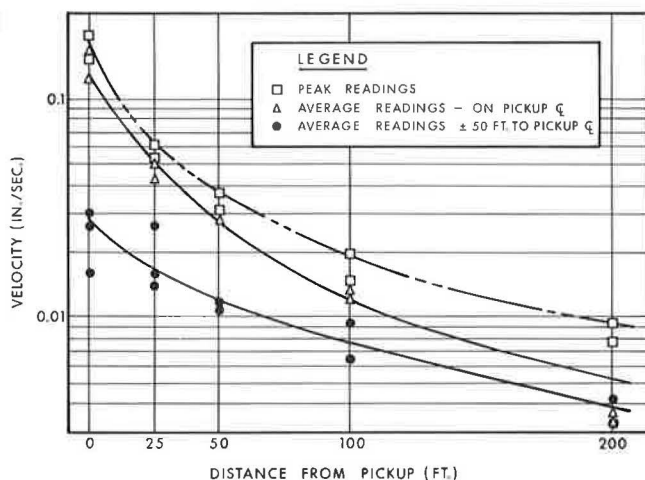
**Figure 5. Vertical vibrations of D8H tractor passing—test 1.**

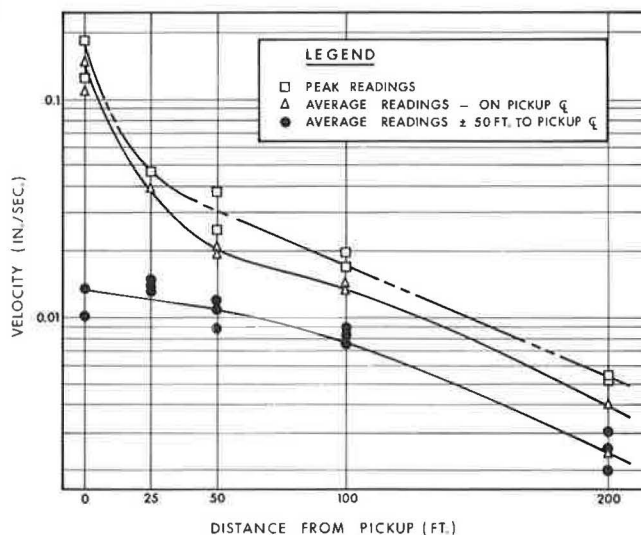
**Figure 6. Longitudinal vibrations of D8H tractor passing—test 1.**

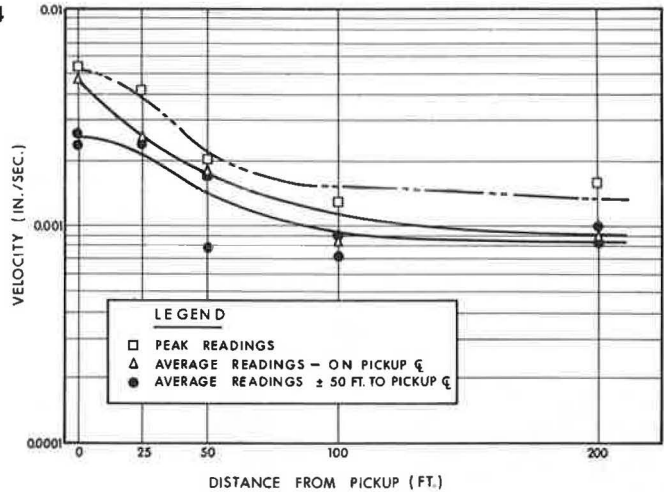
Figure 7. Vertical vibrations of TS24 earthmover slowly passing—test 2.

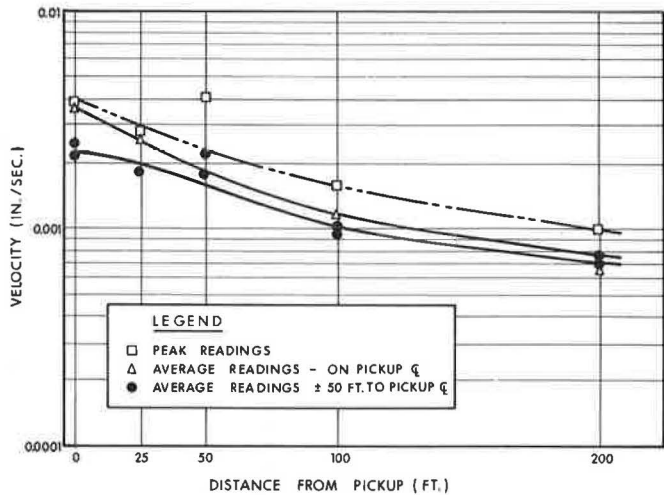
Figure 8. Longitudinal vibrations of TS24 earthmover slowly passing—test 2.

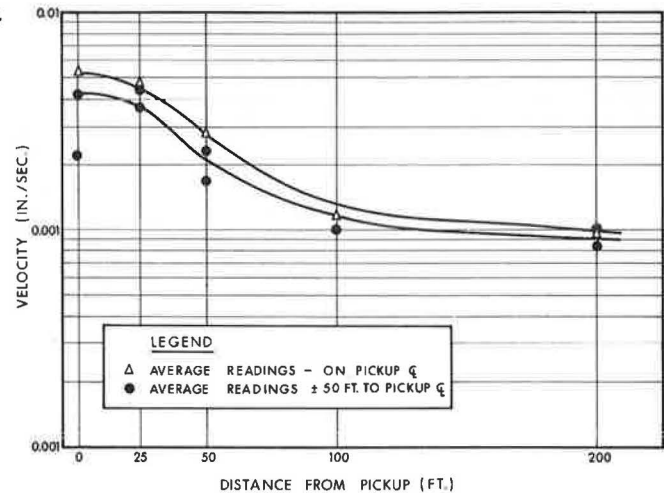
Figure 9. Vertical vibrations of TS24 earthmover rapidly passing—test 3.

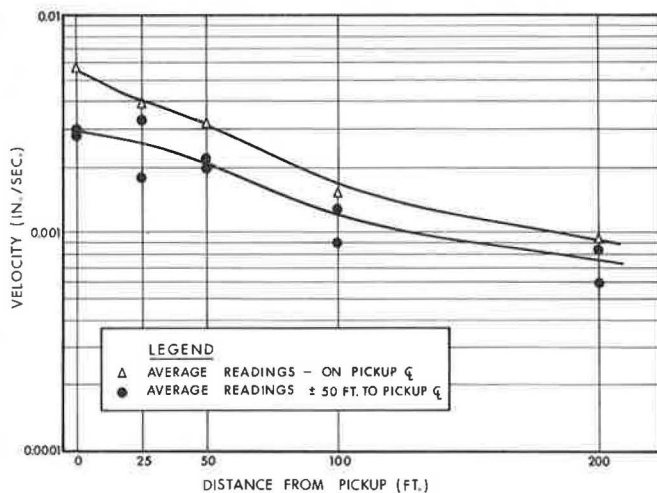
Figure 10. Longitudinal vibrations of TS24 earthmover rapidly passing—test 3.

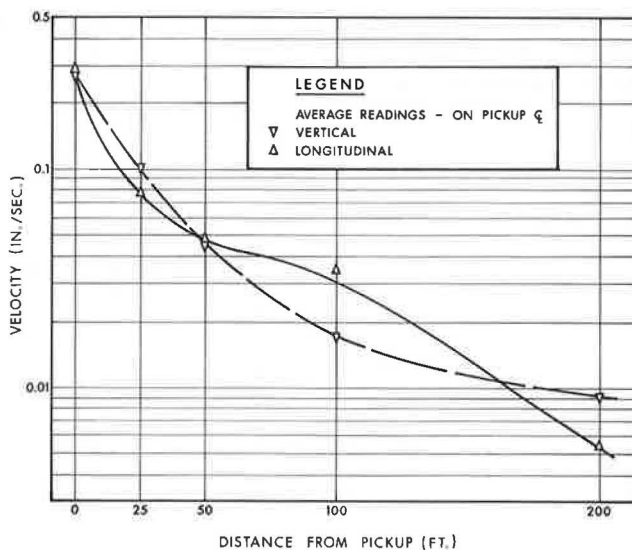
Figure 11. D8H tractor dropping blade to ground—test 4.

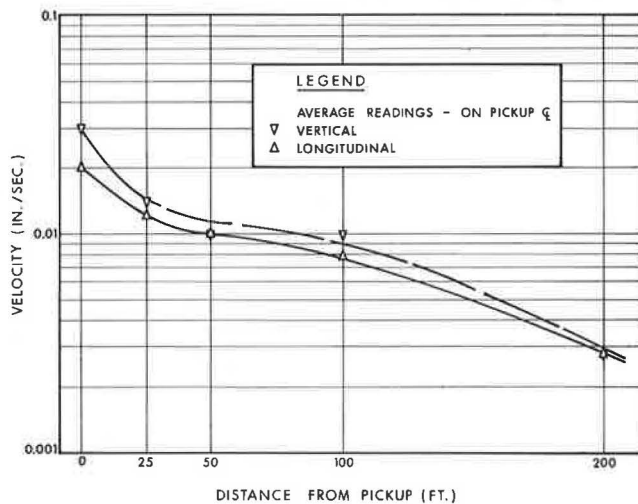
Figure 12. D8H tractor and TS24 earthmover passing but not in contact—test 5.

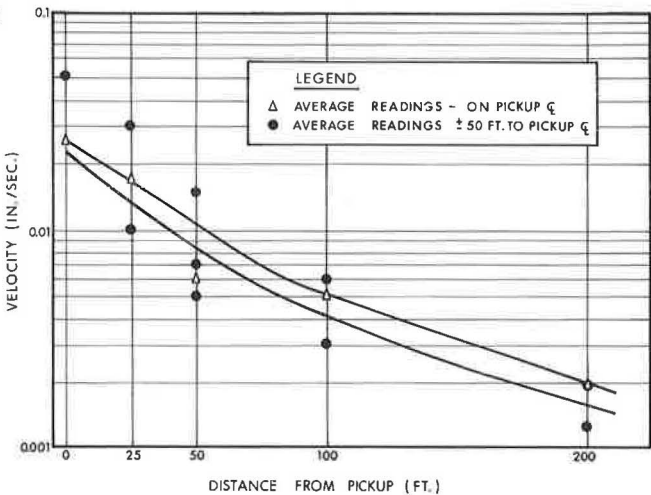
Figure 13. Vertical vibrations of D8H tractor not touching and TS24 earthmover scraping earth—test 6.

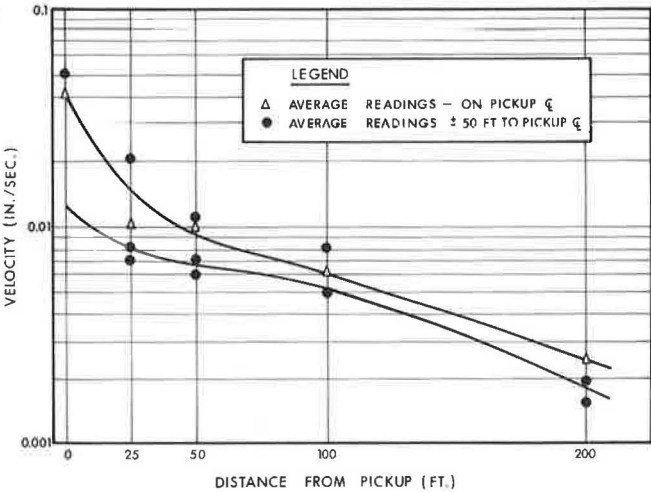
Figure 14. Longitudinal vibrations of D8H tractor not touching and TS24 earthmover scraping earth—test 6.

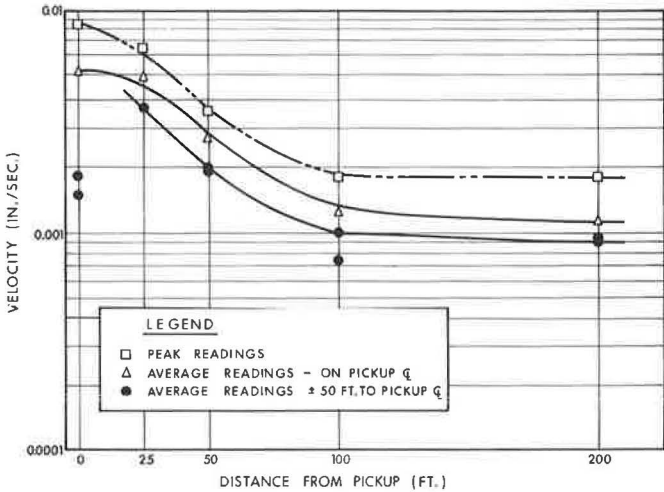
Figure 15. Vertical vibrations of LW777 passing in reverse and not cutting—test 7.

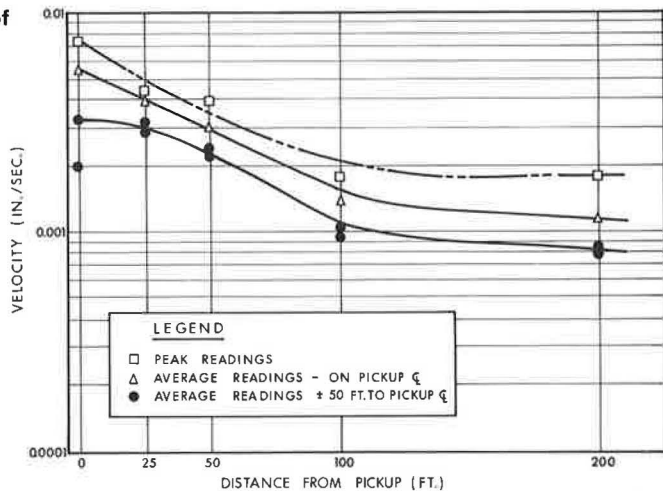
Figure 16. Longitudinal vibrations of LW777 grader passing in reverse and not cutting—test 7.

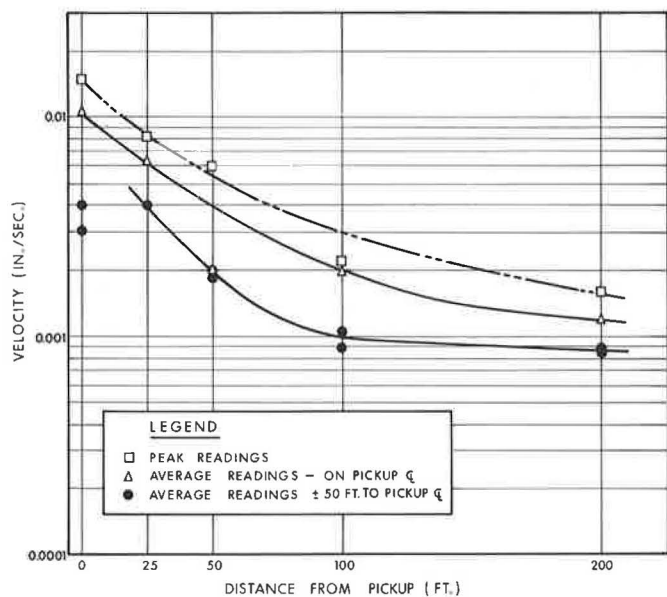
Figure 17. Vertical vibrations of LW777 passing forward and cutting—test 8.

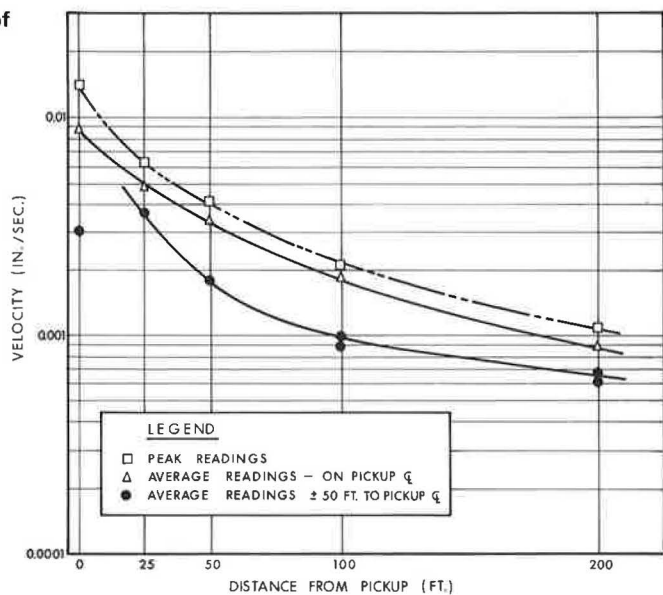
Figure 18. Longitudinal vibrations of LW777 passing forward and cutting—test 8.

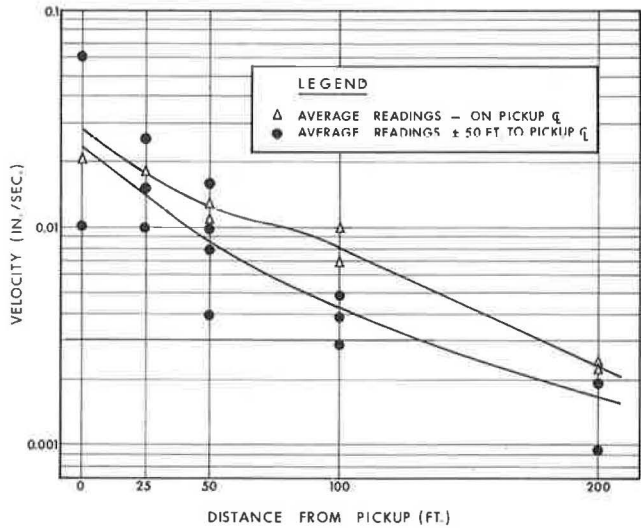
Figure 19. Vertical vibrations of C6 tractor pushing TS24 earthmover cutting earth—test 9.

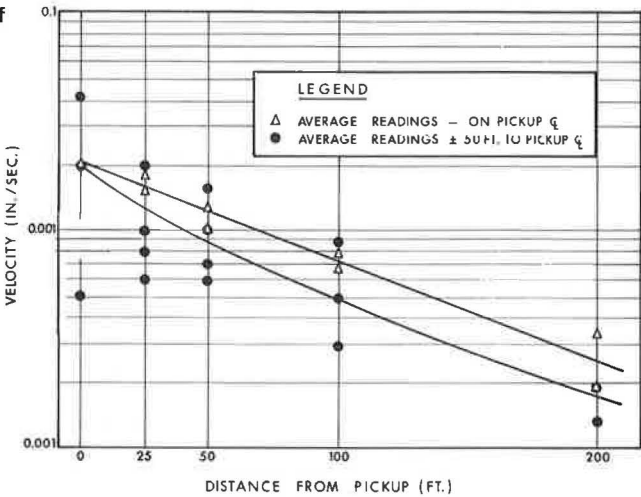
Figure 20. Longitudinal vibrations of C6 tractor pushing TS24 earthmover cutting earth—test 9.

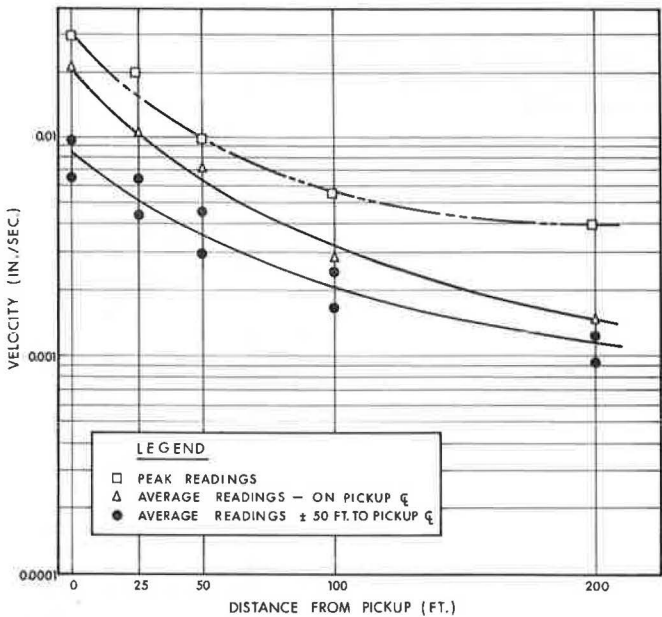
Figure 21. Vertical vibrations of C6 tractor slowly passing—test 10.

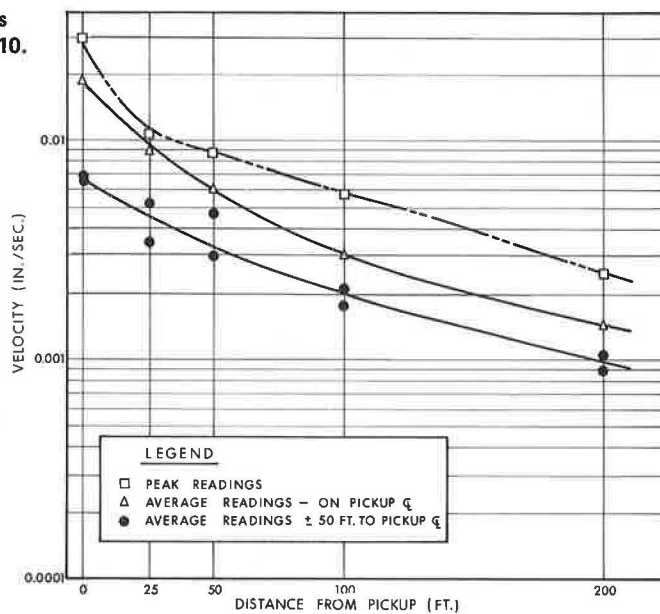
**Figure 22. Longitudinal vibrations of C6 tractor slowly passing—test 10.**

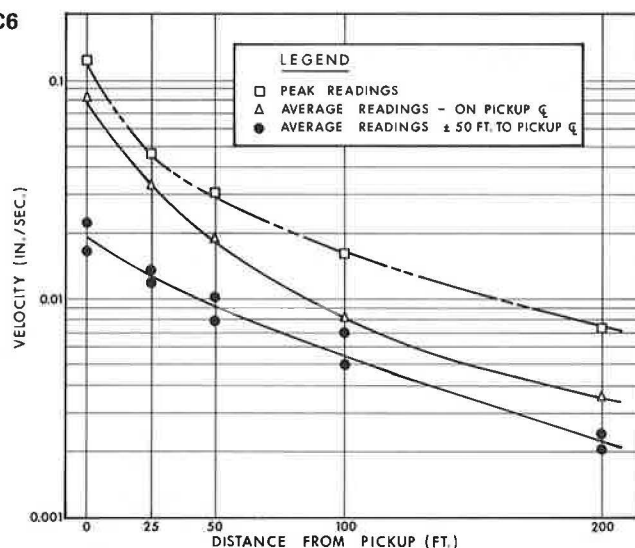
**Figure 23. Vertical vibrations of C6 tractor rapidly passing—test 11.**

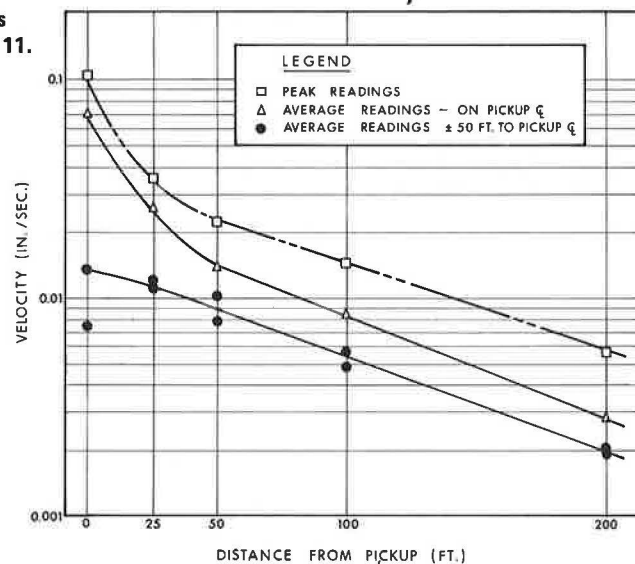
**Figure 24. Longitudinal vibrations of C6 tractor rapidly passing—test 11.**

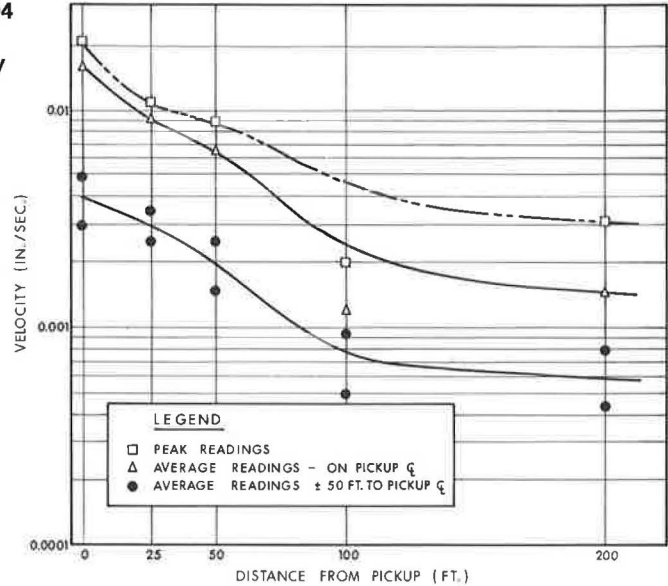
Figure 25. Vertical vibrations of D4 tractor with vibroplus sheepsfoot compactor not vibrating and slowly passing—test 12.

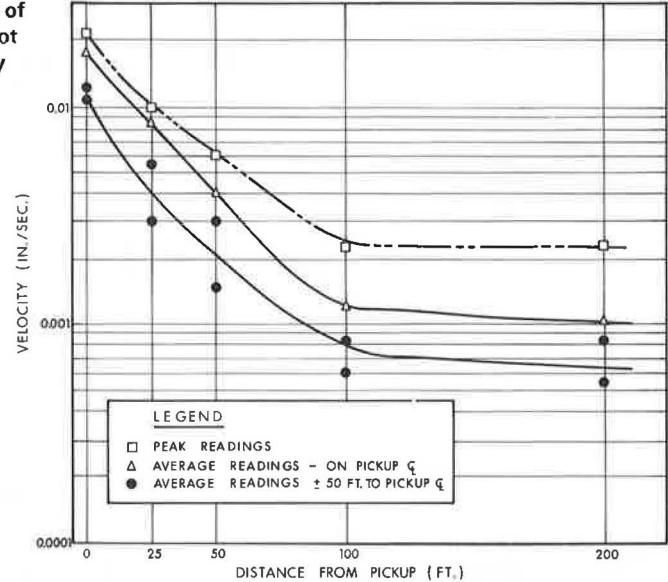
Figure 26. Longitudinal vibrations of D4 tractor with vibroplus sheepsfoot compactor not vibrating and slowly passing—test 12.

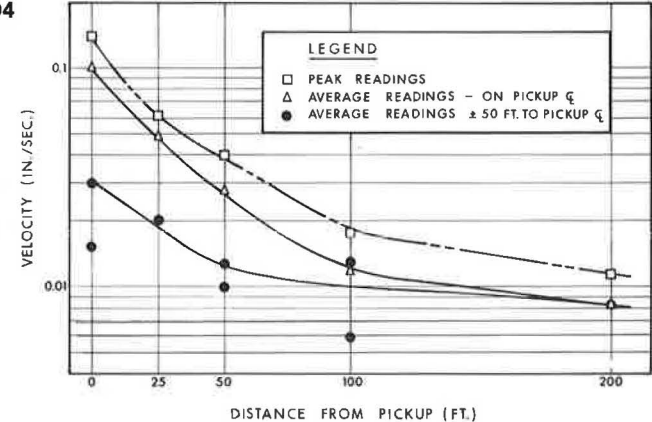
Figure 27. Vertical vibrations of D4 tractor with vibroplus sheepsfoot compactor vibrating—test 13.

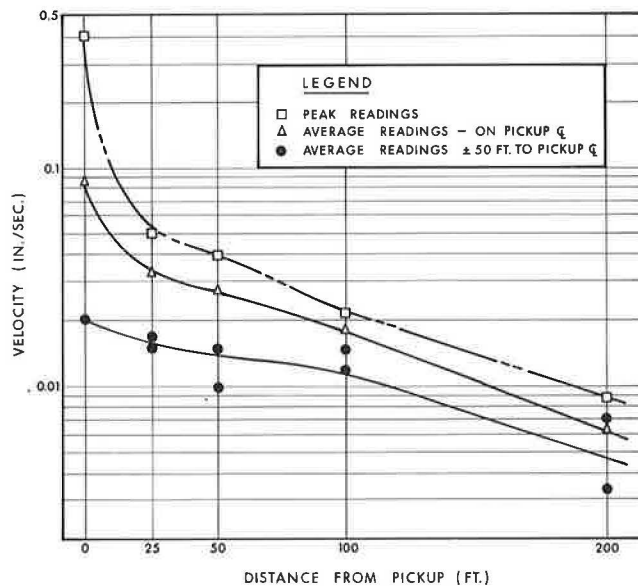
**Figure 28. Longitudinal vibrations of D4 tractor with vibroplus sheepfoot compactor vibrating—test 13.**

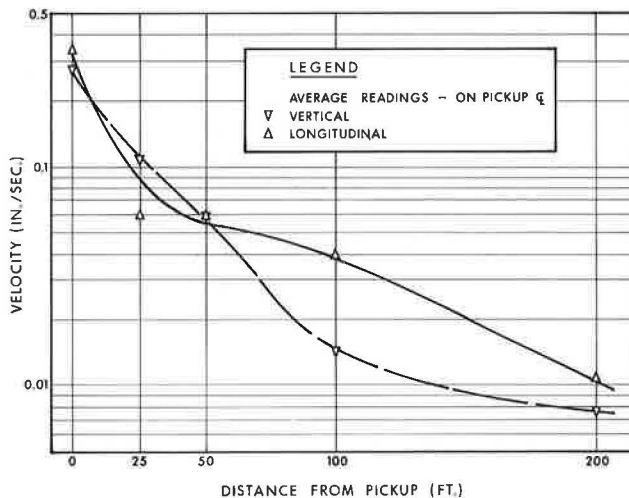
**Figure 29. Stationary vibroplus sheepfoot compactor operating opposite line of pickups—test 14.**

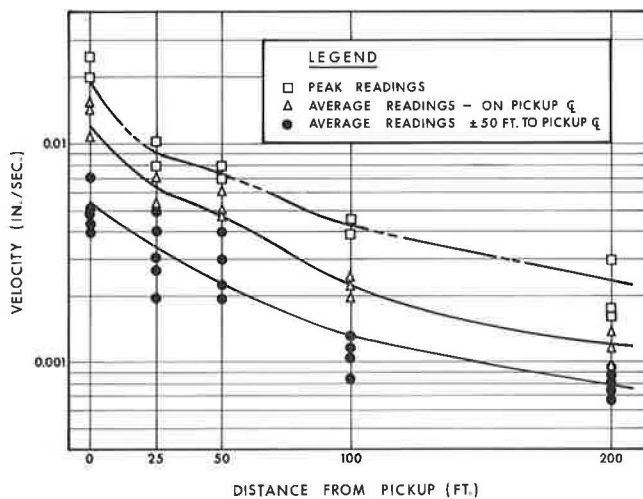
**Figure 30. Vertical vibrations of D4 tractor slowly passing—test 15.**

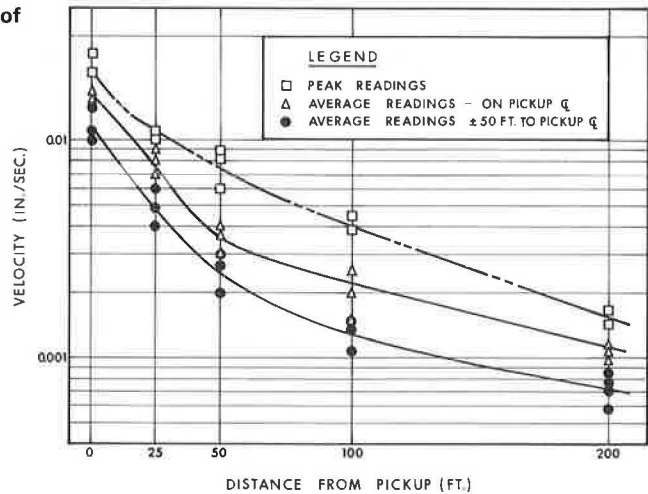
Figure 31. Longitudinal vibrations of D4 tractor slowly passing—test 15.

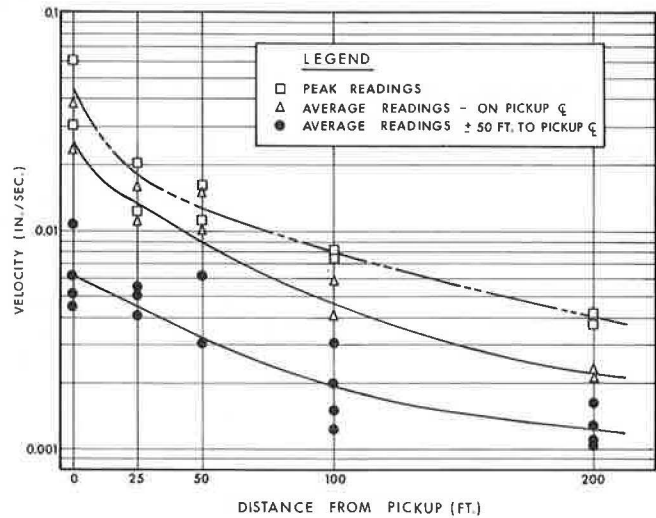
Figure 32. Vertical vibrations of D4 tractor rapidly passing—test 16.

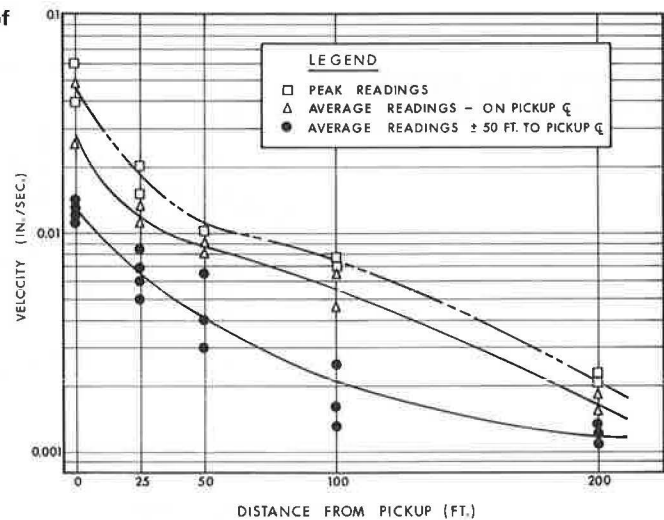
Figure 33. Longitudinal vibrations of D4 tractor rapidly passing—test 16.
