Examples of Approach and Field Evaluation: Research Applications

R. L. Terrel
University of Washington

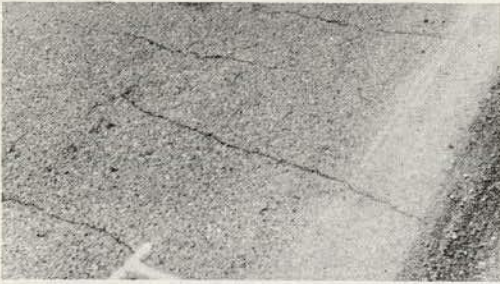
Figure 1. Initial transverse cracks in outer wheelpath of Brampton test road.

The first contained 3½ in. of asphalt concrete, 2 in. of crushed-stone base, and 6 in. of sandy-gravel subbase. After an initial period of service, short transverse cracks began to develop in the outer wheelpath as shown in Figure 1. Progression to more advanced forms of alligator cracking (Figs. 2 and 3) occurred rather rapidly and is somewhat typical for that type of failure. The load-associated cracking shown in those figures is perhaps closest to the pure fatigue failure and has been observed by the author to be frequently associated with asphalt pavements overlying unbound granular bases.

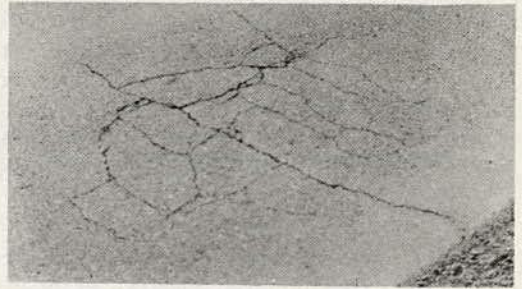
Figure 2. Beginning of alligator fatigue cracks.

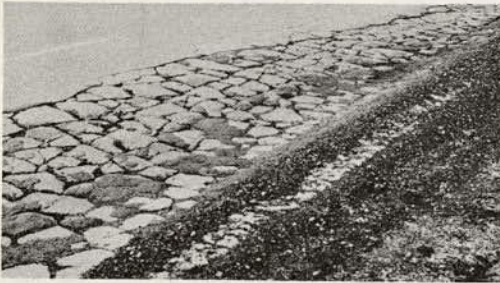
Figure 3. Complete alligator cracking prior to repair.

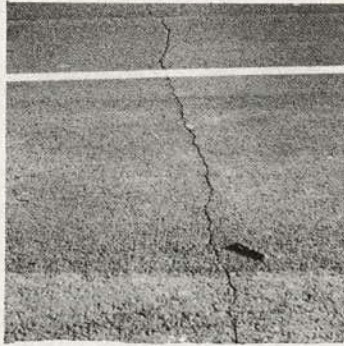
Figure 4. Non-load-associated crack that was thermally induced and may act as catalyst to fatigue cracking.

The second example at Brampton illustrates that crack initiation may be non-load-associated in many instances but may eventually develop into fatigue cracking. Low-temperature cracking, as shown in Figure 4, or reflection cracking from underlying cement-bound layers, as shown in Figure 5, often occurs soon after construction. Those breaks in the pavement surface may permit initially higher than normal deflections because of free boundary conditions or because of influx of water into underlying layers or both.

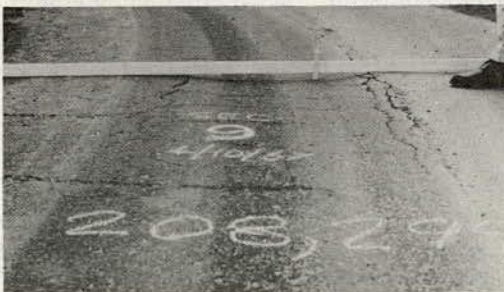
Figure 20. Further crack development and permanent deformation.

Figure 20 shows an example of the next phase of crack advancement. In addition to further cracks, an appreciable amount of permanent deformation has occurred in the wheelpath. That type of failure was often of a local nature and may have been associated with weak or uncompacted underlying materials. A more advanced form of alligator cracking is shown in Figure 21 and is somewhat typical for most of the thinner sections. Fatigue cracks were frequently developed during the summer and autumn months when those test pavements received the first phase of loading. Provided there was no accompanying deformation in subgrade or base courses, the number of load repetitions supported was surprisingly large. In other words, once the primary fatigue cracks appeared, no further development of failure appeared during many thousands of repetitions (note in Fig. 21, 588,000 repetitions).

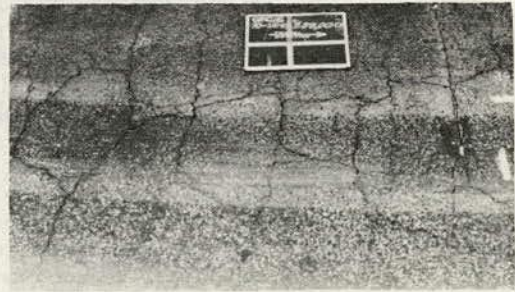
Figure 21. Ultimate form of alligator cracking covering entire trafficked area.

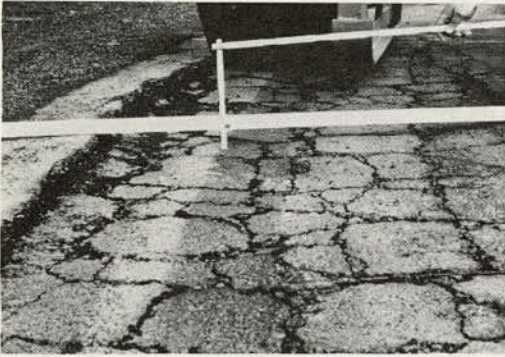
Figure 22. Total failure after subgrade became saturated.

During the wet fall, rainwater accumulated in the depressed areas and thoroughly soaked the untreated bases and subgrade. Intrusion of water through the cracked surface and the usual spring thaw tended to weaken the underlying material. When testing was resumed in the spring, total failure quickly resulted as shown in Figure 22. That was a result not of further fatigue distress but of subgrade failure.

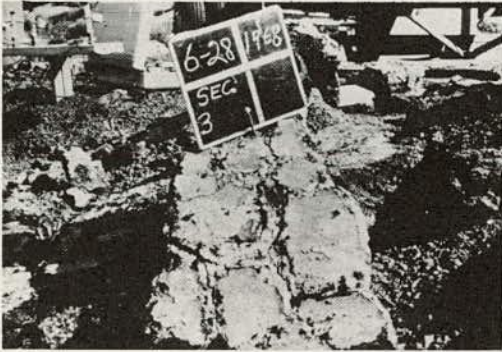
Figure 24. Well-developed crack system on underside of asphalt sections that showed little crack development at surface.

Several of the thicker (up to 9.5 in.) all-asphalt-concrete and asphalt-treated base sections served considerably longer before distress began to appear. Eventually, when the typical short transverse cracks appeared they were often accompanied by evidence of pumping. Figure 23 shows small amounts of the silt subgrade being exuded at the surface. Other thick sections did not exhibit surface cracks. However, when the pavements were removed and examined, there was considerable evidence of alligator cracking on the underside of the asphalt layers as shown in Figure 24. Subgrade soil had also been pumped into that crack system. The fact that cracks were well developed at the bottom and practically nonexistent at the surface was further evidence that the failure was of the fatigue type and that cracks initiate at the bottom and propagate toward the surface.

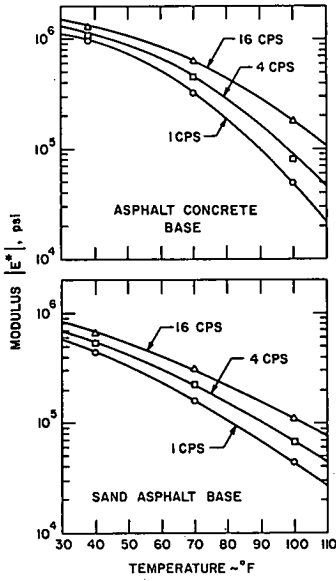
Figure 27. Modulus relations for asphalt base courses.

Untreated crushed-stone base was tested similarly to the subgrade. Cylindrical samples were fabricated to field densities, and resilient modulus values were determined. The asphalt-treated base materials were tested also for complex modulus values as was the asphalt concrete surface. Figures 27 and 28 show the results of those tests.
