HIGHWAY RESEARCH BOARD SPECIAL REPORT 5

CHANNELIZATION

The Design of Highway Intersections at Grade

1952

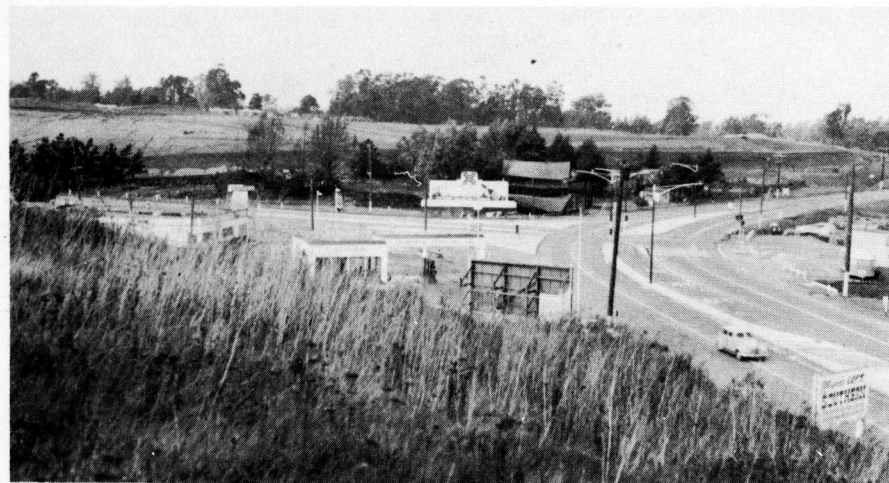
Figure 1. Intersection of El Camino Real and Junipero Serra Boulevard (US 101) looking north.

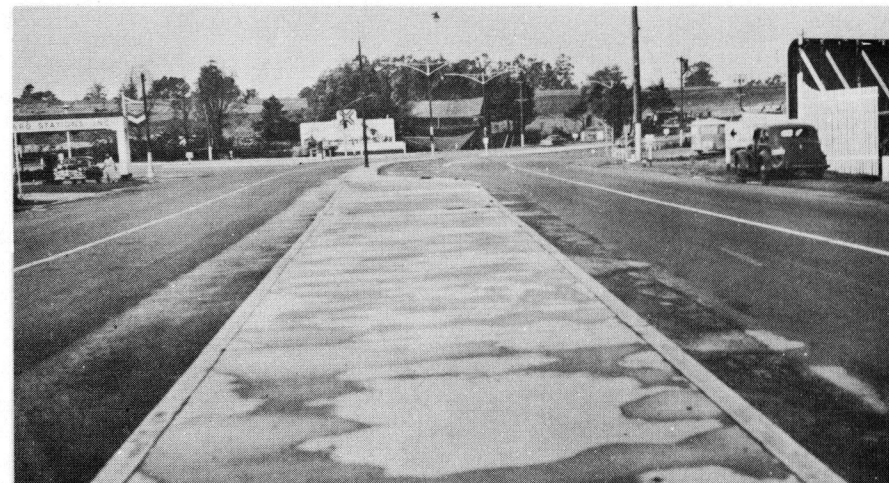
Figure 2. View of the added left-turn lane as seen from the south approach along El Camino Real.

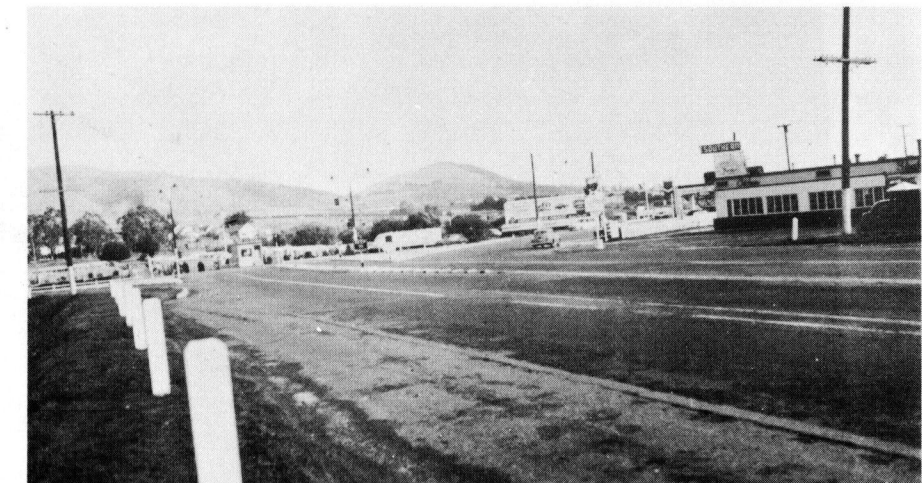
Figure 3. Approach end treatment of divisional island on Junipero Serra Boulevard.

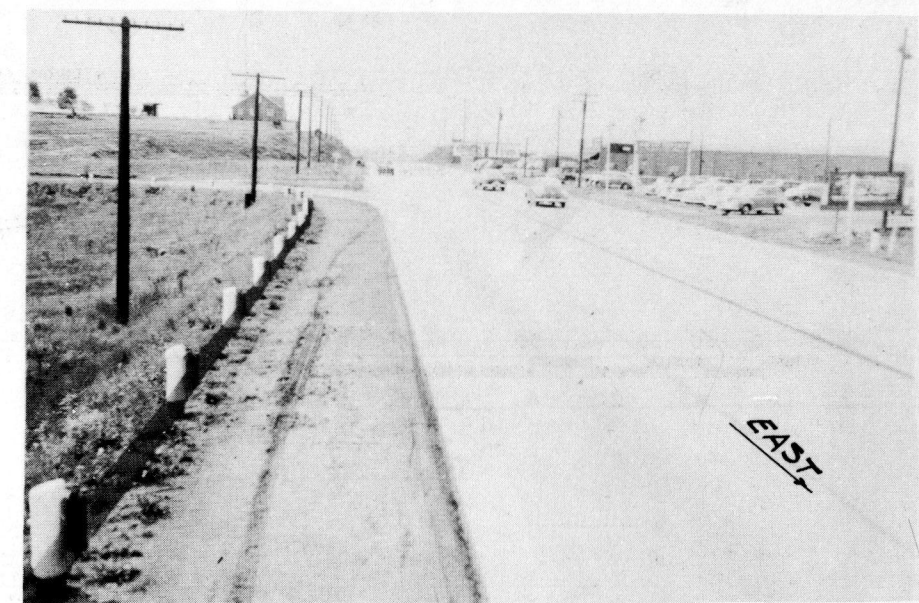
Figure 3. Narrow median on US 40 designed to prevent improper turn into separated right-turn lane.

Figure 3 is not altogether clear as to the points of entrances to the parking lot adjacent to US Route 40. Considerable can be done to provide safer traffic operation on facilities of this type when the points of entrance to adjacent businesses are controlled.

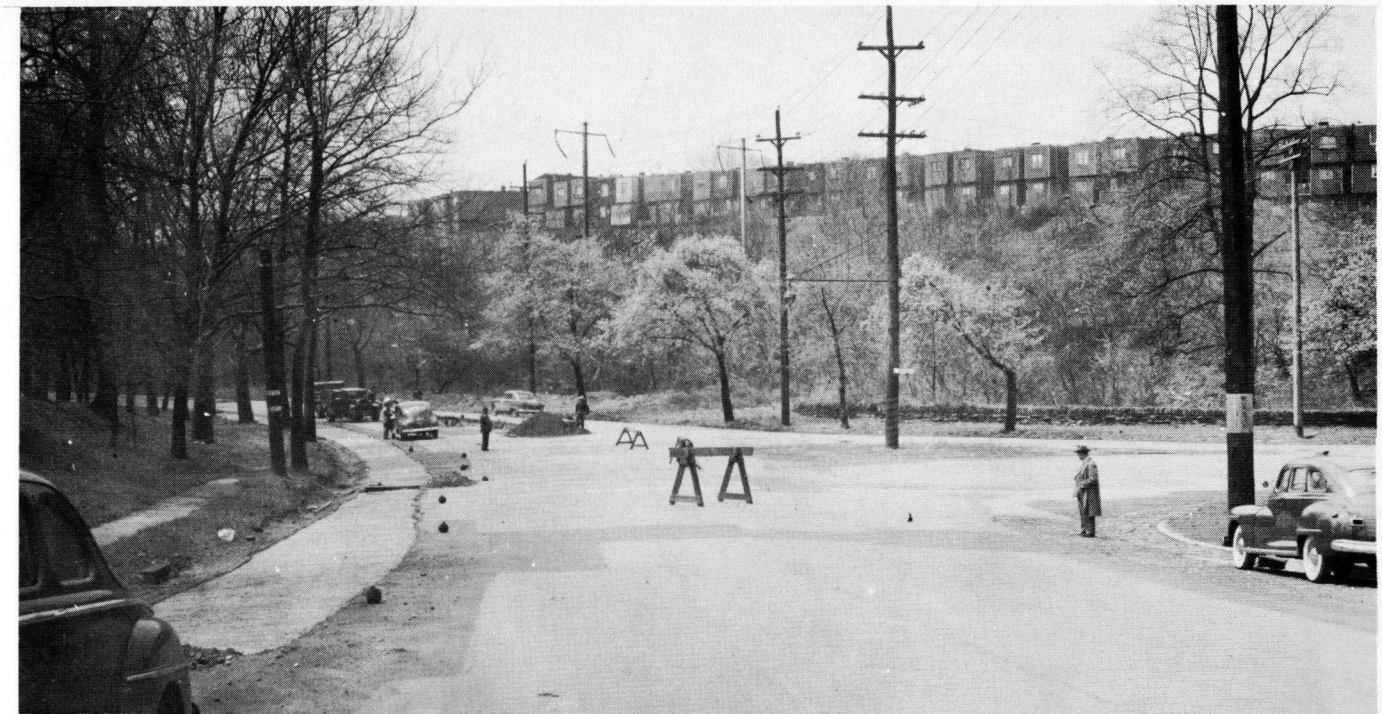
Figure 2. Intersection of Bryn Mawr Avenue and Parkside Avenue before channelization.

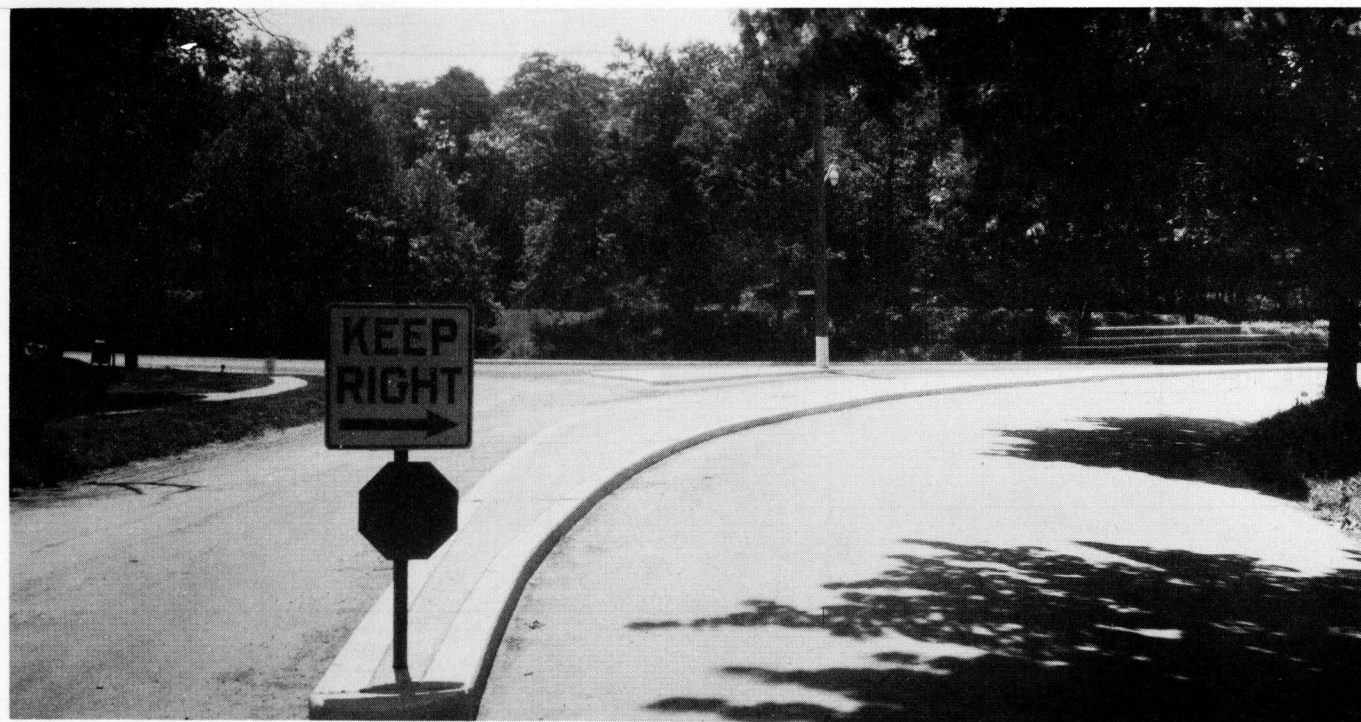
Figure 3. Channelizing island with traffic-control signs on Bryn Mawr Avenue.

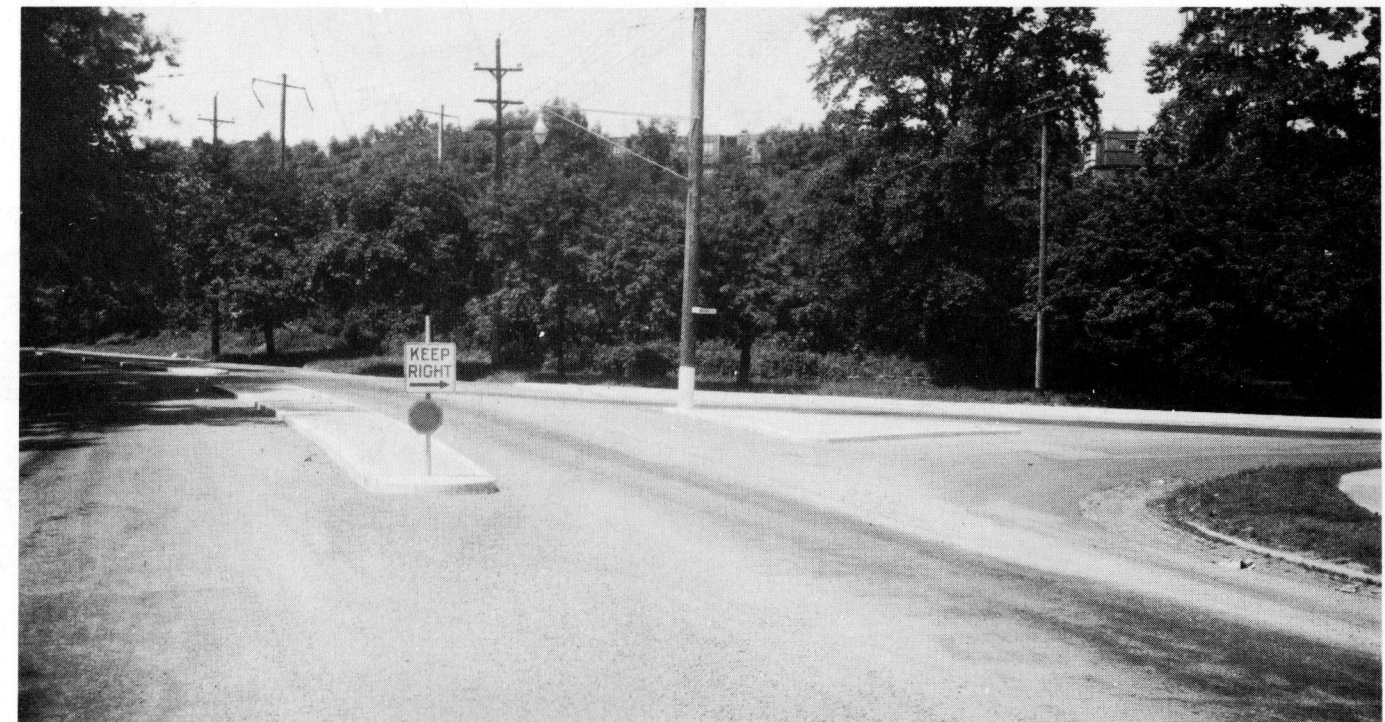
Figure 4. Good contrast is provided when concrete islands are used with asphalt pavements.

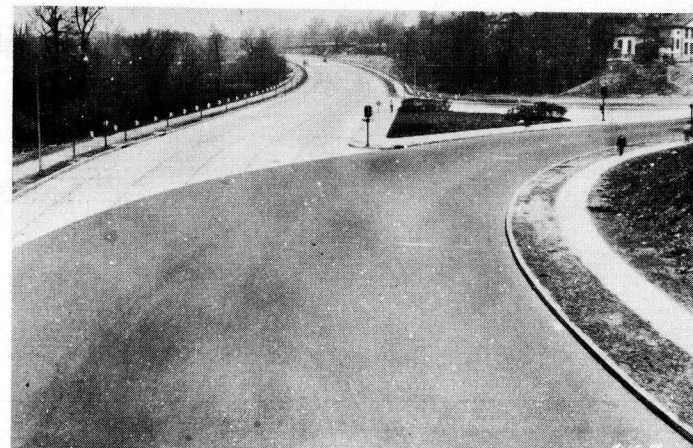
Figure 1. Intersection of University Avenue and Vintage (Curie) Avenue before redesign.

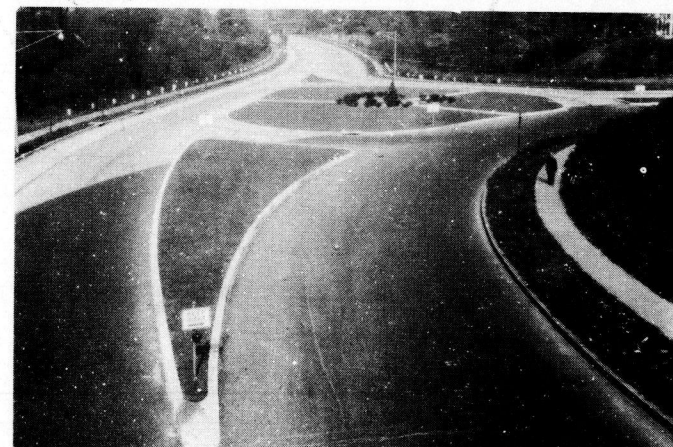
Figure 2. Channelization of 3-way T-type intersection.

1. EDWARD G. WETZEL - From my interpretation of traffic data submitted I would question the advisability of the "after" channelization. I assume the traffic flow divides as follows: "A" being heaviest (more than total of other two) must split fairly evenly with about half turning east on Vintage Avenue and the other half continuing north on University Avenue. In such a case it would seem there would be some congestion around the center circular island because of its small size and the short weaving area.
Although the information submitted with this example indicates the channelization design is satisfactory, I feel it must be due to infrequent occasions when peak traffic occurs, and also the fact that during such times the traffic is practically all passenger cars, the drivers of which expect some delay so are not "crowding" the intersection.
I do not believe this is a good design for a three-way or "T" intersection for such traffic volumes. Instead I would recommend establishing, if there is a major and minor flow, and then favoring the major flow with a separating island and provision for left turns, while a stop sign or signal with "lamb chop" islands could be used to control the minor flow.

2. J. C. YOUNG - The traffic diagram does not show the volume of each turning movement but it looks as though through northbound traffic and both left turn traffic streams are unduly distorted. Although the intersection seems to work well with the low traffic volumes, it obviously would not work if the northbound and westbound traffic began to approach the capacity of those streets. If through northbound and left turns (westbound to southbound) were significant volumes, the weaving distance would be insufficient and a stop sign would be necessary. More capacity and less out-of-direction travel could be accomplished by a simple T-type intersection with free right turns and a stop sign against westbound traffic only. If desired, with the amount of area available, a median island parallel to the University Avenue centerline could be constructed in addition to a triangular island separating the free right turns (northbound to eastbound) from the other east and west traffic.

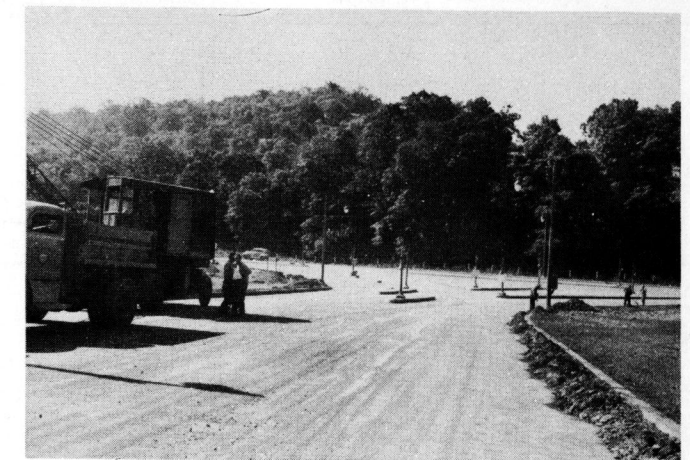
Figure 3. Elaborate channelization with multiplicity of islands requires floodlights and numerous signs to insure effective operation.

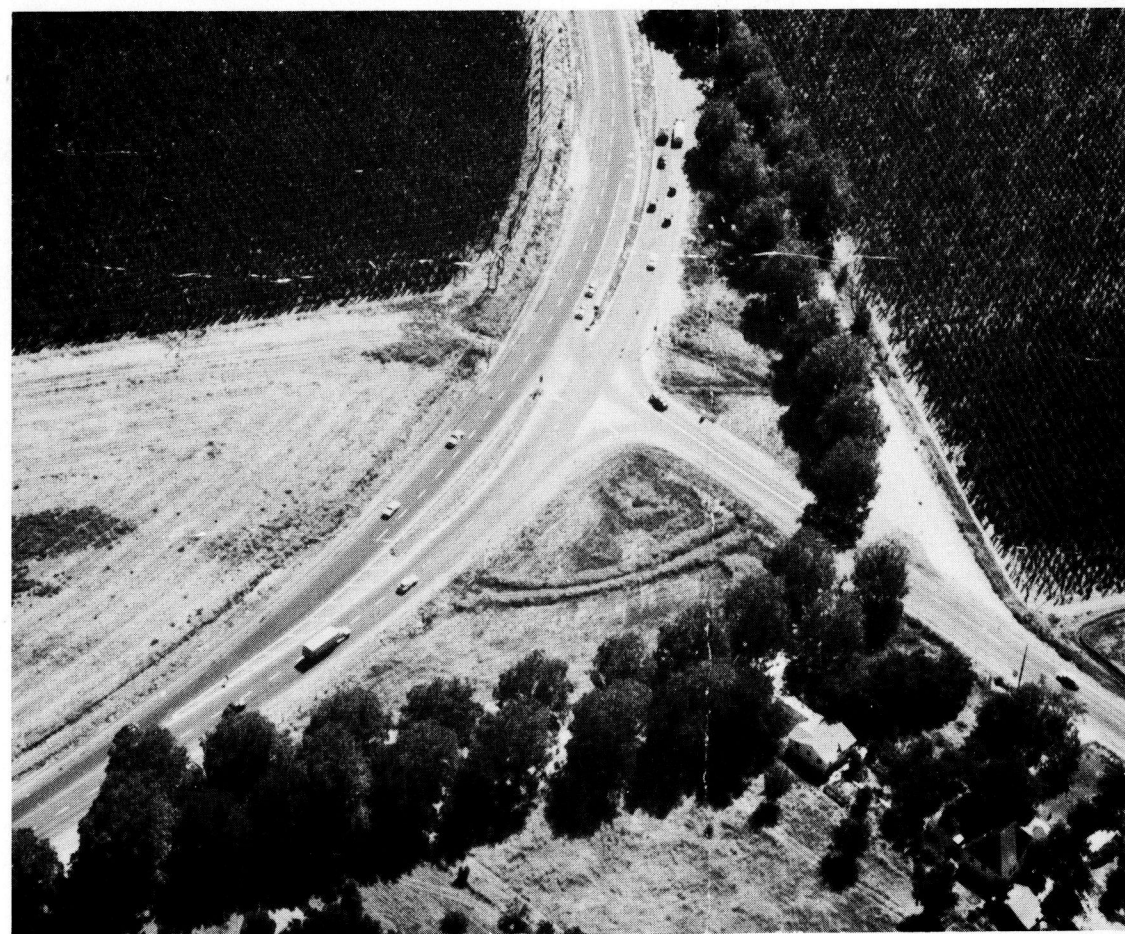
Figure 1. Channelized junction of local roadway (Howe Avenue) with curved section of main highway (Fair Oaks Boulevard). Note left-turn provision and well-organized wheel-track pattern shown on the pavement.

1. Design Features Which Contribute to Safe Operation; to Unsafe Operation:
 - a. "Safety: the northbound traffic from Fair Oaks Boulevard into Howe Avenue had to cross opposing westbound traffic at about a 20-degree acute angle, and due to heavy volumes and relatively high speeds this appeared to be a very hazardous move; however, there were only two accidents of this type in three years, during which average daily traffic was about 16,000 on the west leg, 4,000 on the north leg, and 12,000 on the east leg. To reduce this apparent hazard, a separate turning lane was provided, and signals were installed which give a green arrow to left-turning (northbound) traffic while holding the westbound traffic. There were two accidents in the first two months after construction, and it is going to be hard to prove that any improvement was made, because of the excellent record of the old intersection. However, the mental strain and apparent hazard has been greatly relieved."

2. **EDWARD G. WETZEL** - This scheme eliminates a serious head-on conflict at westerly junction of Howe Avenue and Fair Oaks Blvd. in spite of the fact that the "Before" accident record shows only 2 such accidents. The analysis submitted with this example appears

reasonable as to the effect on the motorist before channelization. However, with increasing traffic volumes and the signals since channelization, delays will undoubtedly become as serious and annoying to the motorist as "Before". In general this scheme is good and should prove of greater value when the capacity of the approaches is increased.

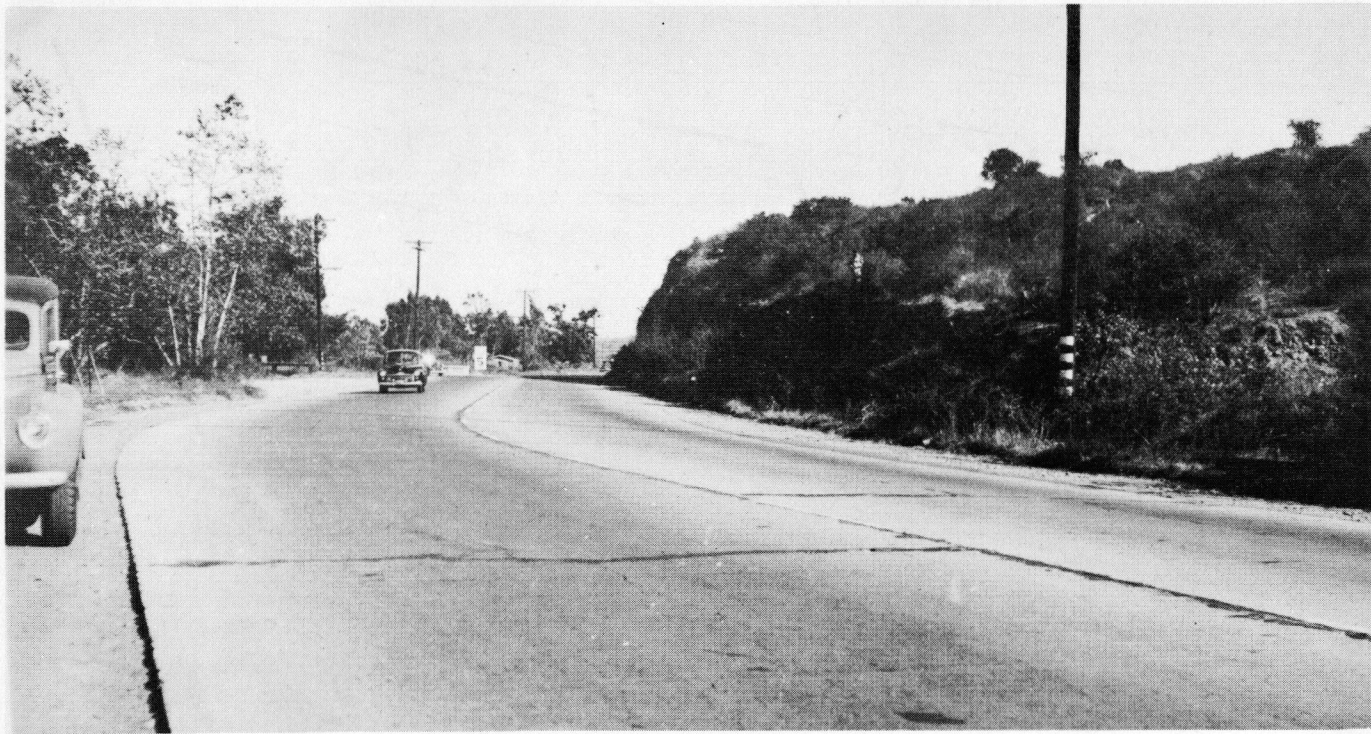
Figure 1. Intersection of California Route 94 and Home Avenue near San Diego before channelization.

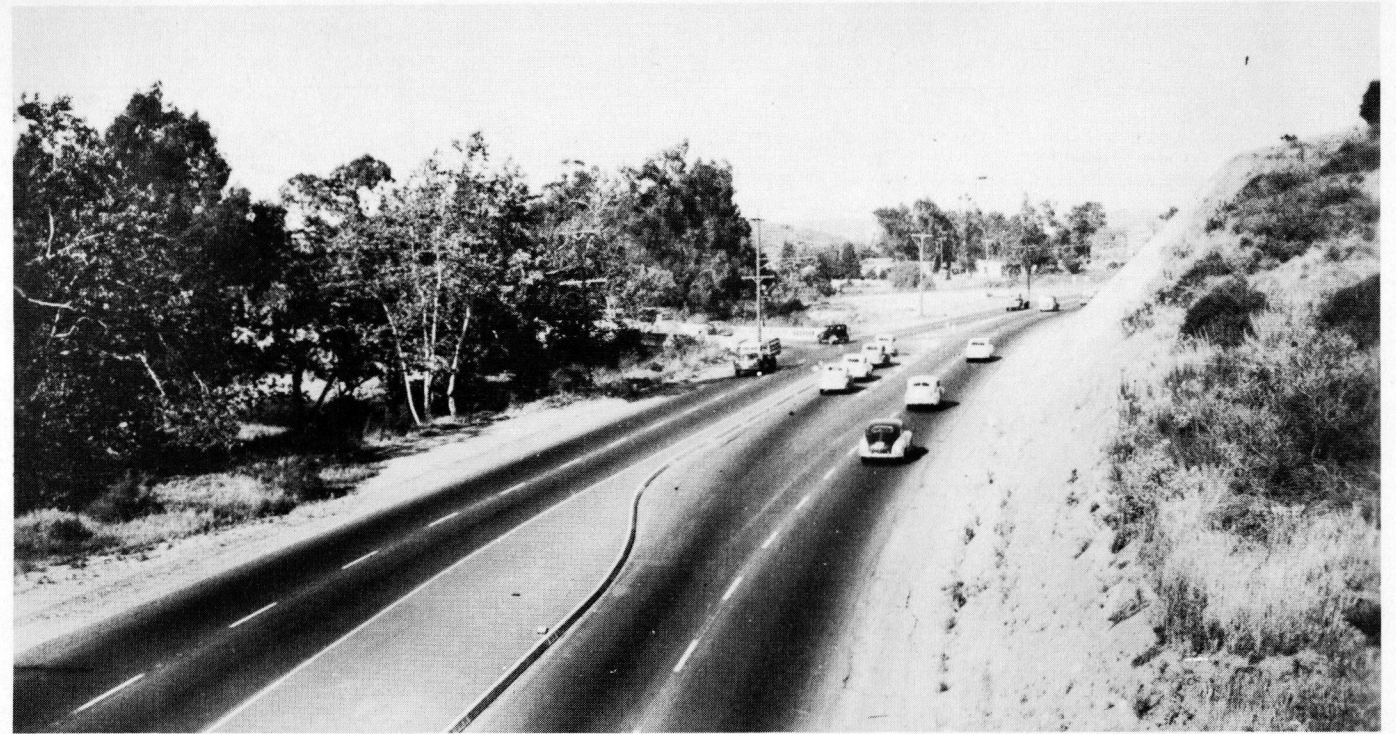
Figure 2. Intersection after channelization. Highway widened and curbed median added. Four vehicles in protected median lane, awaiting opportunity to turn left.

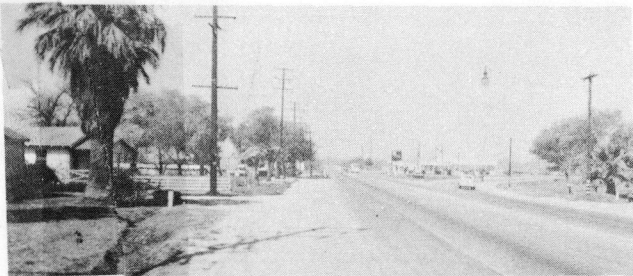
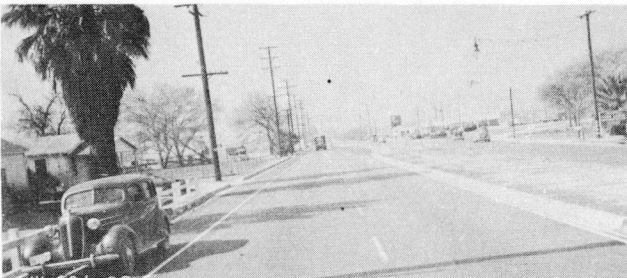
Figure 1. Intersection of Colton Avenue (US 70 and JS 99) and South E Street (California 26) before channelization.

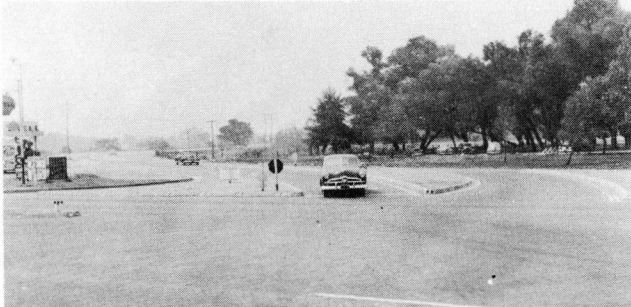
Figure 3. Channelizing islands with reflect-ing curbs.

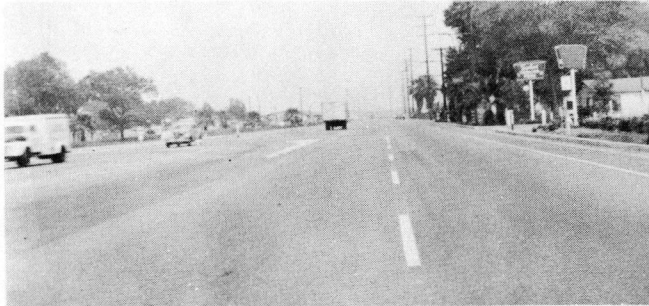
Figure 4. Separated left turn lane on Colton Avenue.

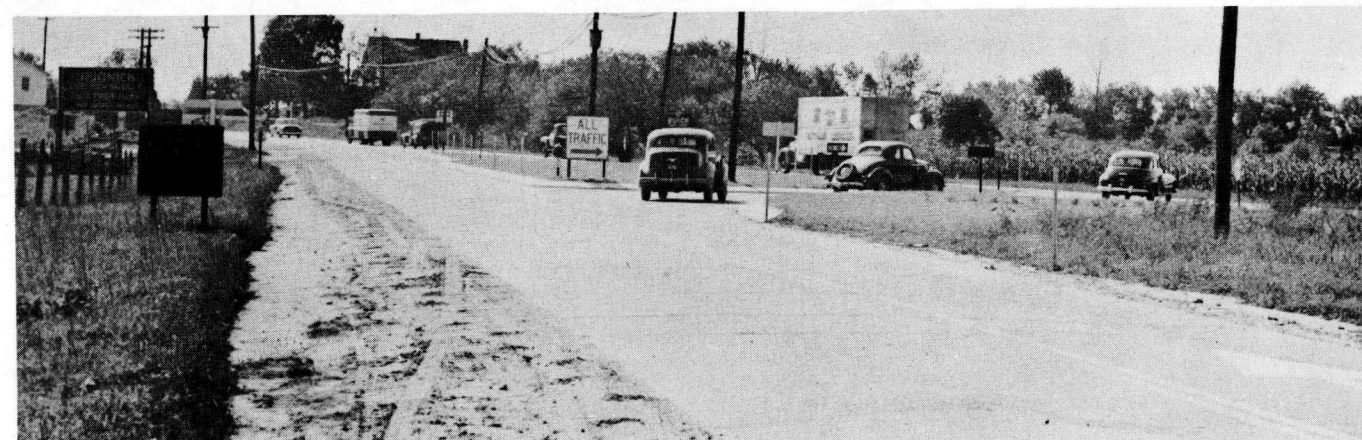
Figure 3. Looking west on Delaware Road 25.

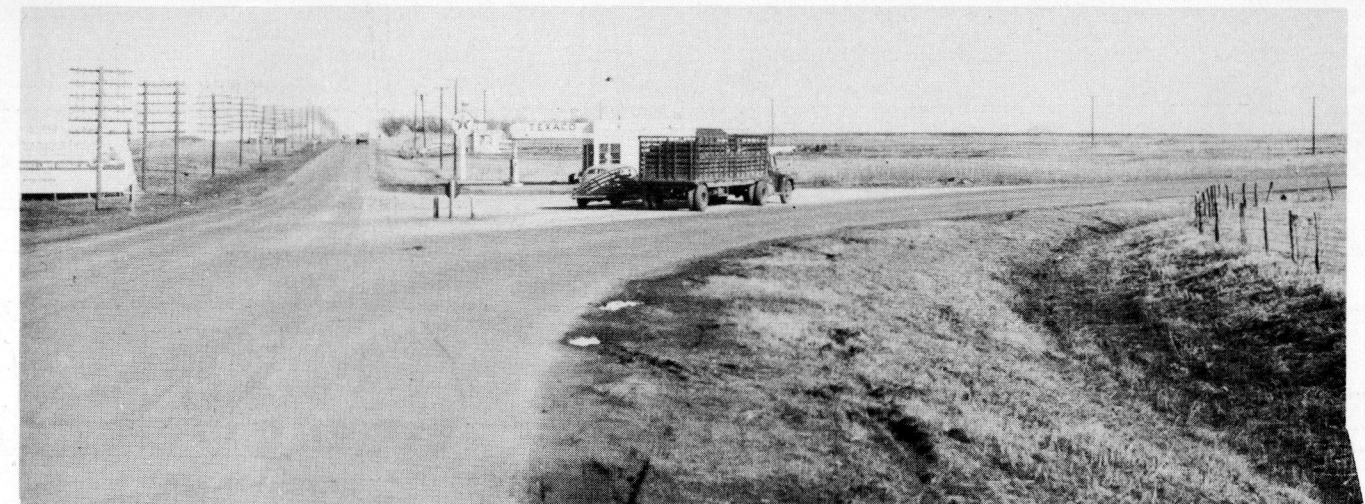
Figure 2. Intersection of US 66 and 10th Street Cutoff before reconstruction.

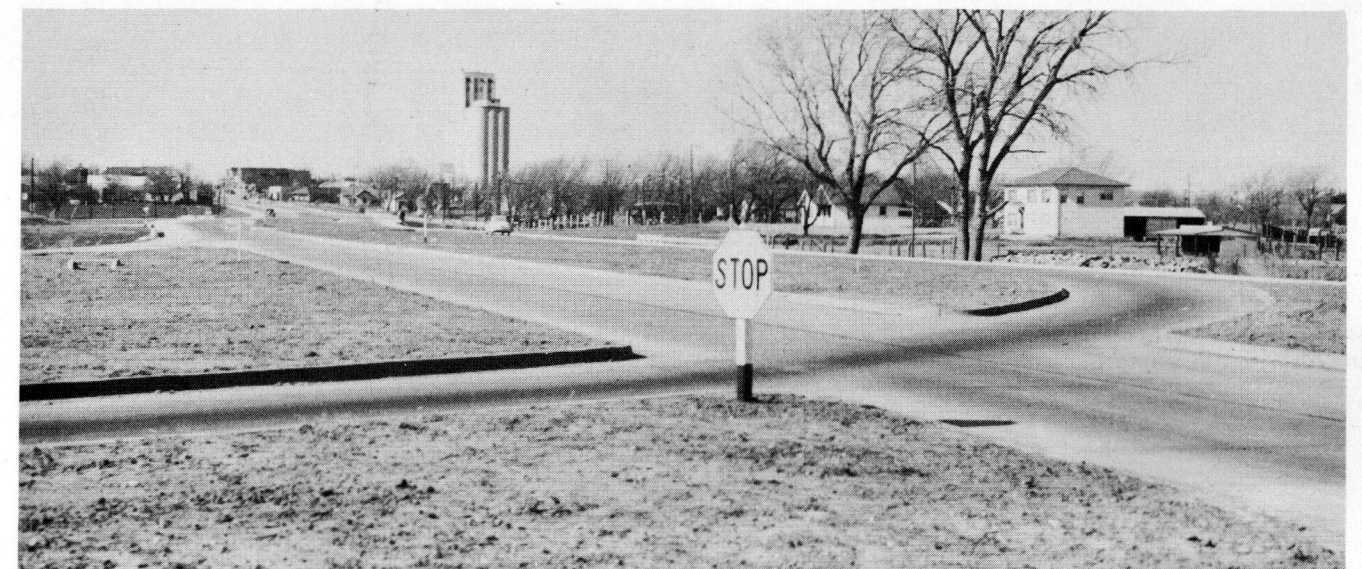
Figure 4. East lane of 10th Street Cutoff entering US 66 subject to stop control.

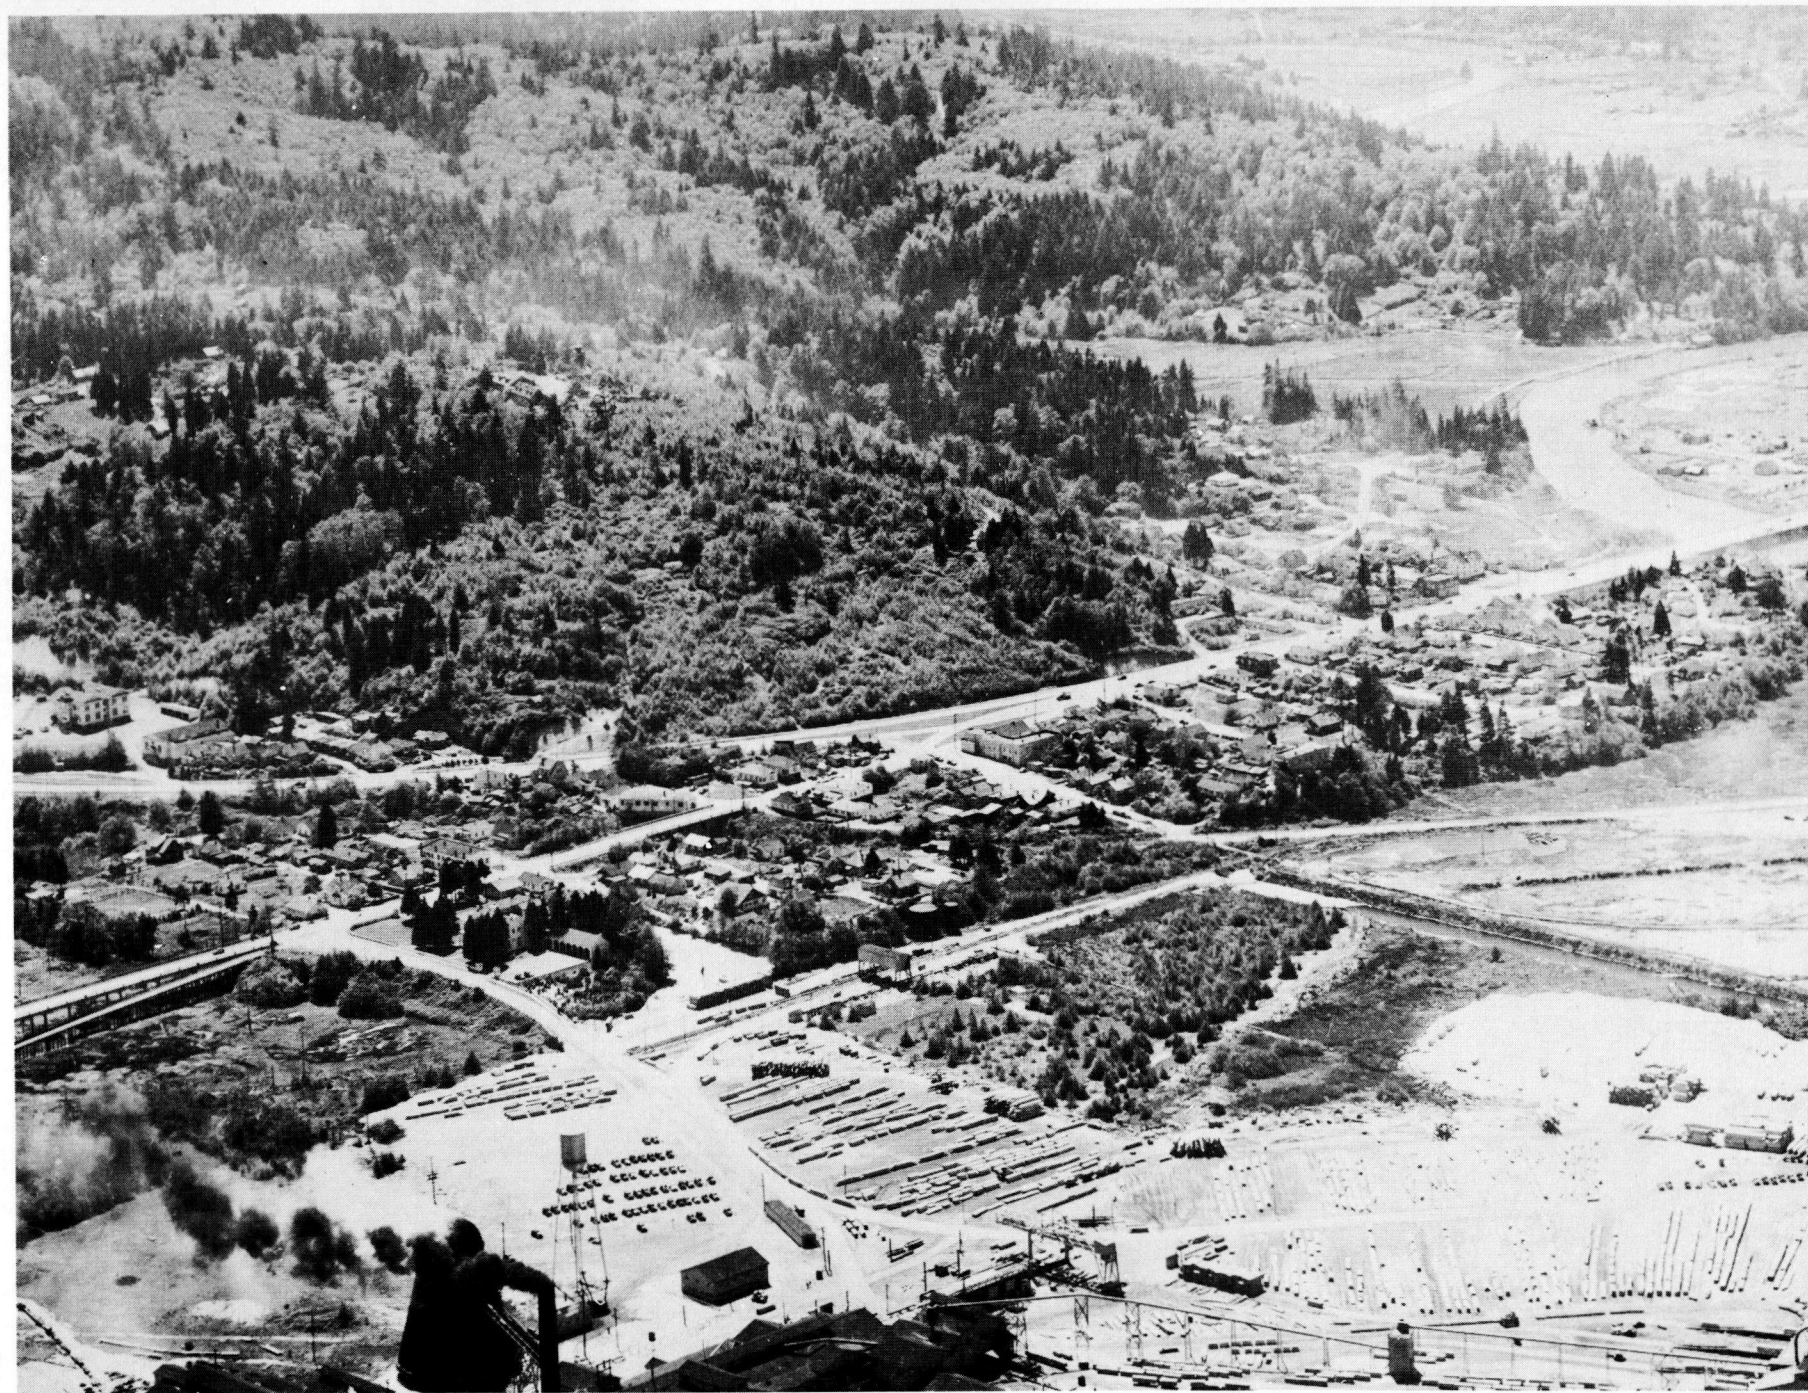
Figure 1. Aerial view of channelized intersection of US 101 and Coos River Highway, Bunker Hill, Oregon.

- 2. H. G. VAN RIPER - Channelization treatment has some unsafe operating conditions - (a) westbound traffic on Coos River Highway desiring to make left turn onto US 101 southbound would not have sufficient weaving distance on approaching Center Street; furthermore, the movement would be hazardous to cross eastbound traffic on Coos River Highway: (b) westbound traffic on US 101 desiring to go north on Center Street would have insufficient weaving movement.
 Snow and icy conditions would cause hazardous operation through the traffic islands. Suggest that light be provided at the toe of the traffic island separating eastbound traffic on Coos River Highway from southbound traffic on US 101.
 "After" accident record indicates that intersection treatment has contributed to safe operation through the elimination of conflicts.

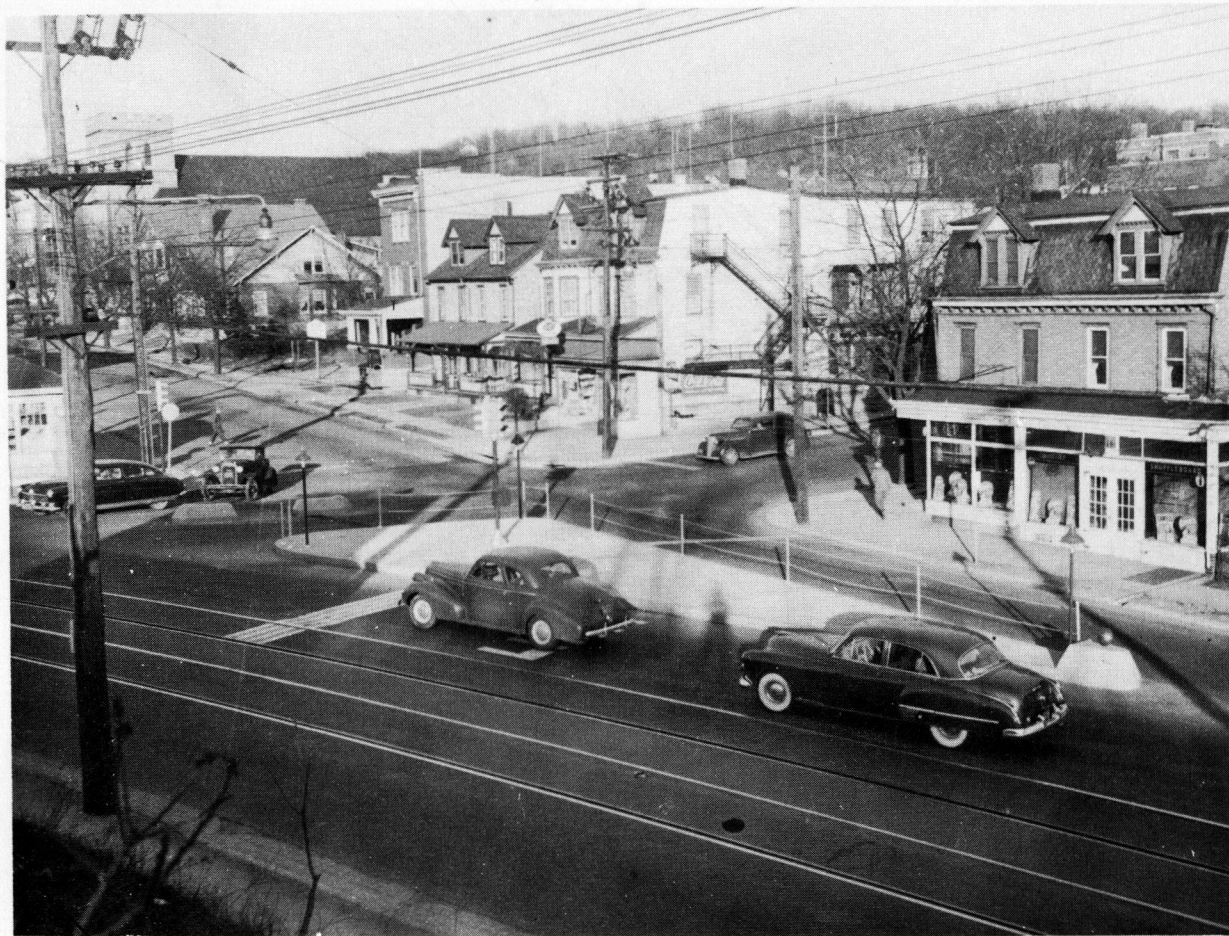
Figure 1. Channelization of the intersection of Carlisle Street, Hanover Avenue, and Hamilton Street in Allentown, Pennsylvania.

- 2. EDWARD G. WETZEL - The comparatively simple channelizing island treatment appears to be a satisfactory solution for this intersection. I heartily recommend the method here of handling the westbound traffic from E. Hamilton Street intersecting at right angle with Hanover Avenue.
With respect to the traffic signals system I note all but northbound on S. Carlisle St. and westbound on E. Hamilton St. have two signal indications while these two have only one. I would recommend two signal indications for all approaching traffic, one on right and other on left.
It appears this signal system is designed to be flexible enough to handle variable volumes through the several approaches. It seems adequate for the pedestrians also. This is highly desirable.

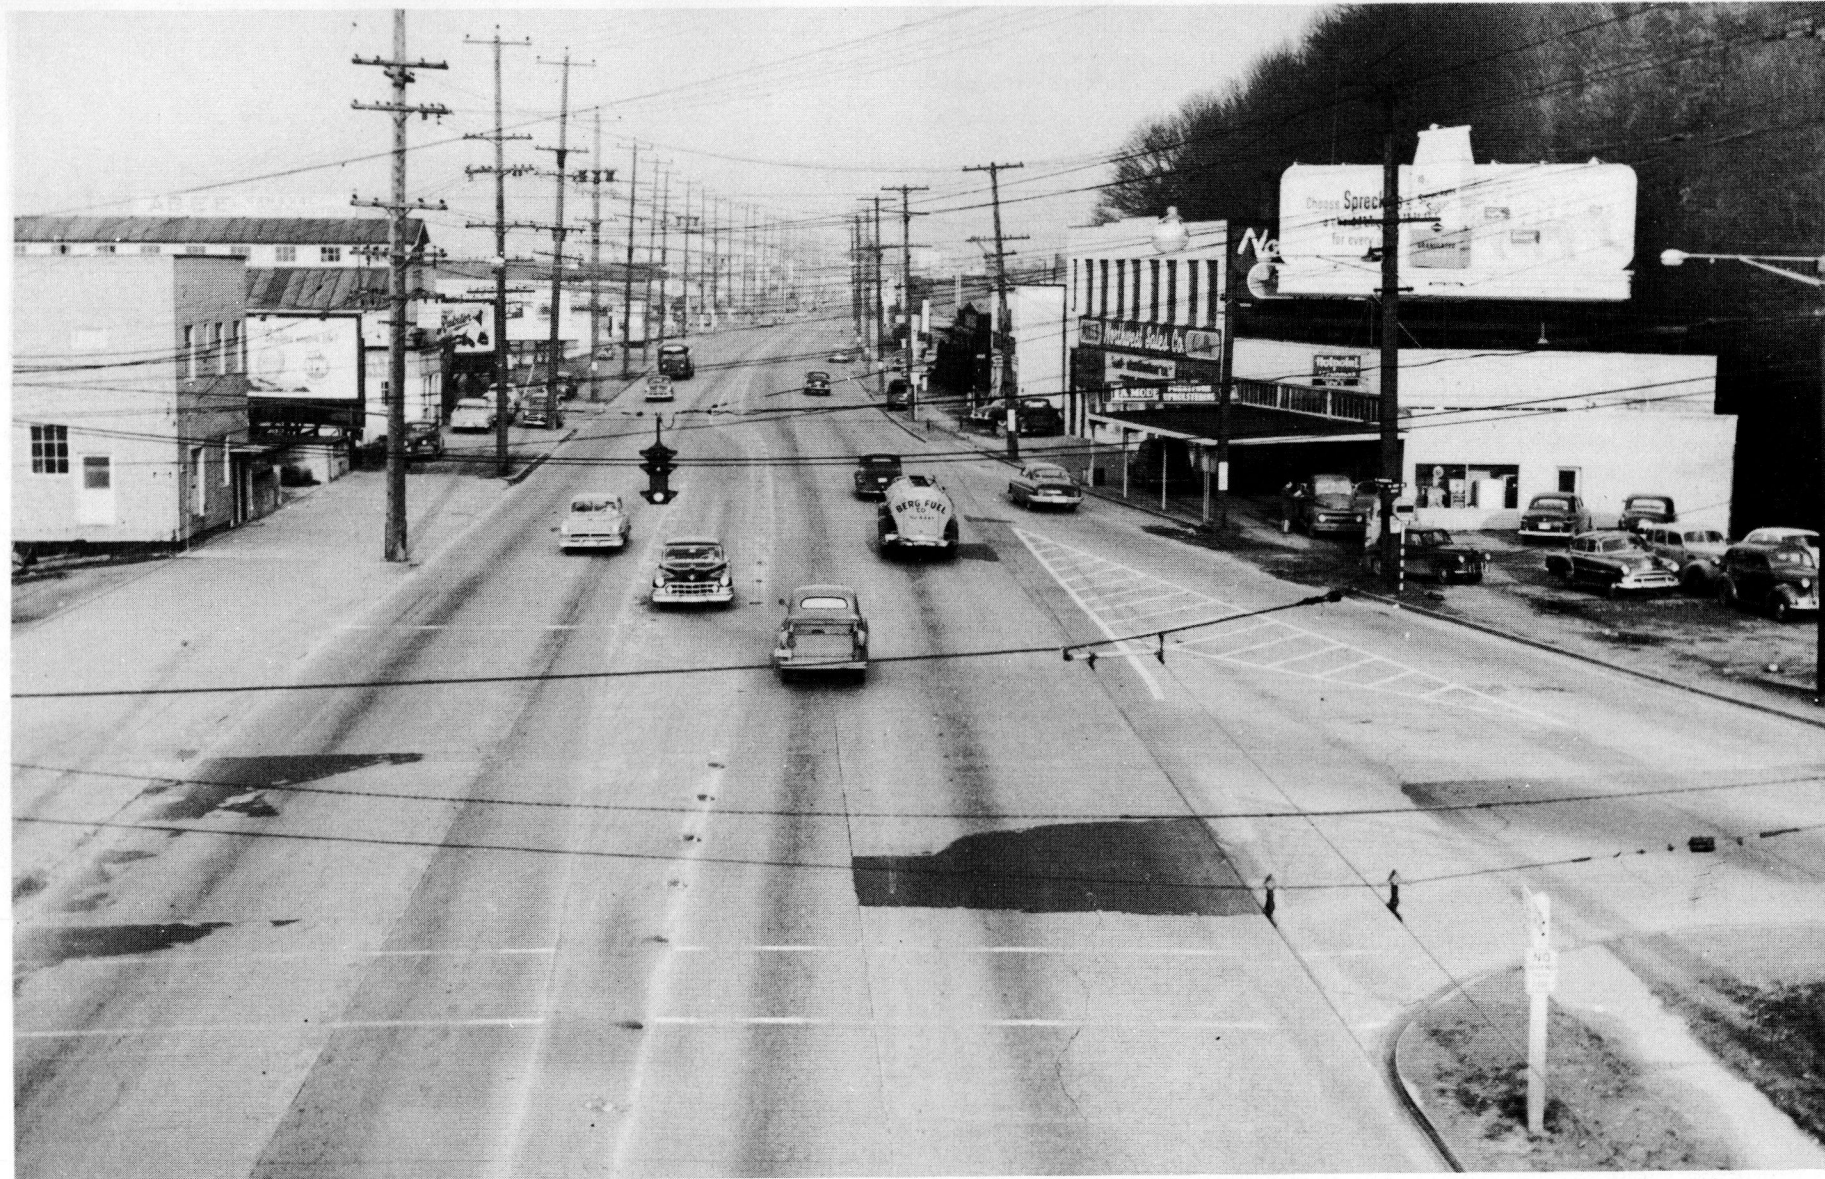
Figure 1. Intersection of Elliott Avenue, W. and West Mercer Place, Seattle, looking northwest along Elliott Avenue.

1. Design Features Which Contribute to Safe Operation:
 - a. Left turn protection provided by stopping northbound traffic.
2. Design Features Which Relieve Congestion:
 - a. The shadowing island eliminates congestion caused by southbound traffic being stopped by cars waiting to make the left turn.
3. Comments Regarding Over-all Operation of the Channelized Intersection
 - a. The installation has reduced congestion considerably and reduced the number of accidents.
 - b. The signal was turned on after the island was completed. A trial was made of a paint island and signal previously, but it was found that a physical barrier was necessary to clear through traffic from the left turn lane.

2. EDWARD G. WETZEL - This channelization scheme appears satisfactory for the left-turn volumes (from Elliott Avenue to Mercer Place) indicated. I would suspect that during winter snows particularly, the delineation is difficult. Having already made the transition from paint lines to buttons and found the geometry apparently satisfactory, the next stage should be raised islands so designed to permit left turn vehicles more "shadowing" and thus more safety. This would probably require widening Elliott Avenue on north side the equivalent of the width of a speed change lane.

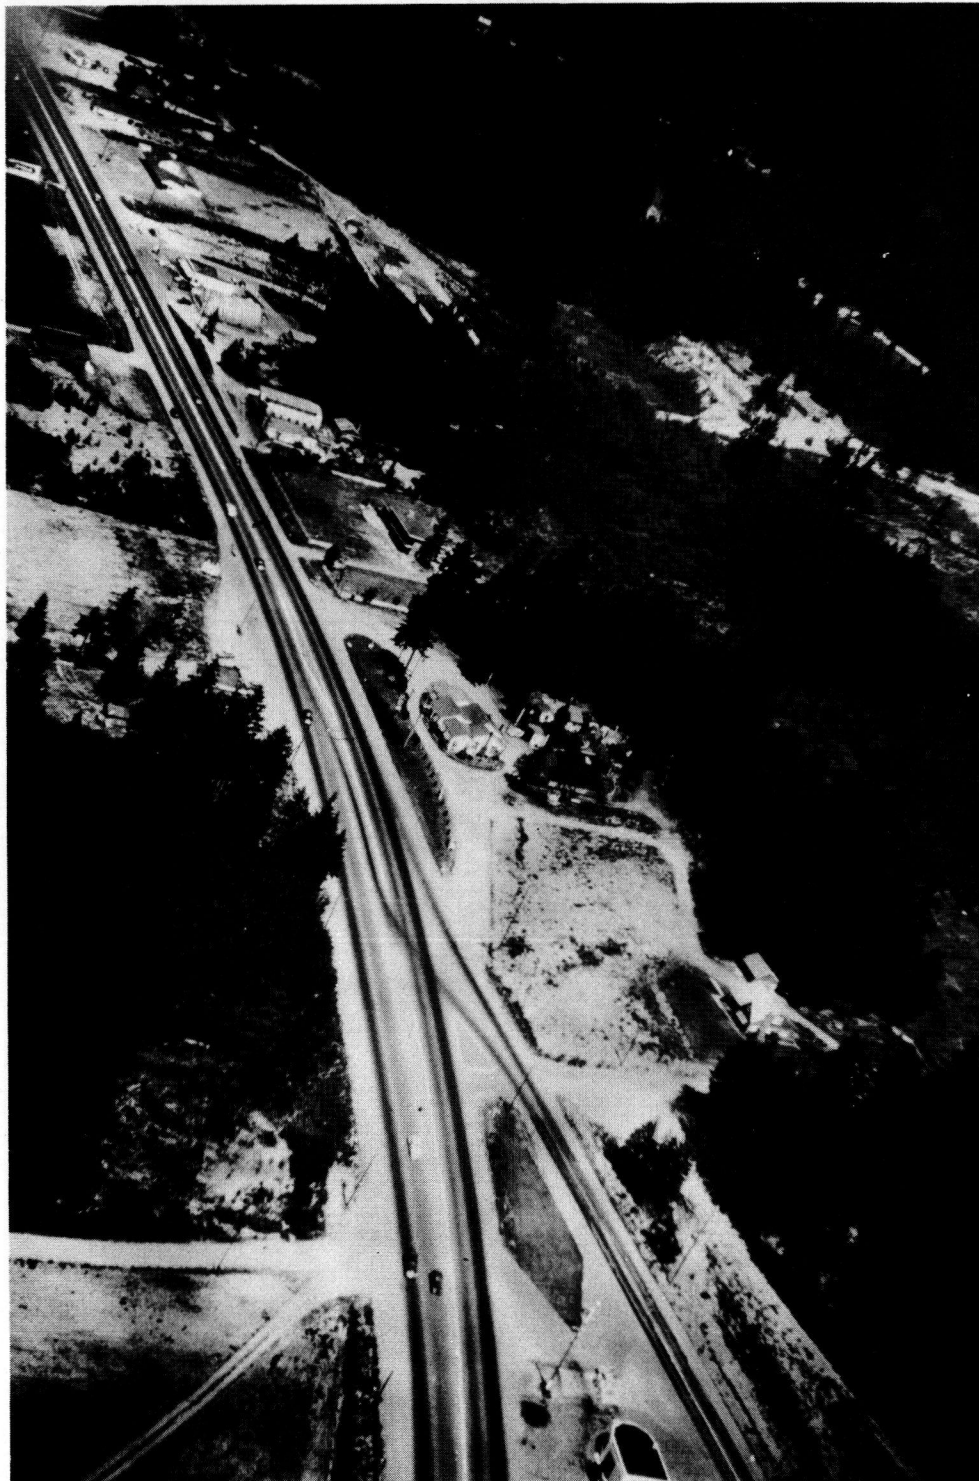
Figure 3. Channelization of Y-type intersection of 4-lane US 99 with 2-lane secondary road, State Highway 5-D, near Puyallup, Washington.

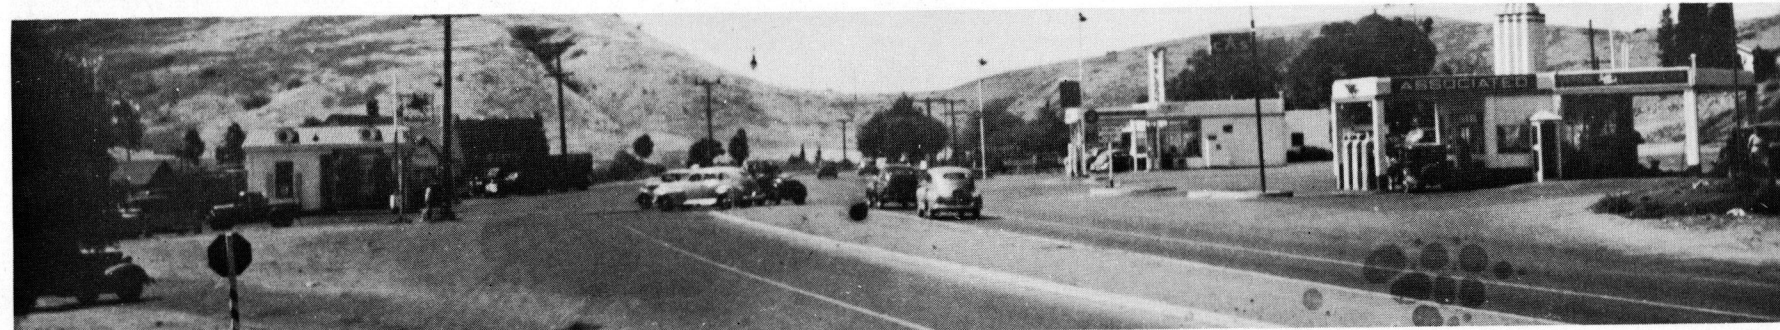
Figure 1. Intersection of Balboa Avenue and Pacific Highway (US 101) northwest of San Diego, California, before channelization.
