HIGHWAY RESEARCH BOARD SPECIAL REPORT 5

CHANNELIZATION

The Design of Highway Intersections at Grade

1952

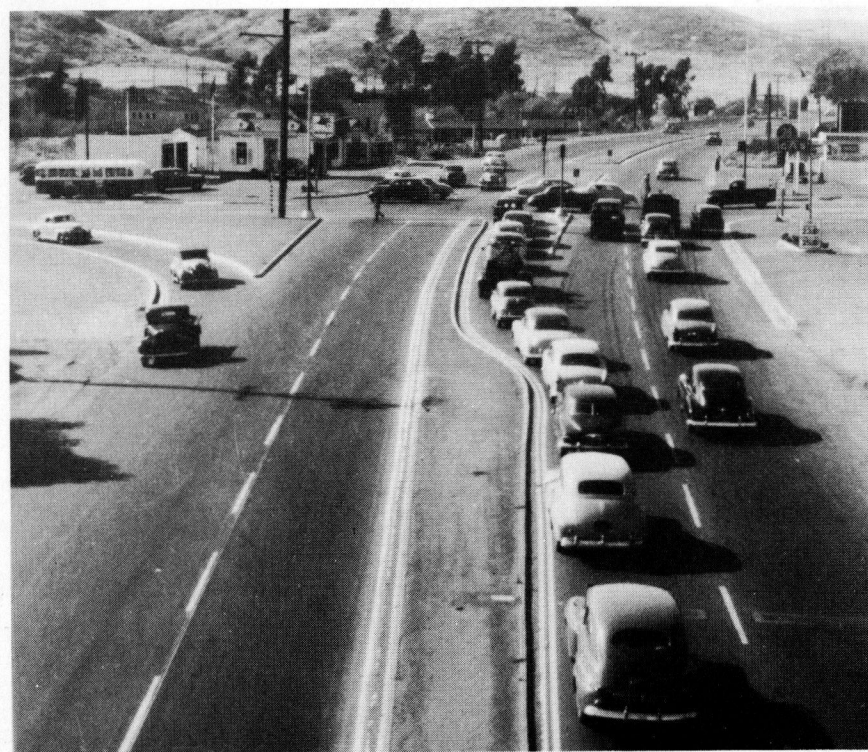
Figure 2. Intersection after channelization with details of separated left-turn lane.

1. Design Features Which Contribute to Safe Operation; to Unsafe Operation
 - a. "The left turn median lane and the 2-phase signal system with 1-phase split to accommodate left turn movement have contributed to the relatively safe operation of this intersection. On Pacific Highway in advance of the intersection are SIGNAL AHEAD signs with yellow flashing lights which operate during times the A phase change and the B phase are in effect. The 2-phase signal system does not fully protect vehicles making left turns from Pacific to Balboa."

1. D. W. LOUTZENHEISER - The layout and traffic control revision rate a "well done." The dimensional treatment, curbed islands, plant-mix roll, bullet-nose median, together with the four-corner plus suspended signal installation, signs and markings are good examples of intersection modernization.
The length of the median lane is deficient during the afternoon peak periods; see photos and notes. The indicated ratio of left versus through traffic favors lengthening the lane. With additional pavement marking the indicated concern regarding through movements within the median lane does not seem in order.
The approach speeds on Pacific Highway are surprisingly high and may account for the continuing accident experience. The split-phase signal control for left-turn movements is considered appropriate for the volume pattern, but it is inconsistent with a high approach speed condition. While signal-phase is not fully explained it appears that further adjustment either in it or in the approach speeds would be in order to reduce left-turn accidents.

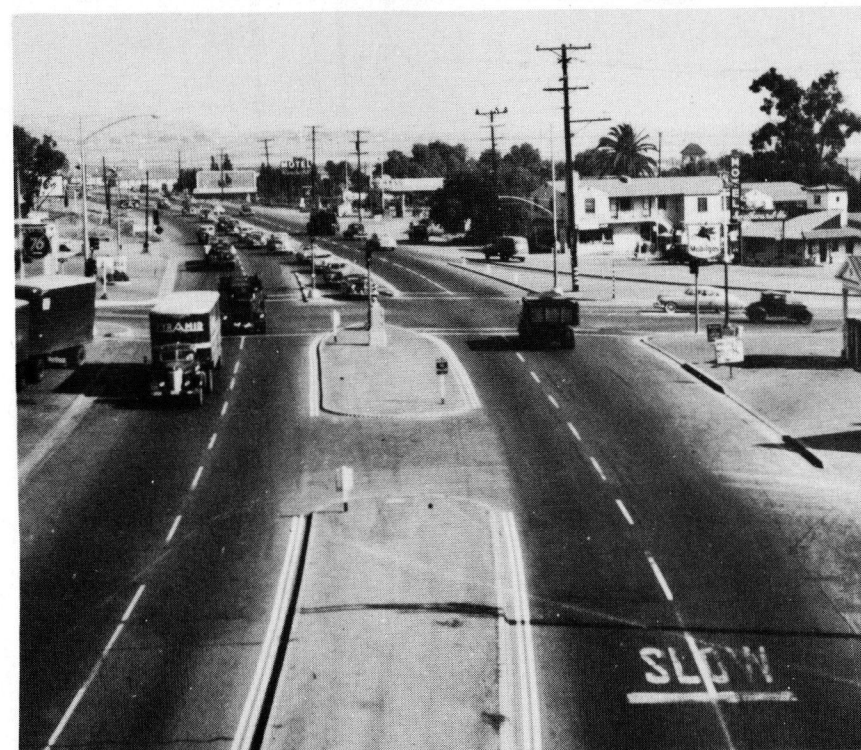
Figure 3. Double line next to reflecting curb improves visibility of median curbs.

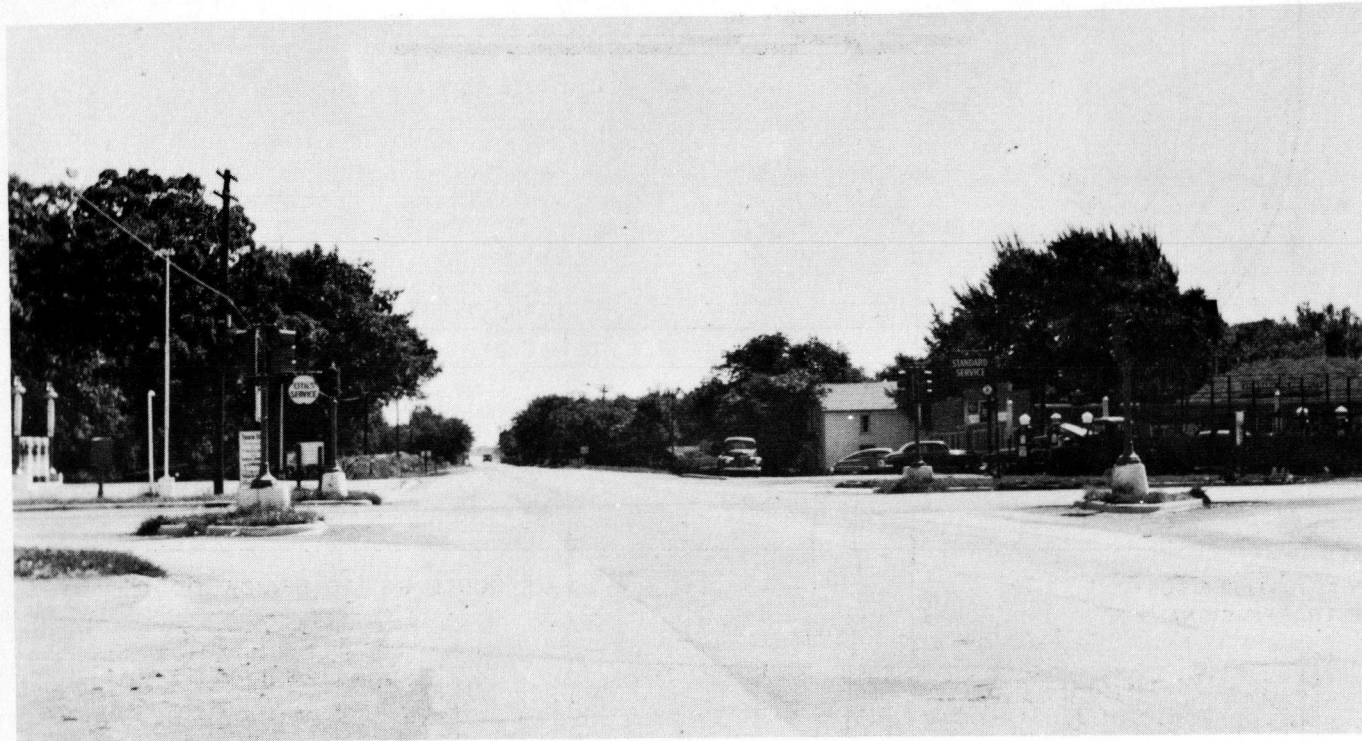
Figure 1. Channelization of 4-way right-angled intersection of US 52 and US 66, Illinois District 1.

- a. The construction of a narrow (12 in.) mountable separator along the center line of approaching roadways and extending away from the intersection for a distance of approximately 150 ft. These separators would discourage left turns into the separated right turn lanes which are reported to occur at the intersection.
- b. The surfacing of the islands with asphalt or concrete. The maintenance of planting on the small islands in this example is not practical.

2. JAMES L. SHOTWELL - The reconstruction of this intersection provided separate lanes

for right turning vehicles which should increase the capacity and safety of the intersection.

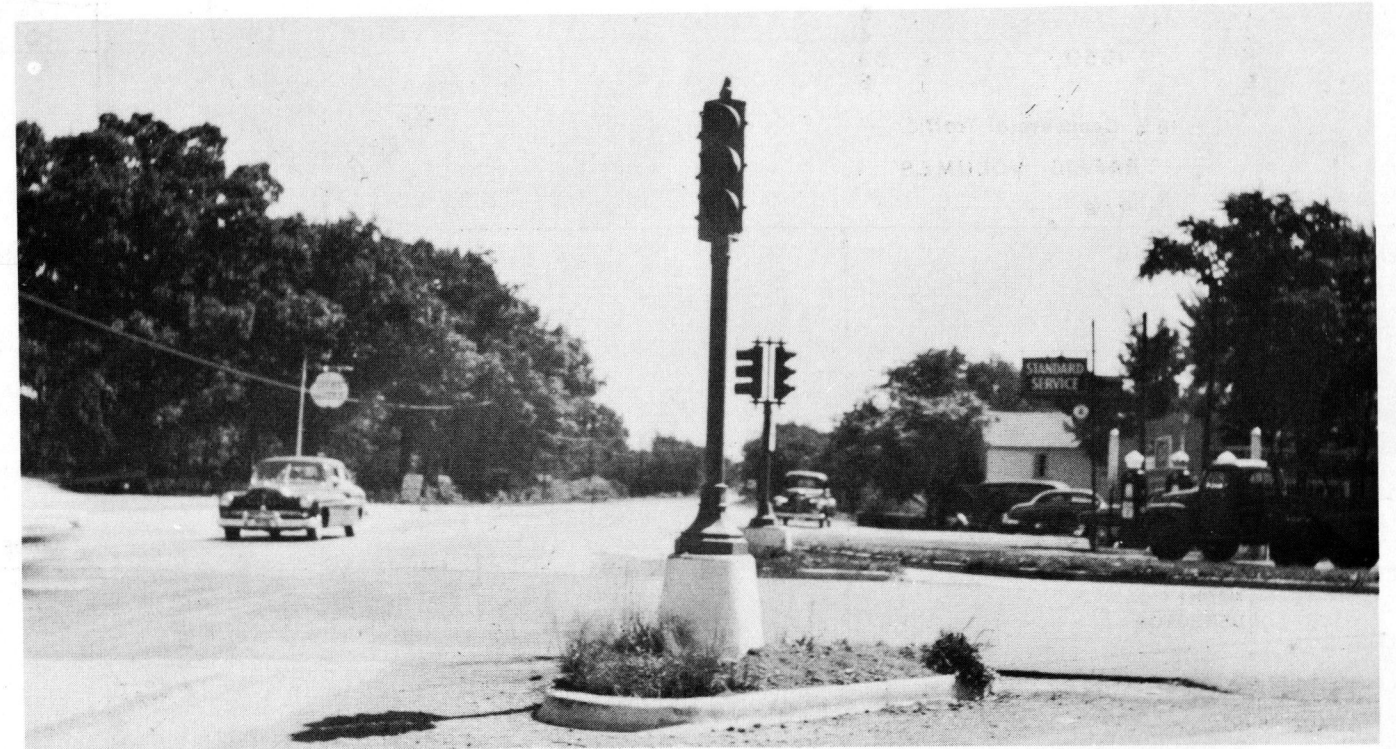
Figure 2. Channelizing island at southwest corner of intersection. Note that the maintenance of planting on small channelizing islands is not practical.

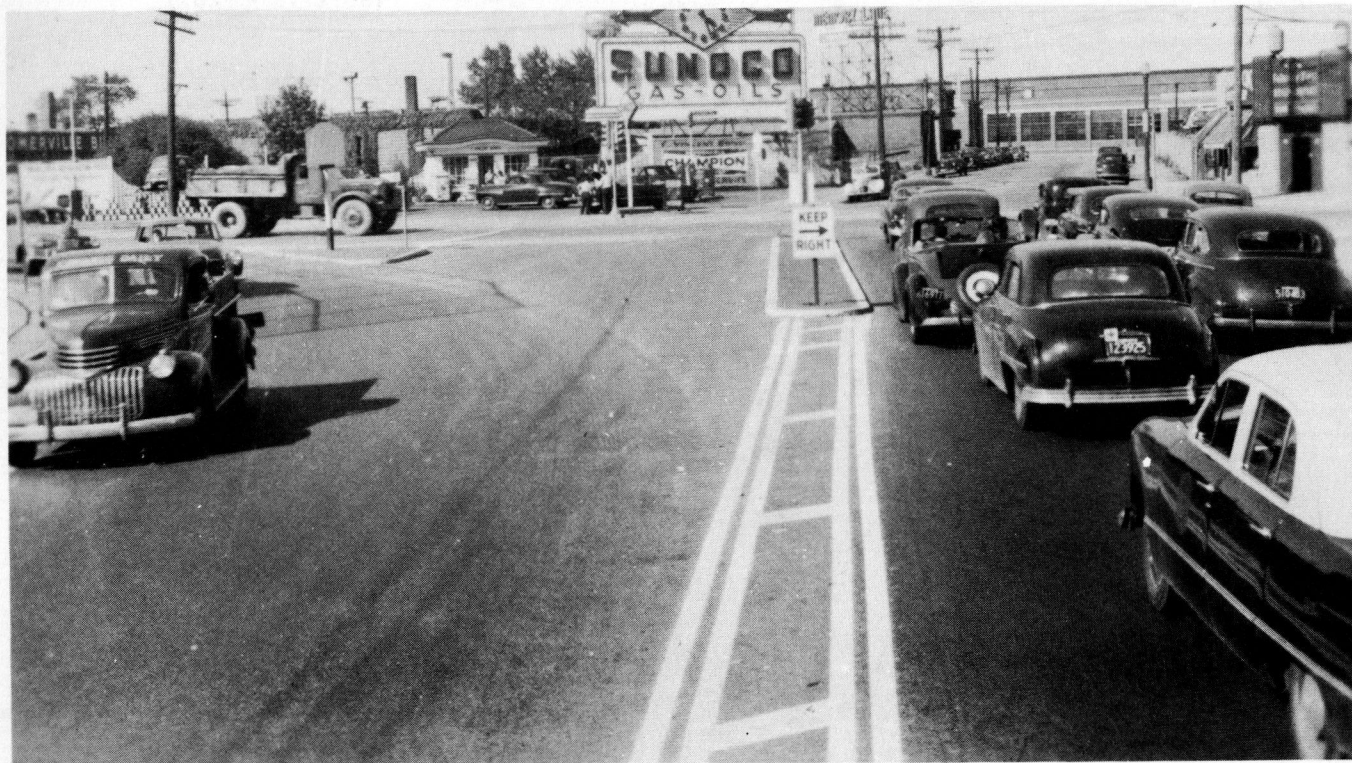
Figure 1. View of intersection of Northern Artery and Mystic Cross Avenue, Somerville, Massachusetts, after channelization showing median and triangular islands added to channelize open area at a four-way crossing under traffic-signal control.

1. NORMAN KENNEDY - This channelization has apparently been successful in reducing the area of conflict. Perhaps its major contribution to the decrease in the number and cost of accidents has been in its provision of locations for traffic control devices, particularly signals.
2. D. W. LOUTZENHEISER - The addition of the two islands and described marking, signing, and traffic signal controls all rate a "well done." The proximity of the one-way Fellsway East roadway complicates the situation, especially the trolley tracks crossing at an acute angle. It appears that much of movement 'D' must swing right to become movement 'M' into Fellsway East. It is not evident how the southbound streetcar movements are controlled to avoid interruptions to the NW flow. A surprisingly high peak-hour flow is handled by this rather confined intersection area.

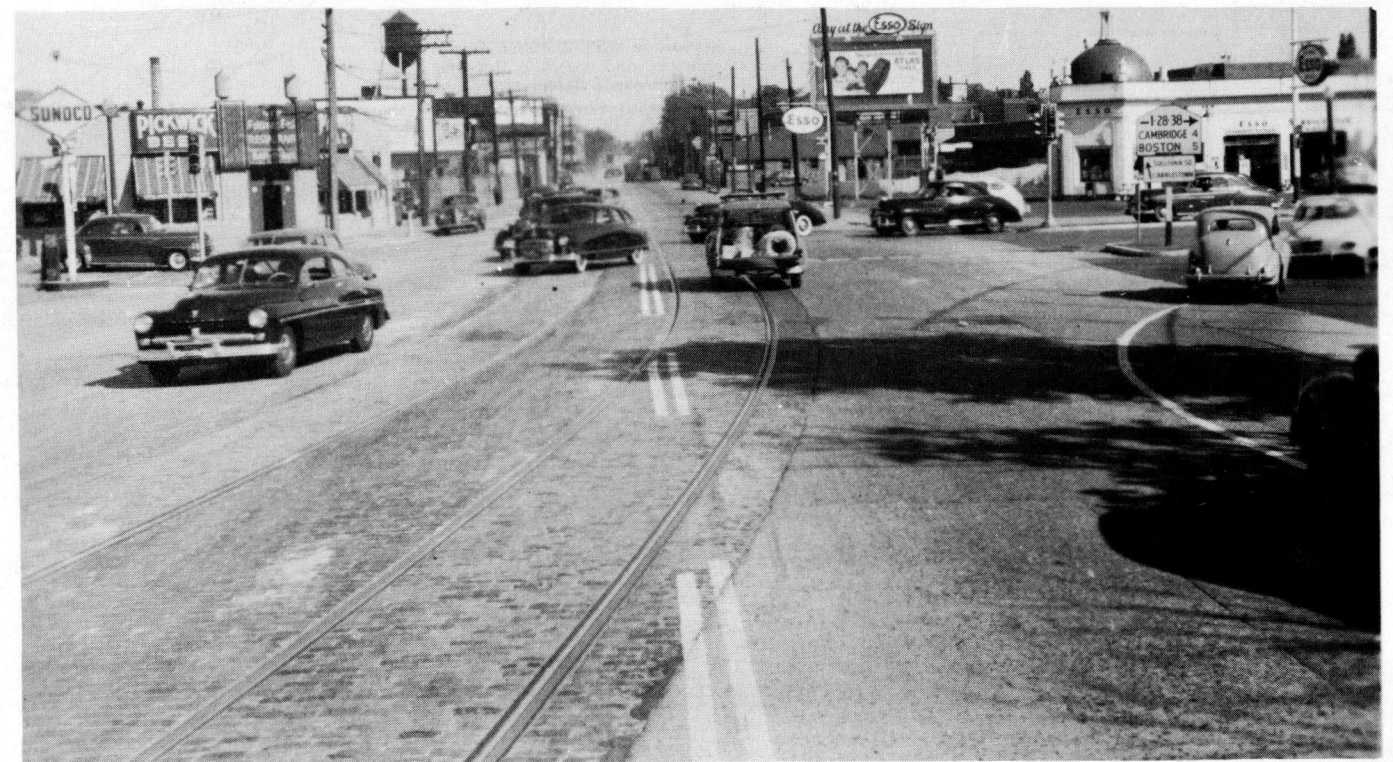
Figure 2. View along Mystic Cross Avenue showing channelizing islands at right in the photograph.

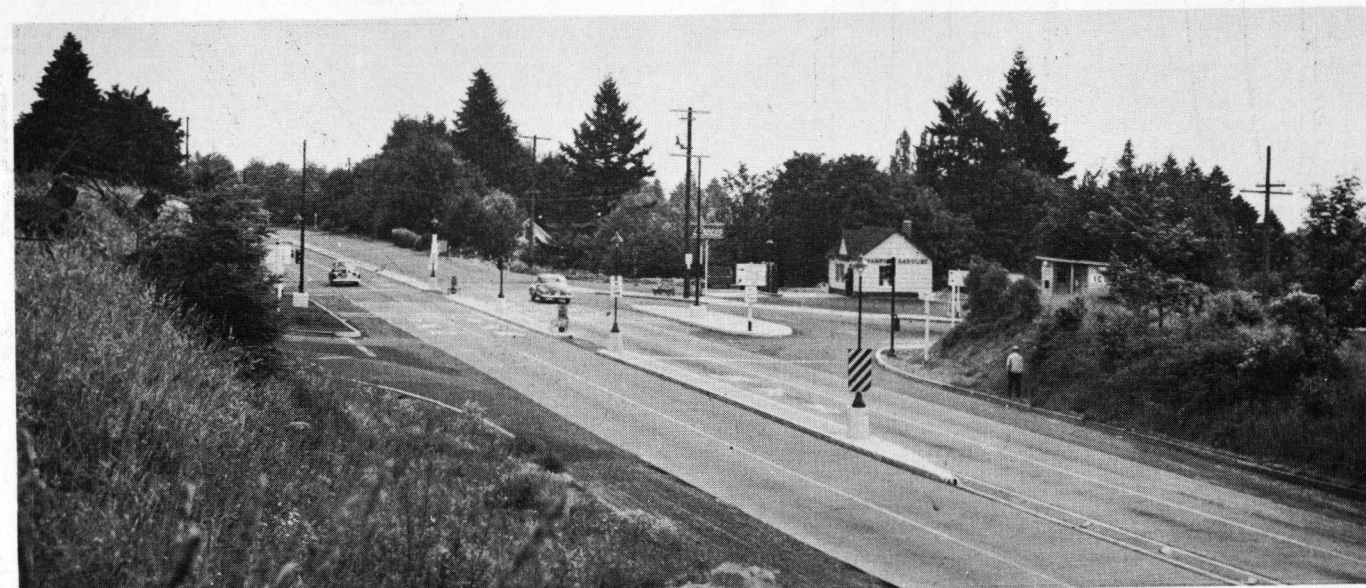
Figure 2. Split-circle treatment of main and secondary highway in which through traffic continues directly and left turns from main highway and cross traffic are deflected to right around islands. Satisfactory results are reported.

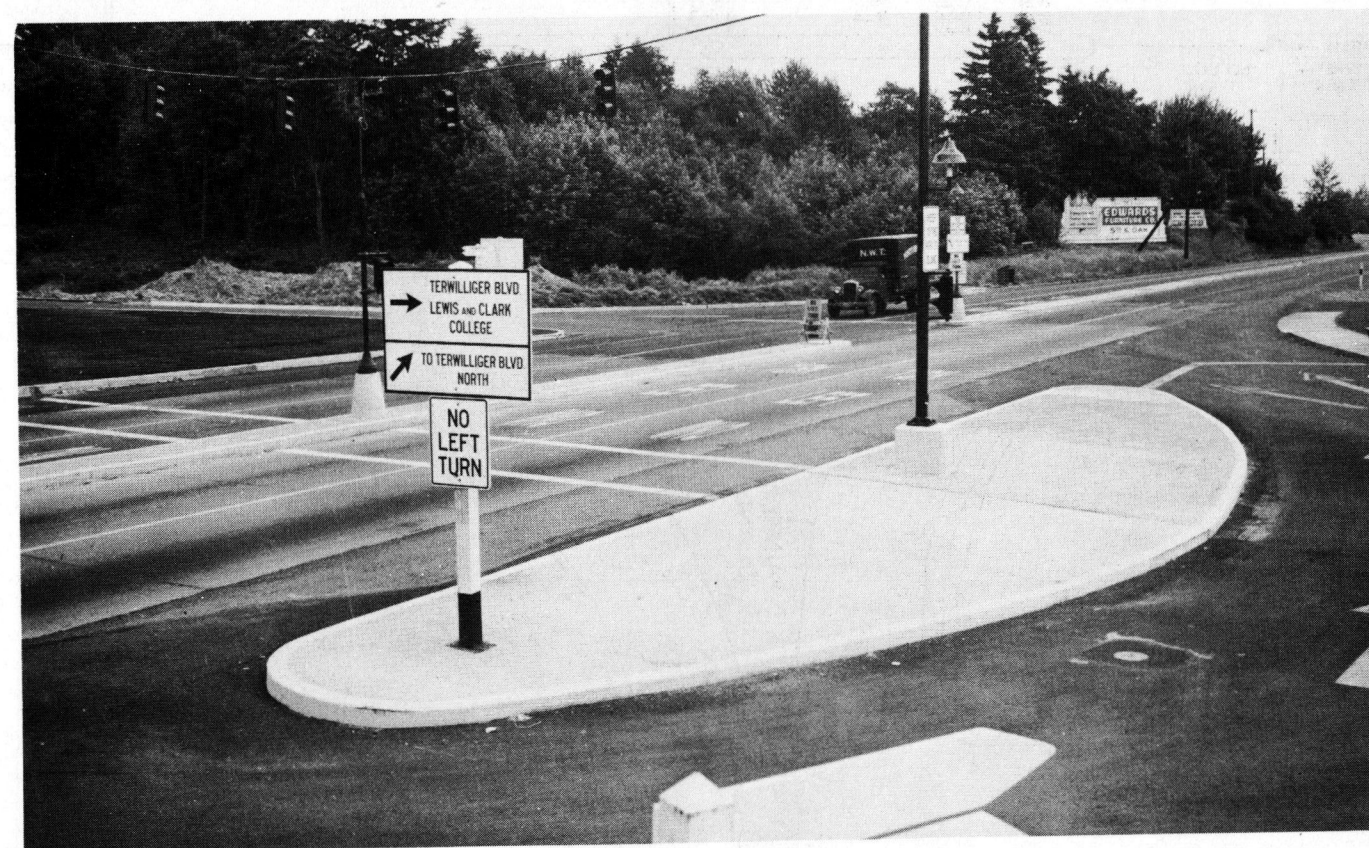
Figure 3. Details of channelizing island and traffic-control devices.

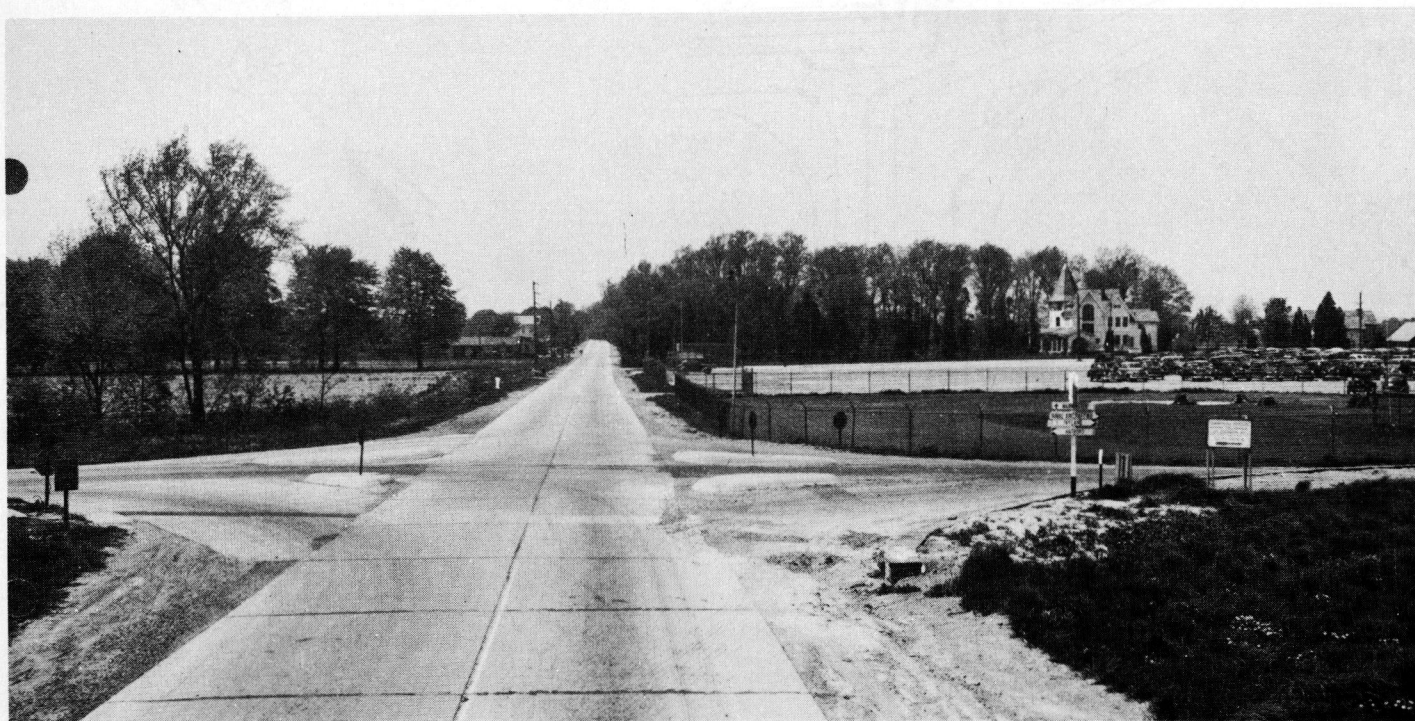
Figure 1. Channelized intersection of Street Road and Jacksonville Road, Bucks County, Pennsylvania. Channelization does not control left turns. Right-turn movements are restricted by short radii and narrow channel widths.

radii should stay at least what they are and as is obvious from Photograph No. 1, tapers must be added on all four legs. I am enclosing a print showing the standard county road connection for two-lane highways in California (Fig. 2), which is used for very low traffic volumes on the entering road. It will be noted that considerably more room is allowed for turns than this channelization example would give, even with the islands removed.

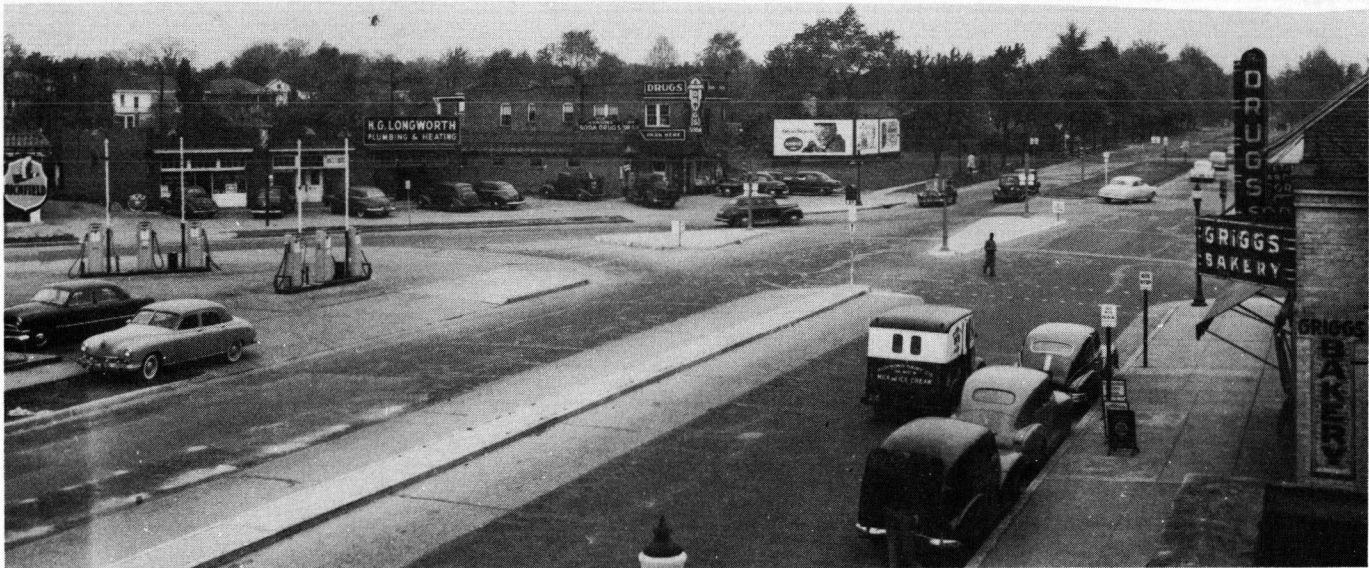
Figure 1. Channelized intersection of Chamberlayne Avenue (US 1), Lombardy Street, and Lancaster Road in Richmond, Virginia.

- 1. NORMAN KENNEDY - The two islands added to this intersection serve two functions: (1) to reduce the area of conflict and (2) to provide locations for the installation of traffic signals. Pedestrian movement through A intersection should be safer. (It is noticed that the photograph shows a "jaywalker".)

- 2. EUGENE MAIER - The value of the channelizing islands introduced into the Chamberlayne-Lombardy-Lancaster intersection appears to be in the reduction of the unnecessarily large paved area, the prohibition of northbound traffic on Chamberlayne turning left into Lombardy, and to provide for locations for the installation of traffic signal controls.
The establishment of the one-way regulation on Lancaster Road, the prohibition of left turns from Chamberlayne to Lombardy, the channelizing of traffic movements by means of the islands within the intersection, and the traffic control signals all contribute to the elimination of major conflicts and promote orderly traffic movements through the intersectional area.

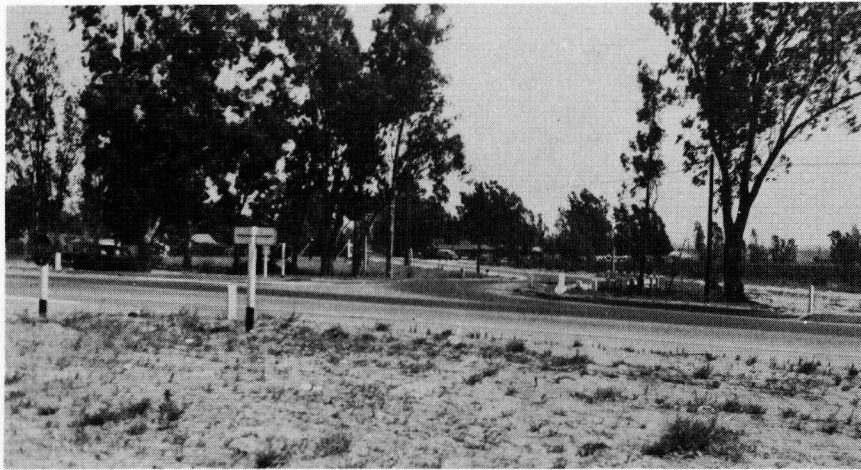
Figure 1. Intersection of Mission Boulevard, Bain Street, US 60, and California 19 before channelization.

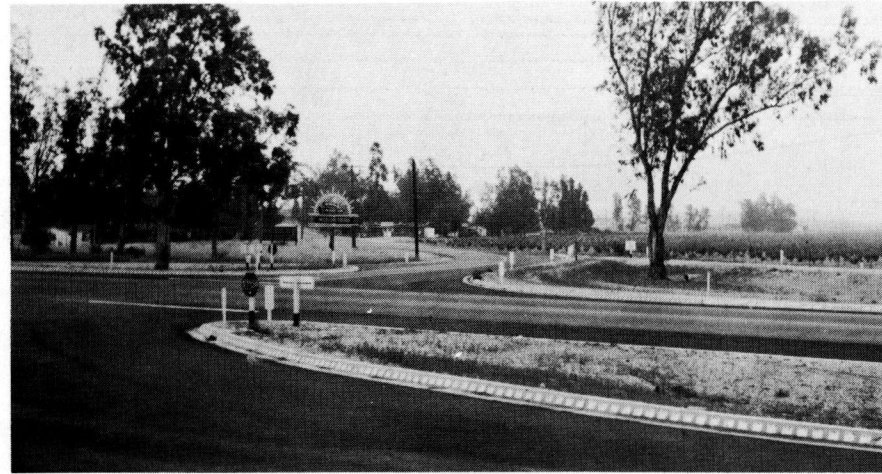
Figure 2. Northbound approach of Mission Boulevard to State Route 19 at Bain Street.

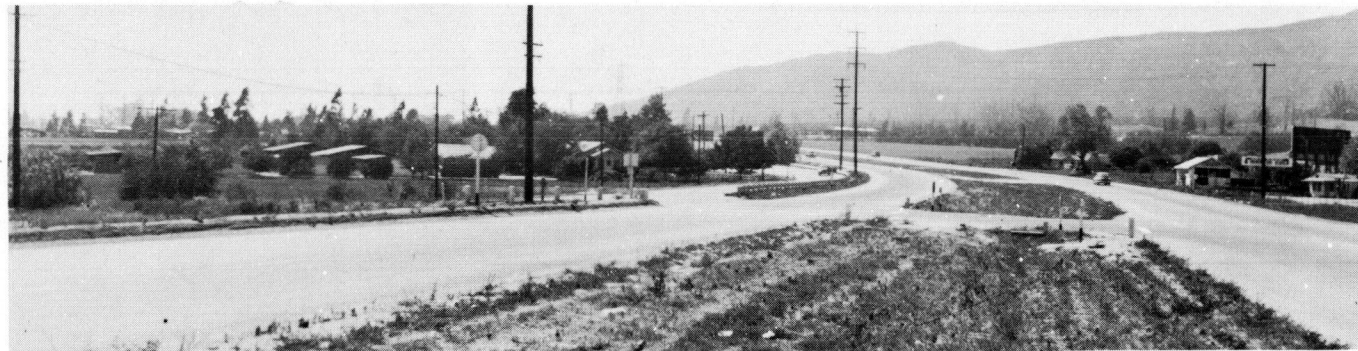
Figure 1. Intersection of Mission Boulevard, Valley Way, US 60, and California 19 before reconstruction.

parallel to and approximately 23 ft. south of Route 19 westerly from the intersection. It was difficult for eastbound traffic on Route 19 to make the U-turn and proceed westerly on the old Mission Boulevard. Since this movement was often made by school buses, criticism of the intersection was severe. Other movements involving traffic on the south leg were less difficult, but the design features were below the standard for which the highway was constructed.

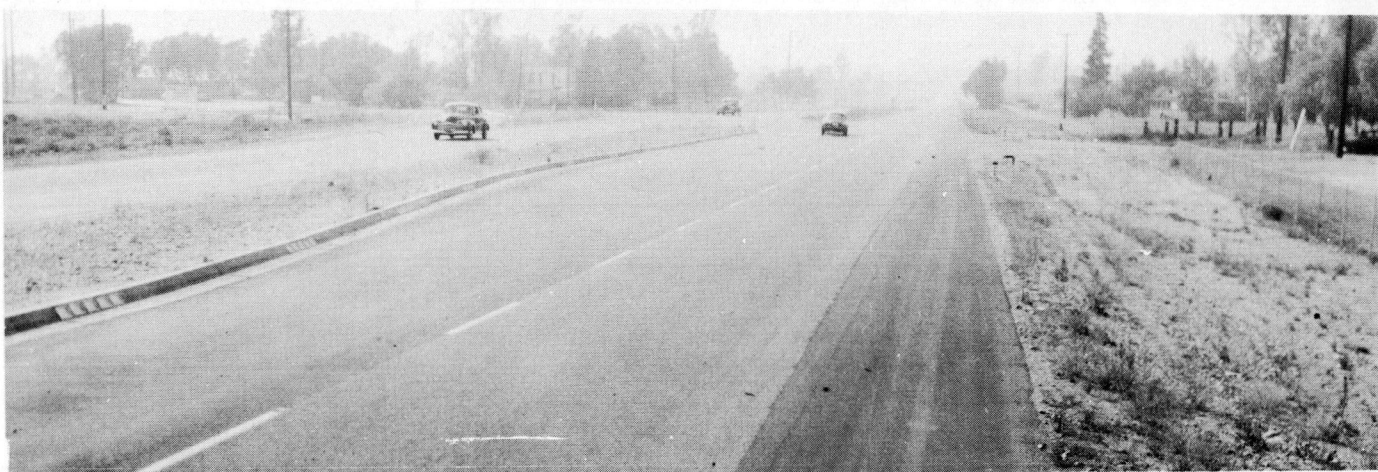
Figure 2. Looking north on US 190, showing the deceleration area and the added left-turn lane

1. GUY KELCEY - The channelization shown appears to be as satisfactory as possible for this acute angle intersection. It would have been better if, in the redesign of the route, the secondary roadway could have been brought across Route 190 at a right angle.
2. EUGENE MAIER - The intersection of California 190 and 3rd Street is an excellent example of channelization of a 4-way oblique rural highway intersection. Outstanding features of the design include: (a) Free-flowing separated right-turn lanes with adequate accelerating areas; (b) Added left-turn lanes with adequate decelerating areas for vehicles turning left from the major roadway. An alternate design would be separated left turn lanes as used at the intersection in Example 1; (c) Good treatment of the approach ends of channelizing islands; (d) Funneling of separated turning lanes.

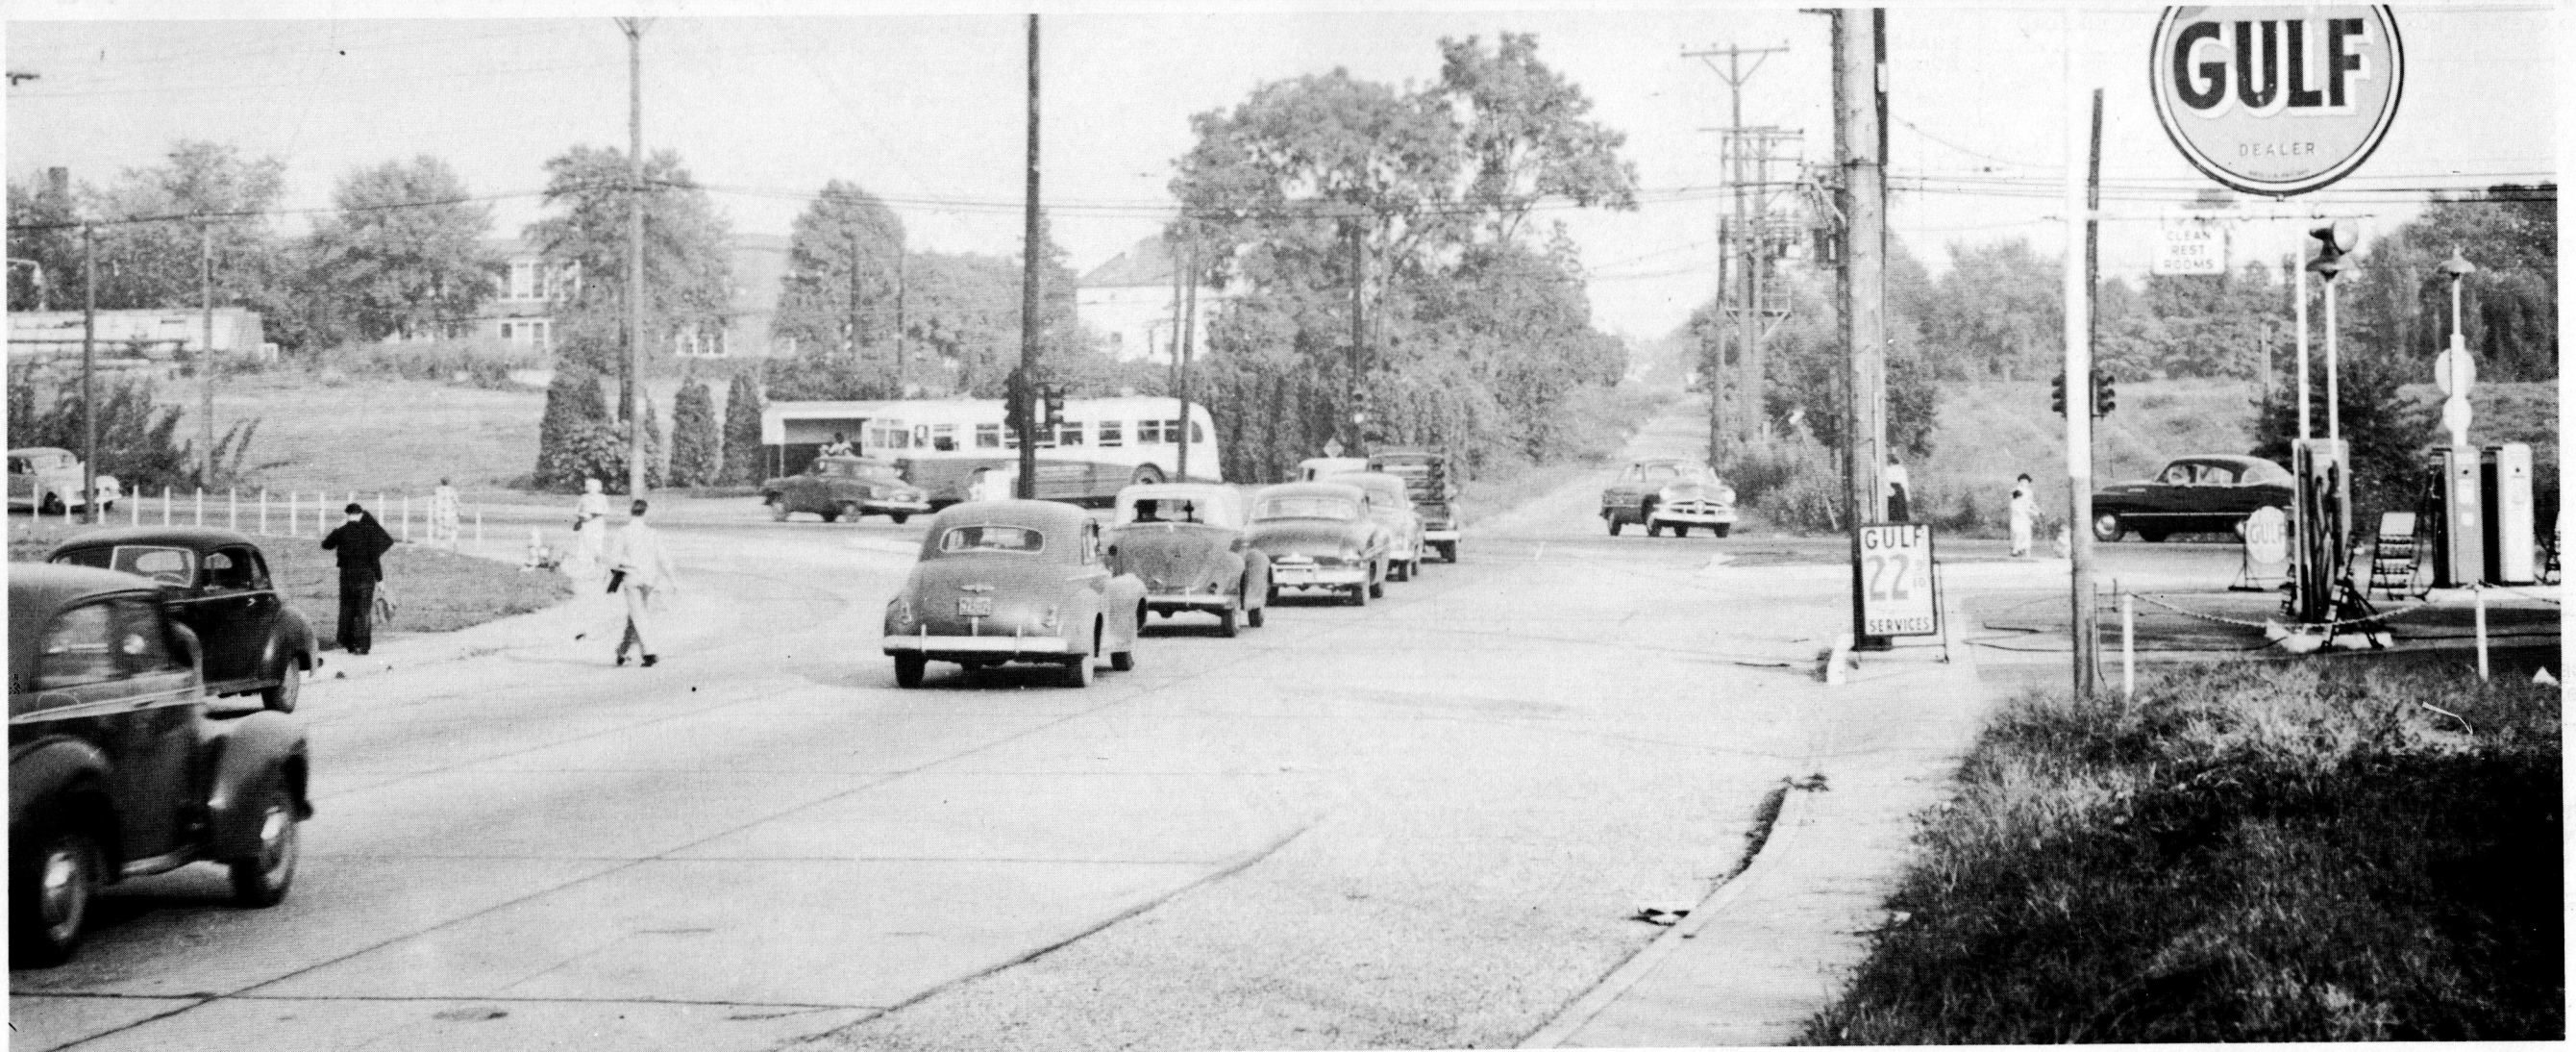
Figure 1. Channelized intersection of Maryland Avenue, Boxwood Road, and Middleborough Road. Note the pedestrian barrierfence at the left of the intersection.

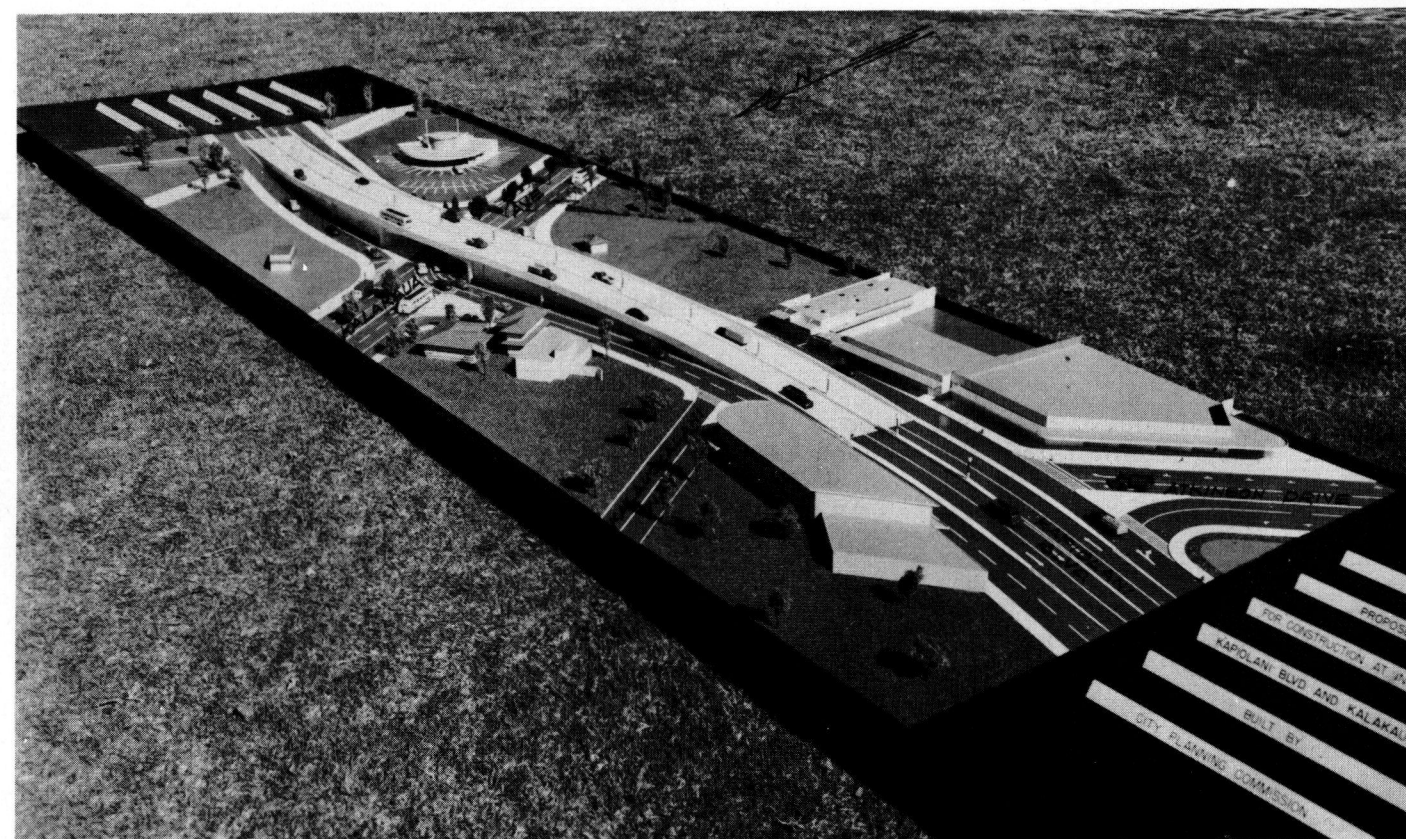
Figure 2. Scale model of proposed redesign of Kapiolani-Kalakaua intersection.

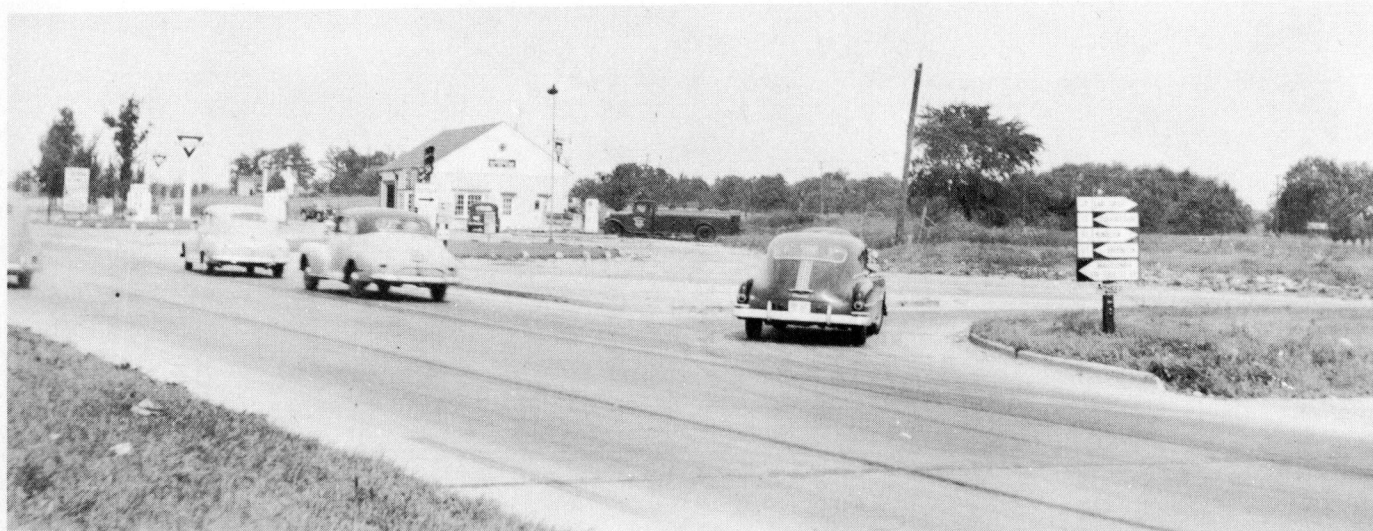
Figure 1. Channelization of acute-angle intersection of high-speed state route, US 12, and secondary highway, Illinois 12 and 22, near Lake Zurich. Right-turn islands provide better placement of signals and remove right turns from intersection.

the left-turn movements to leave the divided highway and the opposing through traffic. Median ends readily could be extended inward and by use of unsymmetrical bullet-nose design (patterned to permit left turns to enter the divided highway on a control edge radius of 50 to 60 ft.) the length of opening reduced to about half that shown. These ends would amply clear the cross road width. The outside of the triangle islands could have been made tangent, giving a better funnel effect.

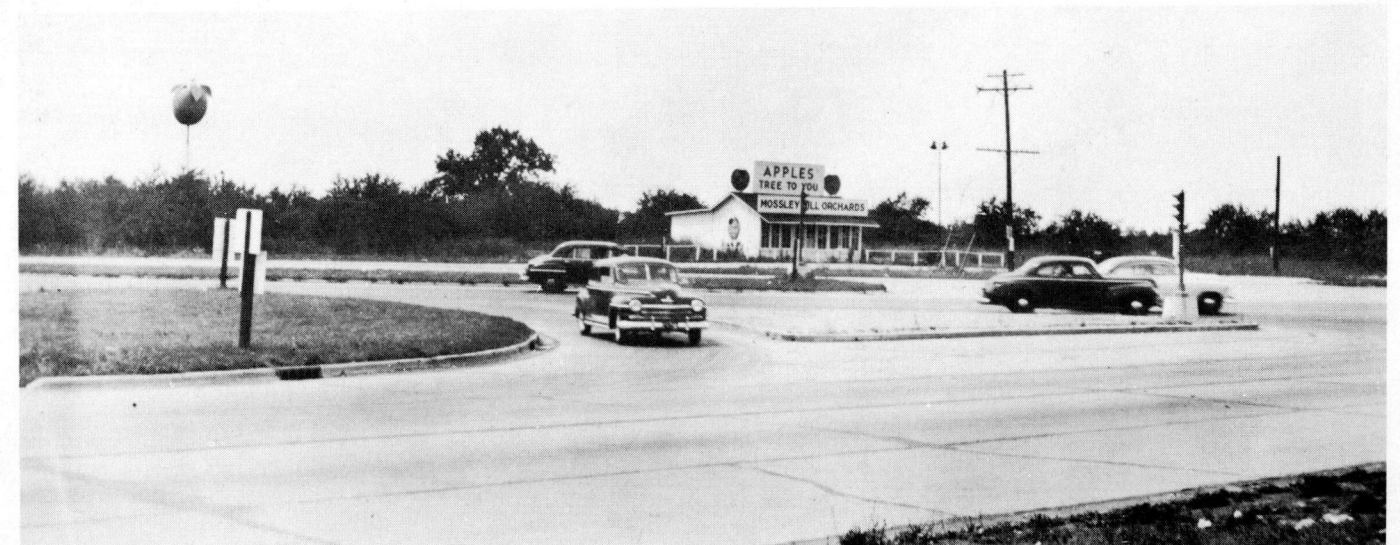
Figure 2. Close-up of south corner island, traffic signal, and curbs. Median on US 12 just beyond far vehicle.

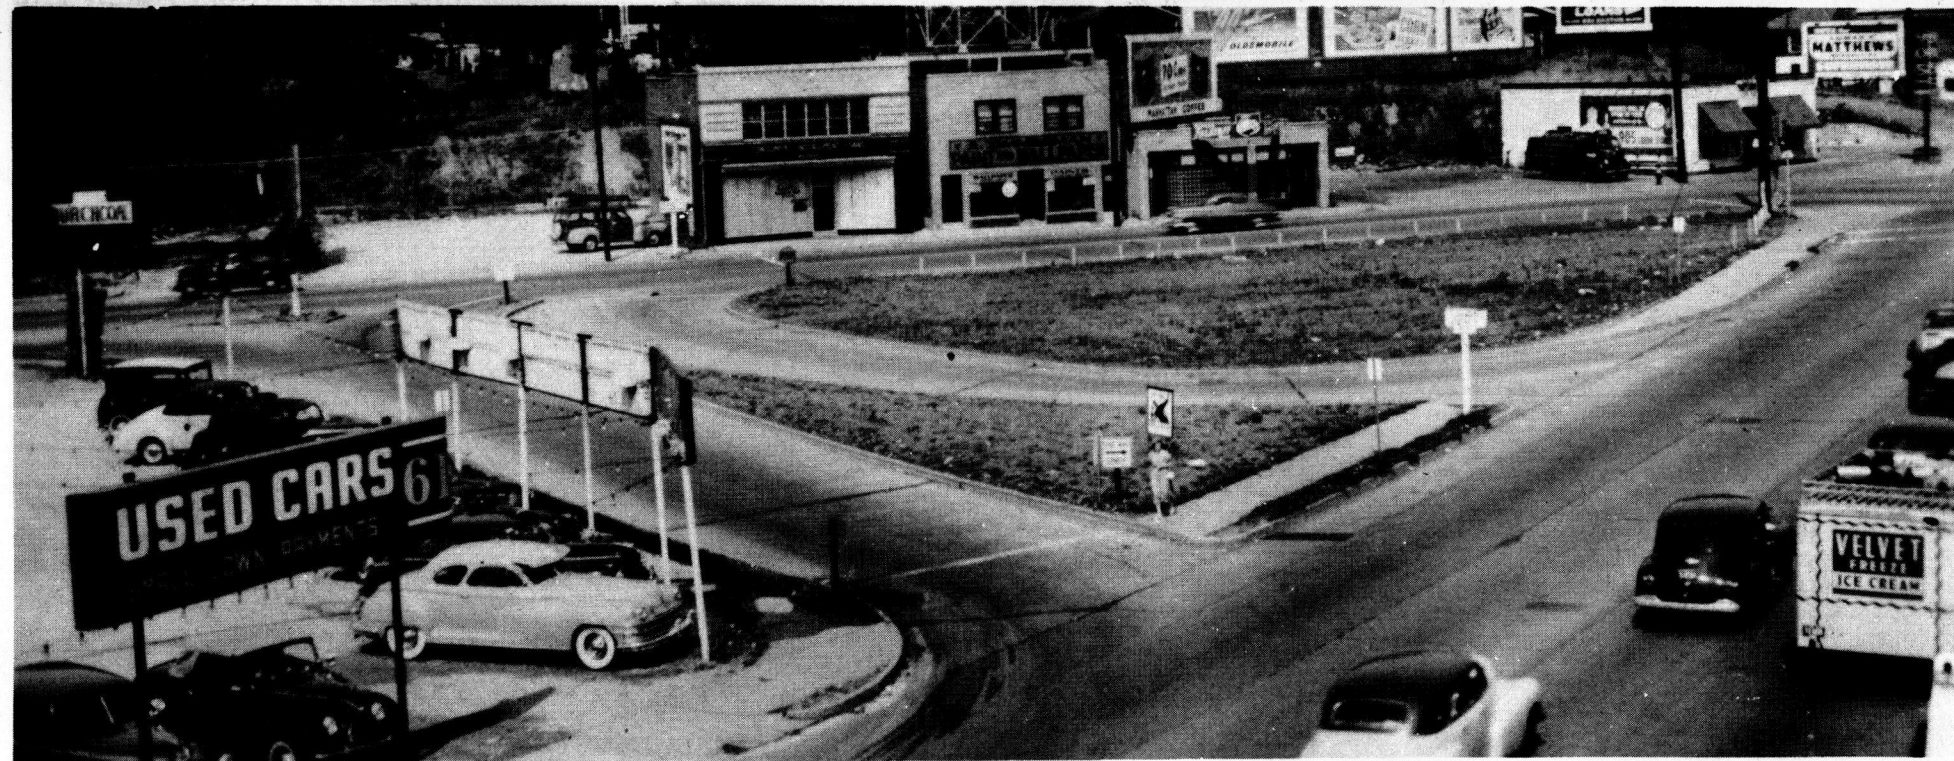
Figure 1. Channelization of intersection of Jennings Station Road, Kienlen Avenue, and Natural Bridge Road, St. Louis County, Missouri. This channelization is designed to eliminate left turns within the intersection.

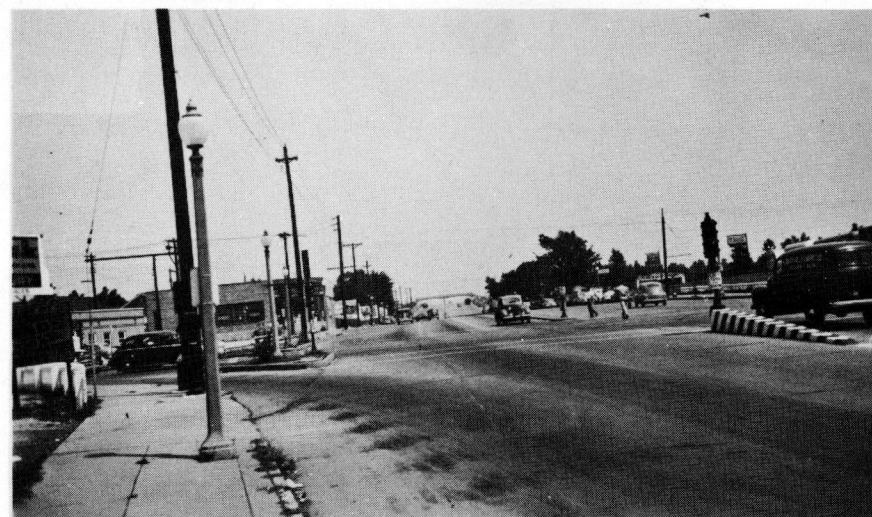
Figure 2. Channelization of Goodfellow Boulevard and Natural Bridge Road, St. Louis.

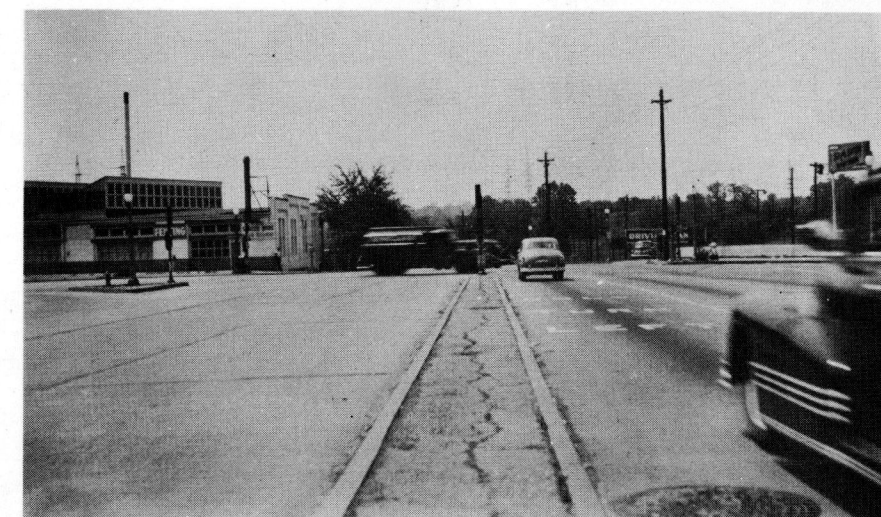
Figure 3. Looking south of Goodfellow Boulevard. The small island at the left has been used for locating a traffic-control signal, street-lighting standard, and fire hydrant.

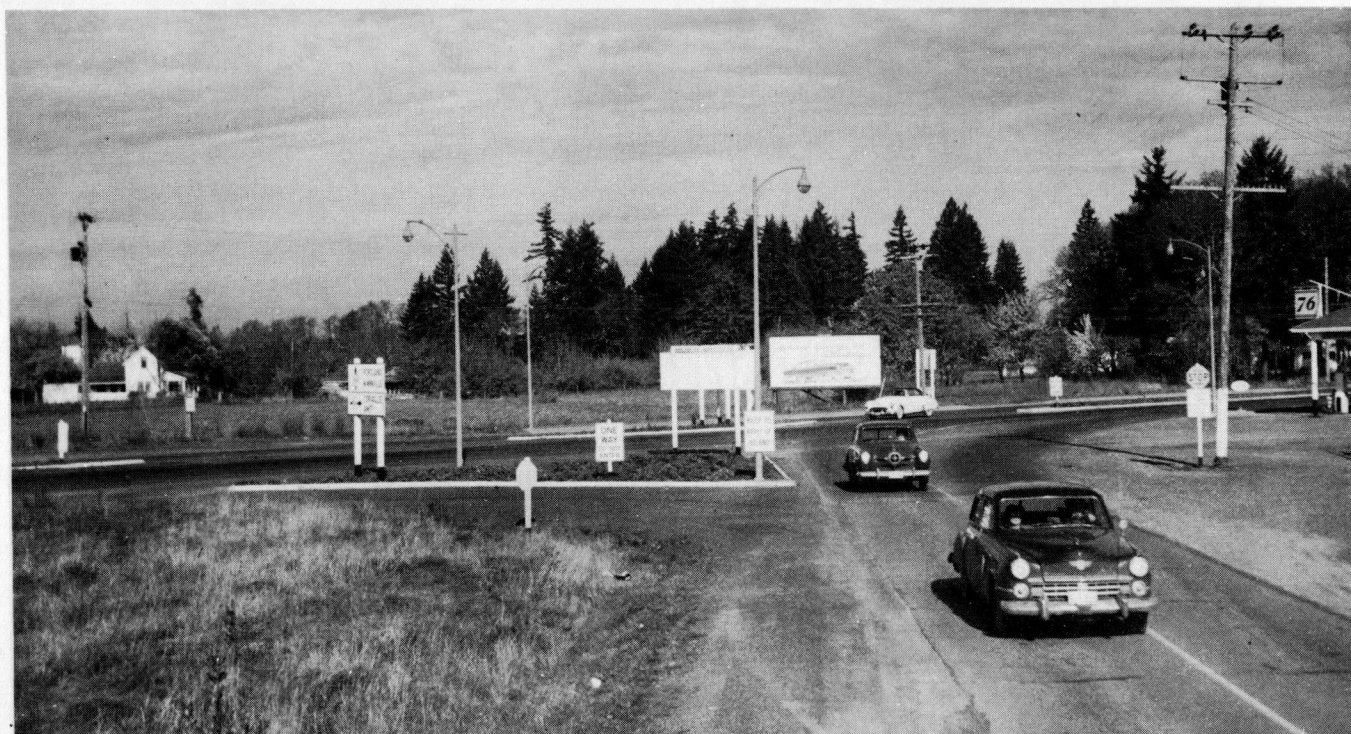
Figure 1. Channelization of four-way oblique rural intersection of US 99W and Oregon 18, near McMinnville.
