HIGHWAY RESEARCH BOARD SPECIAL REPORT 5

CHANNELIZATION

The Design of Highway Intersections at Grade

1952

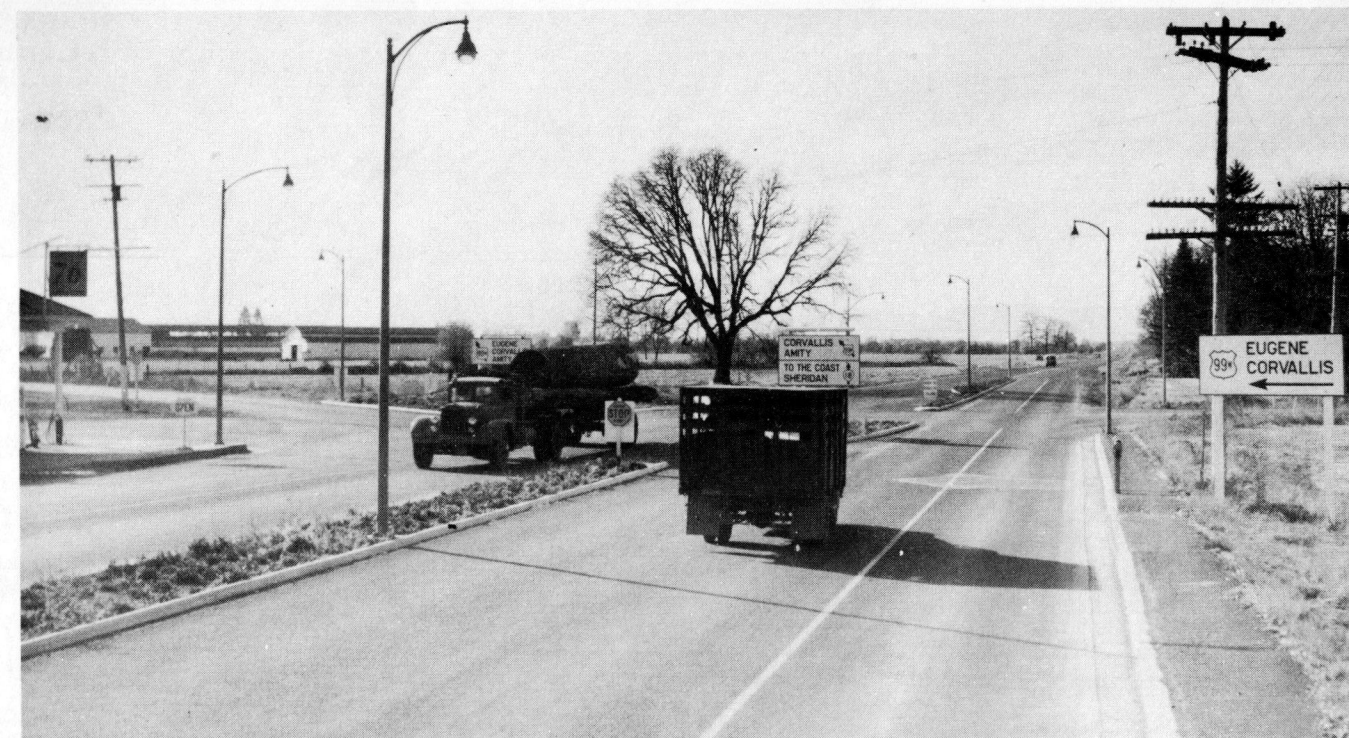
Figure 2. Looking southwest from the McMinnville leg towards Willamina. Note the modern lighting used in connection with channelization of a rural intersection.

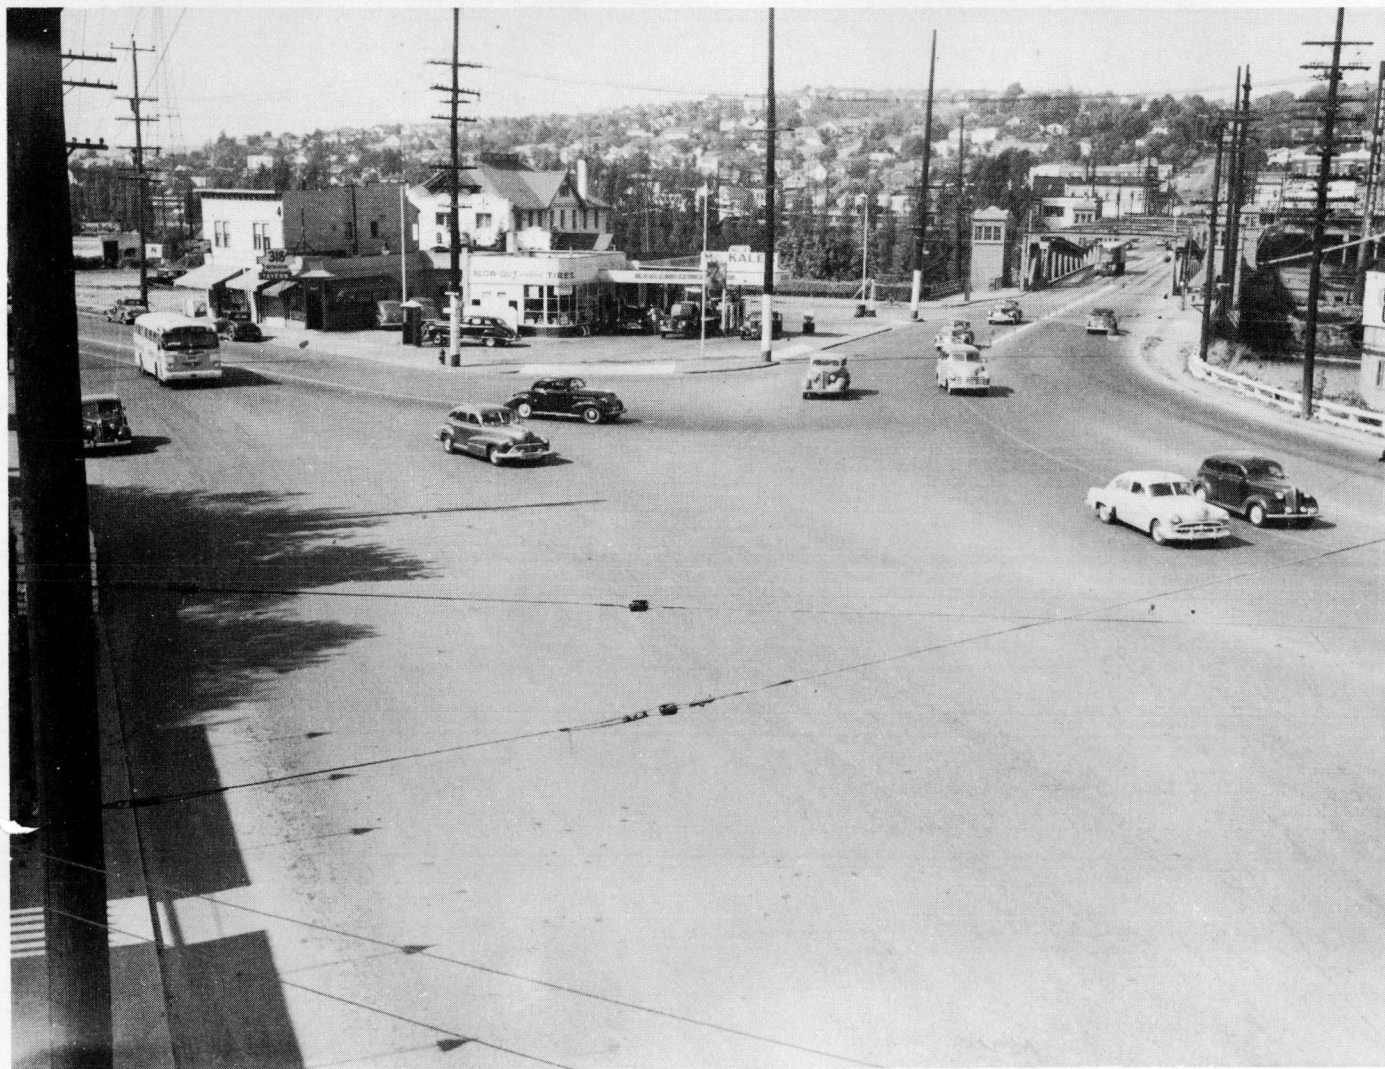
Figure 1. Intersection of 4th Avenue, N., and Nickerson Street, looking north from Dexter Avenue, Seattle, before channelization.

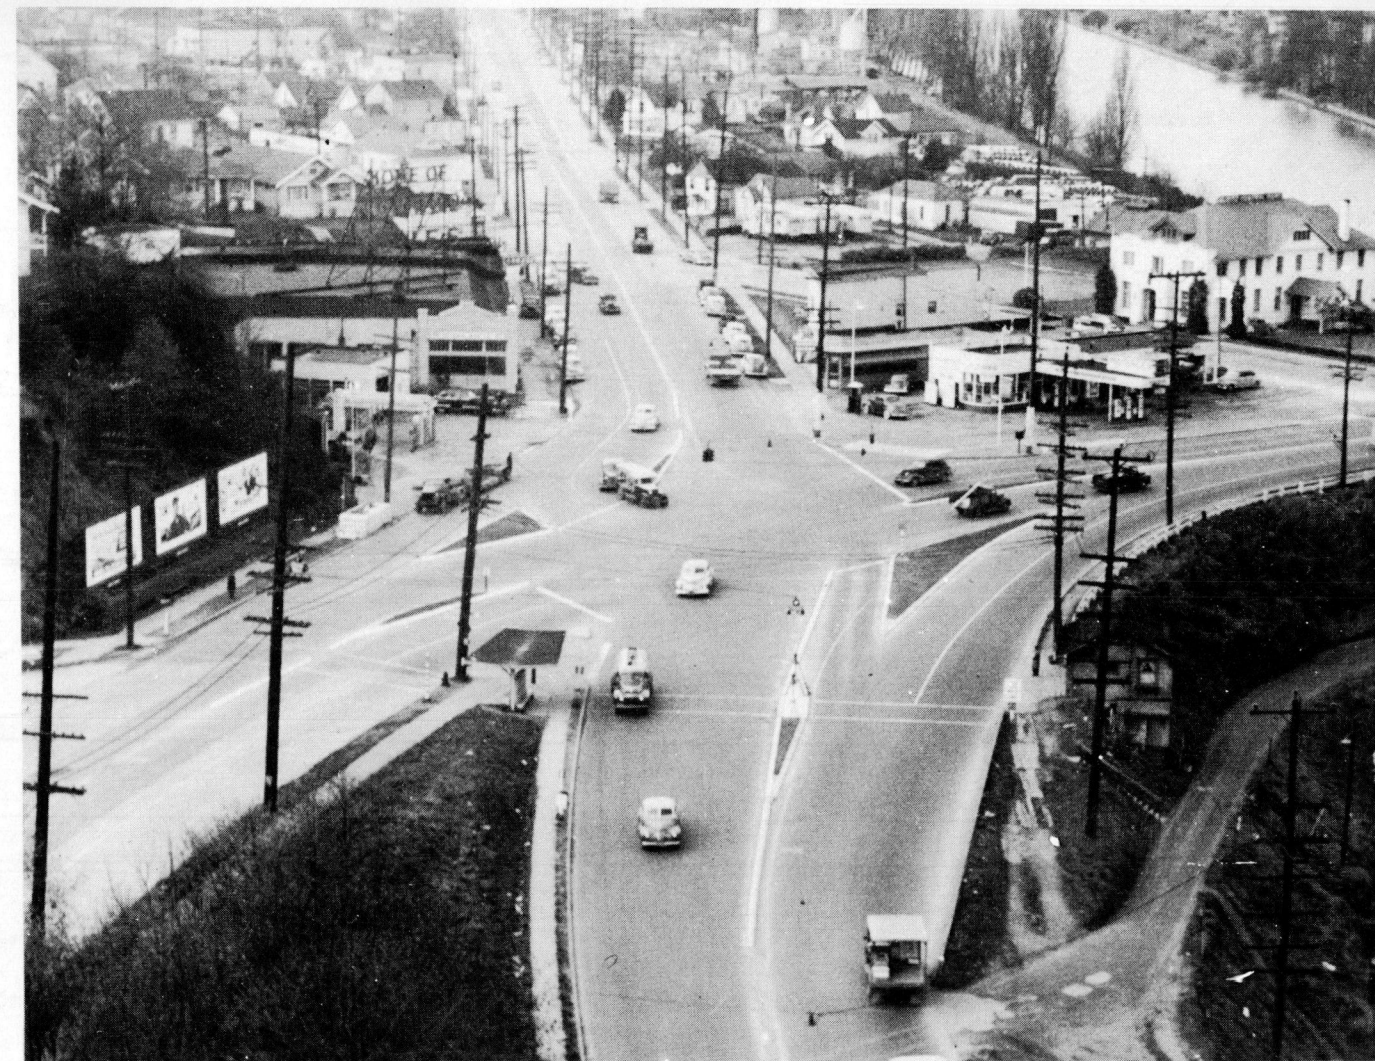
Figure 2. Intersection looking west after completion of channelizing islands and signal controls.

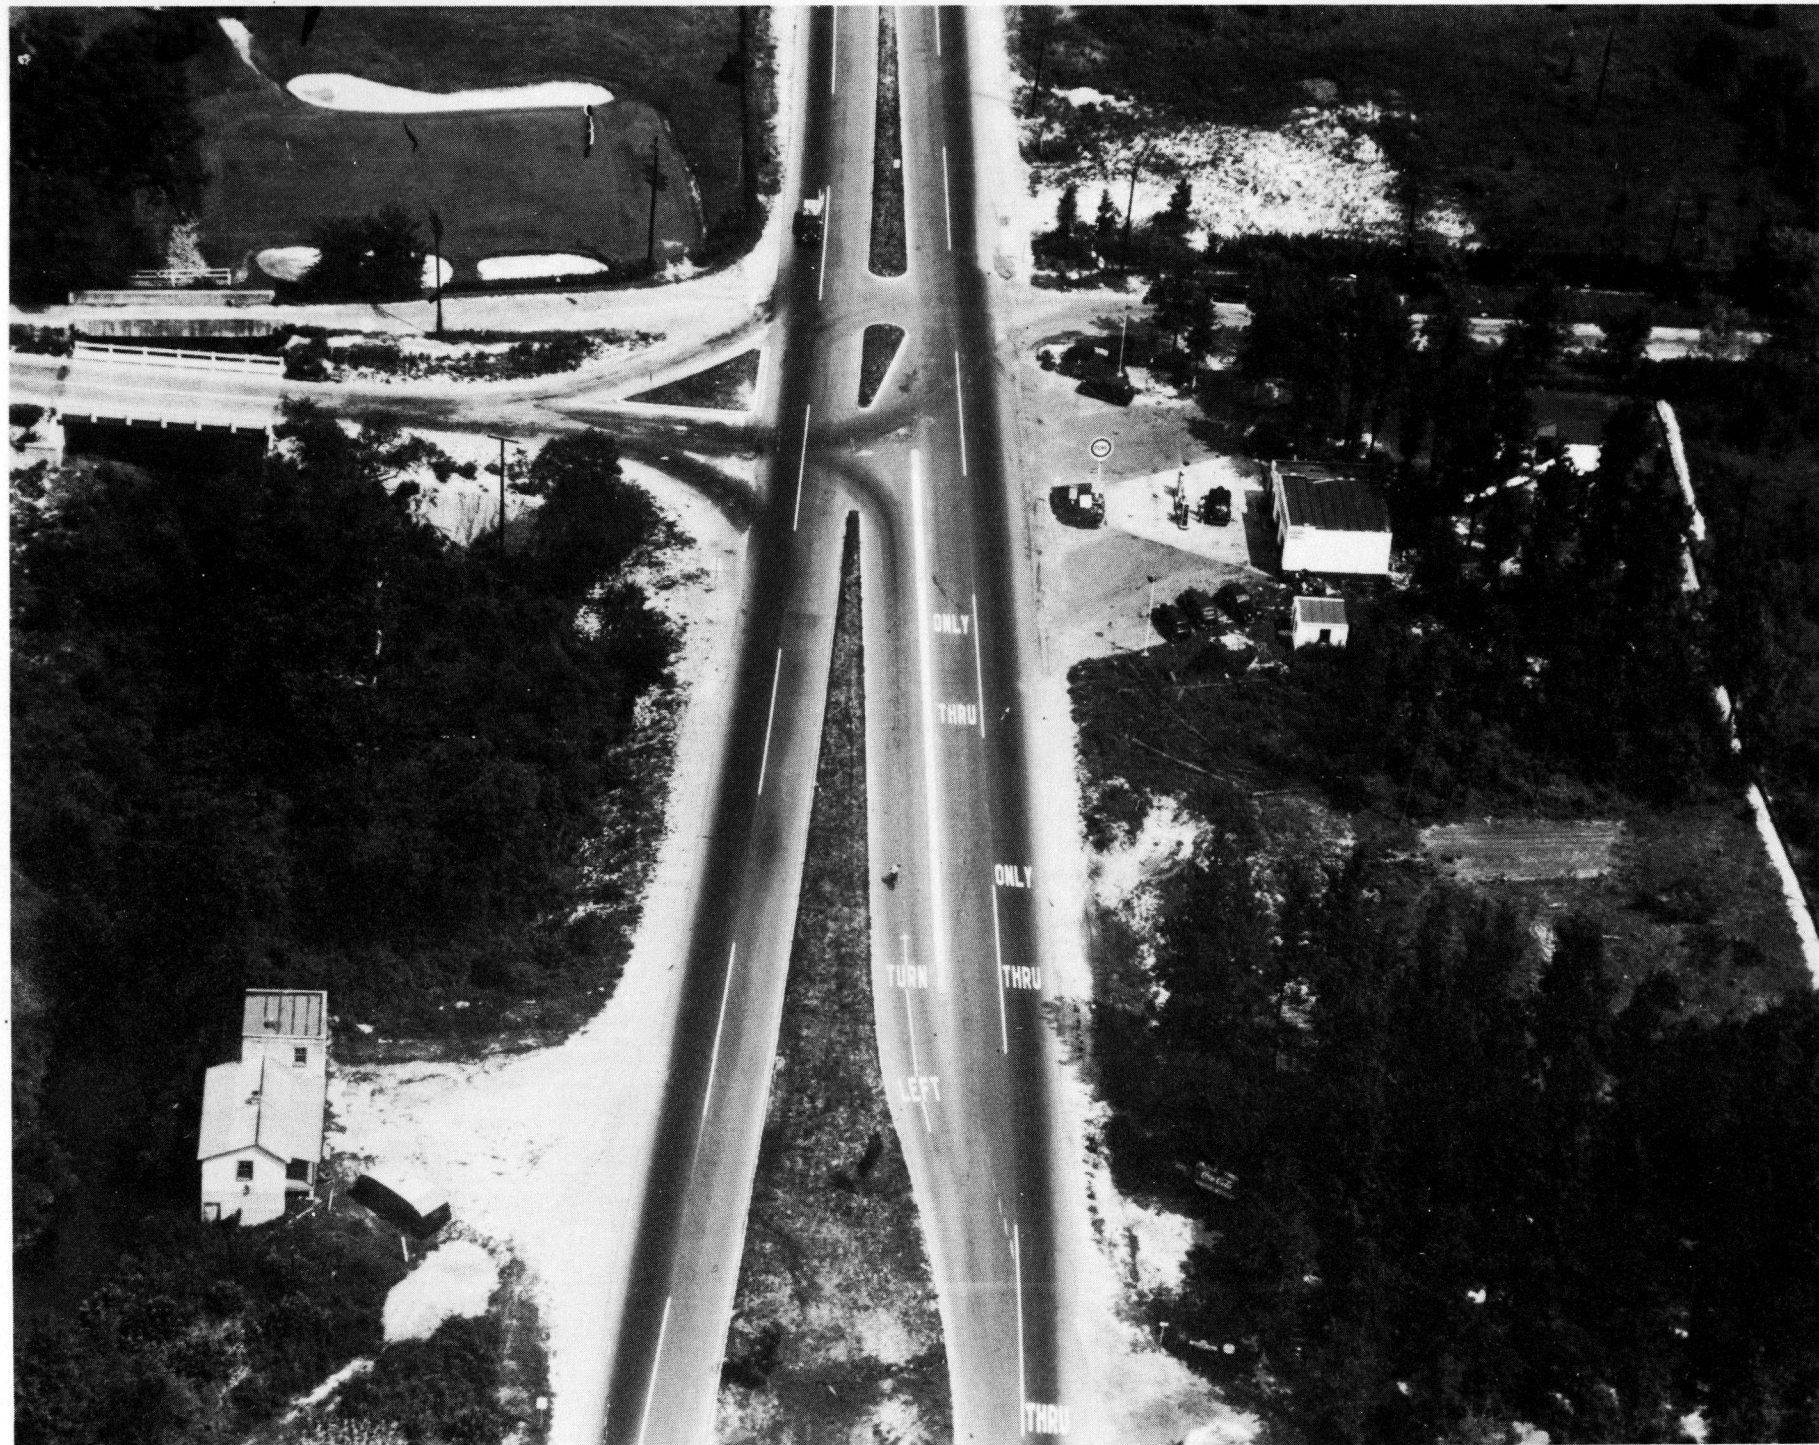
Figure 1. Four-way offset intersection of US 1 and Virginia 161 near Richmond. The wheel-track pattern shows excellent organization of traffic movements at intersection of a high-speed, heavy-volume artery with a secondary road.

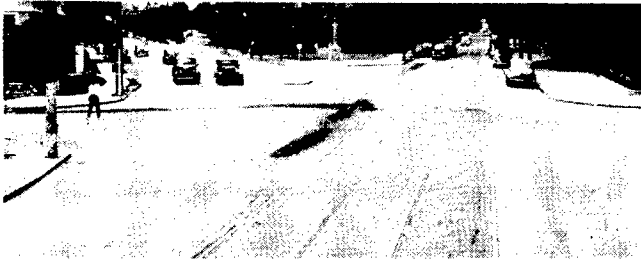
Figure 1. Intersection of Delaware Avenue, Van Buren Street, and Pennsylvania Avenue in Wilmington, Delaware.

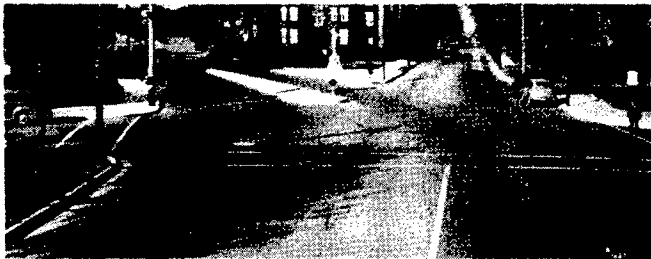
Figure 2. Intersection after channelization. Note that the pedestrian crosswalk has been cut through the median on Pennsylvania Avenue.

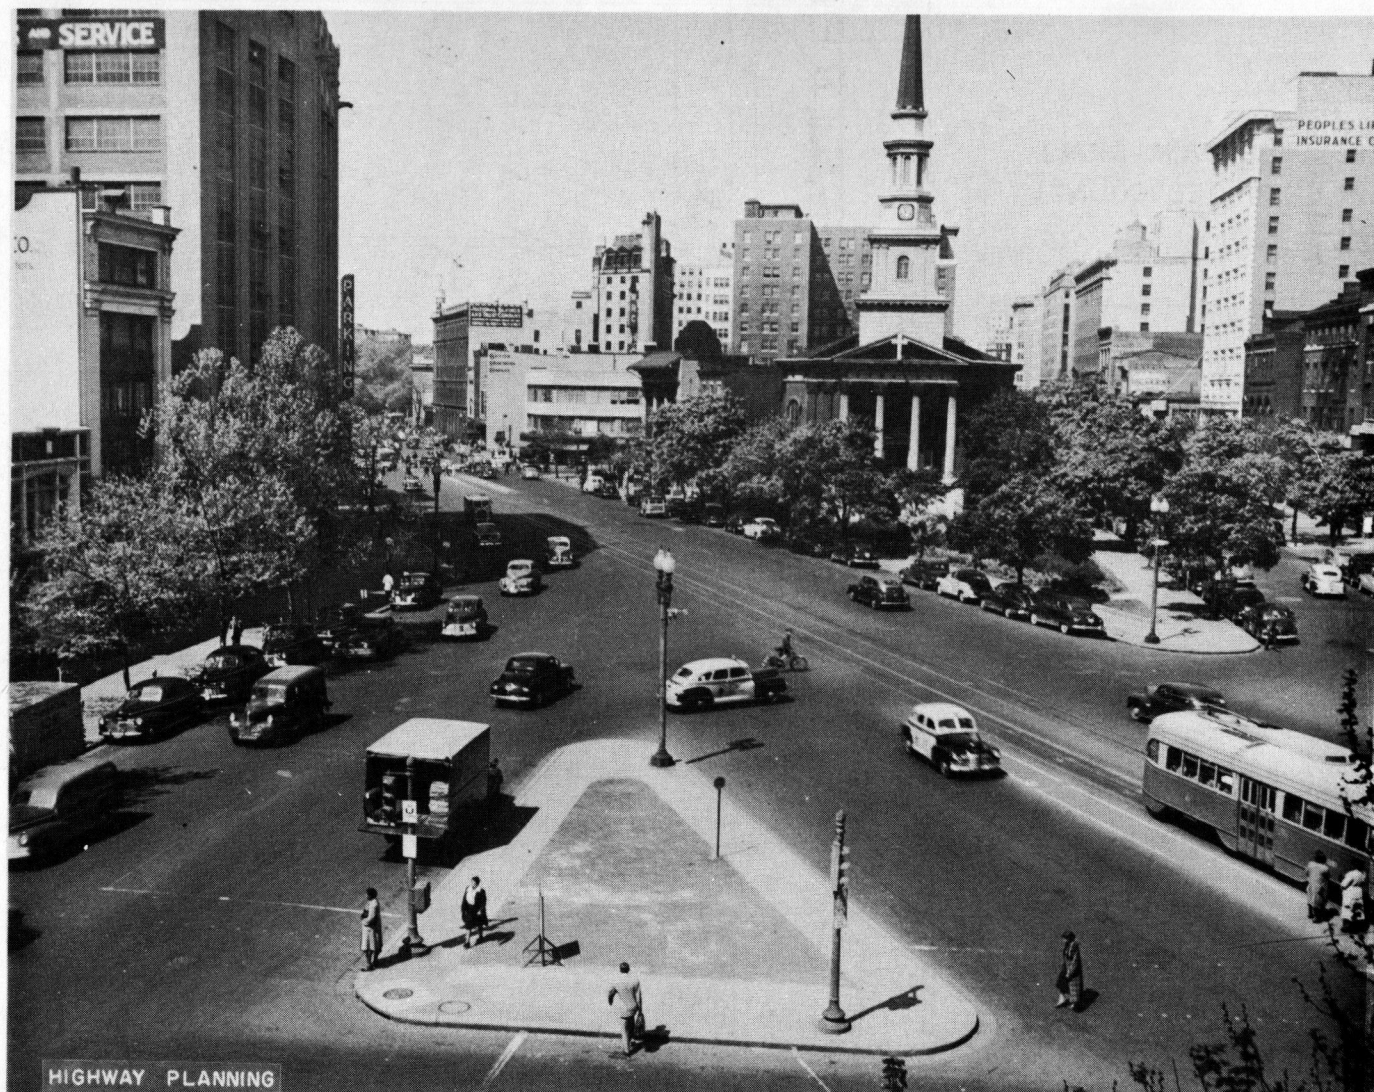
Figure 1. Multiway intersection of New York Avenue, 13th Street, and H Street NW., Washington, D. C. before channelization.

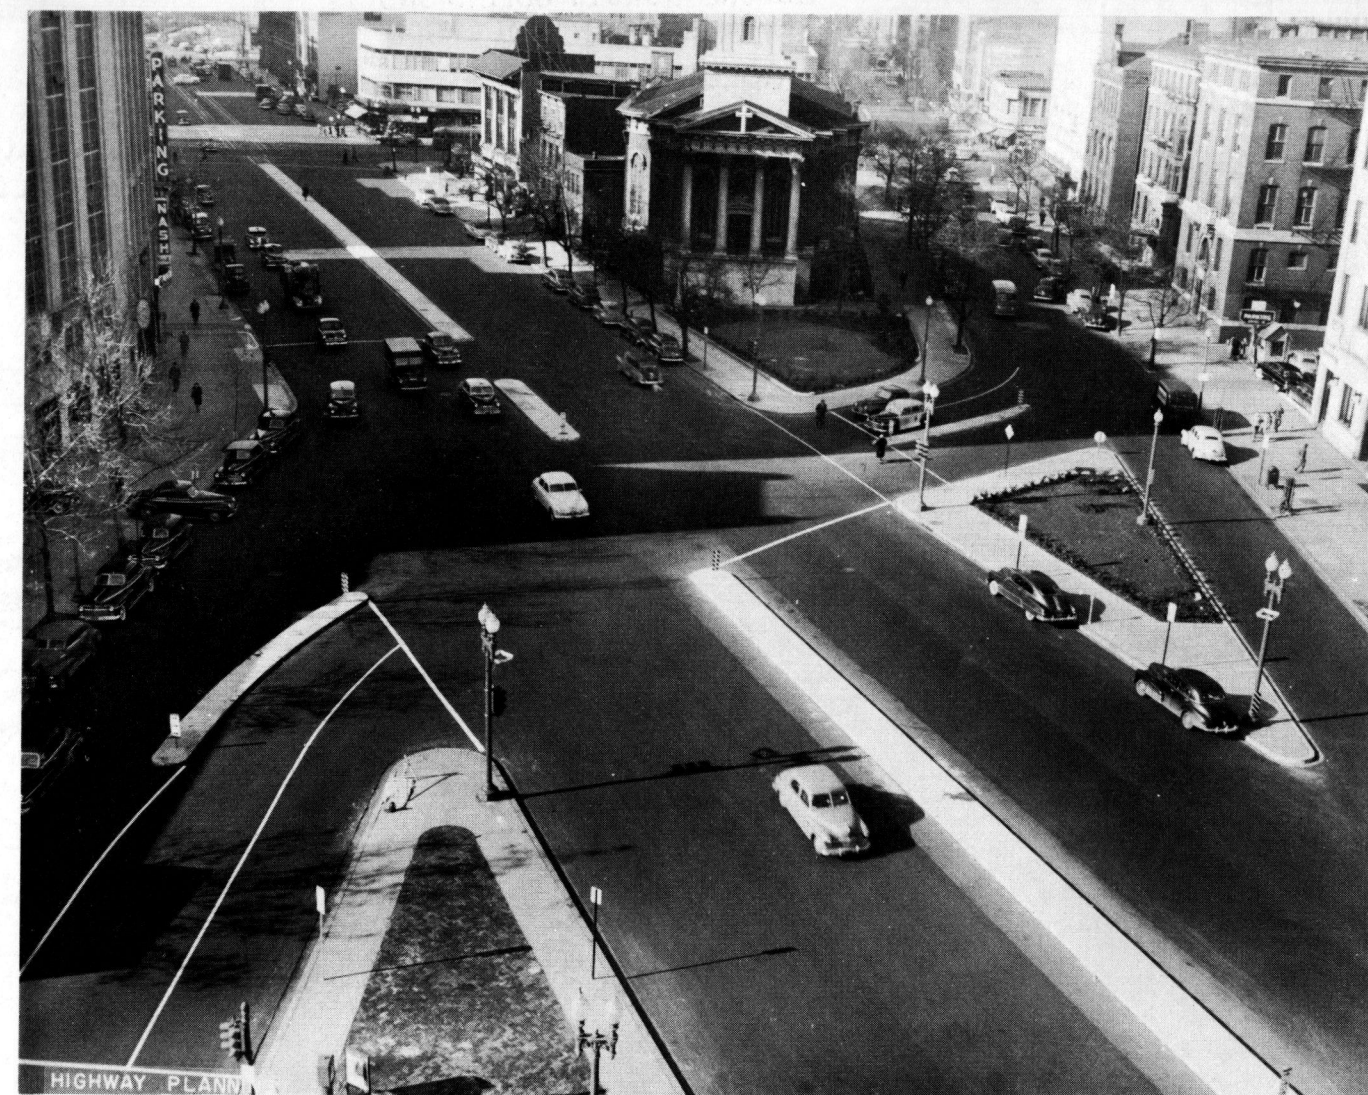
Figure 2. Completed channelization of intersection. Note the good contrast achieved between the concrete islands and the asphalt street surface.

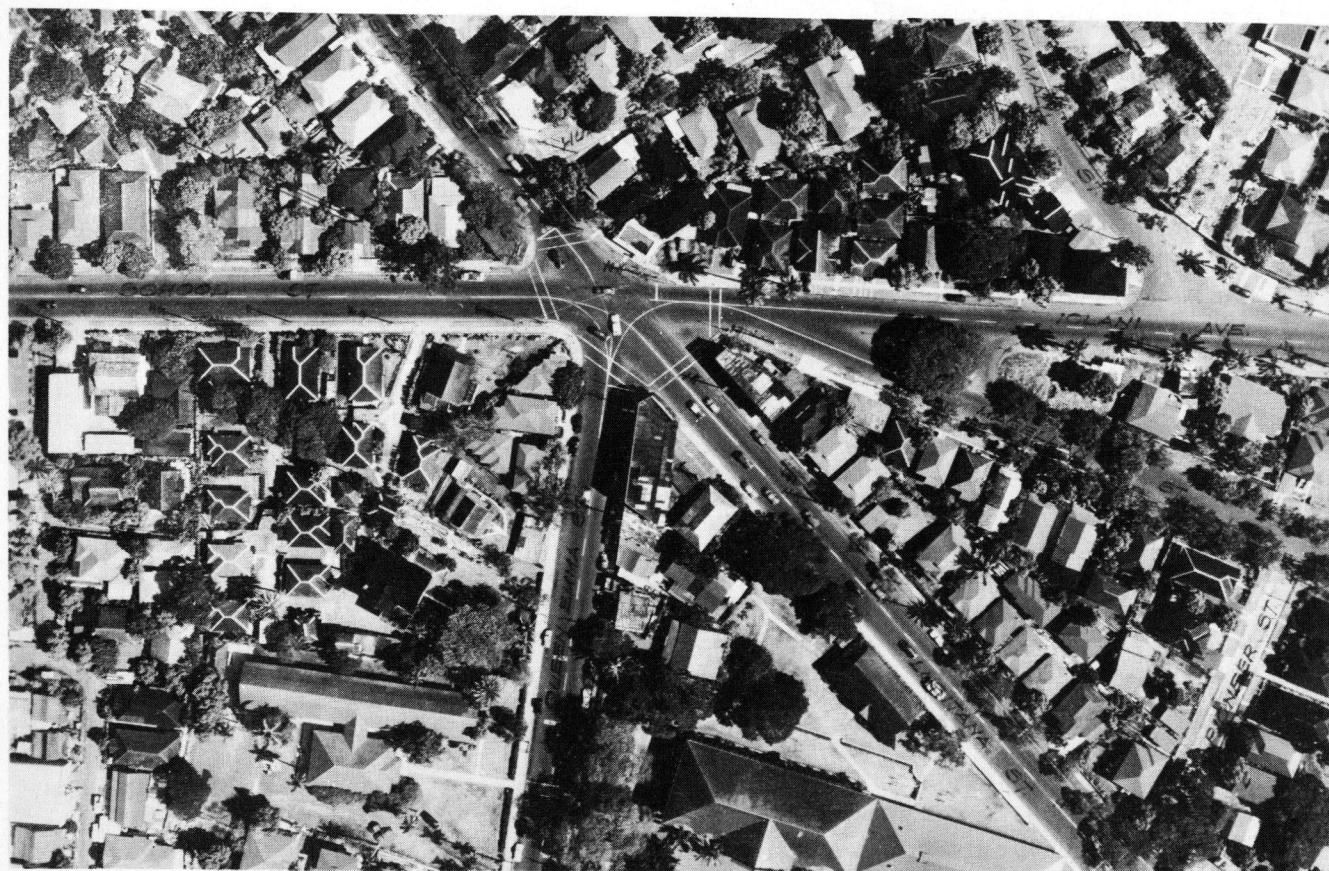
Figure 1. Aerial view of present intersection of School, Emma, Lusitana, Iolani, and Magellan Streets in Honolulu.

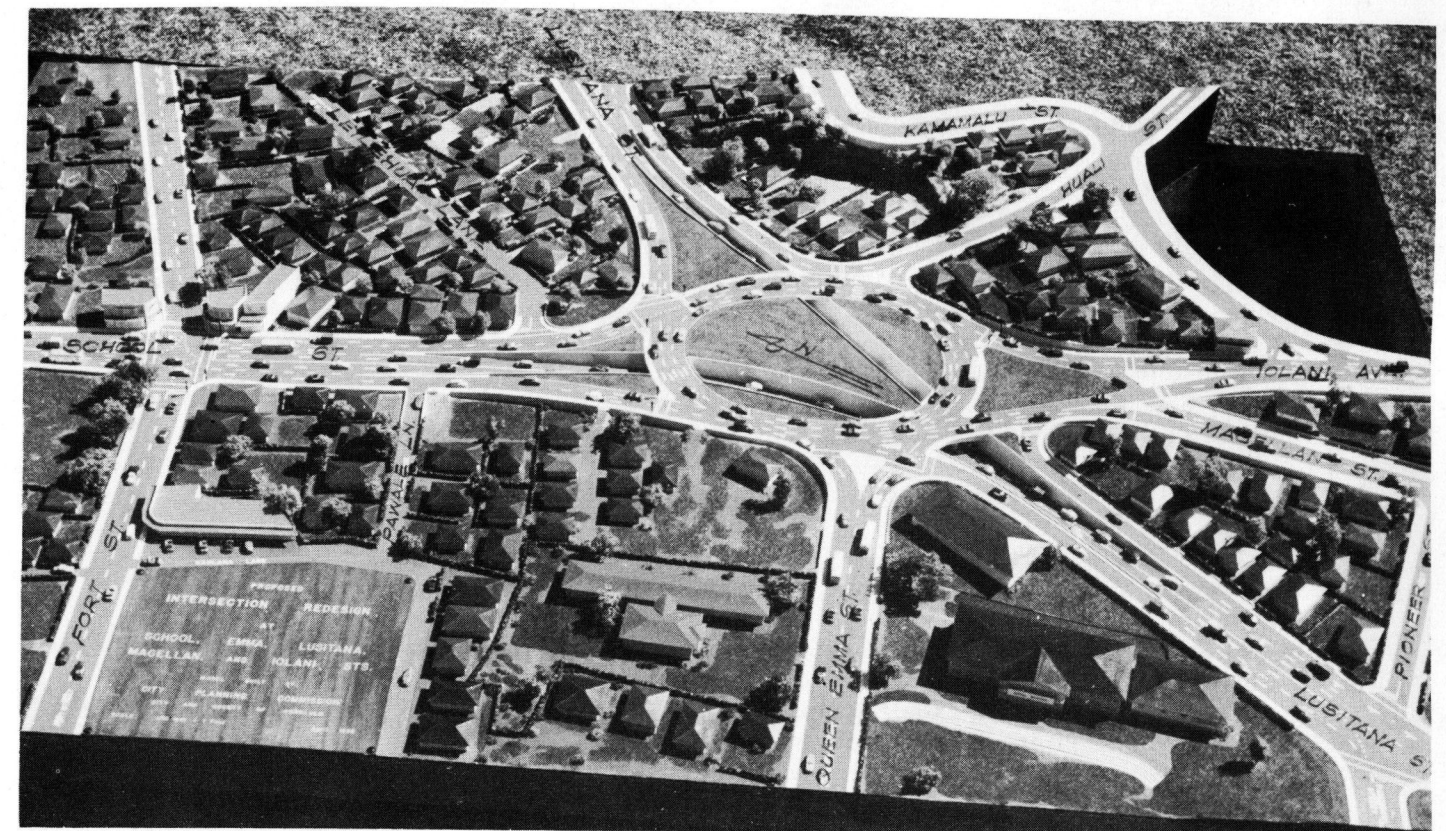
Figure 2. An excellent example of the use of a scale model to present a proposed intersection design. Note the fine detail and the clear presentation of a complicated reconstruction project. The cost of the model was \$2,849.

After due consideration of the various types of channelization, both at grade and vertical separation, it was concluded that the underpass type of construction, as noted on the model favoring the 43 percent traffic entering the intersection, would provide a workable solution. There are some questions in the mind of those who have reviewed the model, that due consideration was not given to the possible signalization of this intersection. That phase of the solution was gone into, and it was concluded that a three phase traffic signal without extensive channelization is unsuitable and unworkable in view of the six main conflicting streams of traffic. If anything, it would require a four phase signal control at this intersection. Imagine what would happen if a four phase traffic signal was installed at this multiple intersection - traffic movement would be paralyzed and traffic waiting to pass through the intersection on the green phase would back up worse than under present day conditions.

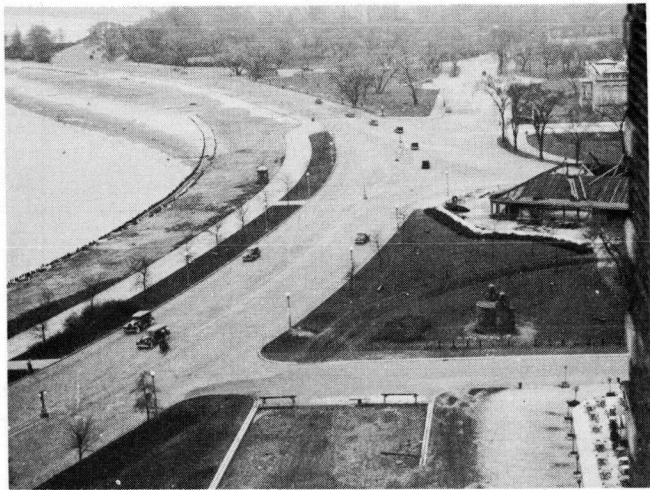
Figure 1. Birdseye view, looking south of the Shore Drive and 57th Street intersection before revision. Shore Drive curves left, North Circuit Drive is straight ahead in the center of the picture. Fifty-Sixth Street is in the immediate foreground, and curving right at the wrecked pavilion is North Circuit Drive. Fifty-Seventh Street is immediately beyond, on the right. The wide-open plaza, devoid of traffic lanes, shows itself as a traffic danger spot.

Shown is a 'bird's-eye view', looking south of the Shore Drive-Fifty-Seventh Street intersection before revision. Shore Drive curves left, North Circuit is straight ahead in the center of the picture. Fifty-Sixth Street is in the immediate foreground and curving right at the wrecked pavillion is North Circuit Drive. Fifty-Seventh Street is immediately beyond, on the right. The wide-open plaza, devoid of traffic lanes, shows itself as a traffic danger spot."

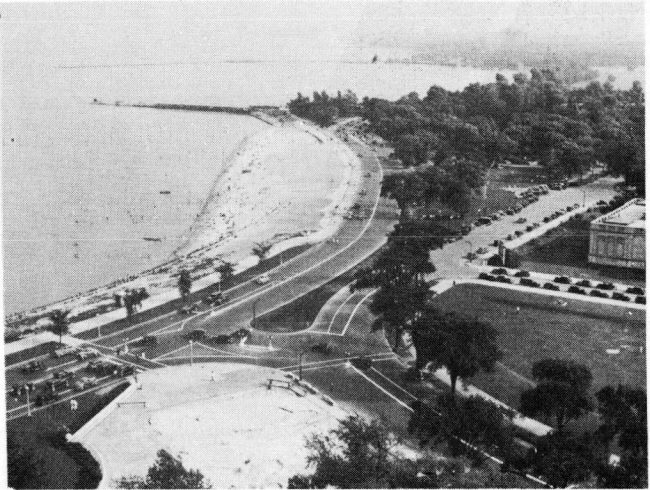
Figure 2. Traffic movement was measurably accelerated at the 57th Street intersection of Shore Drive after the installation of the center parkway (shown slightly to the right of center in the picture) and the application of well-defined lane marking. Removal of the old pavillion (from area in foreground) provided a clear view for southbound motorists. Shore Drive curves left along the shore of the lake, while North Circuit Drive is at the right.

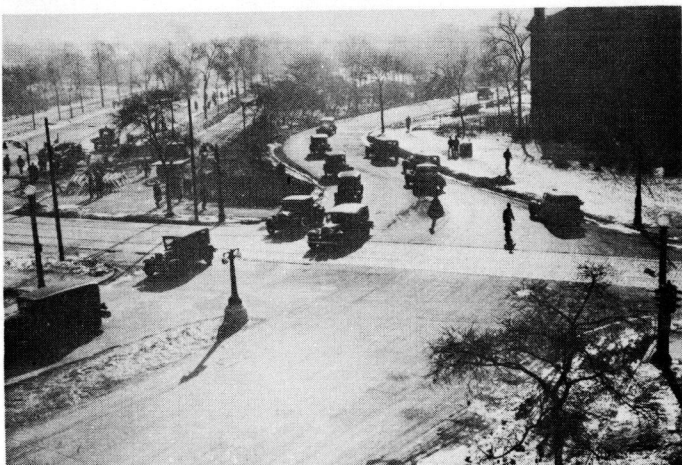
Figure 1. Intersection of 51st Street and South Parkway, Chicago, in January 1936 before channelization, showing dangerous reverse curb on South Parkway, with Washington Park at extreme left. Note the several ancient features.

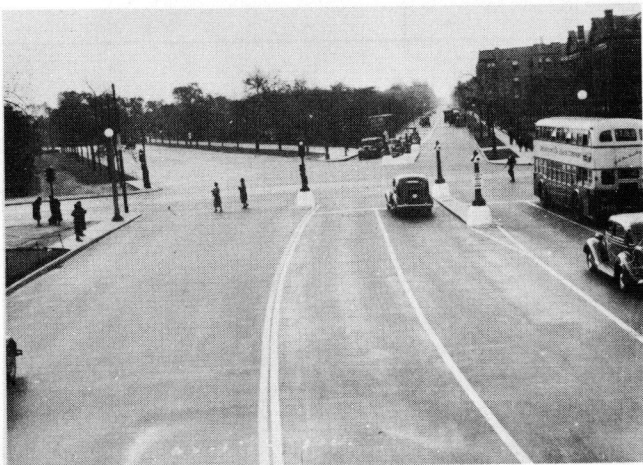
Figure 2. October 1936, after reconstruction, looking across 51st Street down South Parkway at right. Safety islands and lightposts are part of improvement.

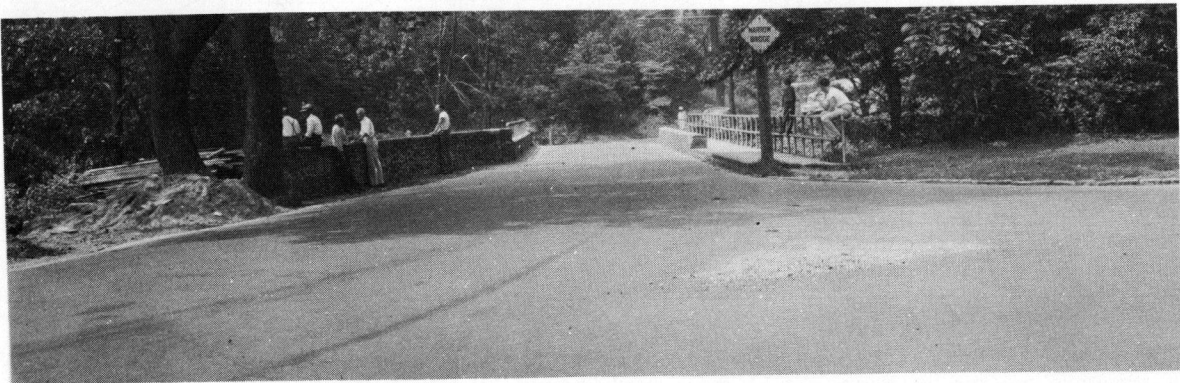
Figure 1. Intersection of Church Lane, Cobb's Creek Parkway, and 70th Street in Philadelphia before reconstruction and channelization.

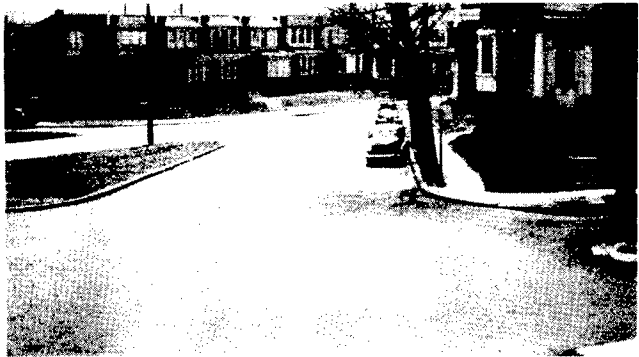
Figure 2. Existing intersection of 10th, 11th, Somerville, and Wagner Streets in Philadelphia, looking south from 11th Street.

2. JAMES L. SHOTWELL - The existing intersection no doubt confuses the unfamiliar driver because of the lack of signs and markings. It appears that much could be done by a channelized design other than a rotary.

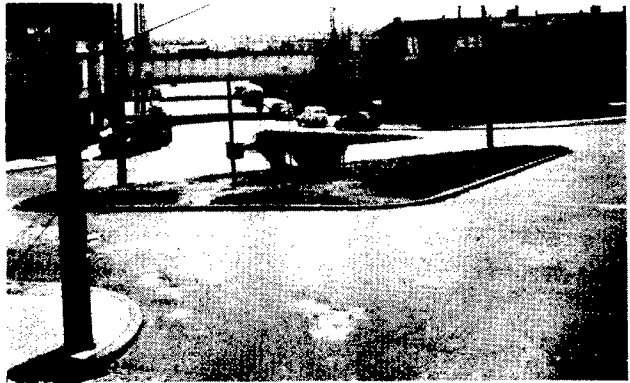
Figure 3. Existing intersection looking southwest from 11th and Somerville Avenue.

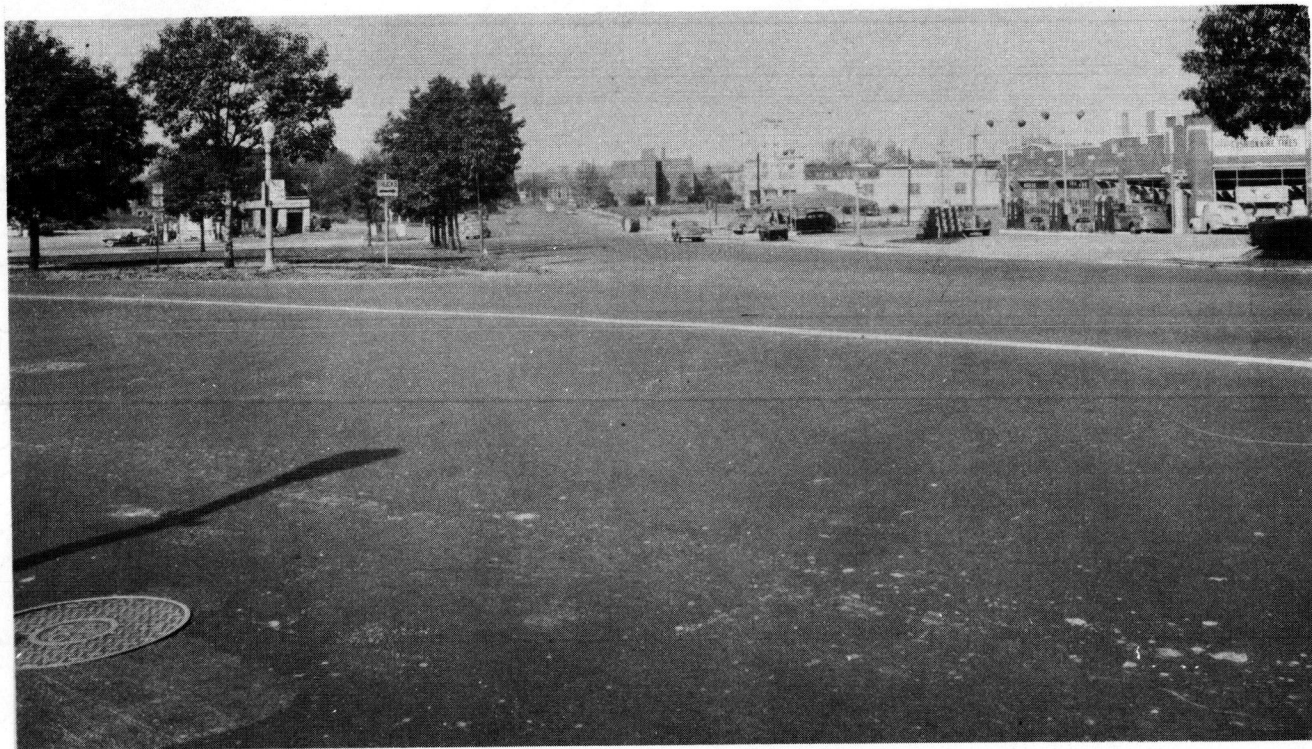
Figure 1. Intersection of Roosevelt Boulevard, Whitaker Avenue, and Adams Avenue, Philadelphia, before redesign and channelization.

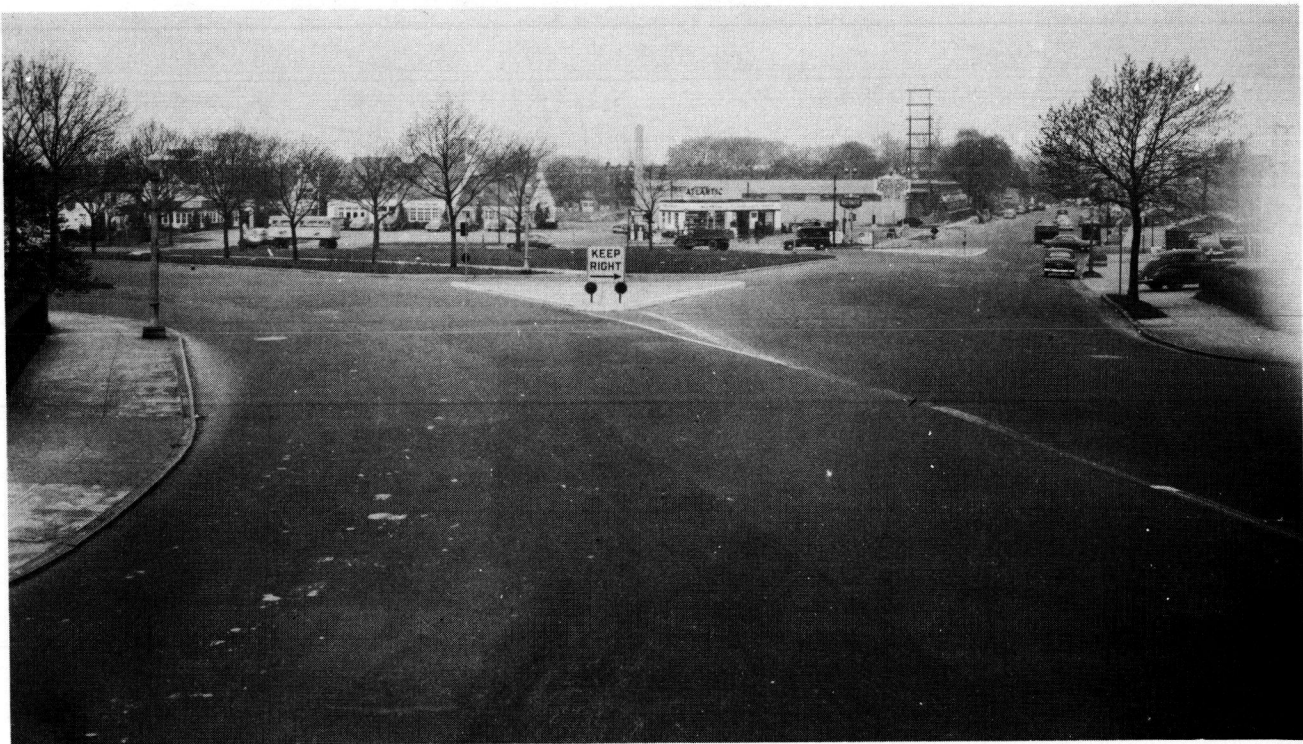
Figure 2. Looking west from intersection of Roosevelt Boulevard and Adams Avenue after channelization.

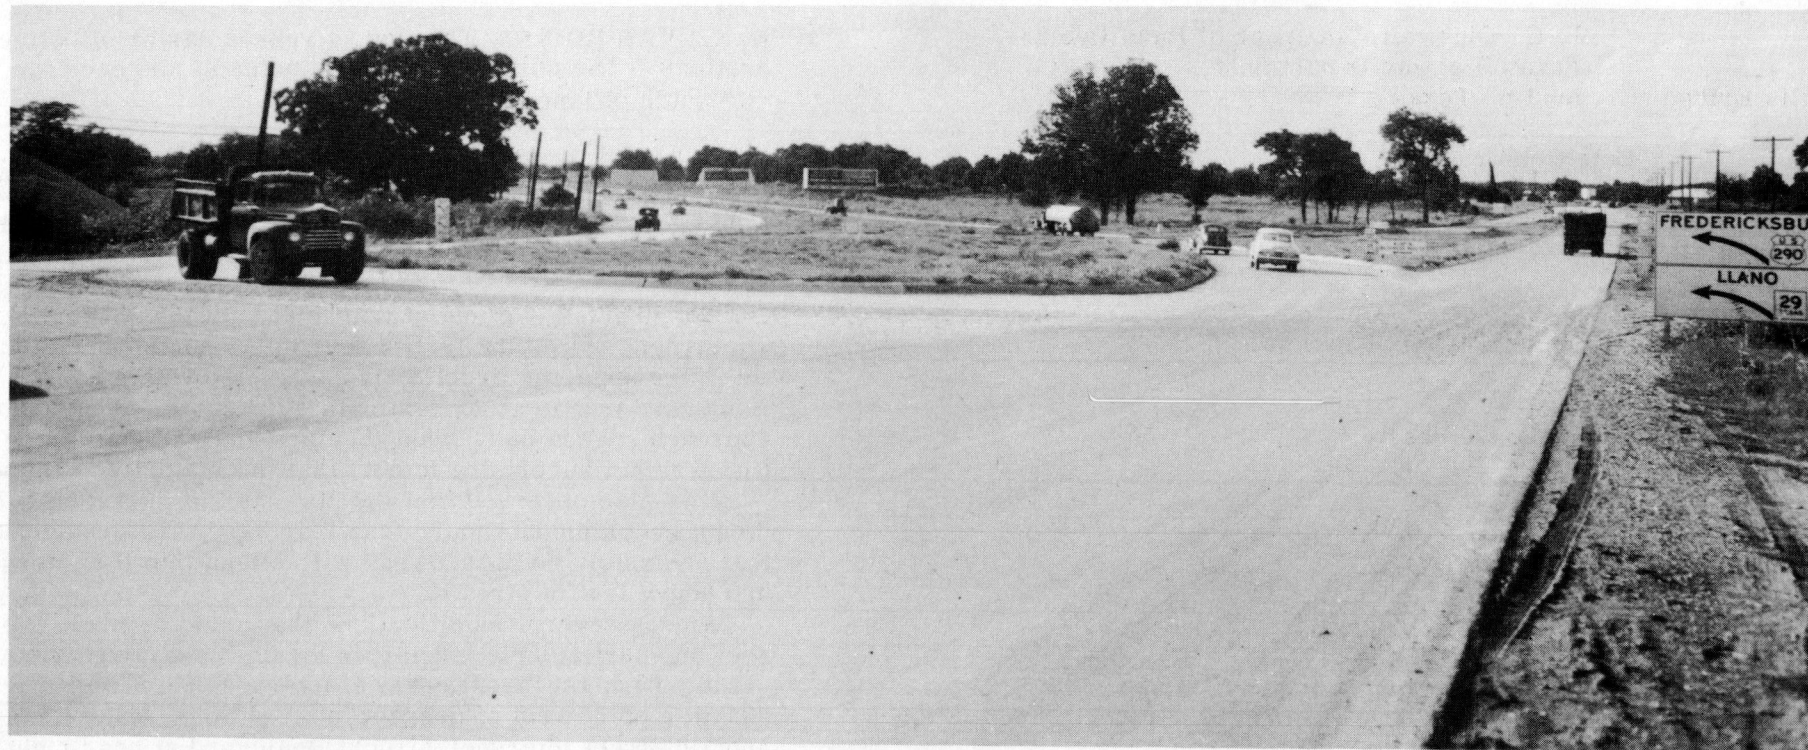
Figure 1. Channelized intersection of US 290, Texas 29, and 7th Street, near Austin.

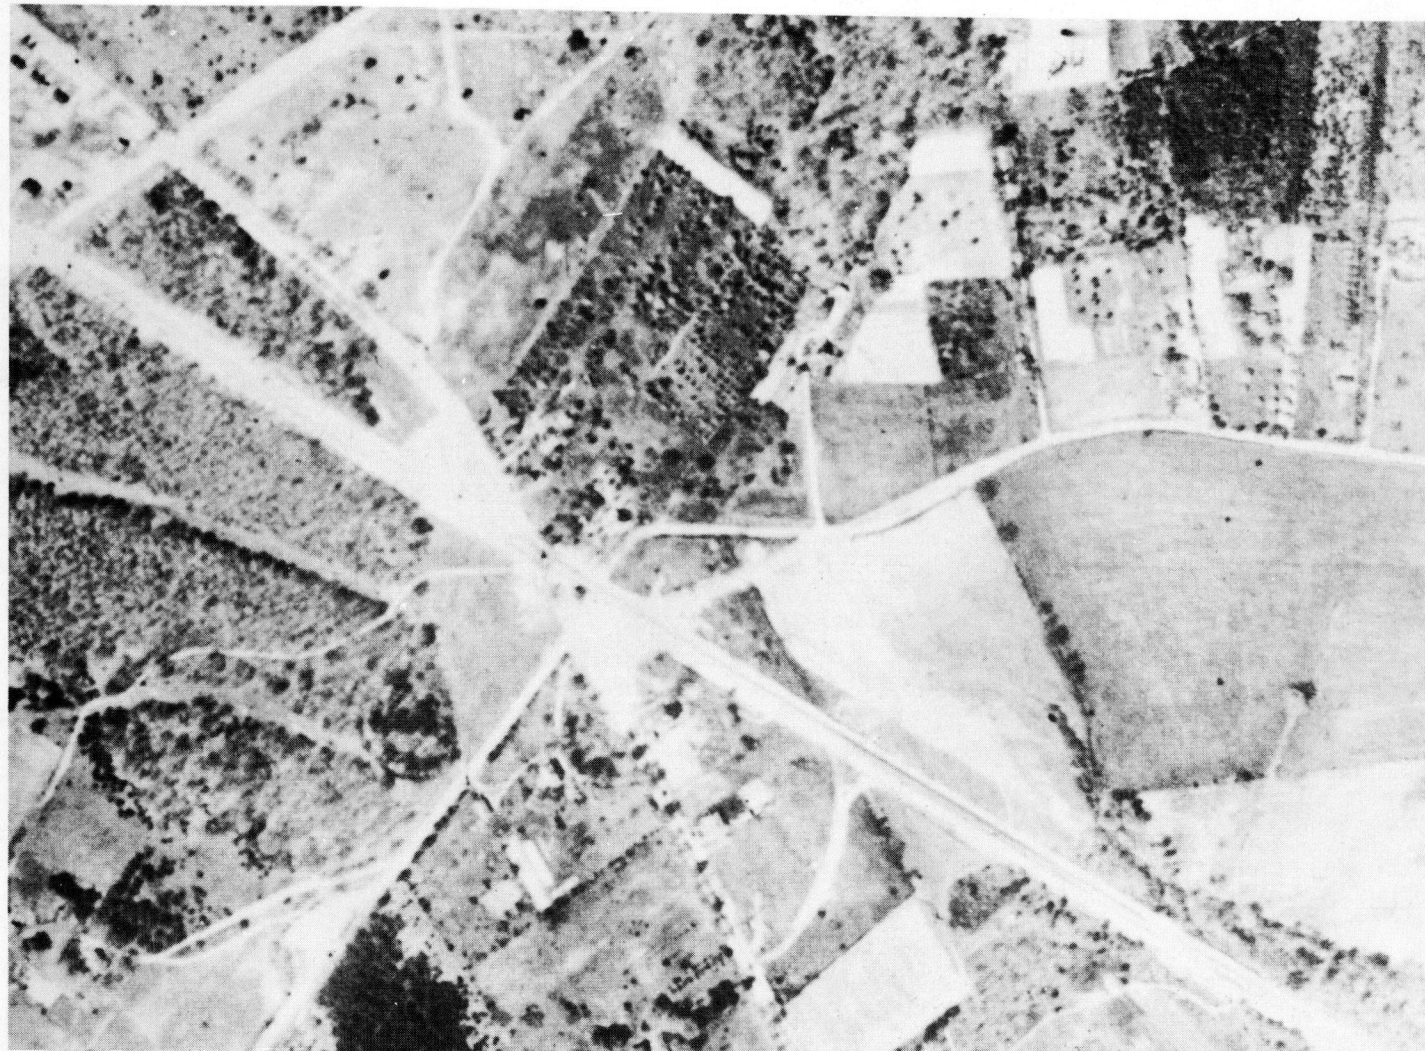
Figure 1. Fort Buffalo Intersection of US 50, Virginia 338, Virginia 613, Virginia 7, and Wilson Boulevard, near Falls Church, before channelization.

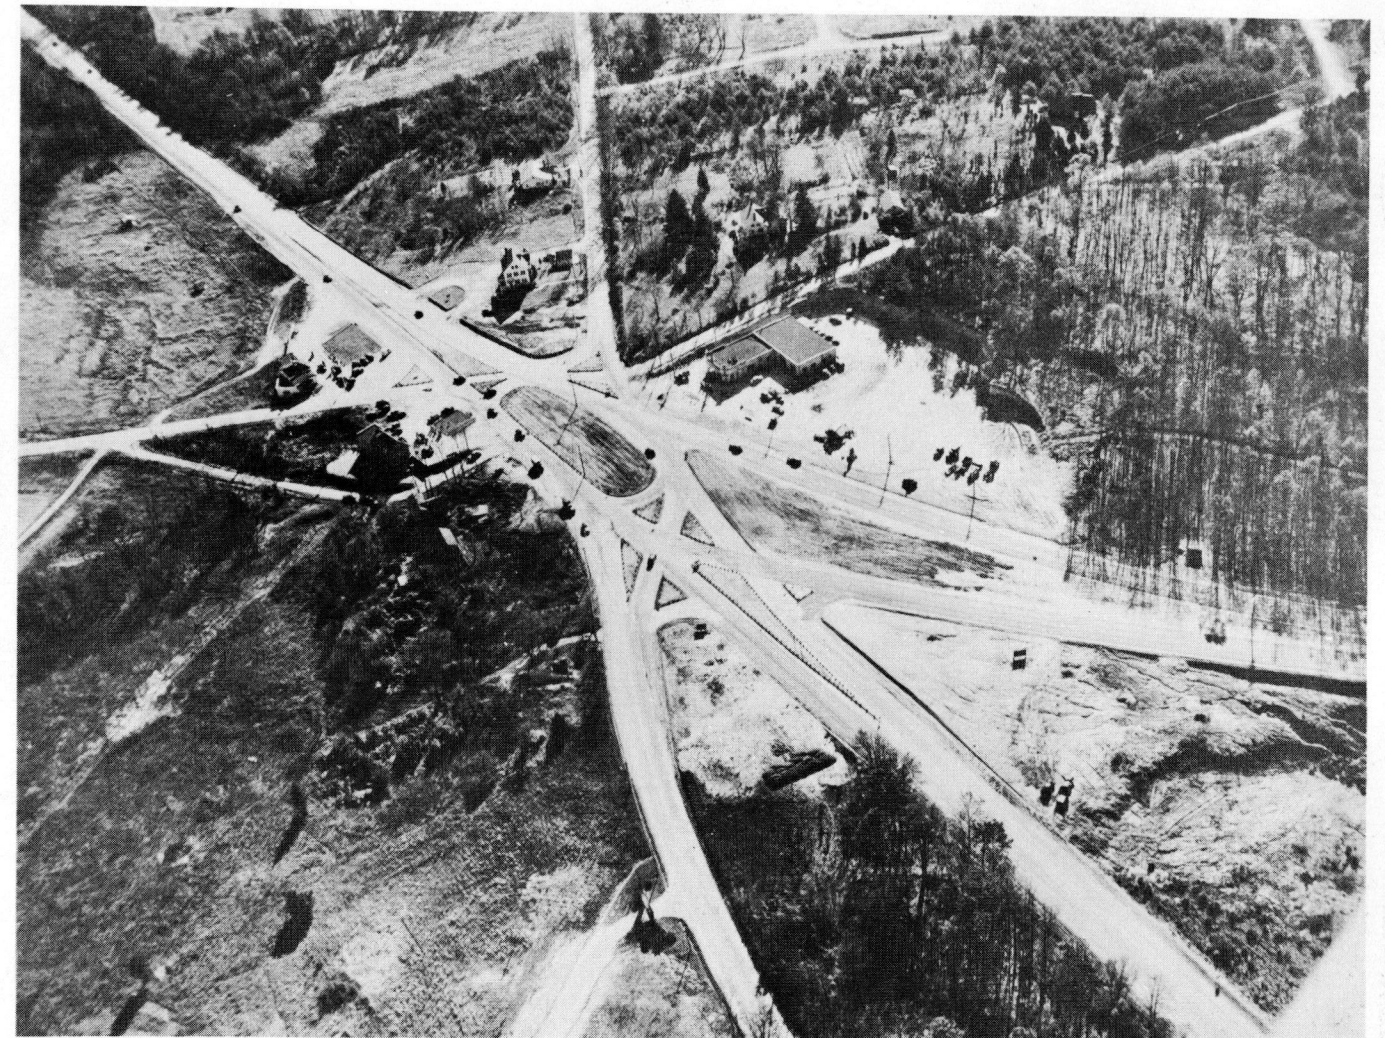
Figure 2. Channelization of a multiway intersection with seven approach roads and complex turning movements.

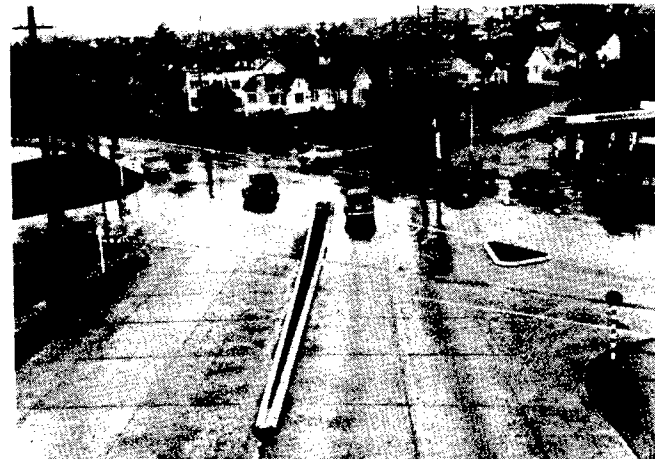
Figure 1. Channelization of multiway intersection of Green Lake Way and 50th Street Seattle. Note the pavement level beacon at the approach end of the median in the foreground.
