HIGHWAY RESEARCH BOARD SPECIAL REPORT 5

CHANNELIZATION

The Design of Highway Intersections at Grade

1952

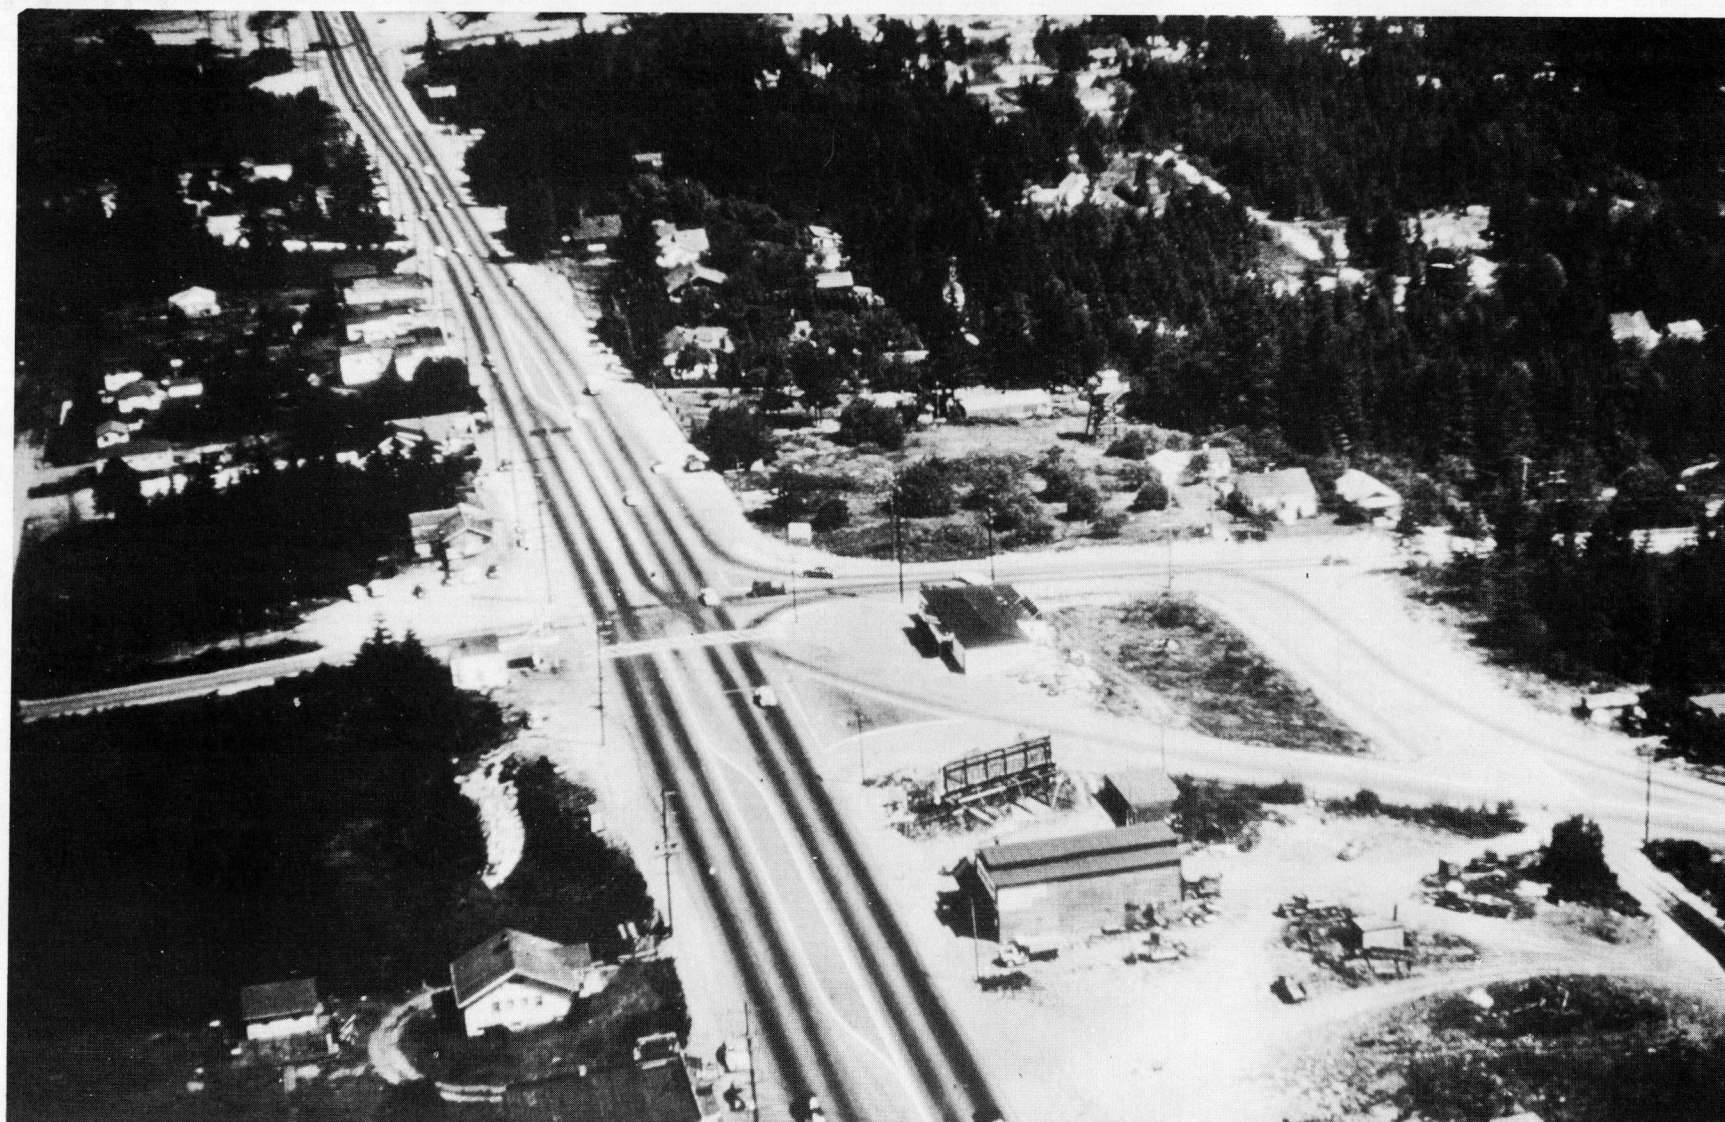
Figure 1. Effective channelization treatment to correct a dangerous intersection: US 99, North 145th Street, and SSH 1-J, near Seattle.

<u>Physical Data</u>		2. H. G. VAN RIPER - This is considered a good example of effective channelization treatment in correcting a dangerous condition at an intersection at a reasonable cost. All turning movements have been satisfactorily provided for, especially westbound traffic from SSH 1-J.

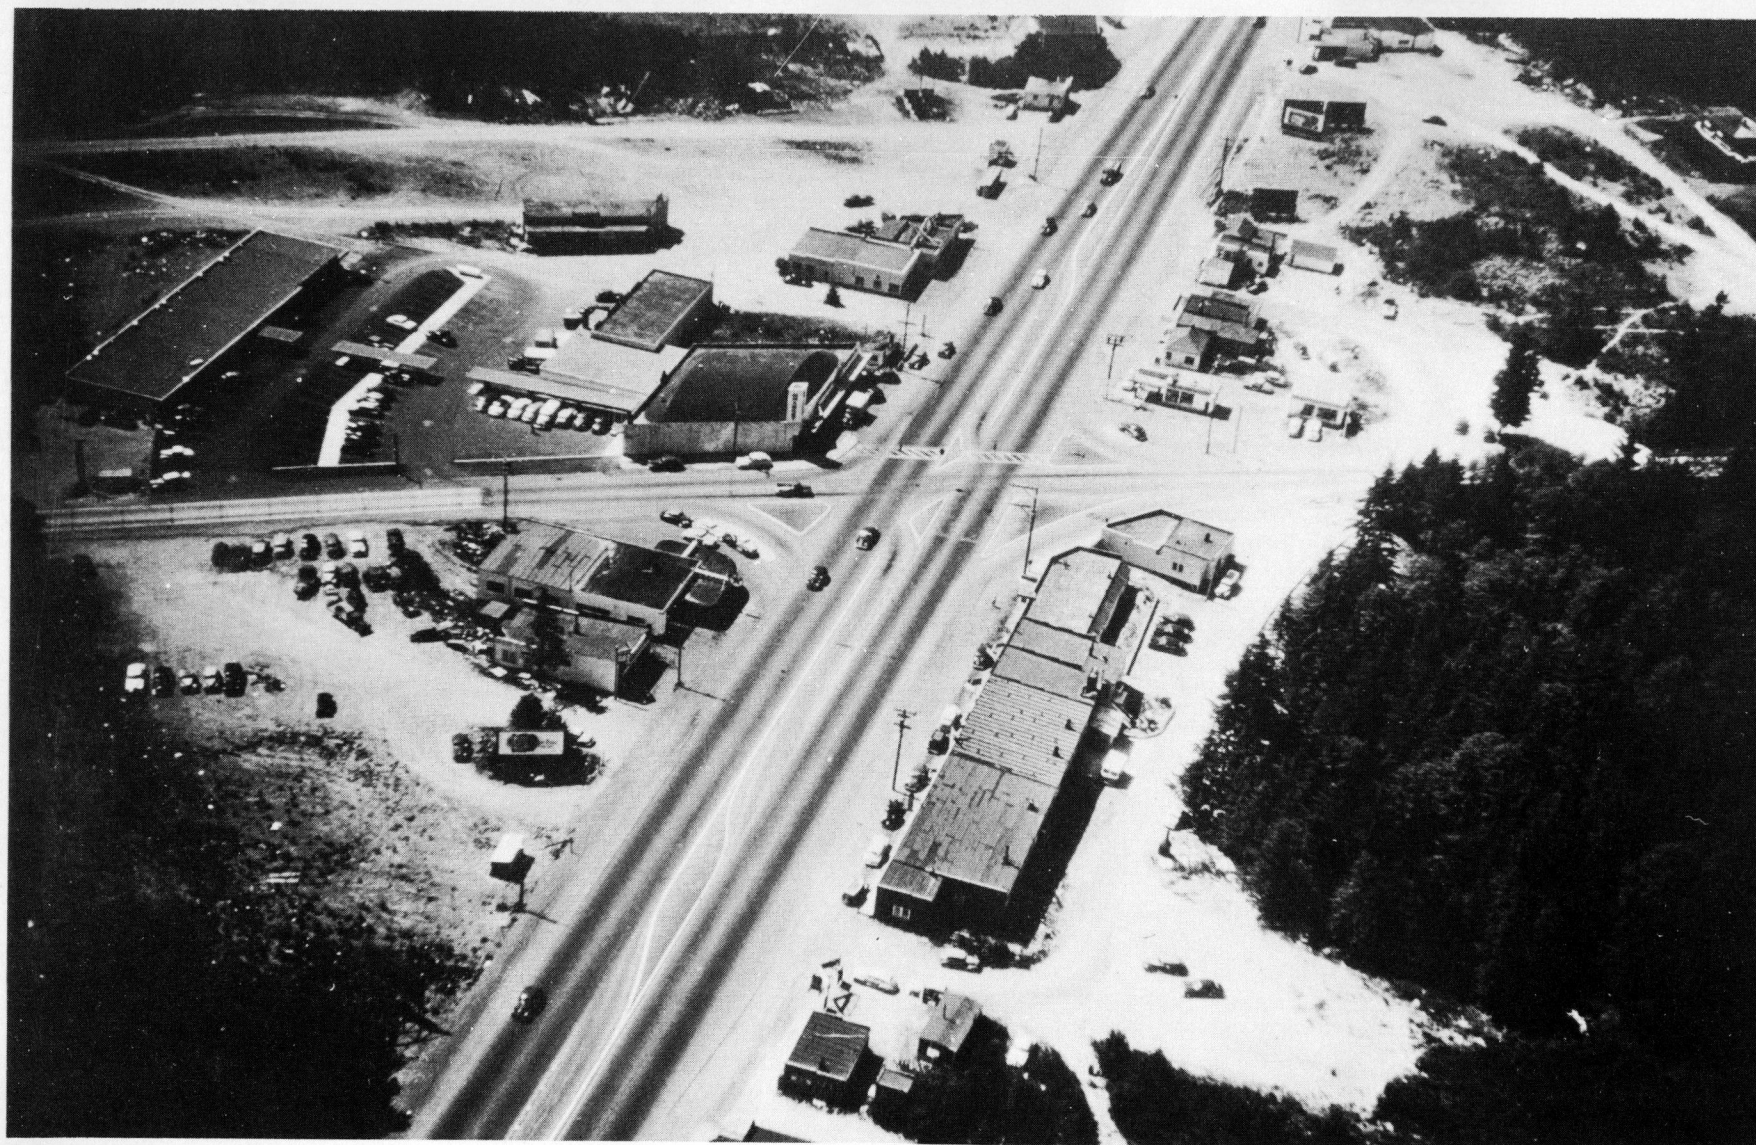
Figure 1. Aerial view of US 99 after 4-lane divided highway with 4-ft. median was widened, median expanded to include left-turn lanes, and channelizing islands added.

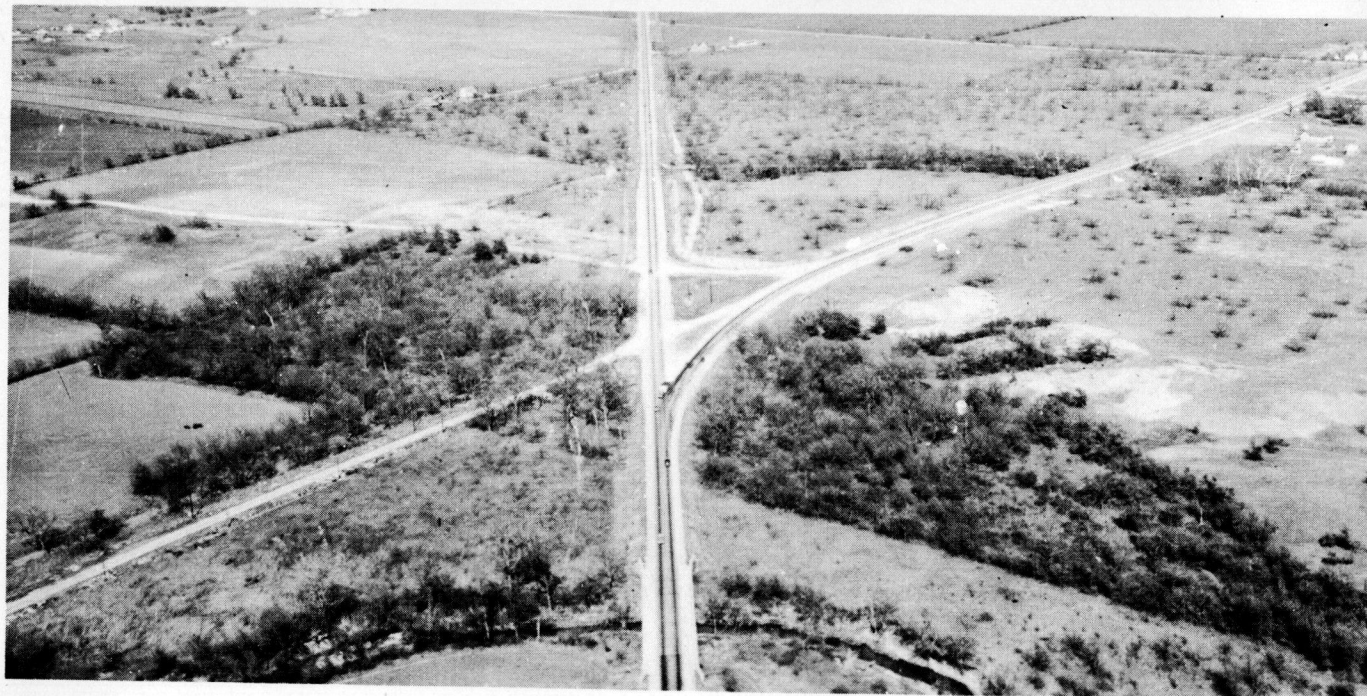
Figure 1. Three-way Y-type intersection near Fort Worth, Texas, with 2-way, 2-lane legs before reconstruction.

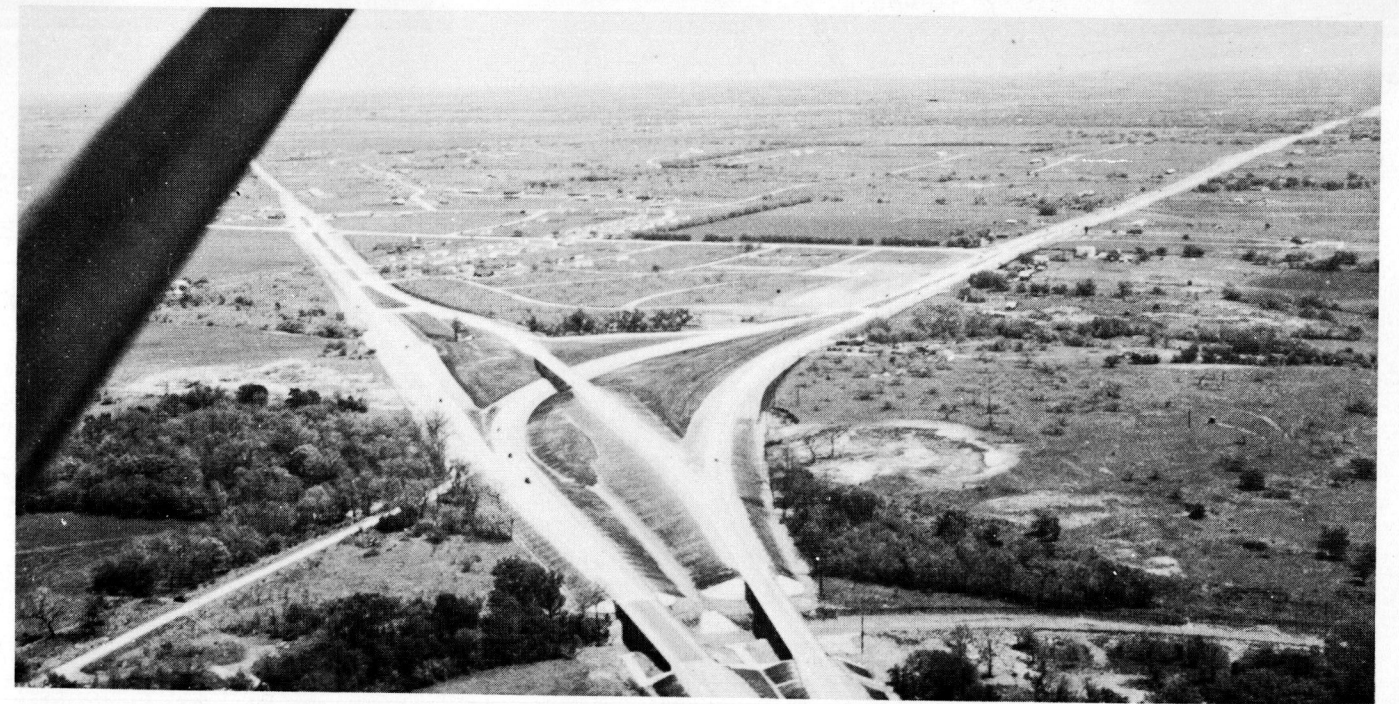
Figure 2. Intersection after reconstruction with Y-type interchange and with certain features of highway channelization.

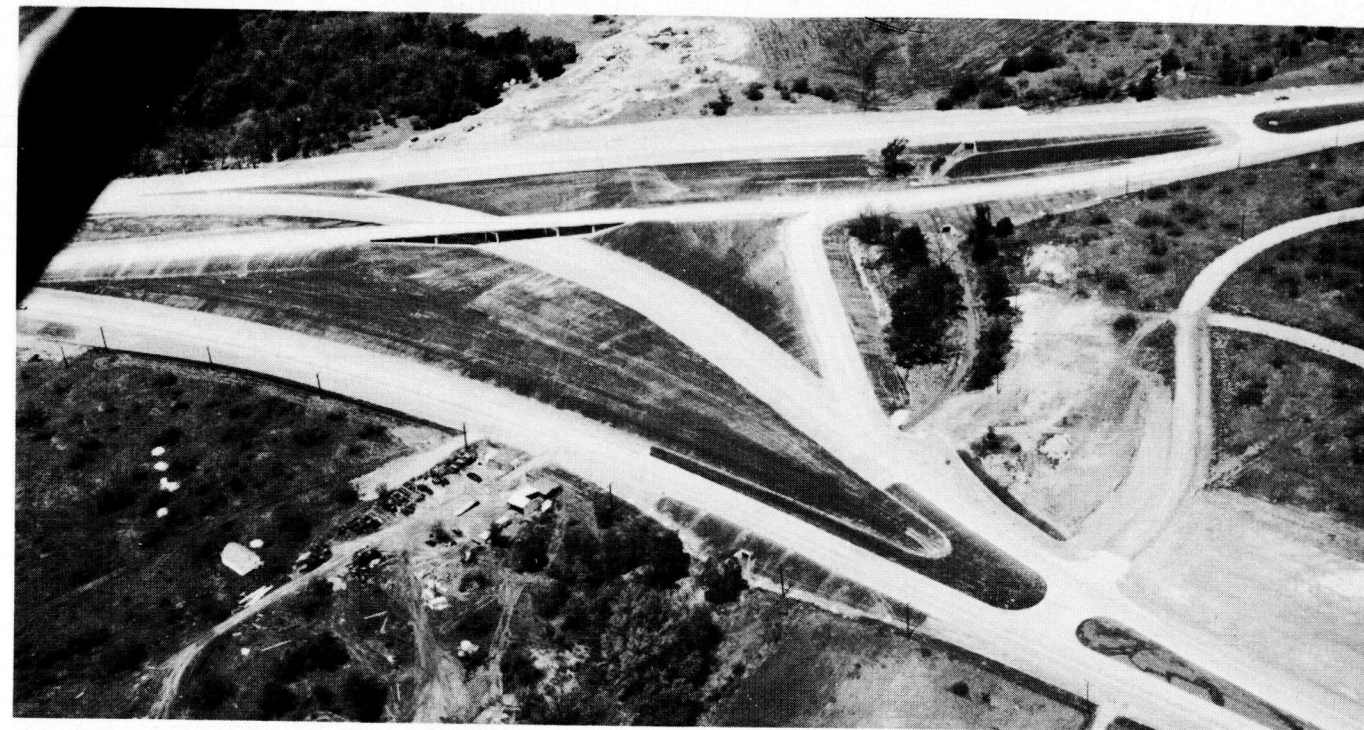
Figure 3. Close-up of interchange area with details of channelizing islands.

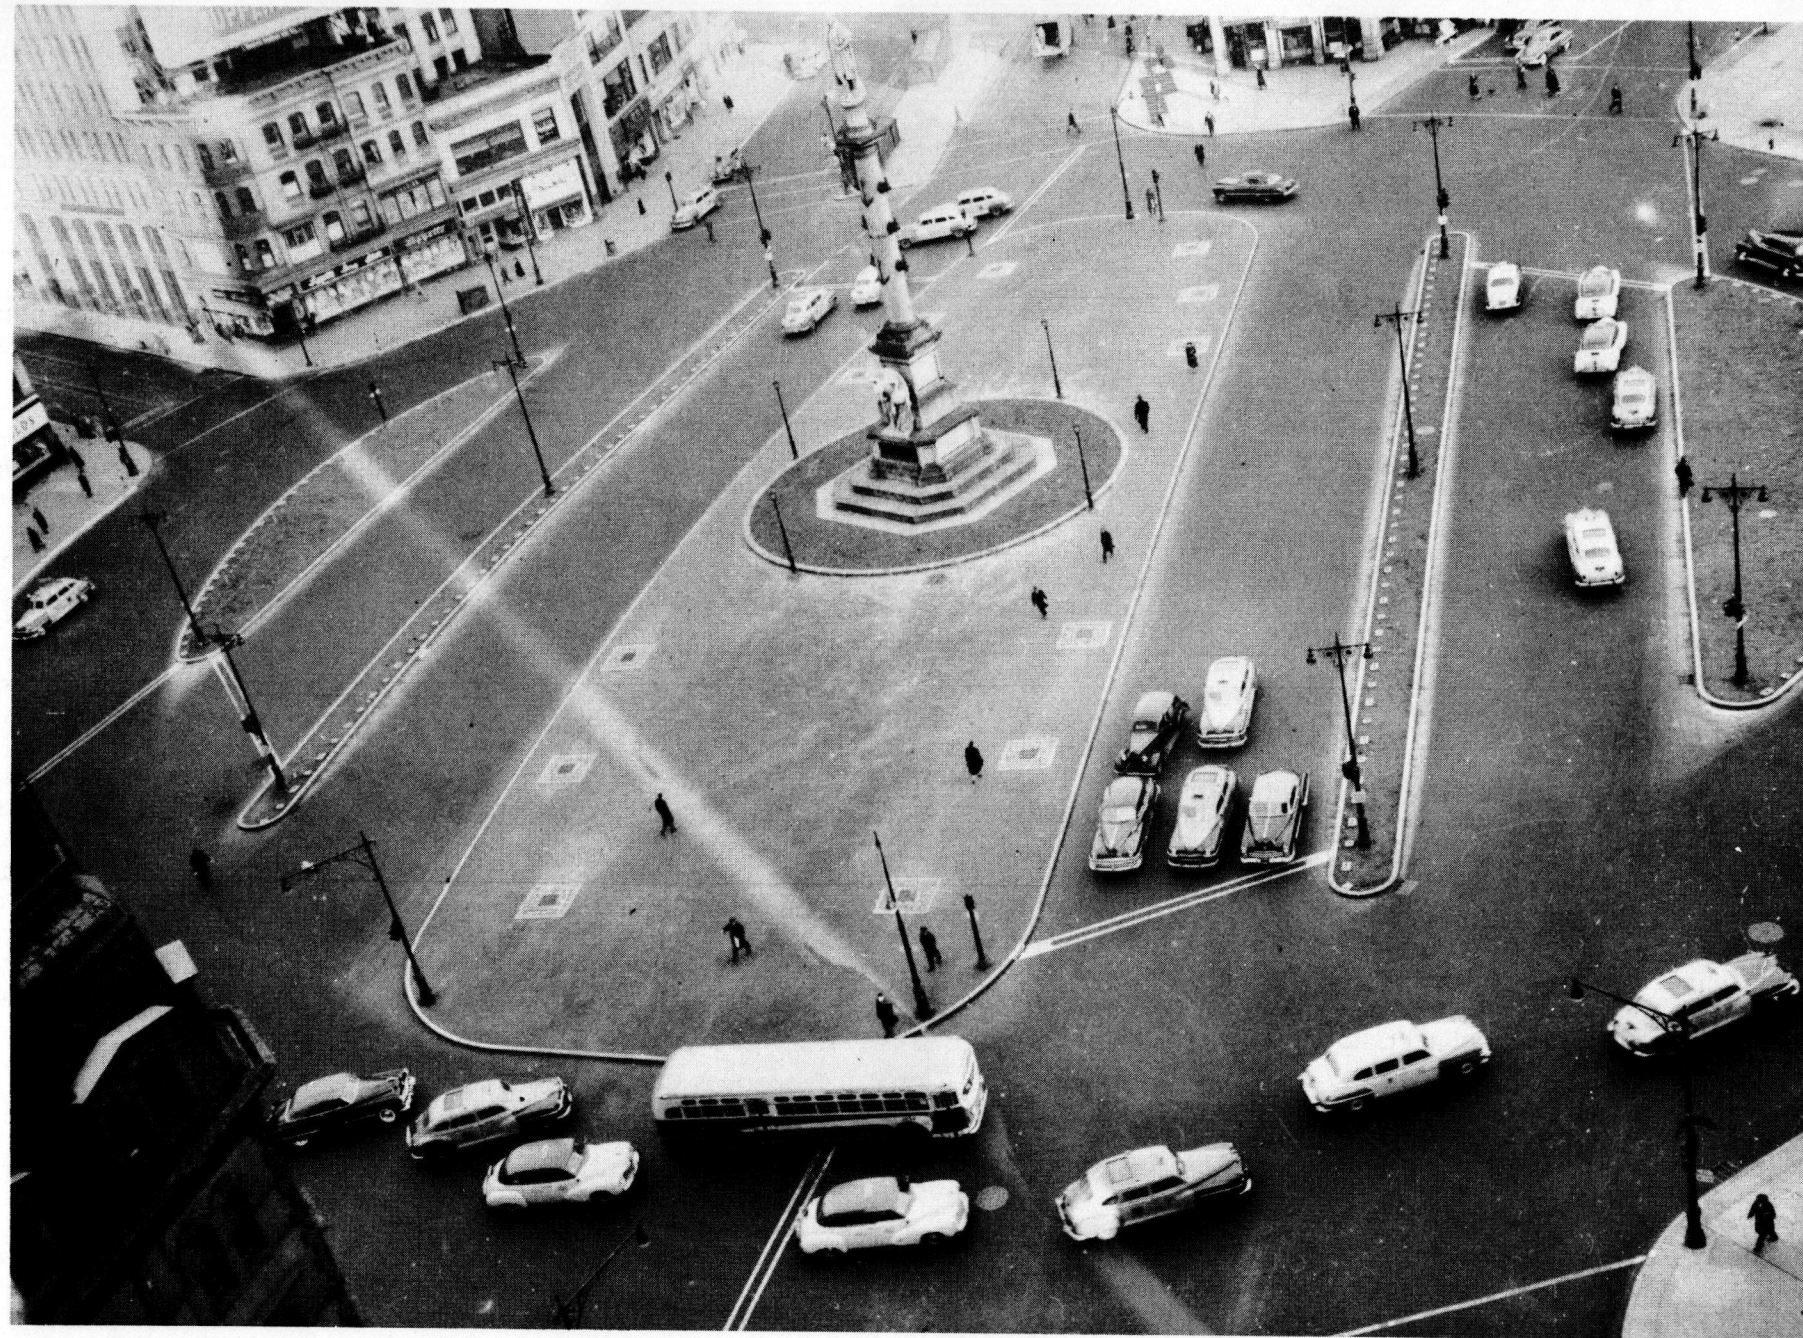
Figure 1. Revised intersection at Broadway and 8th Avenue, New York. All turning movements are made on periphery of original circle, with double through movements across center. Traffic signal control is necessarily complex.

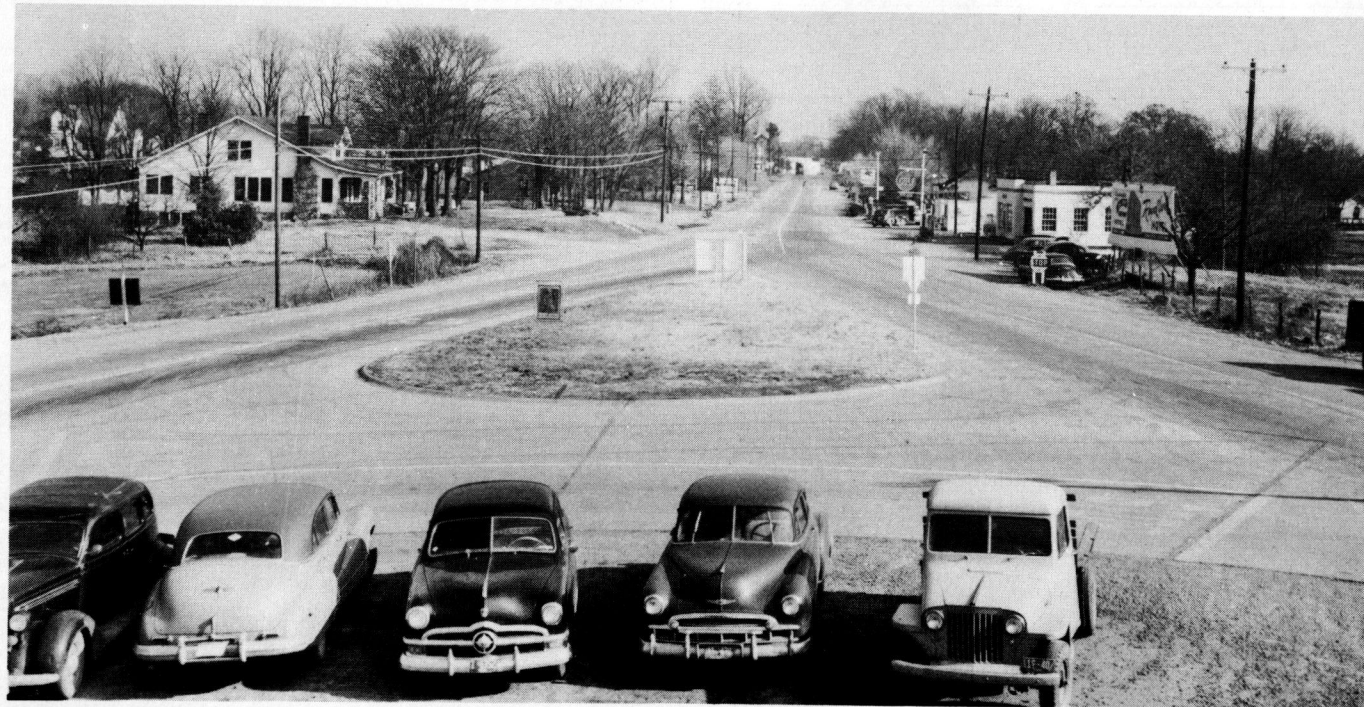
Figure 1. Channelized intersection of US 79 and US 41A, near Clarksville, Tennessee.

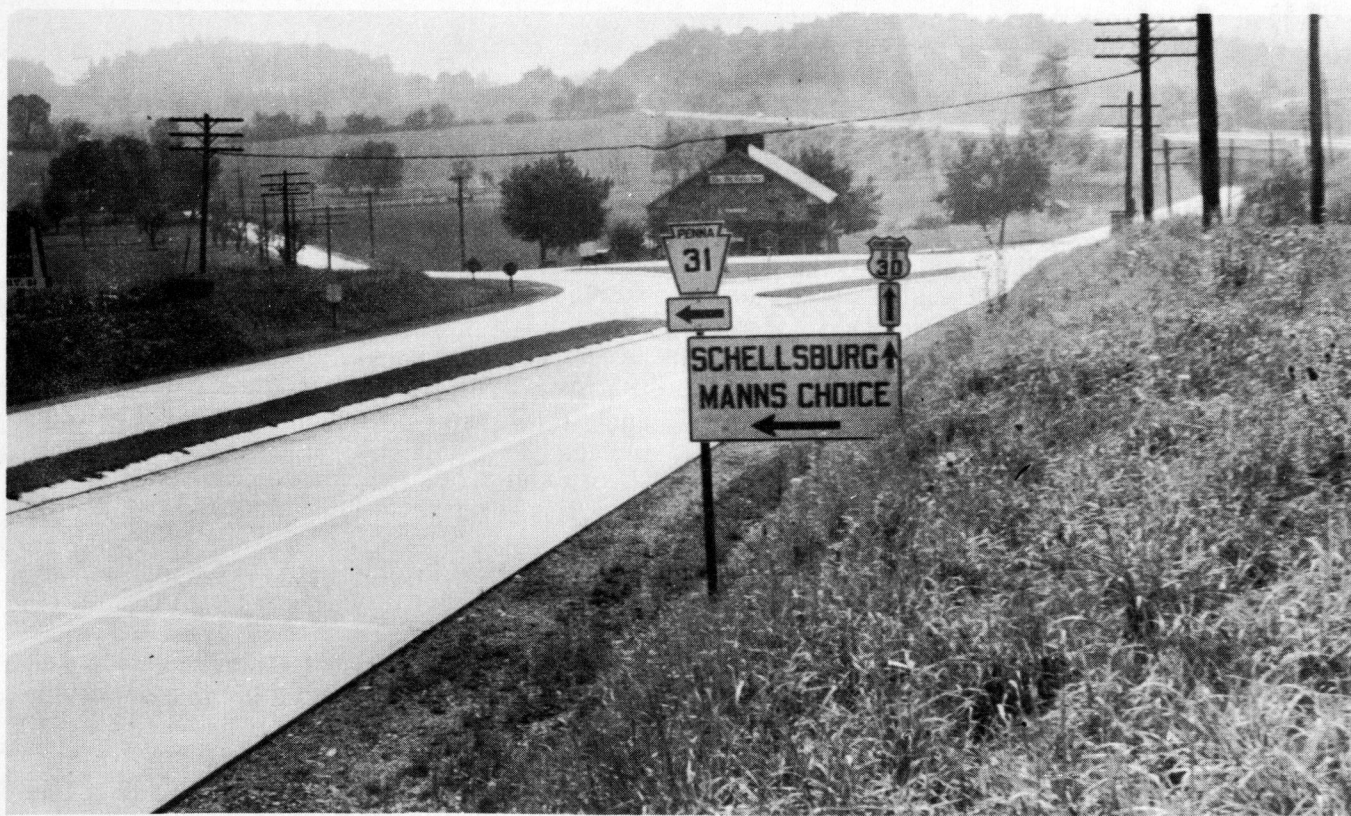
Figure 1. Three-way, Y-type channelized intersection of US 30 and Pennsylvania 31 looking southwest.

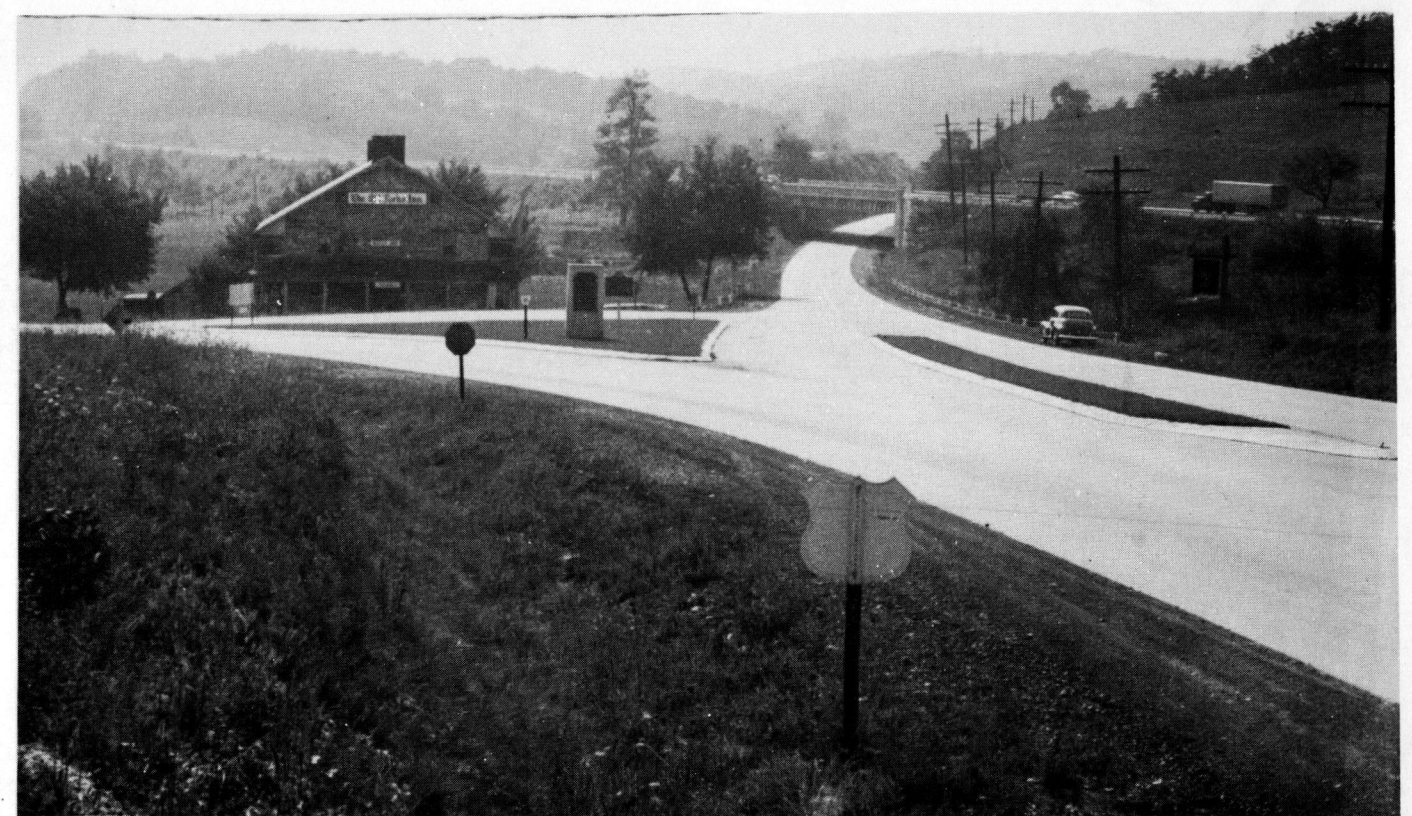
Figure 2. Sloping curbs around islands painted with white reflectorized paint to improve contrast and night visibility.

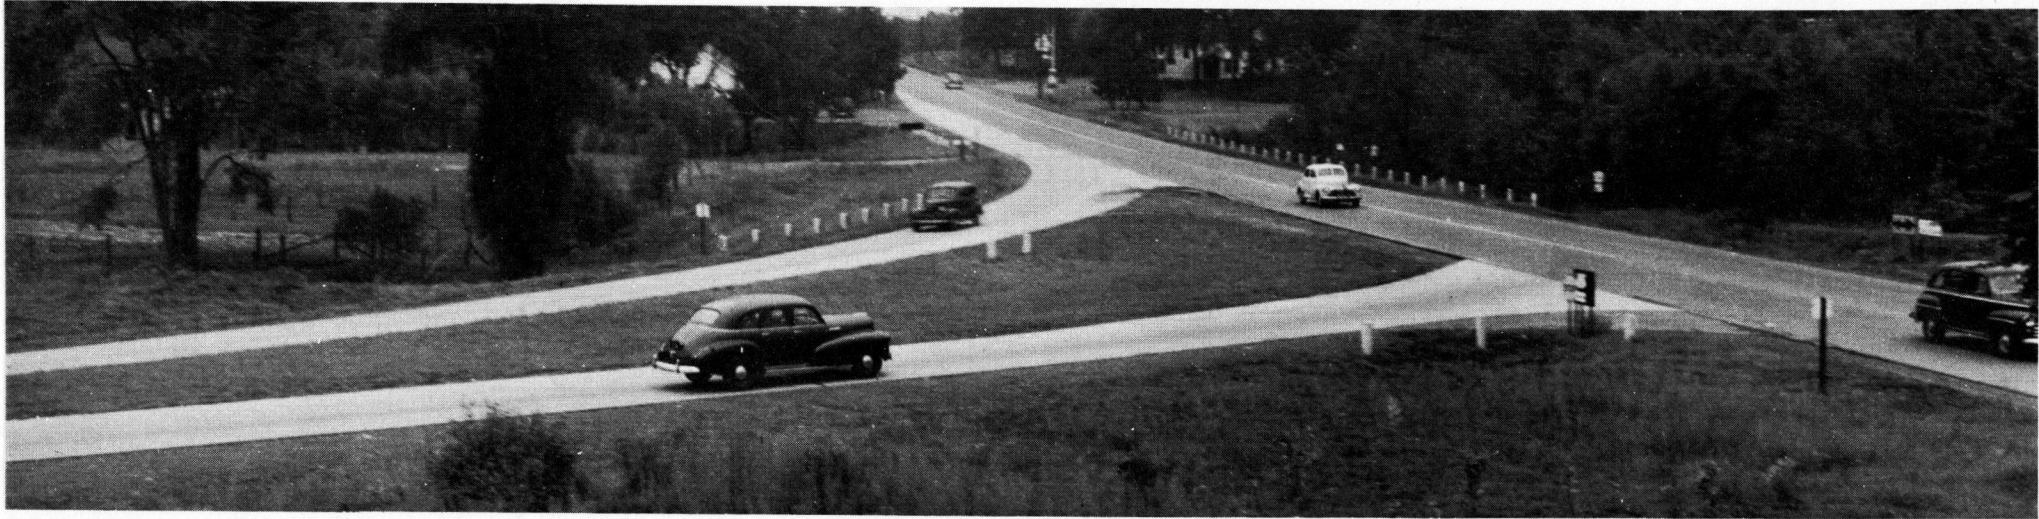
Figure 1. Channelized intersection of US 9 and Mechanicville Road (New York 236), looking south.

- 1. EUGENE MAIER - Noteworthy features of this channelized three-way intersection includes:
(a) Treatment of the approach end of the island on Route 236 by the use of lines painted on the pavement; (b) The design of the generous speed change area for traffic traveling northwest on US 9 and turning right onto Route 236. Good definition is afforded this speed change area by the contrast in surface type.
A suggested addition to this design would be the widening along the northeast side of US 9 between the separated roadways on Route 236. The widening should vary in width from approximately 6 ft. to the southeast point of the island to zero at the northwest point of the island. It appears in the photograph that this area has been subject to travel either by vehicles traveling northwest on US 9 or by southeastbound traffic on US 9 negotiating a prohibited left turn into Route 236.

- 2. J. A. REDMAN - This design is good and adequate in all respects. The restriction in number of turns makes a simple intersection possible. The use of grass for the island area without use of curbs is attractive in appearance and makes passing of stalled vehicle possible.
