# Pavement Design of Gantry Crane Lanes for the Port of Portland

C. A. Bell  
R. G. Hicks  
Transportation Research Institute, Oregon State University  
Corvallis, Oregon

The pavement design of gantry crane lanes for the principal container facility of the Port of Portland is described. The pavement design was required to replace deteriorated sections of portland cement concrete pavement in an area subject to heavy trafficking. Traffic included forklift trucks and regular trucks as well as gantry cranes with wheel loads of as much as 80,000 lb. Alternate portland cement concrete and asphalt concrete pavement designs were investigated, and an evaluation of construction and drainage considerations and joint sealants was made. The alternate designs were investigated using layered elastic analysis and finite element techniques. Critical responses were compared with allowable fatigue criteria to estimate design life. The favored alternate design was 22 in. of reinforced portland cement concrete. Work began in June 1985 to replace the deteriorated sections with this alternate in three out of eight container storage areas. To minimize disruption of the facility, the storage areas are be

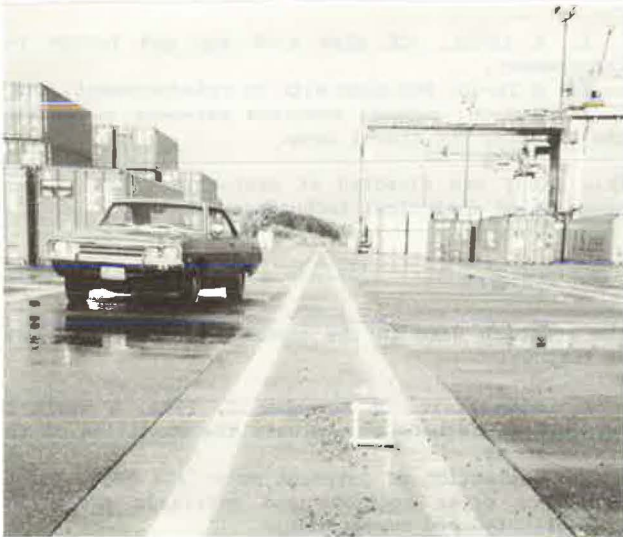
1. Longitudinal cracks in the concrete slab (Figure 1), followed by transverse cracks, followed by spalling in the center crack in the lane;

FIGURE 1 Longitudinal cracking of slab with subsequent spalling.

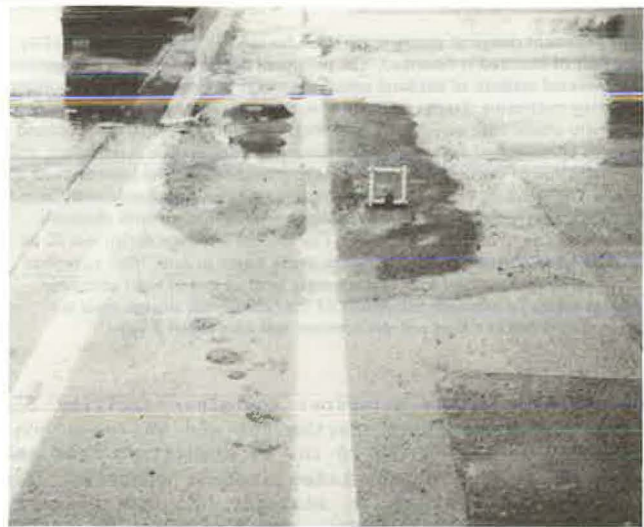
3. Patching of slabs with asphalt concrete (Figure 3); and

FIGURE 3 AC patching of slab deterioration.

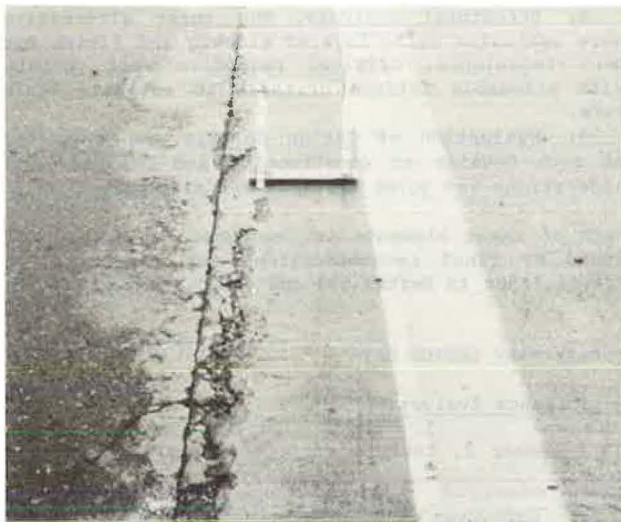
2. Minor spalling of the longitudinal joint between the PCC and the asphalt concrete (AC) (Figure 2);

FIGURE 2 Spalling of longitudinal joint between the PCC slab and the asphalt concrete.

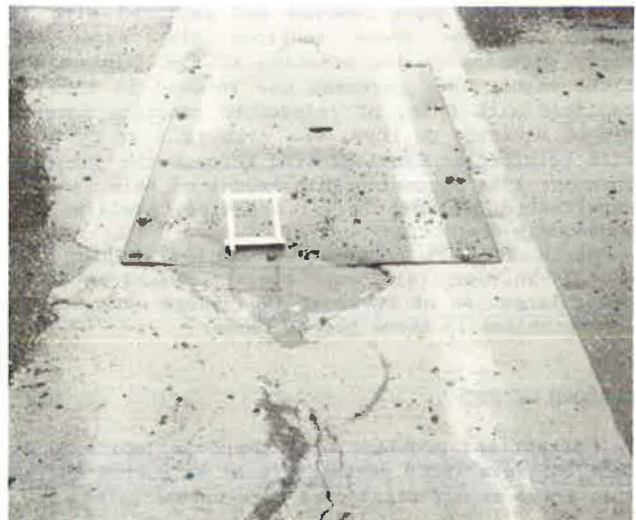
4. Patching of slabs with metal plates (Figure 4).

FIGURE 4 Patching of slab with metal plate.

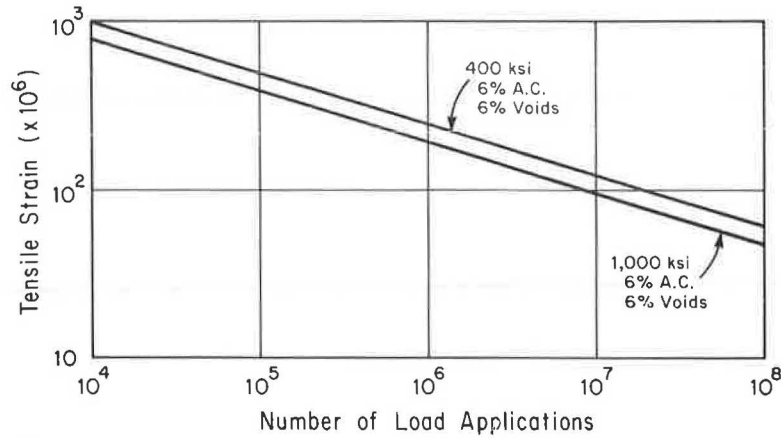
Fatigue curves for asphalt concrete as a function of modulus are shown in Figure 5.

FIGURE 5 Fatigue relationship for asphalt concrete [MS-1 (3)].

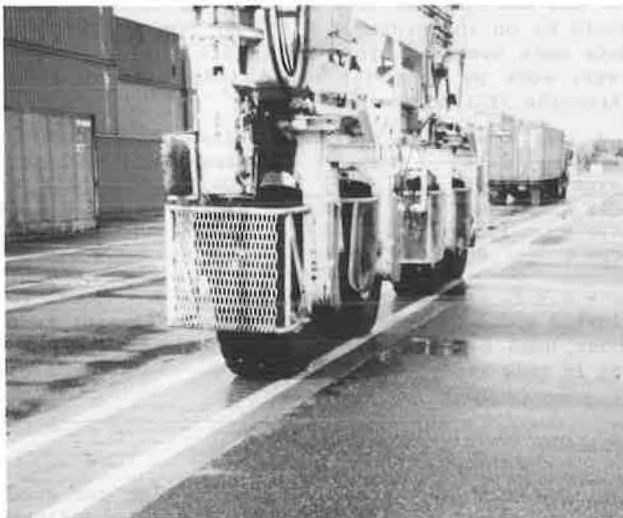
1. Several types of gantry cranes that operate directly on the concrete slab (Figures 6 and 7); these are all rubber-tired vehicles.

FIGURE 6 Gantry cranes operating on PCC slab.

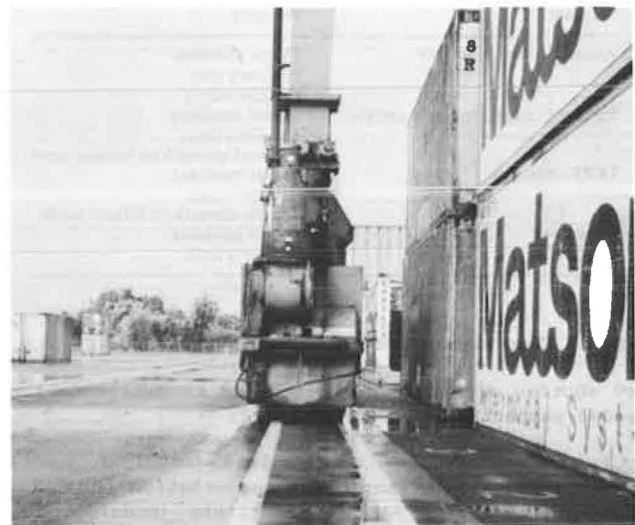
FIGURE 7 Second view of gantry crane operating on PCC slab.

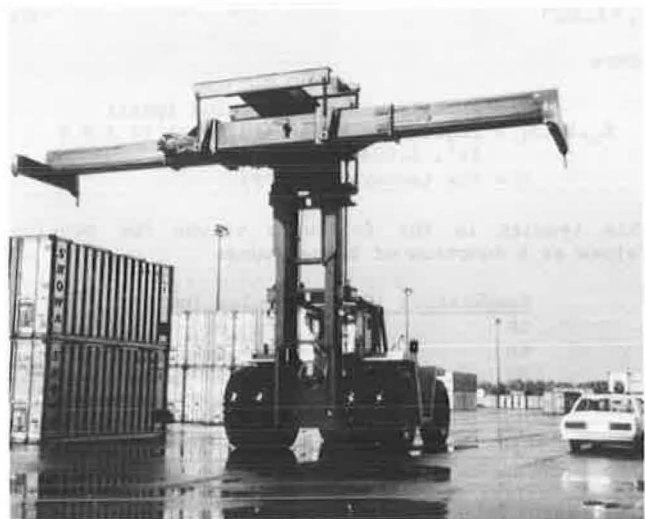
2. Several types of rubber-tired forklifts that operate either parallel to or at angles to the concrete travel lanes (Figure 8).

FIGURE 8 Other vehicles operating in Terminal 6 area.

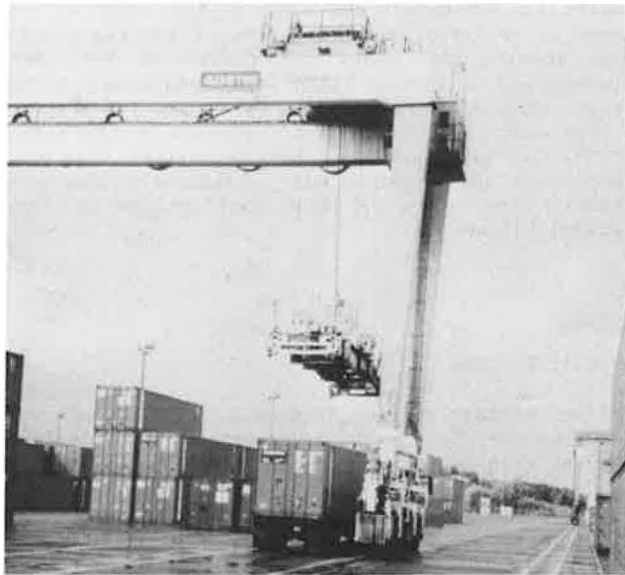
3. Fully loaded trucks that operate either parallel to or at angles to the concrete slab (Figure 9).

FIGURE 9 Second view of other vehicles operating in Terminal 6 area.

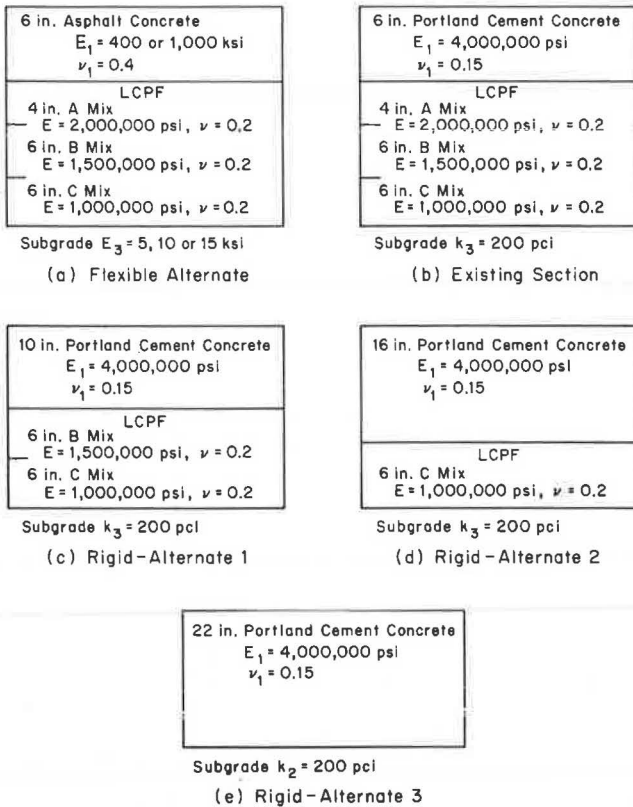
The analyses used in both models assumed the material properties and cross sections shown in Figure 11. The loads and contact areas for each vehicle and analysis are shown in Figure 12. In the case of the

FIGURE 11 Cross sections for pavements analyzed.

For the asphalt section (Figure 11), ELSYM5 was used to calculate the tensile strain in the asphalt layer and the tensile stress in the LCPF for four vehicles:

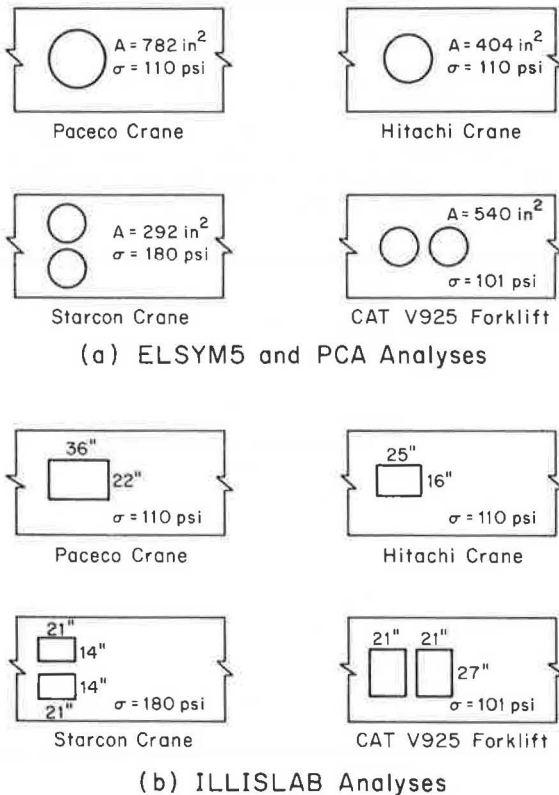
FIGURE 12 Design footprints for vehicles.
