## SAFETY APPURTENANCE DESIGN AND VEHICLE CHARACTERISTICS

*Barry D. Stephens*  
*Energy Absorption Systems, Inc.*

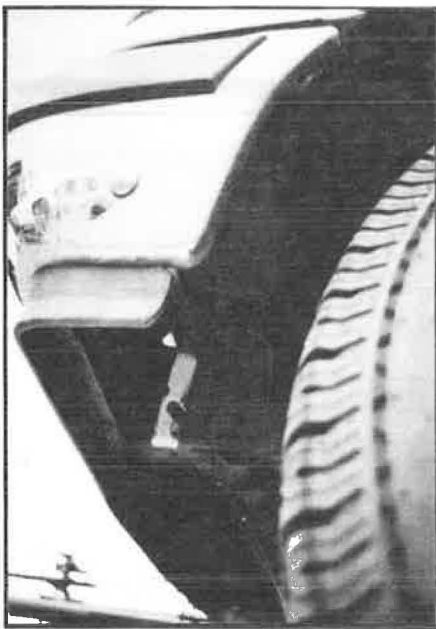
FIGURE 1 1990 Ford F250 front bumper reinforcement.

reinforcement, depicted in Figures 1, 2, 3, and 4. In this example, a comparison is made between the Ford F250 and the Chevrolet 2500. Both types of front bumpers are equipped with reinforcing braces. The Chevrolet 2500's lateral brace ties into the side of the truck frame. The Ford's reinforcing braces tie back into the bumper itself. The Chevrolet design is inherently stronger due to the triangulation of the bumper, bracket, and truck frame. The Chevrolet's bumper appears to offer more protection for the front wheel of the vehicle. Vehicles with better lateral bracing of the front bumper experience less front wheel snagging during offset and angled impacts.

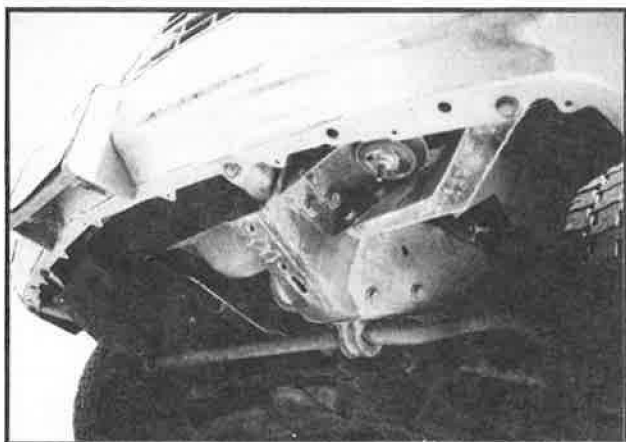
FIGURE 3 1989 Chevrolet 2500 front bumper reinforcement.

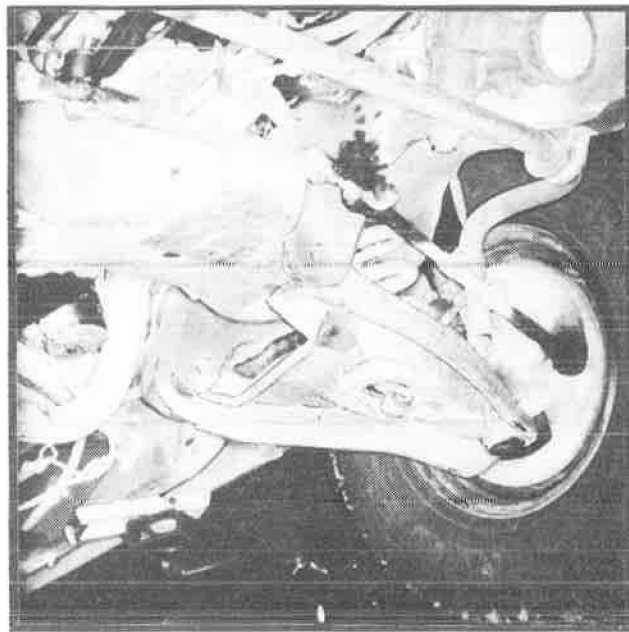
FIGURE 7 1989 Chevrolet 2500 front suspension.

depicted in Figures 5, 6, 7, and 8. In this example, a comparison is made between "I-beam" and "Wish-bone" suspensions. Experience has shown that when the "I-beam" suspension's vertical strut fails during severe front-angled impacts, upward loading can be imparted

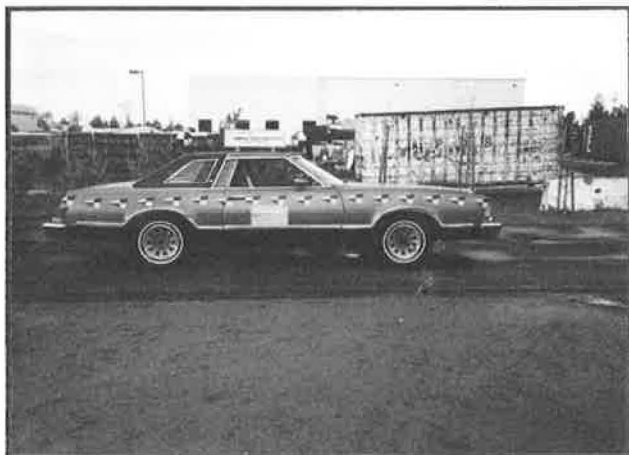
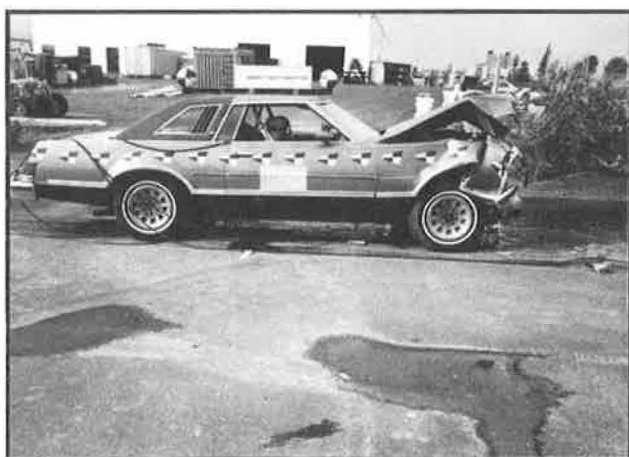
FIGURE 17 Before and after front end crush of a 4500S vehicle.

approximately 5% of the vehicle's kinetic energy. Using the crush of the 4500S vehicle plus the stroke of the attenuator, a designer could design the shortest practical system to meet the occupant risk criteria recommended by NCHRP 230. The front ends of 2000P vehicles are much stiffer and do not have as much overhang as the 4500S cars. Thus, they do not have the ability to safely absorb as much kinetic energy. Consequently, to meet the new NCHRP 350 standards, attenuators will need to be made longer or collapse more efficiently to dissipate the extra energy not safely absorbed by the crush of the 2000P vehicle. The variations in the front end crush between the 4500S and the 2000P vehicles can be seen in Figures 17 and 18.

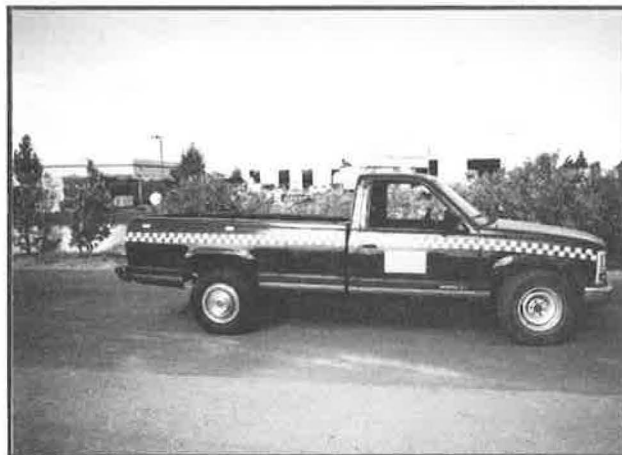
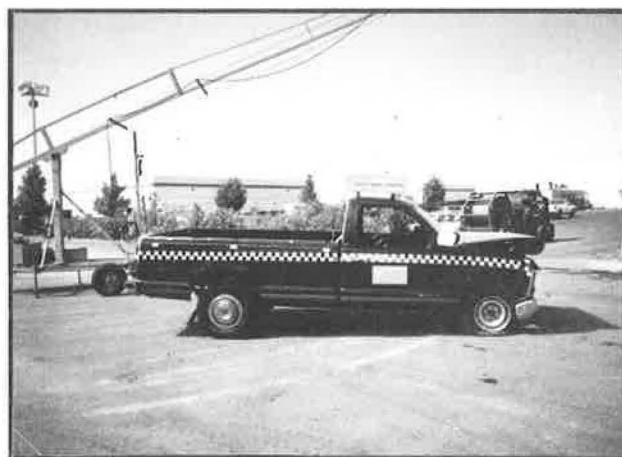
FIGURE 18 Before and after front end crush of a 2000P vehicle.

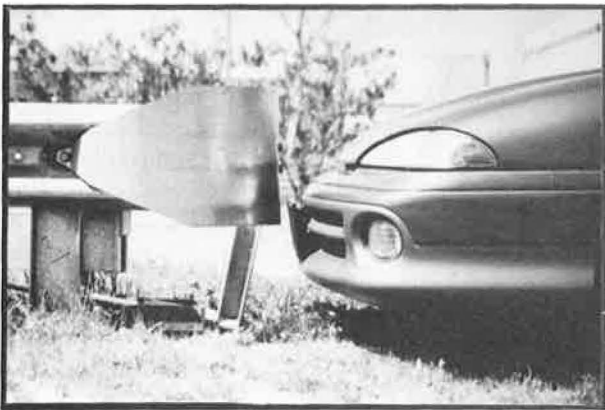
**FIGURE 20** Variation in vehicle bumper heights.

Figures 19 and 20 represent a picture study of typical vehicles placed immediately in front of typical highway appurtenances. The depicted vehicles include a 1988 Ford Festiva, a 1990 Ford F250 pickup, a 1994 Dodge Intrepid, and a 1991 Dodge Stealth. The highway appurtenance shown in Figure 19 is a cut away of a typical 320 kg (700 lb) inertial barrel showing the proper fill height for the sand. The highway appurtenance shown in Figure 20 is a typical guardrail end terminal.

The conclusion that can be drawn from Figures 19 and 20 is that highway appurtenance designers must

optimize their designs to accommodate a wide range of front bumper heights as well as vehicle shapes. The height of the front bumpers, measured to the center, ranges from 41.9 cm (16.5 in) for the Intrepid to 65.4 cm (25.75 in) for the Ford F250. Vehicles with low bumper heights combined with the currently popular aerodynamic wedge shape have a greater tendency to "nose dive" under some devices. "Nose-diving" can lead to possible windshield penetration and, because the safety device's energy dissipation capabilities are not efficiently utilized, the vehicle may impact the hazard at a higher-than-normal rate of speed. Vehicles designed to have high ground clearance combined with high front bumpers have a greater tendency to ramp. A ramping vehicle will not be decelerated efficiently by highway appurtenances, which can result in possible high-speed

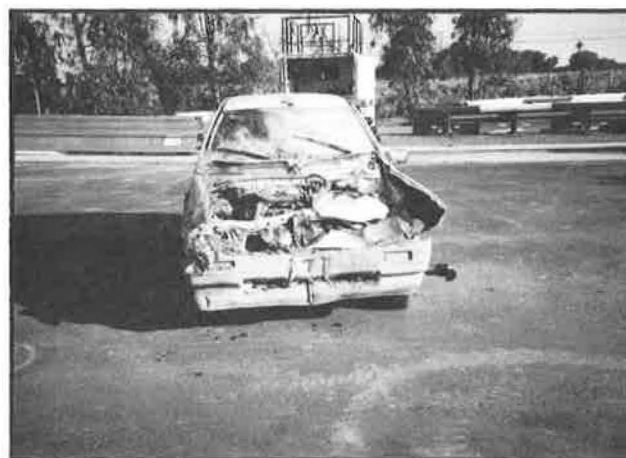
**FIGURE 21** 1988 Ford Festiva with missing hood after impact into inertial barrel array.

Figure 21 depicts the after test results of a subcompact vehicle impacting an inertial barrel array at 100 kph (60 mph). Note that the vehicle's hood is missing. Experience has shown that some vehicles, especially low-cost, light-weight, subcompacts have hood latches and

hinge mechanisms that are not structurally adequate enough to keep the hood attached during certain types of relatively safe, low g impacts. This characteristic is not so much a flaw of highway safety hardware, but instead, is an undesirable characteristic of the impacting vehicle. This is a problem that needs to be addressed by the automotive design engineers.
