TRANSPORTATION RESEARCH RECORD

Highway Maintenance Equipment and Employee Protection

QUIET PAVEMENT BREAKING RESEARCH AND DEVELOPMENT AT THE INSTITUTE OF GAS TECHNOLOGY SINCE 1962

George M. Long, Institute of Gas Technology, Chicago

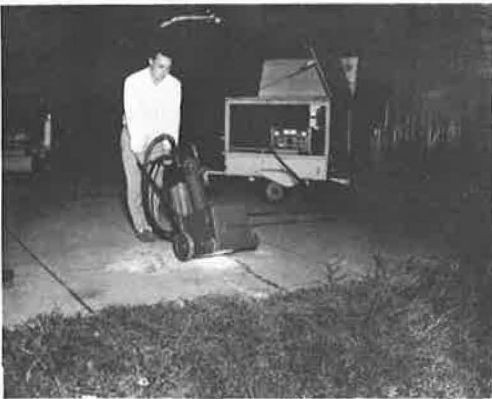
Figure 2. Plasma torch cart with sound-attenuation housing.

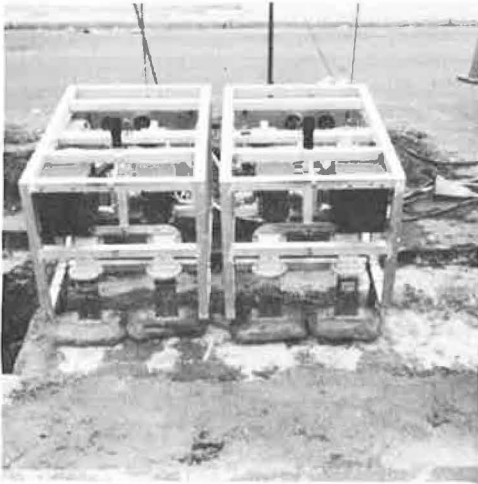
Figure 5. Microwave applicator modules.

From this work several microwave applicators were designed, constructed, and tested. All of them were to alleviate the necessity of predrilling a hole as required for the probe type of applicator. One, a multihorn applicator design, was selected for further development because its linear alignment allowed crack location and direction to be reasonably well controlled.

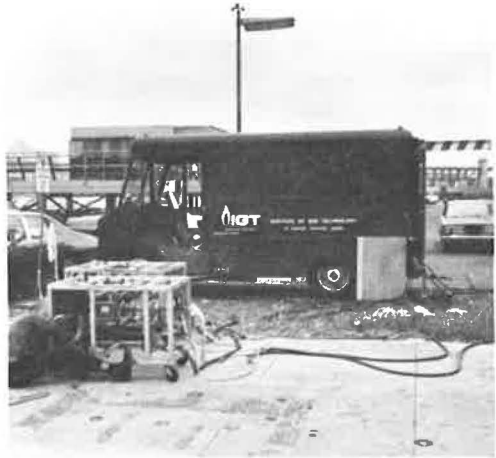
Figure 6. Microwave van.

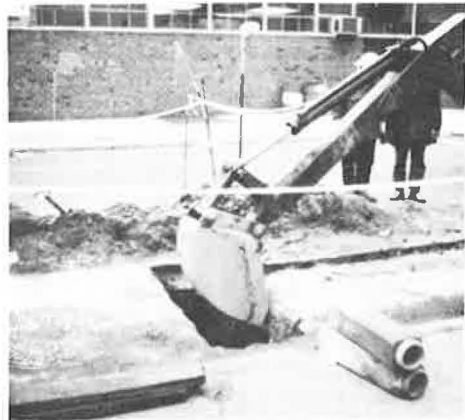
Figure 8. Backhoe removal of microwave-cracked concrete from a free edge.

and could be readily removed with a backhoe when working from a free edge as a starting point (Fig. 8).

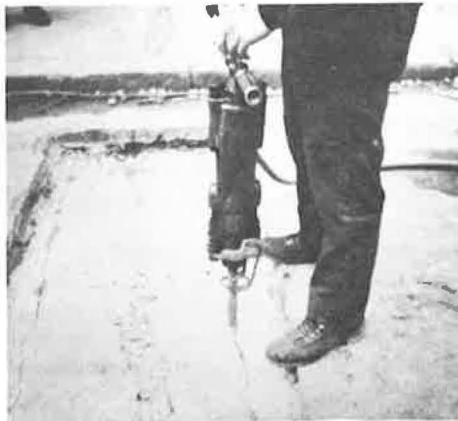
Figure 9. Use of an air hammer to break away microwave-fractured concrete.

2. If no free edge was available, as would be true for a midstreet repair hole, conventional tools (e.g., air hammers) were needed to provide room for the cracked, but interlocked, concrete to separate. Conventional tool use, however, was reduced to one-fifth to one-third the time required without microwave cracking (Fig. 9).

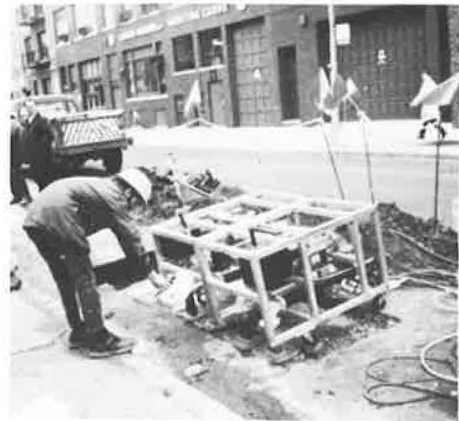
Figure 11. Checking for stray microwave radiation.

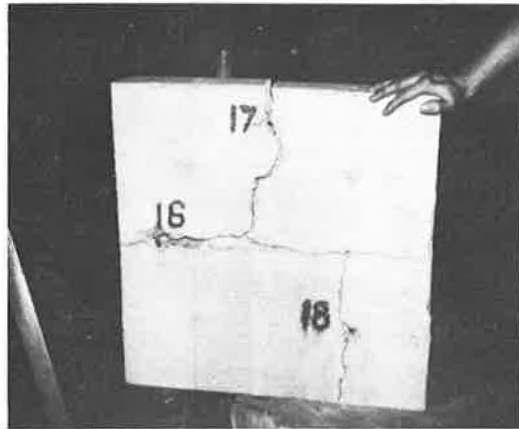
Figure 12. Results of three water-jet shots on microwave-cracked concrete.

High-pressure water jets are being investigated, tested, and constructed as a companion to the microwave concrete-breaker. When concrete samples were preweakened with microwave-induced cracks, water-jet shots effectively exploited those cracks (Fig. 12) and overcame the interlock problem caused by the uneven surface of the crack plane.

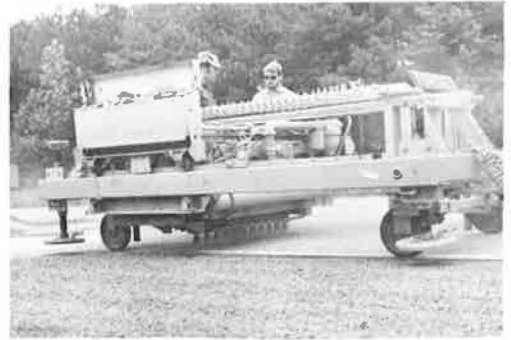
Figure 3. Klarcrete machine in operation.

The Klarcrete general-purpose concrete repair machine removes the pavement surface by employing 11 percussive hammers that operate independently, each striking the pavement approximately 1,500 blows/min. The machine operates on compressed air and requires at least a 600-ft³ (17-m³) per min compressor capable of producing 100 lb/in.² (689 kPa) of compressed air. The hammers are 2¼ in. (57.2 mm) in diameter and 2¼ in. apart. They are mounted on a carriage that allows vertical movement and that in turn is attached to a transverse carriage that allows lateral movement. The lateral movement is necessary to get uniform removal of concrete over the width of operation. The width of cut can be varied from 4½ in. (114.3 mm) (diameter of cutting head plus space between cutting heads) to 49½ in. (1.3 m) in 4½-in. (114.3-mm) increments by adding or deleting individual cutting heads. Figure 1 shows the configuration of the cutting heads. The cutting heads, which require no lubrication and are free to rotate, break the concrete into small particles of a gradation not much larger than dust and cause no damage to the surrounding concrete. A person standing on the pavement beside the machine while it is in operation can notice the vibrations, but they are not great. The machine removes the surface by the number of impacts rather than the force of individual impacts. When the object is to remove the top surface of the concrete in a continuous sweep, the machine travels slowly forward under its own power. The depth of removal of concrete depends on the forward speed of the machine. A small pneumatic motor attached to the left rear wheel allows automatic operation and permits the towing of a compressor power source.

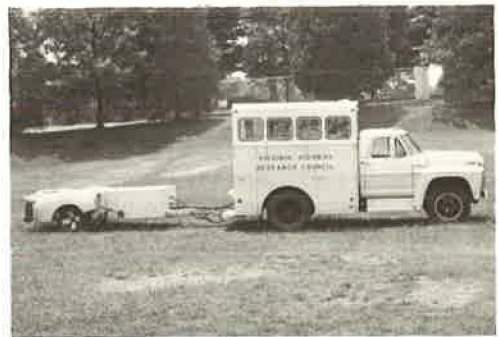
Figure 10. The Virginia Highway Research Council's skid-resistance measurement vehicle.

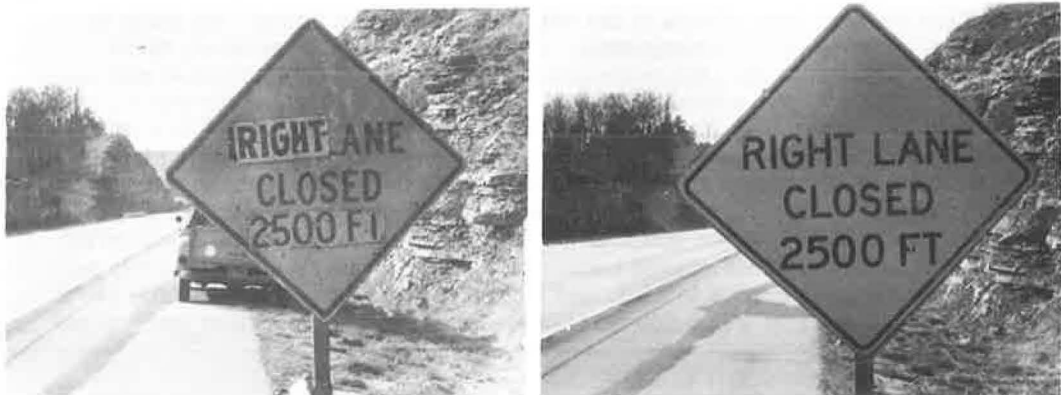
Figure 4. Contractor's sign (left) as contrasted with test sign.

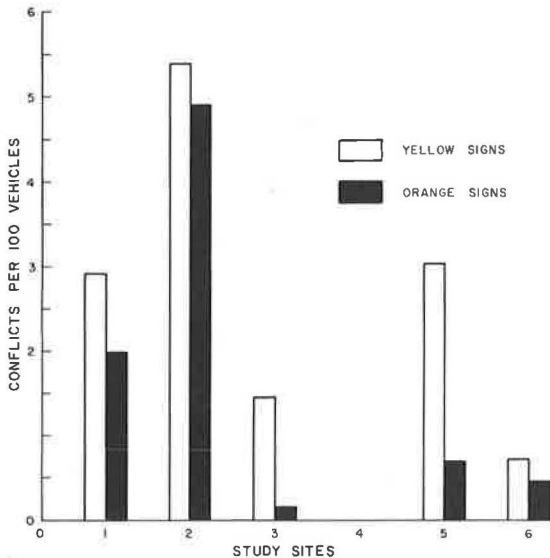
Figure 6. Conflicts per 100 vehicles at each study site (left-lane closures, Phase 2).

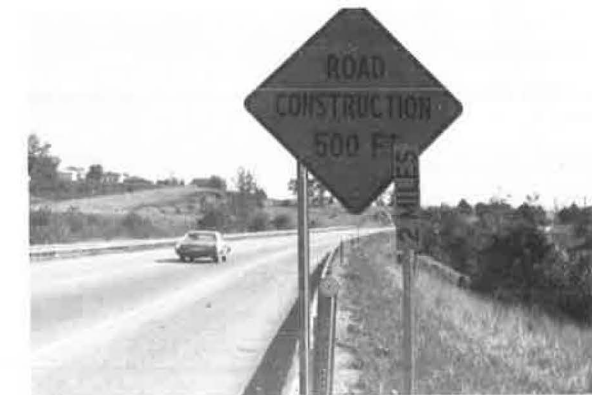
Figure 15. Errors that cause confusion and disrespect for warning signs.

maintenance or lane closure ahead. This practice also creates disrespect for maintenance signs. Such signs should be neatly covered or removed when work is suspended.
