DEVELOPMENT OF A NEW MEDIAN BARRIER TERMINAL

Maurice E. Bronstad and Jarvis D. Michie, Southwest Research Institute

The objective of this research was to develop and evaluate a new median barrier terminal concept by a series of crash tests.

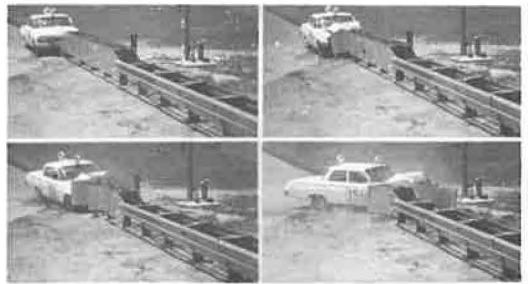
Figure 6. End-on impact of BCT-MB4W configuration.

In test 158, the five terminal posts were 6- \times 8-in. (150- \times 200-mm) southern pine members embedded in concrete footings; an MB4W system was installed downstream of the terminal. A standard-sized vehicle impacted the barrier end-on at a speed of 64.8 mph (104 km/hour) and was decelerated to rest in contact with the barrier as shown in Figure 6. The effective stopping distance was 22 ft (6.7 m).

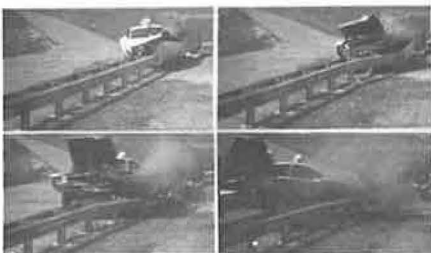
Figure 9. Angle impact of BCT-MB4S configuration.

Crash test evaluation of the finalized median barrier BCT configuration was conducted with standard sedans impacting the barrier upstream of the third terminal post with standard impact conditions [i.e., 4,000-lbm (1800-kg) vehicle, 25 deg, 60 mph (97 km/hour)]. Tests were conducted with the BCT installed with the MB3 and MB4S. The transition from the BCT to the box-beam median barrier was effected as shown in Figure 7. Although significant rolling occurred, which caused the test vehicle to ride up the barrier, the vehicle was redirected (Fig. 8). The BCT-MB4S system installation was impacted upstream of the third post, and the vehicle was then redirected as shown in Figure 9.

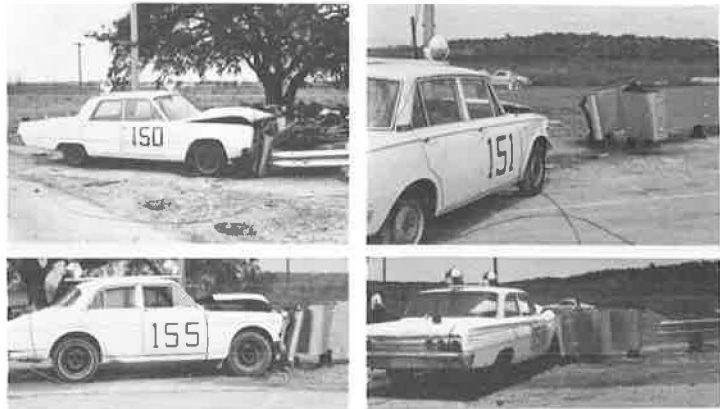
Figure 10. Photographs after end-on tests.

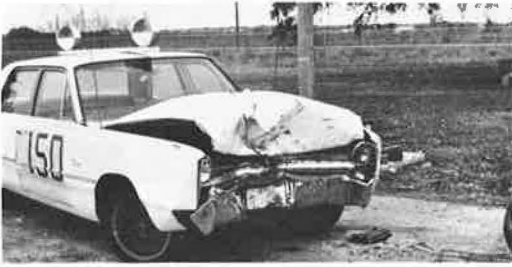
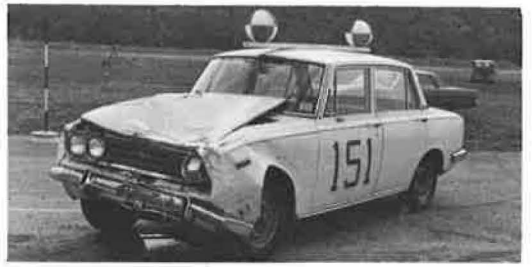
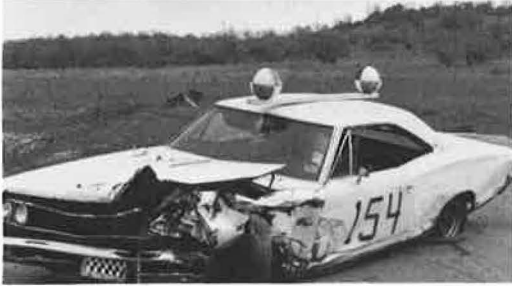
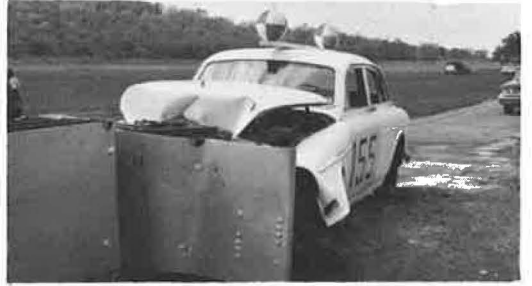
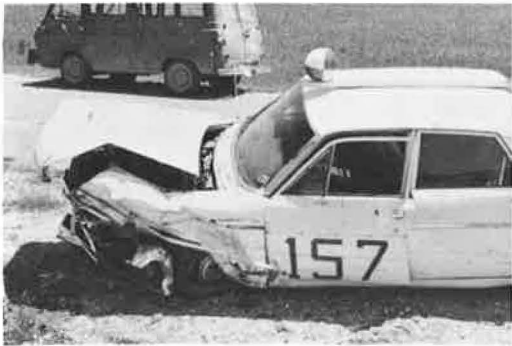
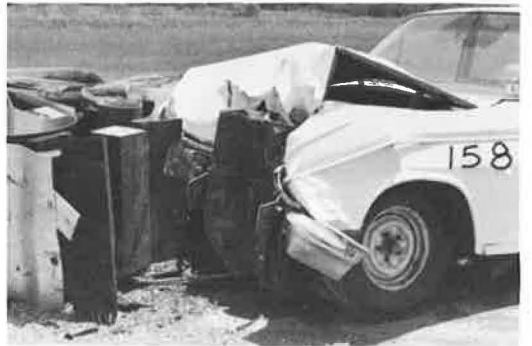
Figure 12. Vehicle damage.

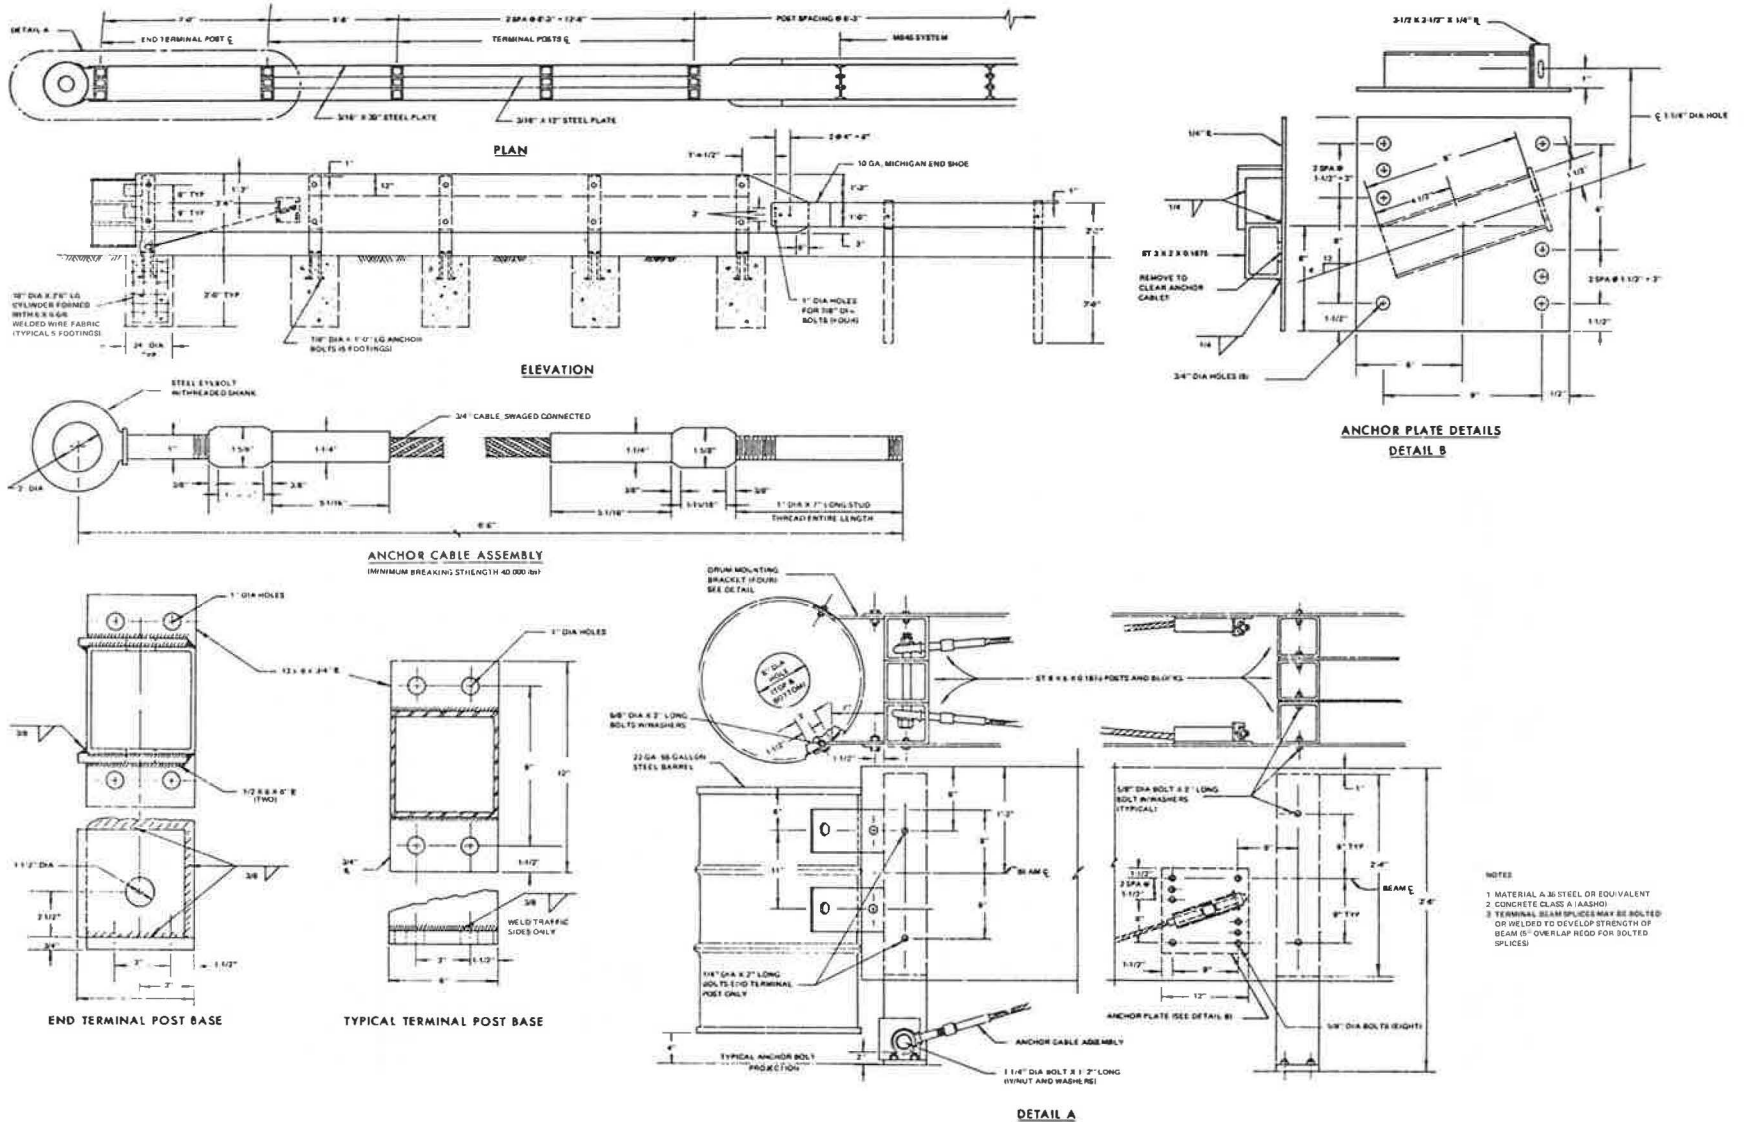
Figure 13. Median barrier BCT design drawing.

The finalized BCT configuration as shown in Figures 3 and 13 (Appendix) is characterized by the following features and components: terminal length, beams, posts, nose, and BCT hardware.

Terminal posts were of the same material as the system. A design drawing of the BCT installed with the MB4S system is shown in Figure 13. Also shown in the Appendix are photographs of the test series.
