CRASH TEST EVALUATION OF THRIE BEAM TRAFFIC BARRIERS

M. E. Bronstad and J. D. Michie, Southwest Research Institute;
J. G. Viner, Federal Highway Administration; and
W. E. Behm, Anderson Safeway Guard Rail Corporation

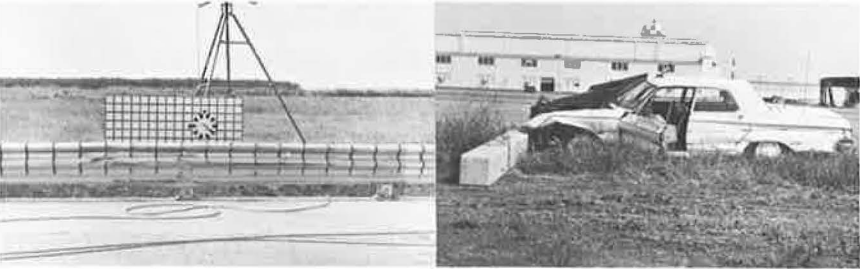
About this time, a test (T1-D) was conducted on a bridge rail that used two standard W sections overlapped (6). This 18-in. (0.5-m) deep rail is shown in Figure 1a after a 60-mph (97-km/h), 25-deg impact with a 3,600-lbm (1.6-Mg) vehicle (test T1-D), and the vehicle is shown in Figure 1b. The results of a similar test (T1-B) with a normal 12-gauge W section without the second overlapping section are shown in Figure 2. In this case, the 18-in. (0.5-m) deep overlapped W rails clearly reduced both vehicle damage and barrier damage (6). Thus, FHWA staff speculated that such an 18-in. deep section might help solve the problems noted in the G2 guardrail system.

Figure 1. Barrier and vehicle damage after test T1-D.

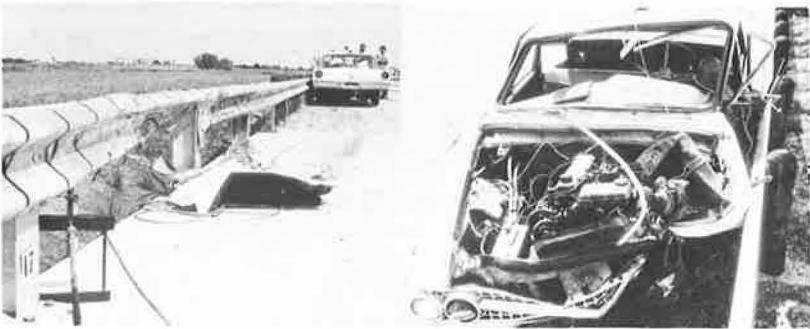
Figure 2. Barrier and vehicle damage after test T1-B.

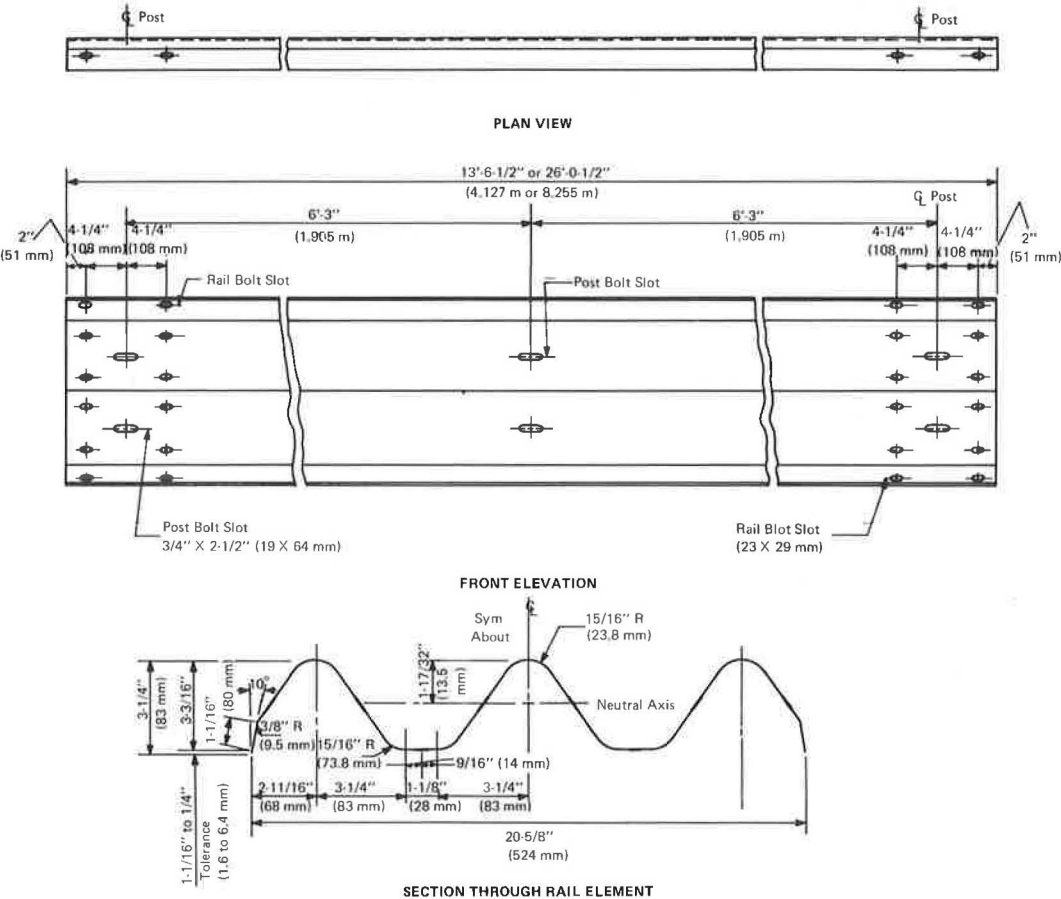
Figure 3. Thrie beam geometry.

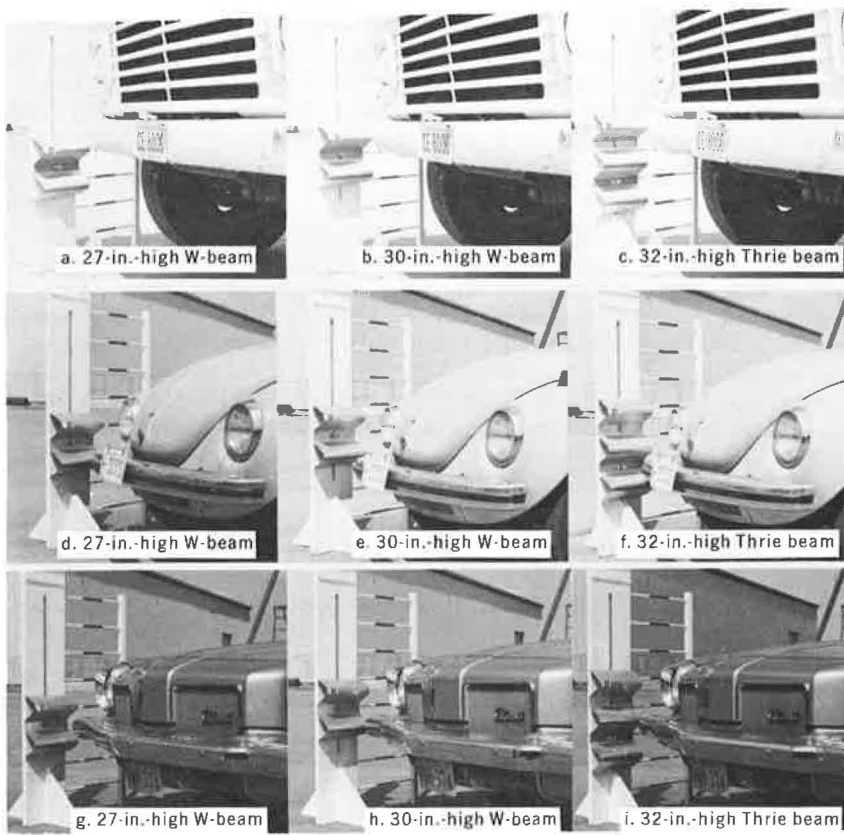
Figure 4. Bumper-beam interface.

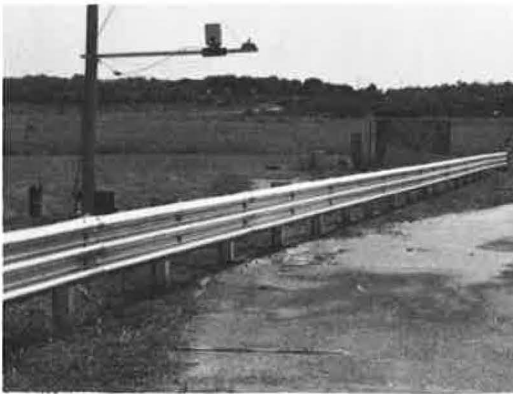
Figure 5. Installation for test AS-1.

The cost of the channel rub rail element is significant—as much as 25 percent more than the W-beam element. The function of the rub rail could also be served by increasing the depth of the W-beam. Accordingly, AS-1 test conditions (Fig. 5) were formulated to permit comparison of the Thrie beam installation with California test 103, which featured the standard W-beam mounted on 8 × 8 timber posts with a channel rub rail (8).

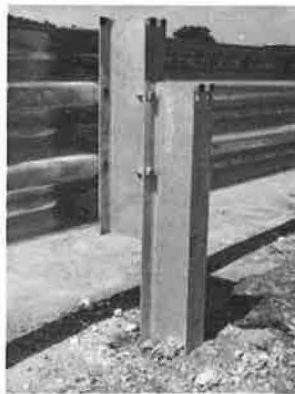
Figure 6. Installation for test AS-2.

The Thrie beam is proposed as a higher warranty barrier, affording better protection for a greater range of vehicles. Because 24-in. or less barriers warrant upgrading, it would be desirable to salvage as much of existing installations as possible in an upgrading program. Hence, test AS-2 was devised to evaluate performance of the 32-in. (0.8-m) Thrie beam system mounted on short posts (Fig. 6) as would occur with upgrading an existing installation by using the in-place posts. Of particular interest was the effect of the block-out projecting 6 in. (150 mm) or more above the top of the post.

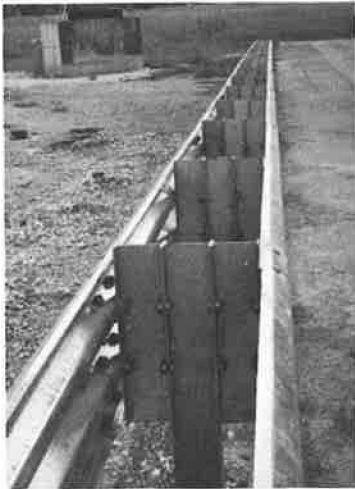
Figure 7. Installation for test AS-3.

The standard test conditions originally outlined in HRB Circular 482 (9) characterized by a 4,000-lbm (1.8-Mg) vehicle and 60-mph (97-km/h), 25-deg impact are considered to constitute a strength test of the barrier; i.e., these conditions permit evaluation of the capacity of the barrier to restrain and redirect a vehicle impacting at these conditions. It is conjectured that impact angles of 15 deg or less represent the preponderance of actual impact angles. Test AS-3 was designed to evaluate dynamic performance of the 32-in. (0.8-m) Thrie beam median barrier system when impacted by a 2,000-lbm (0.9-Mg) subcompact car at 60 mph from an angle of 15 deg. The installation for test AS-3 is shown in Figure 7

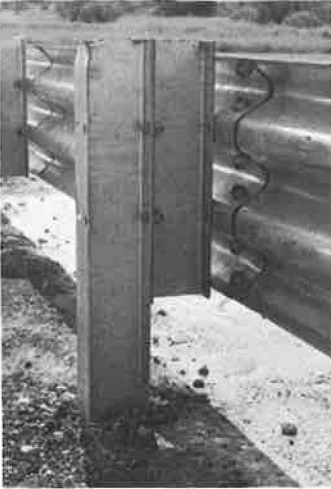
Figure 8. Installation for test AS-4.

The purpose of the test was to evaluate the performance of a 32-in. high Thrie beam guardrail system when impacted at 60 mph and 15 deg by a 4,000-lbm (1.8-Mg) vehicle. The test installation for AS-4 is shown in Figure 8.

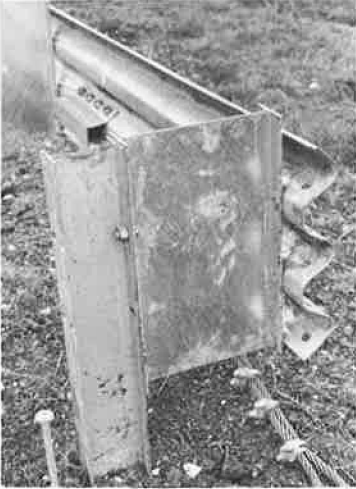
Figure 9. Installation for test AS-5.

The objective of this test was to evaluate the effectiveness of 14-in. (0.36-m) spacer used with 10-gauge (5.5-mm) Thrie beam in a guardrail installation. The M14 \times 17.2 spacer element was selected because of its compatible flange width with the standard W6 \times 8.5 post (Fig. 9). Standard crash test conditions were selected to evaluate performance of this increased spacer block depth; a goal of this test was to prevent wheel contact with posts.

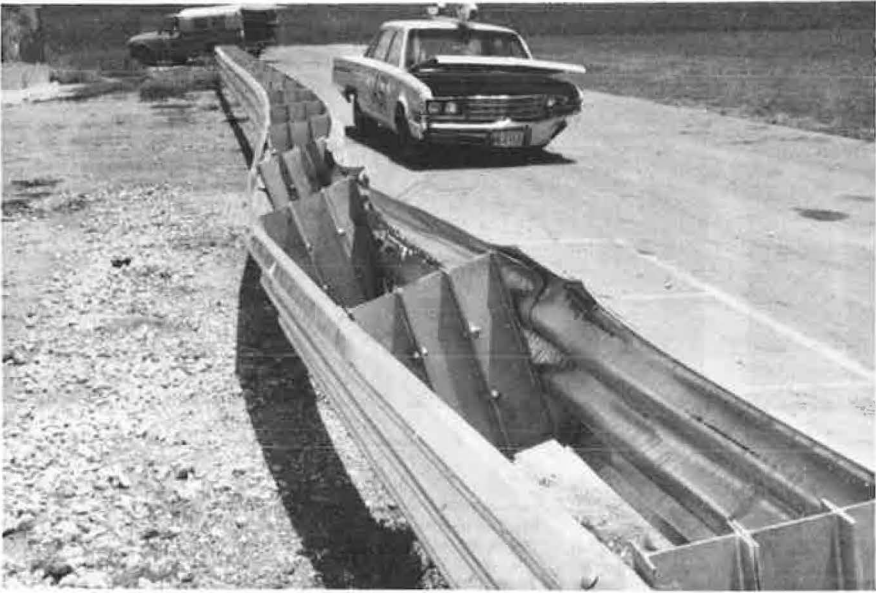
Damage to the installation included two rail sections between posts 10 and 14, spacer blocks at posts 11 and 12, and post 12. Maximum permanent rail deflection of 22 in. (0.56 m) occurred between posts 12 and 13. Vehicle damage was severe at the left front corner as shown in Figure 11.

Figure 11. Beam and vehicle damage after test AS-1.

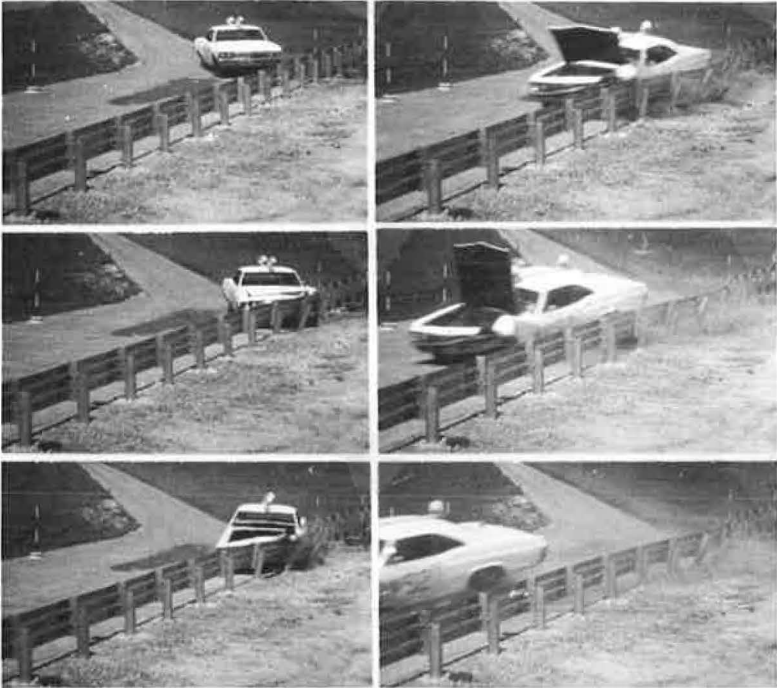
Figure 12. Test AS-2.

The 4,000-lbm (1.8-Mg) vehicle impacted the barrier downstream of post 10 at a speed of 67.1 mph (106 km/h) and an angle of 28.7 deg. The vehicle was redirected at a large exit angle as shown in Figure 12. Vehicle stability appeared to be good until the vehicle left the pavement. As the vehicle dropped off the pavement, the damaged left wheel plowed into the rain-soaked ground causing complete vehicle rollover; there was evidence of some wheel snagging on post 13.

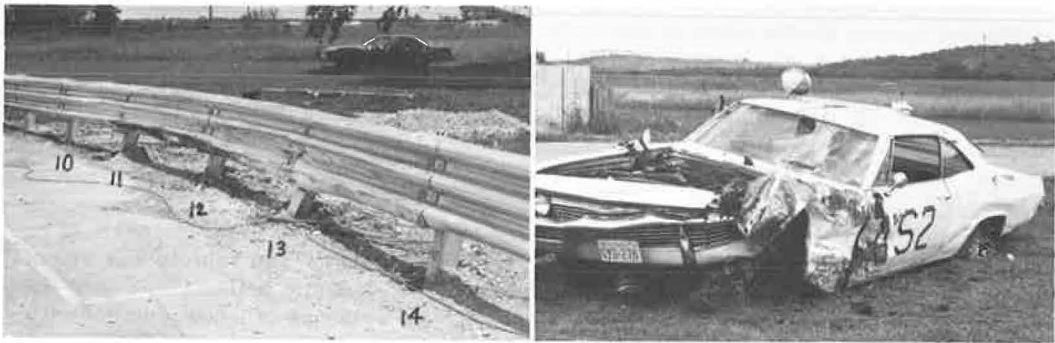
Damage to the barrier (Fig. 13) included two beam sections between posts 10 and 14. Although locally deformed near grade by the vehicle, post 12 was reusable. All posts and spacer blocks were judged to be reusable. There was no evidence of distress

Vehicle damage was severe because of the rollover; however, the passenger compartment was not deformed badly. Evidence of severe damage to the left corner of the vehicle (Fig. 13) is typical for strong-post guardrail systems under standard test conditions.

Figure 13. Beam and vehicle damage after test AS-2.

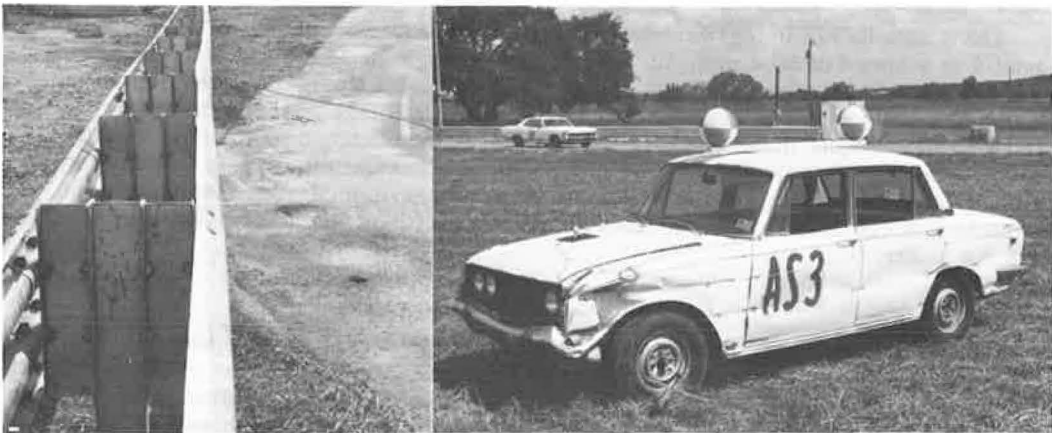
Barrier damage as shown in Figure 15 was insignificant. The vehicle was driven from the test site with minimal front-end damage.

Figure 15. Beam and vehicle damage after test AS-3.

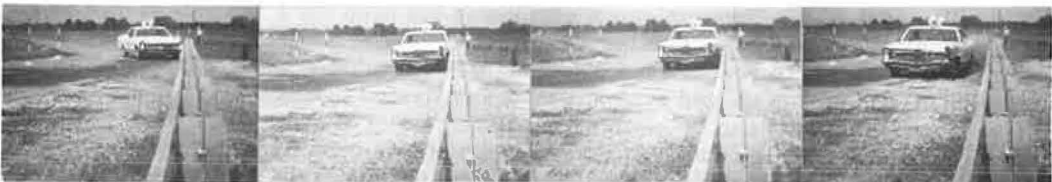
Figure 16. Test AS-4.

The 4,500-lbm (2.0-Mg) vehicle impacted the barrier 0.1 ft upstream of post 9 at a speed of 59.1 mph (95 km/h) and an angle of 15.9 deg. The vehicle was redirected as shown in Figure 16. No evidence of wheel contact with posts was noted, and the vehicle was very stable throughout the impact. Maximum dynamic deflection of 7 in. (180 mm) occurred between posts 9 and 10. Damage to vehicle and barrier was very moderate (Fig. 17). The left rear vehicle tire was cut during the post impact trajectory; otherwise, the vehicle was driveable and was driven back to the impact zone.

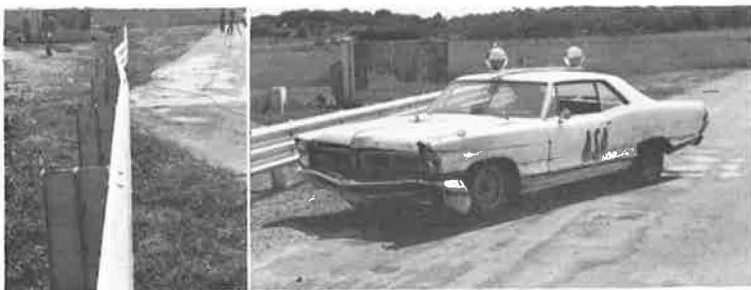
Figure 17. Beam and vehicle damage after test AS-4.

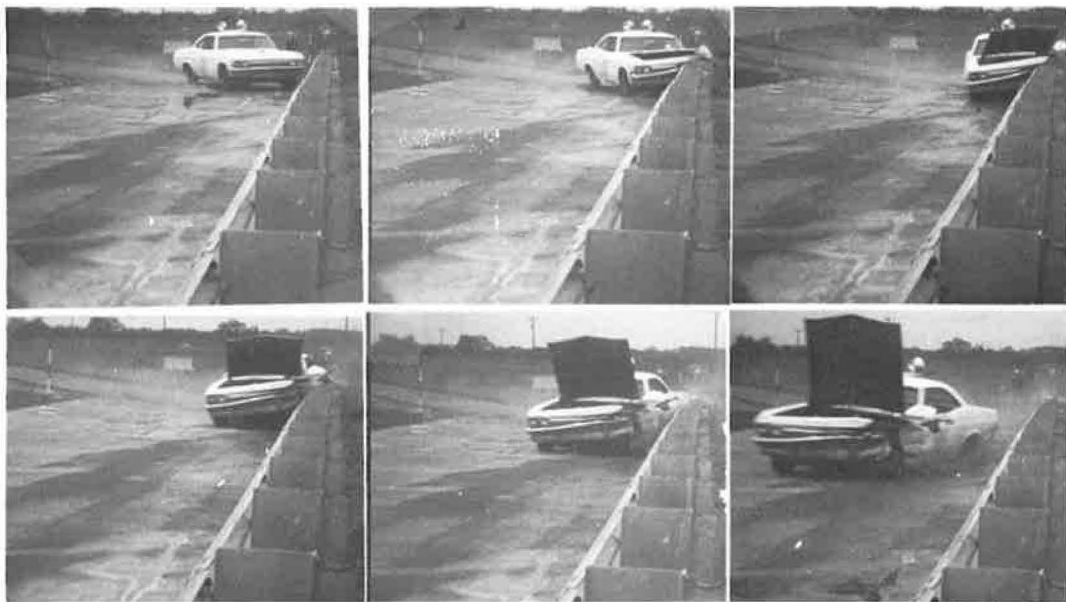
Figure 18. Test AS-5.

The 4,000-lbm (2.0-Mg) vehicle impacted the barrier 2.3 ft (0.7 m) downstream of post 9 at a speed of 56.4 mph (90.7 km/h) and an angle of 25.5 deg. The vehicle was redirected with no wheel-to-post contact (Fig. 18). Maximum dynamic deflection of 1.5 ft (0.56 m) occurred between posts 10 and 11. Damage to the barrier was limited to two rail sections inasmuch as most of the energy absorbed by the barrier was dissipated in beam flexure (plastic deformation) and translation of posts in soil (Fig. 19). No crushing or buckling of the 14-in. (0.35-m) spacers occurred. Damage to the vehicle was confined to the left front quarter; significant frame and suspension damage did not occur.

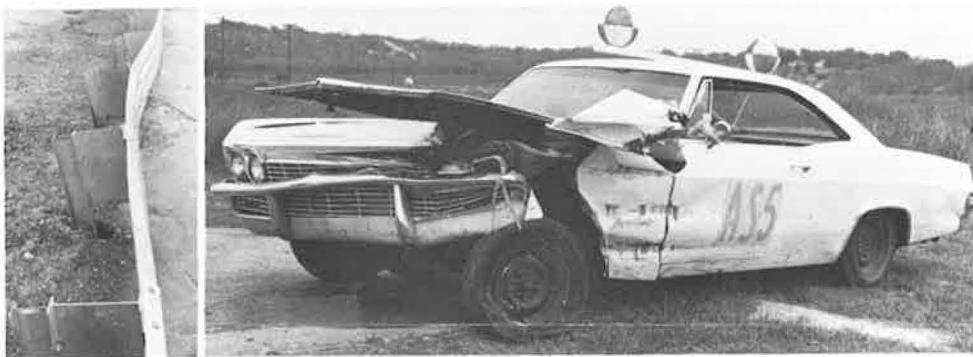
Figure 19. Beam and vehicle damage after test AS-5.
