TRANSPORTATION RESEARCH RECORD
488

Safety
Appurtenances

**11 reports prepared for the 53rd Annual Meeting
of the Highway Research Board**

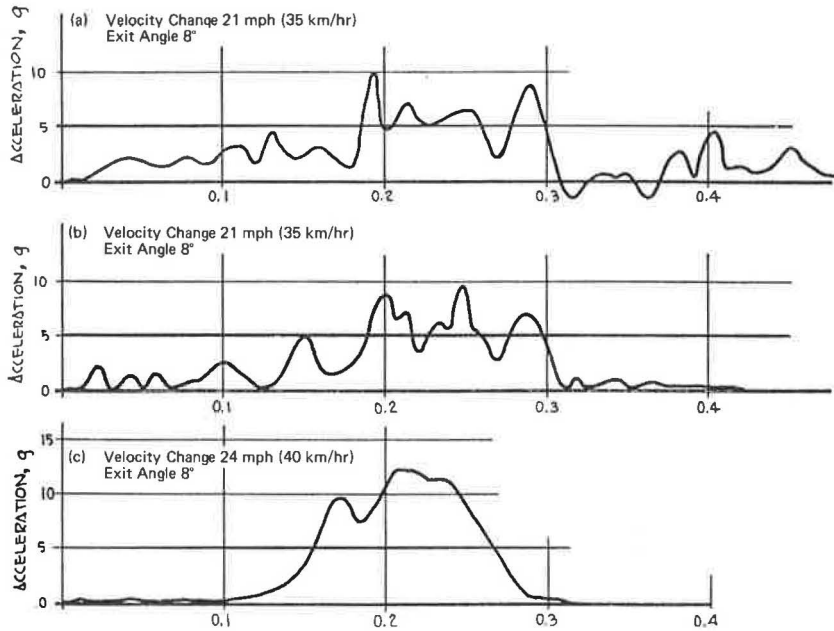
Figure 5. 20-deg angle impacts with standard-sized cars: (a) lateral and (b) longitudinal accelerations of 4,000-lbm vehicle traveling at 60 mph and (c) longitudinal acceleration of 3,700-lbm vehicle traveling at 68 mph.

In the first test, a 1960 Chevrolet Bel Air four-door sedan impacted at 68 mph (109 km/h) and 20 deg. The exit angle was 8 deg with the face of the unit, resulting in a 28-deg total change of direction. After impact the test vehicle followed a curving path back to the side of the road and came to rest 165 ft (50 m) from the point of impact. The left front quarter panel of the vehicle was severely damaged. The left front wheel was torn loose from the lower control arm. The change of velocity during impact was 24 mph (38 km/h). Unfortunately, electronic acceleration data were lost during this test.

Photographic data indicated a smooth redirection of the vehicle with a roll about the longitudinal axis of only 15 deg away from the barrier. The left side of the car rose approximately 1 ft (0.3 m) from the ground, but the right wheels remained on the ground throughout the test. Three side panels on the attenuator were moderately damaged, but they remained in place and were judged capable to resist further side impacts until replaced. Approximately 10 percent of the head-on energy-absorbing capability of the unit was destroyed during this angle impact, but the shear pins remained intact and kept the unit erect, thus preserving its capability to sustain another head-on or angle impact without maintenance.

A second test was run at 60 mph (97 km/h) to further demonstrate fendering capability. A 1962 Dodge four-door sedan weighing approximately 4,000 lbm (1800 kg) impacted the side of the unit at the same point and angle as before. The results were almost identical except that there was less damage to the attenuator and car. The exit angle of the second test car was 9 deg, compared with 8 deg for the first car. There was no roll about the longitudinal axis of the second test vehicle. The change of velocity during impact was 21 mph (34 km/h). The peak longitudinal acceleration was 10 g, with an average of less than 4 g during the 150-msec duration of highest deceleration. The peak recorded lateral acceleration was 10 g with 4.5 g average during the highest 150 msec.

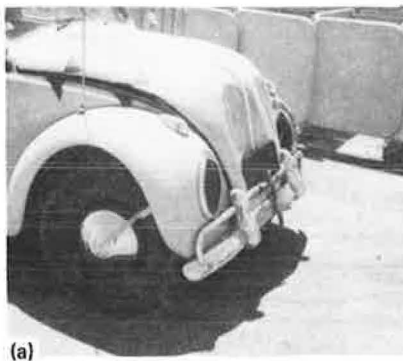
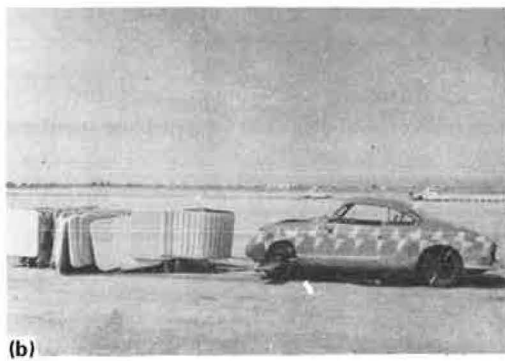
Figure 6. Subcompact cars after (a) 58-mph impact and (b) 50-mph impact.

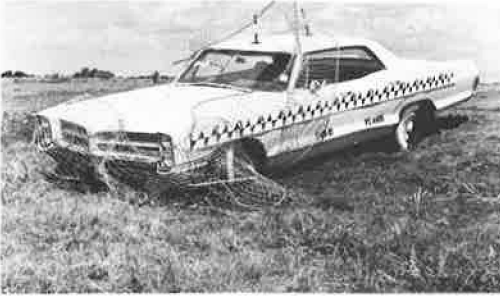
Figure 4. Vehicle after test D1 in which both tapes failed.

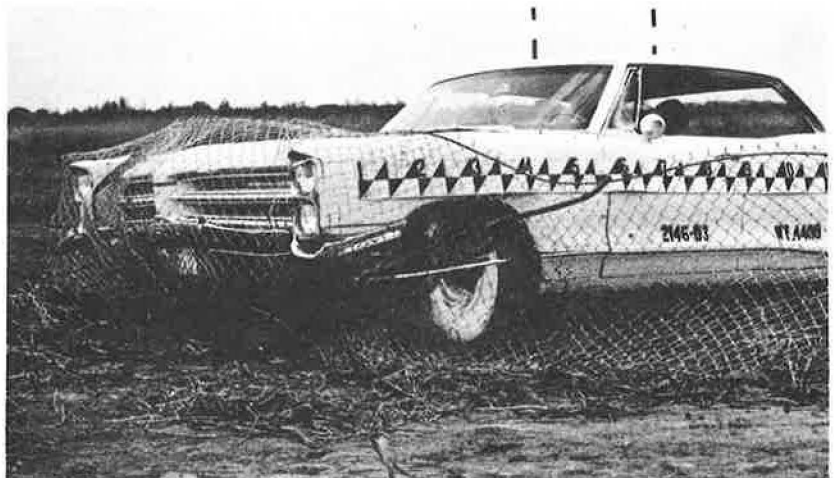
Figure 9. Vehicle entrapped in net after test D3.

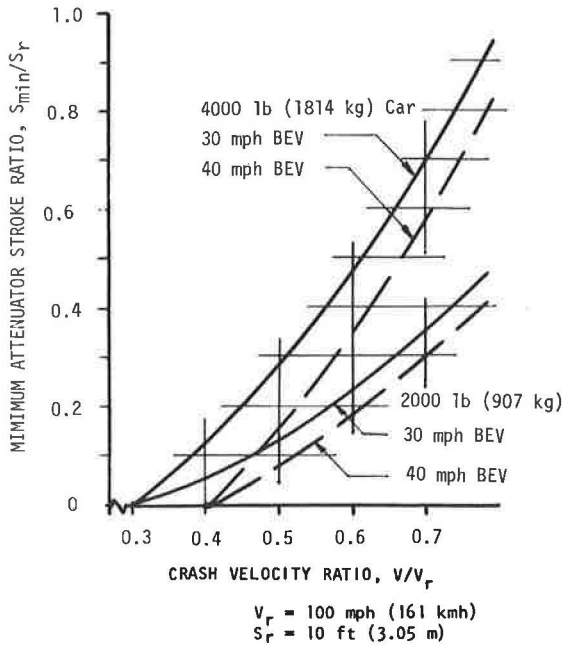
Figure 3. Minimum attenuator stroke versus fixed-object crash velocity ratio.

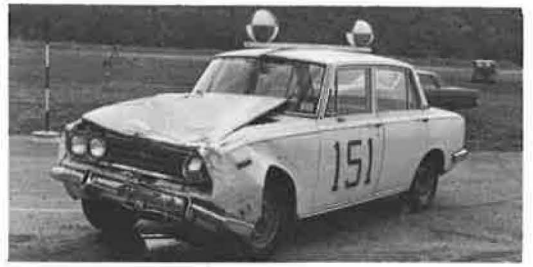
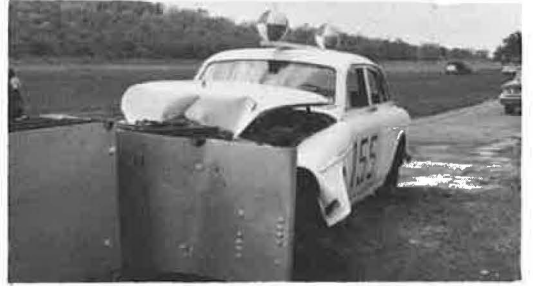
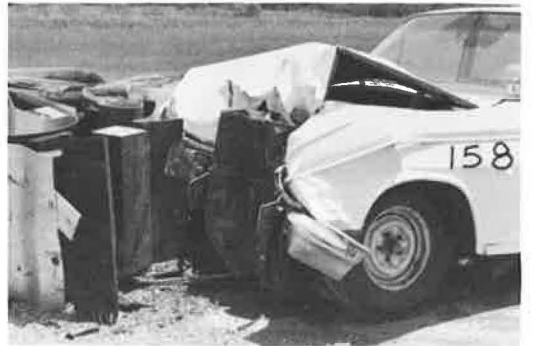
Figure 12. Vehicle damage.

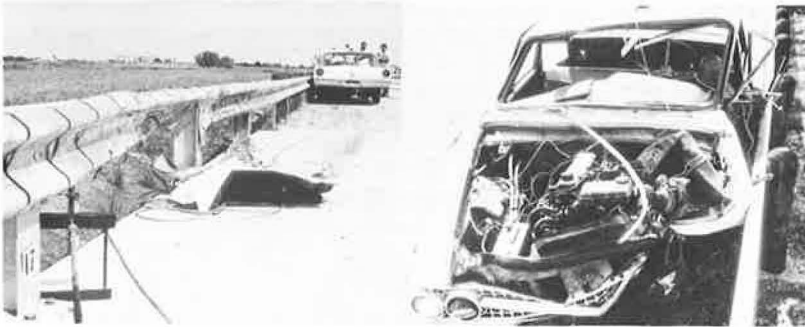
Figure 2. Barrier and vehicle damage after test T1-B.

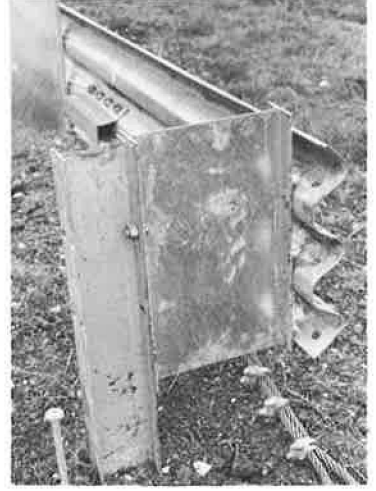
Figure 9. Installation for test AS-5.

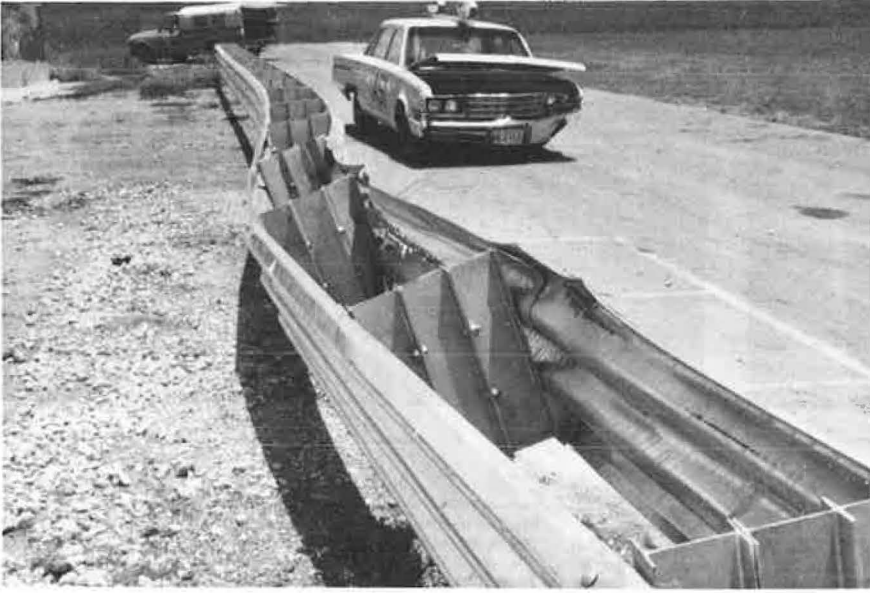
Figure 11. Beam and vehicle damage after test AS-1.

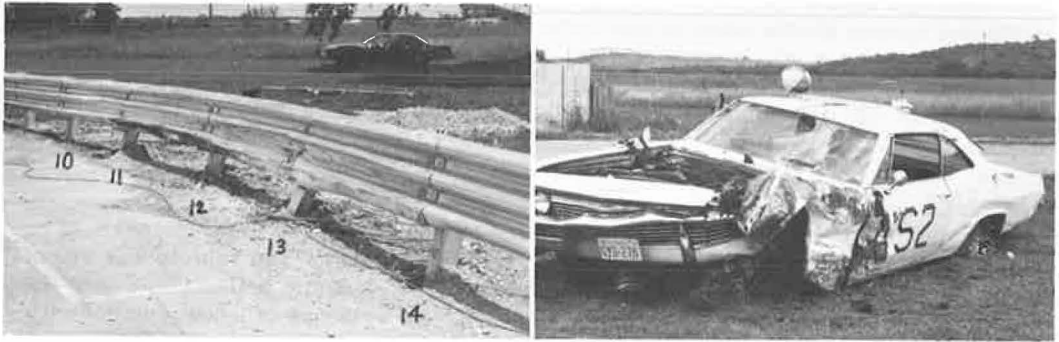
Figure 13. Beam and vehicle damage after test AS-2.

Damage to the barrier (Fig. 13) included two beam sections between posts 10 and 14. Although locally deformed near grade by the vehicle, post 12 was reusable. All posts and spacer blocks were judged to be reusable. There was no evidence of distress

Vehicle damage was severe because of the rollover; however, the passenger compartment was not deformed badly. Evidence of severe damage to the left corner of the vehicle (Fig. 13) is typical for strong-post guardrail systems under standard test conditions.

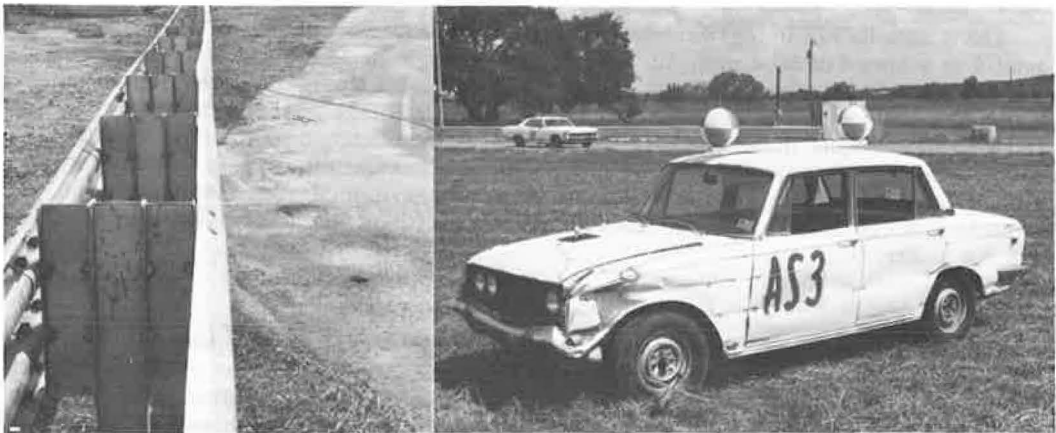
Figure 15. Beam and vehicle damage after test AS-3.

Barrier damage as shown in Figure 15 was insignificant. The vehicle was driven from the test site with minimal front-end damage.

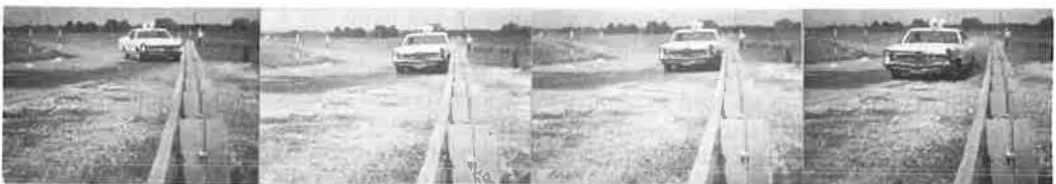
Figure 16. Test AS-4.

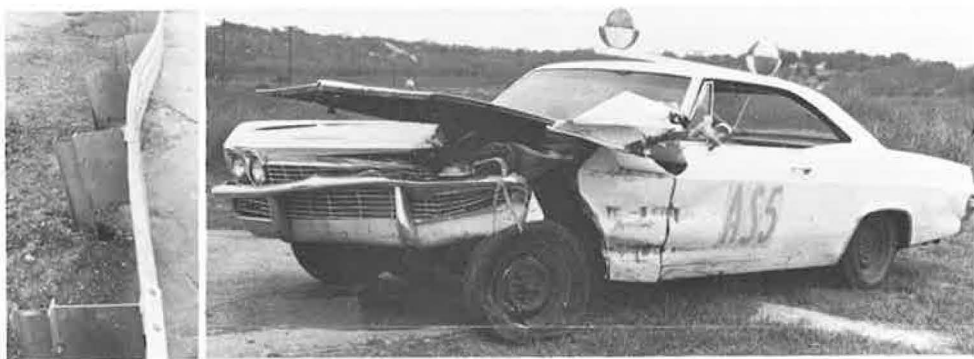
Figure 19. Beam and vehicle damage after test AS-5.

4. Use of 10-gauge (5.5-mm) Thrie beam element with 14-in. (356-mm) spacers prevented wheel contact with posts in test AS-5.

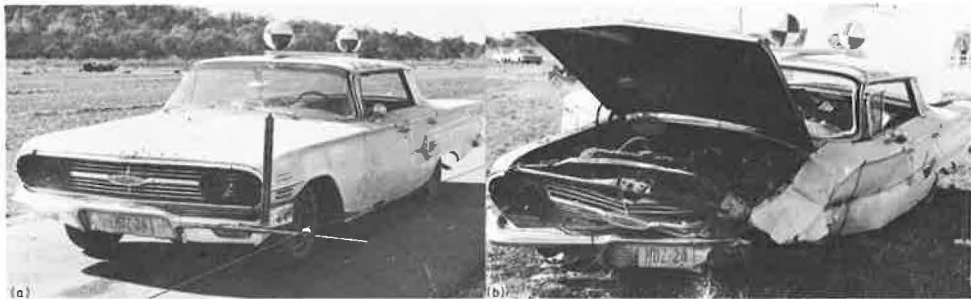
**Figure 4. AA-5 test vehicle (a) before and (b) after impact.**

After impacting the rail 0.8 ft (0.2 m) downstream from transition post T-2 (Fig. 1) at 58 mph (94 km/h) and 23 deg, the 3,965-lbm (1798-kg) AA-5 test vehicle was re-directed at 20 deg after being in contact with the rail for 0.51 sec. Maximum lateral dynamic deflection of the system was 1.4 ft (0.45 m) and occurred between transition post T-1 and bridge post DR-2 (post BR-1 was taken out). Maximum vehicle accelerations were -6.6 (long.) and -7.8 (lat.) g. Installation damage is shown in Figure 3; vehicle damage is shown in Figure 4.

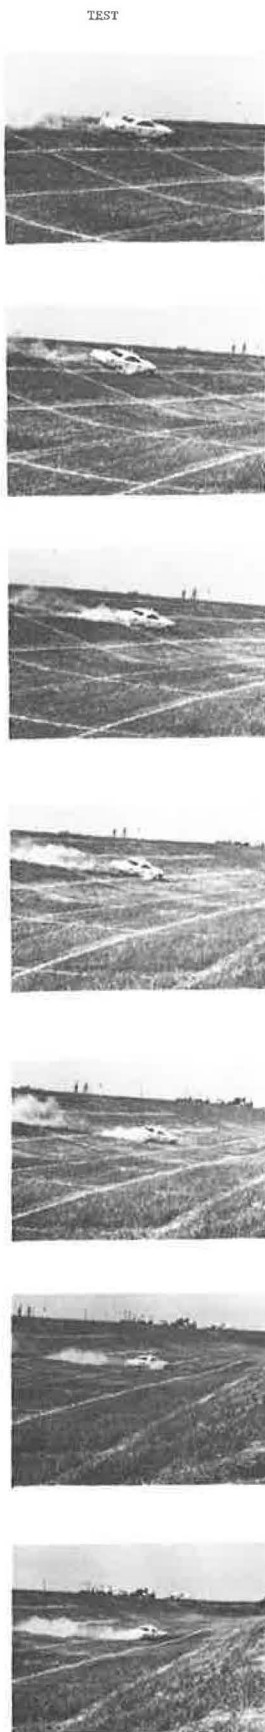
Figure 6. HVOSM versus test results for test 1 (camera position 1).

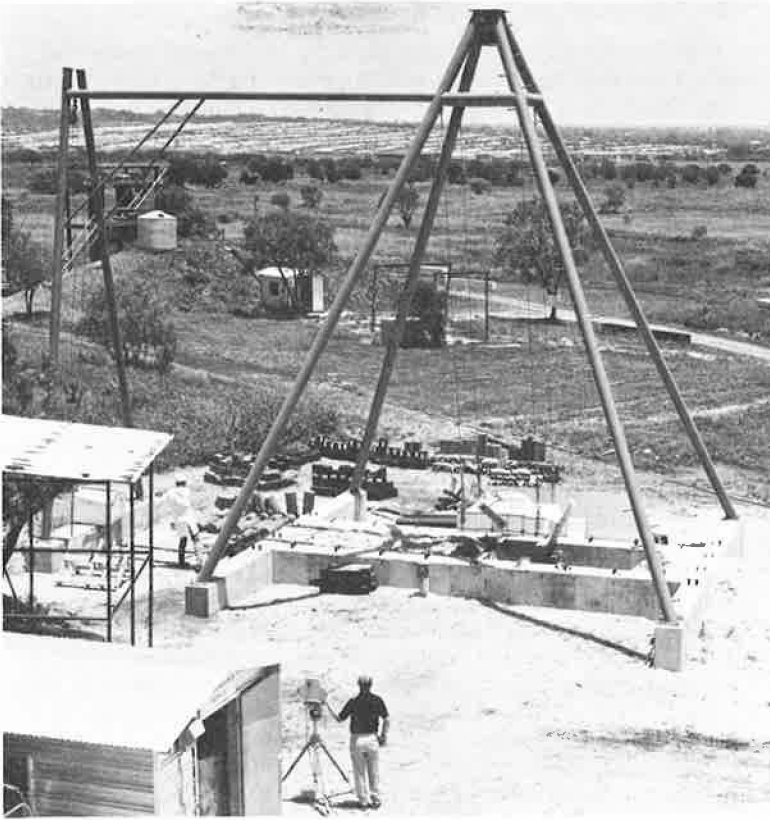
Figure 8. Southwest Research Institute pendulum impact tester.
