**TRANSPORTATION RESEARCH RECORD**  
**500**

# Corrosion and Corrosion Protection

**6 reports prepared for the 53rd Annual Meeting  
of the Highway Research Board**

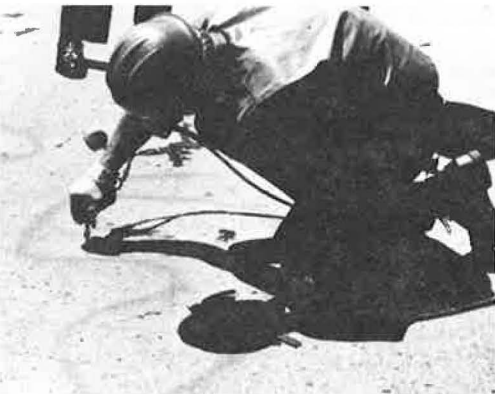
In an attempt to keep costs as low as possible, it was decided not to repair the deterioration by the process of concrete removal and replacement. Previous repairs of this kind had cost up to \$16/ft<sup>2</sup> (\$172/m<sup>2</sup>) of repaired area. Instead, it was reasoned that if the concrete could be bonded together by injection of a suitable "glue," then structural loosening by traffic would be minimized. Also, if the cathodic protection system were successful, then continued corrosion-caused spalling would be stopped. Two materials were selected to use to bond the loose concrete to the underlying deck: a monomer, used recently in experimental concrete impregnation studies and an epoxy resin (32). The locations where each material was used are shown in Figure 3. At each spall, at least one 1/2-in. (1.3-cm) diameter hole was drilled into a central area. The debris from the hole was then removed by the use of an industrial vacuum cleaner. All injections of monomer and epoxy resin were made via these holes as shown in Figure 4.

Figure 4. Injecting epoxy into undersurface structure.

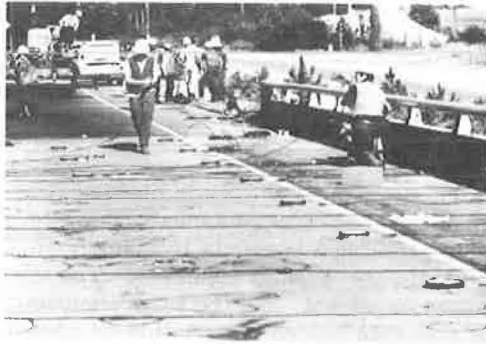
Figure 6 shows the anodes in place, and the paving operation in progress. Figures 7 and 8 show the actual depths of the loose or uncompacted coke-breeze asphalt concrete as well as the area that contains full-depth (5-in., 12-cm) natural-aggregate asphalt concrete. As shown in Figure 8, the thickness of various areas of the uncompacted depth of coke breeze is 3<sup>1</sup>/<sub>2</sub>, 3, and 2<sup>1</sup>/<sub>2</sub> in. (8.9, 7.6, and 6.4 cm). The varying depth of coke-breeze asphalt concrete was used to explore the feasibility of reducing the total depth of the composite asphalt concrete.

Figure 6. Anodes on concrete surface.

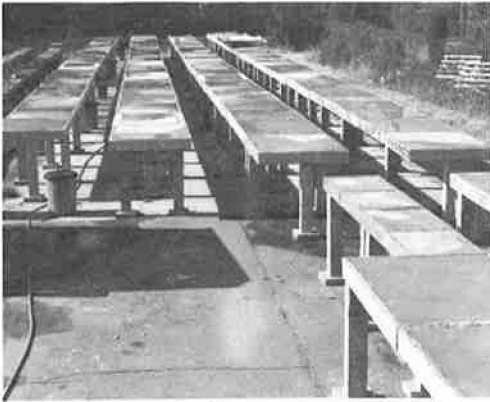
Figure 1. Test slabs.

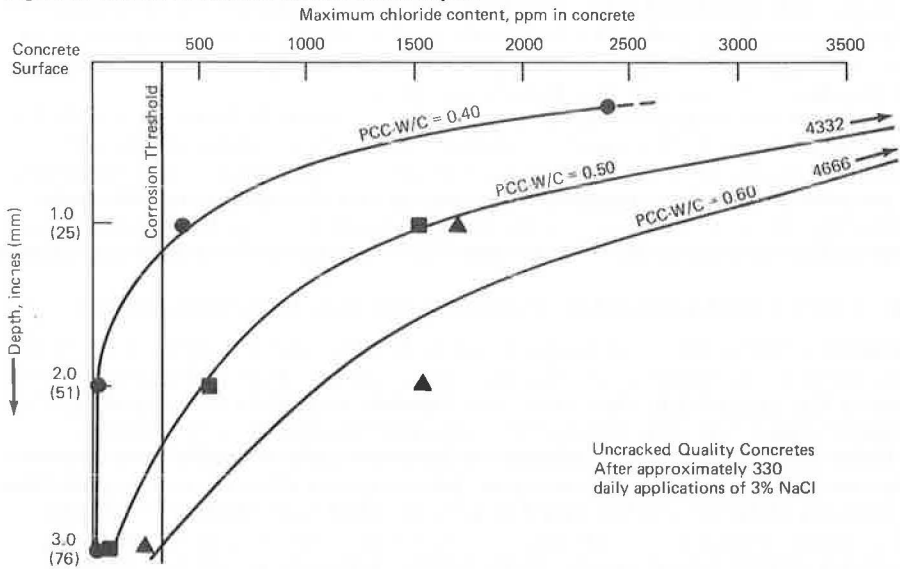
**Figure 5. Maximum chloride content versus depth.**
