FURTHER EVALUATION OF DEICING CHEMICALS

R. F. Stratfull, D. L. Spellman, and J. A. Halterman,
Transportation Laboratory, California Department of Transportation

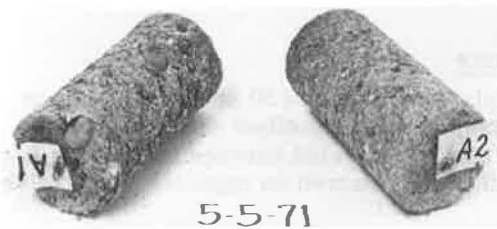
Figure 2. Concrete cylinders after 40 cycles in a sodium chloride solution.

2. Concrete cylinders cycled and fully submerged in a saturated sodium chloride solution were first observed to have scaling of the surfaces of all cylinders after the third cycle. A progressive deterioration of the surface continued for approximately 80 cycles. After 80 cycles, the deterioration was so severe that the test was discontinued. Typical deterioration of the 7-sack concrete that was alternately immersed in the sodium chloride solution is shown in Figure 2.

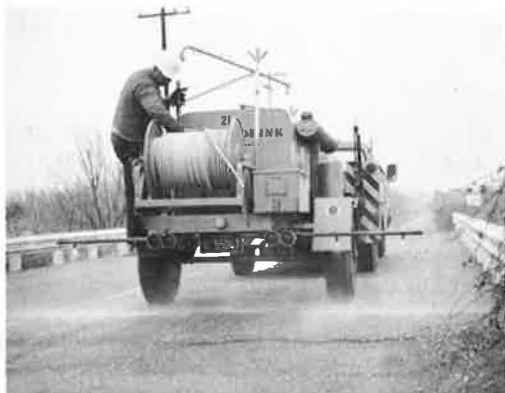
Figure 4. Application of 30 percent solution of TKPP.

7. Sutter County, G. S. Houseley Bridge, corrugated steel plank deck with AC riding surface—The bridge is a county-owned bridge that does not normally receive deicing chemicals. Therefore, TKPP was applied only to the northbound lane and the southbound lane was left untreated as a control. The typical method of applying the chemical is shown in Figure 4.

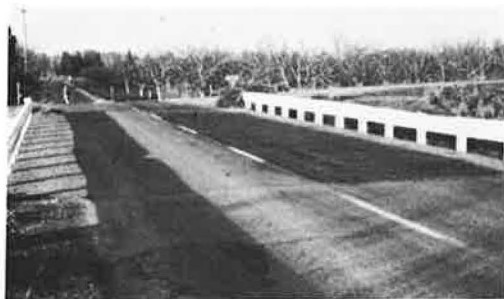
Figure 5. Sutter County test bridge: 30 percent TKPP has been applied to right side of bridge; note frost on left side.

Two days after TKPP solution was applied, the southbound lane was frosty (no chemical) while the treated northbound lane was frost-free but wet. The air temperature was 29 F and the relative humidity was 90 percent. The typical appearance of this bridge during the test is shown in Figure 5.

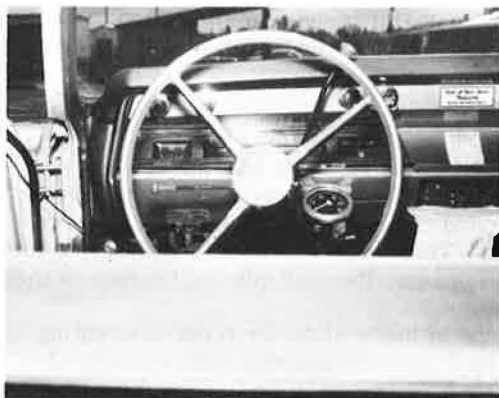
Figure 6. Special speedometer mounted adjacent to the steering wheel to better control the 10-mph test speed.

Because the commonly used skid testing devices did not show the true effect of the chemical, it was decided to try the skidding car method (10). This method consists of measuring the length of skid of a standard sedan with locked wheels. The automobile was equipped with a powder-actuated marking device connected to the brake pedal. The test speed used was 10 mph. The distance between a chalk mark on the pavement occurring at the instant of wheel lock and another one made after stopping is the measure of skid resistance. The specially mounted speedometer used to more easily control the test speed is shown in Figure 6; Figure 7 shows the special marking devices mounted on the automobile bumper.

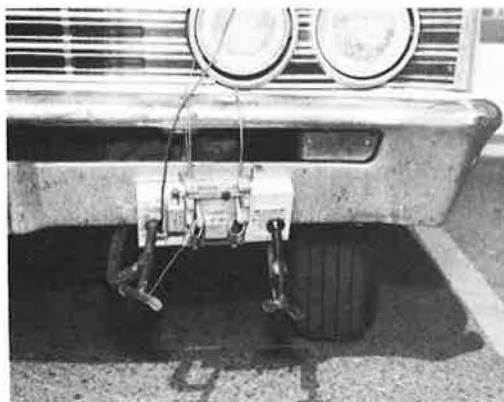
Figure 7. Two-shot marking device mounted on test vehicle.
