# ASSESSMENT OF FATIGUE LIFE OF A STEEL GIRDER BRIDGE IN SERVICE

Fernando Cicci, De Havilland Aircraft of Canada, Ltd.; and Paul Csagoly, Ministry of Transportation and Communications, Ontario

To assess the fatigue life of welded, cover-plated steel girders, strain gauges were placed in critical locations on the superstructure of the Leslie Street overpass on the Toronto Bypass. Data were gathered for 200 hours in 12-hour continuous tape recording sessions. Analysis of the data revealed that normal traffic caused a live-load stress peak of 4,000 psi (2757 MPa) only once in 10 hours, which is less than 50 percent design live-load stress. Stress data gathered by various agencies during the past few years seem to indicate that either design stress does not occur at all or it occurs with such a low frequency that the development of any fatigue situation is precluded. The phenomenon is associated with the low probability of the simultaneous, multiple presence of loaded commercial vehicles on a structure. The problem is therefore statistical in nature. Its recognition appears to be in conflict with the prevailing concept used in fatigue consideration of highway bridges.

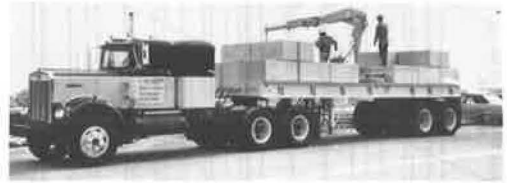
**Figure 3. Load-testing vehicle.**

Phase 1 was carried out with the ministry's structural research test vehicle (Fig. 3) loaded to a gross weight of 112,000 lb (50 000 kg). During this pilot test, the core lanes were closed to normal traffic and the bridge was traversed by the test vehicle that traveled in different lanes at two different speeds.

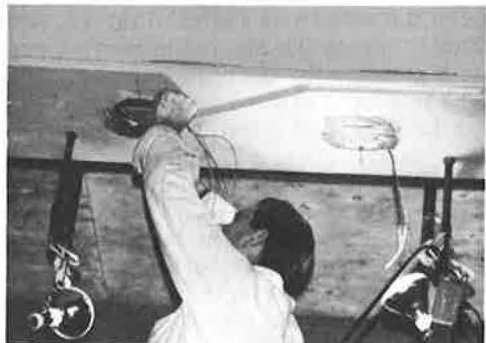
**Figure 6. Strain gauge application.**

The strain gauges were initially bonded with AE-10 to a 4-in.-wide (102 mm) strip of carrier material (Dupont Polyimide Kapton 200H), which had been previously abraded. The gauges were wired in the full bridge configuration (Fig. 7) and waterproofed by a layer of GW-5 approximately  $\frac{1}{8}$  in. (3.18 mm) thick. These patches were trimmed to 3 by 3 in. (76 by 76 mm) and installed at previously described locations on the steel girders with AE-10 adhesive, pressure pads, and heat lamps as shown in Figure 6.

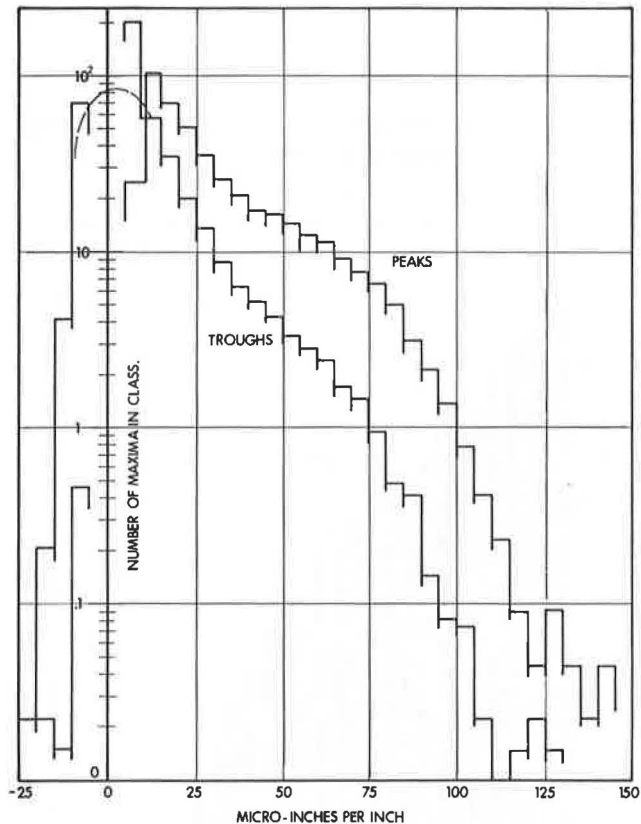
The distributions of maxima (peaks) and minima (troughs) per hour for station 123 are shown in Figures 17 and 18. As in the case of the amplitude distributions, these are not probability curves and the same considerations apply.
