# BRIDGE DECK DETERIORATION PROMOTED BY ALKALI-CARBONATE REACTION: A DOCUMENTED EXAMPLE

M. A. Ozol, Martin Marietta Laboratories\*, and  
H. H. Newlon, Jr., Virginia Highway and Transportation Research Council

Fifteen Interstate bridges in Virginia were constructed within the same time period in the same general locality and with the same materials and engineering design, except for differences in the lithologies of the coarse aggregate. In 9 of the structures an argillaceous dolomitic limestone was used, in 6 a crystalline dolomite. Both aggregates meet abrasion and soundness specifications. The limestone has a rock prism expansion in alkaline solution of 1 percent at 6 months; the dolomite under the same conditions shows no expansion. Recent surveys of the 15 bridges, opened to traffic in July 1960, show 90 percent of the slabs of the 6 containing dolomite to be free of pattern cracking and scaling, but only 15 percent of the slabs of the 9 bridges containing limestone to be free of these defects. The 15 structures have the same exposure and maintenance history, and there are no differences in the air void system characteristics of the hardened concrete that could explain the d

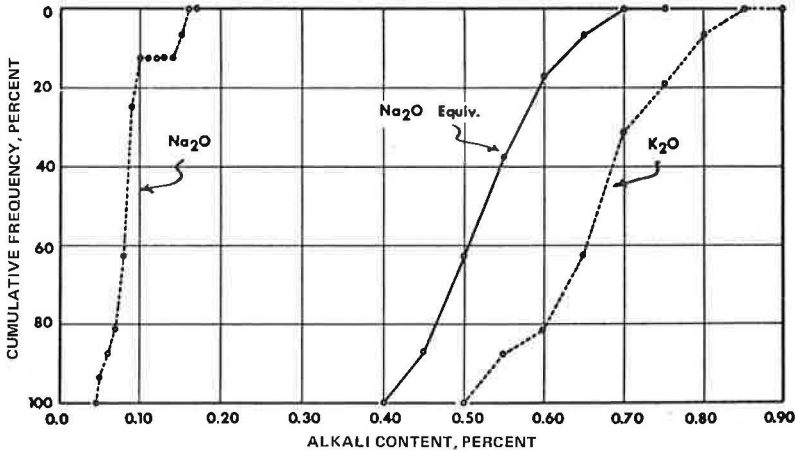
Figure 1. Alkali contents of cements from the same source used during the period of construction of bridges in both the northern and southern projects.

Rock prisms of the northern aggregate have an average expansion in alkaline solution of about 1 percent at 6 months, whereas the southern aggregate has no expansion for the same length of time. The northern aggregate was from the source that contained the stone designated "1-8" in previous Virginia Highway Research Council reports of studies of alkali-carbonate reactivity (2, 3, 4). Pertinent to the subject of expansion of the rock in alkaline solution is the fact that plant analyses supplied by the cement producer for the period of construction indicate a total alkali content between 0.45 and 0.55 percent expressed as  $\text{Na}_2\text{O}$  equivalent. In addition, data from random samplings from various construction projects during this period (Figure 1) show that 80 percent of the samples from the cement source were between 0.40 and 0.60 percent total alkalis. The remaining 20 percent were greater than 0.60 percent alkalis, although in general the cement would conventionally be referred to as "low alkali".

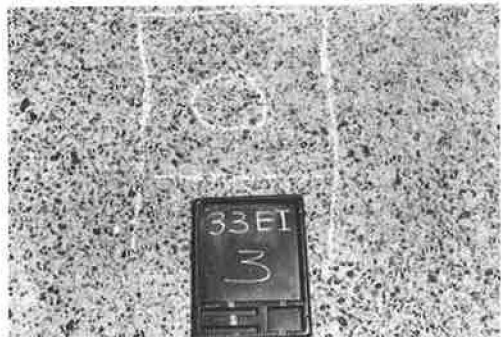
Figure 2. Typical view of severely scaled area in northern project.

Severe scaling on some of the bridges, which subsequently necessitated periodic repairs, was noted after the second winter; however, a detailed slab-by-slab survey of the decks was made in the summer of 1966 when the decks were about 8 years old. The survey revealed two principal types of distress: scaling (Figure 2) and map or pattern cracking (Figure 3), which in most cases was coincident with the scaling. The frequency of occurrence and the amount of area affected by this distress were vastly different for the northern and southern projects. On the southern project, 90 percent of the decks were free of pattern cracking, and of the 10 percent affected all had less than 25 percent of the area affected. Some 65 percent of the decks in the southern project were free of scaling. Of those not free, 85 percent had less than 25 percent of the area affected. Figure 4 is a typical view of the pavement condition in the southern area.

In contrast, in the northern area only 15 percent of the decks were free of pattern cracking, and of the 85 percent affected more than two-thirds had over 25 percent of the area affected. Only 12 percent of the area in the northern project was free of scaling, and of the scaled fraction a little more than half had more than 25 percent of the area affected. Table 3 gives a more complete representation of the percentage of affected decks and the area of those decks affected.

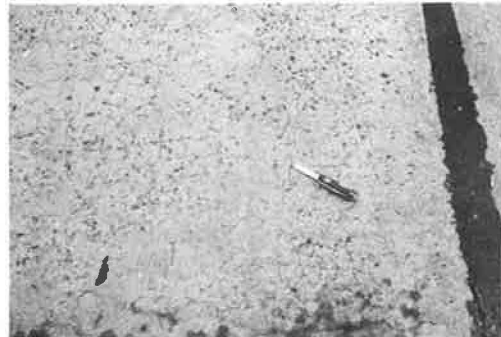
Figure 3. Typical view of pattern cracking on northern project.

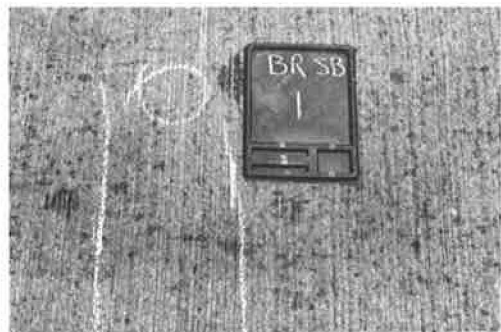
Figure 4. Typical view of pavement condition in southern project.

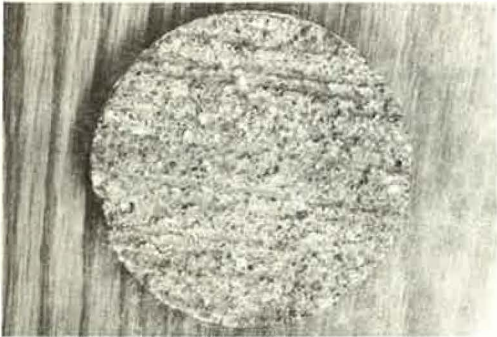
Southern Project—Core samples from undistressed pavement surfaces on the southern project had finishing marks still well preserved, with strong lineation and good relief (Figure 5). The fine aggregate was firmly held and the paste was somewhat carbonated and hard and dense. There were no hairline cracks or similar features of distress. Observation of at least 4 horizontal interior polished surfaces for each core from the southern project revealed only that the paste had a few isolated, fine, discontinuous cracks that did not transect either coarse or fine aggregate particles.

Figure 5. Typical view of pavement surface of core from southern project; note finishing marks still visible.

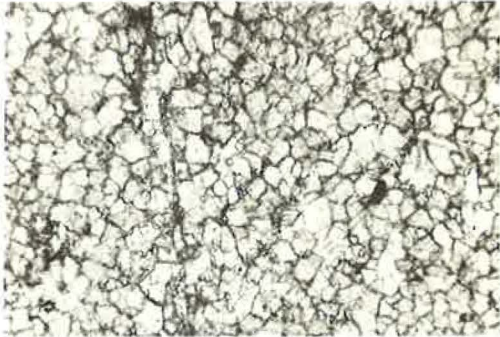
The coarse aggregate used in the southern project was a typical example of a rock of its particular kind; a nearly pure "crystalline" dolomite, which is a coarse-grained mosaic of generally equigranular interlocked dolomite subhedra, with a small amount of quartz, feldspar, and opaque minerals (Figure 6). The total acid-insoluble residue comprised about 6 percent of the rock.

Figure 6. Typical view of crystalline dolomite coarse aggregate from southern project; field is 1.3 mm across, plane polarized light.

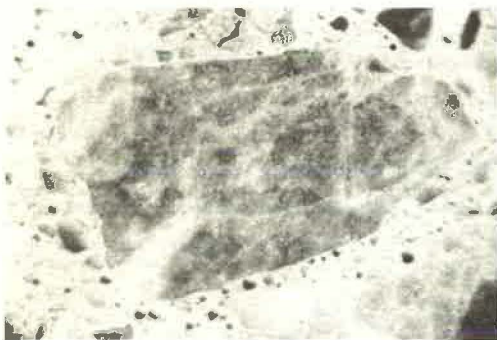
Almost all of the dolomite coarse aggregate particles had internal fractures and veins that were intrinsic to the stone but did not extend into the paste. An example is shown in Figure 7.

Figure 7. Detail view of coarse aggregate particle from southern project in cut and polished surface; note internal fractures and veins within the particle.

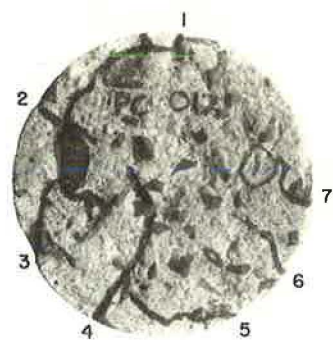
Northern Project—The concrete specimens from the northern project were taken to sample two conditions: (a) presumably "good" areas that exhibited no scaling or pattern cracking and (b) scaled and pattern-cracked areas. Pavement surfaces on core samples taken to represent the latter condition typically showed no visible lineations or finishing marks but instead displayed deep scale with a maximum relief of about 15 mm and well-exposed coarse aggregate—some particles of which were disrupted and broken apart as shown in Figure 8. There was a network of vertical-trending hairline cracks transecting, parallel to, and radial to coarse aggregate particles.

Figure 8. Top slice of core (pavement surface) from scaled and pattern-cracked area in northern project; note exposed coarse aggregate (dark gray to black) and crack across core and alongside coarse aggregate particles.

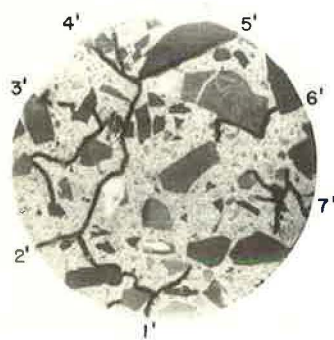
Interior polished surfaces of the core showed essentially the same crack pattern as did the pavement surface (Figure 9). If some lateral shifting with the depth of the cracks is allowed for, the surface pattern could be superimposed on the trace of the pattern on the interior surface with good agreement, and in many cases cracks could be traced down the sides of the cores to the interior surfaces. These observations established that the cracks were not isolated and discontinuous but were a continuous 3-dimensional network through the mortar and coarse aggregate particles and that the pavement surface cracks were extensions of cracks from below.

Figure 9. Interior polished surface of core with same crack pattern as the pavement surface (underside of slice in Figure 8).

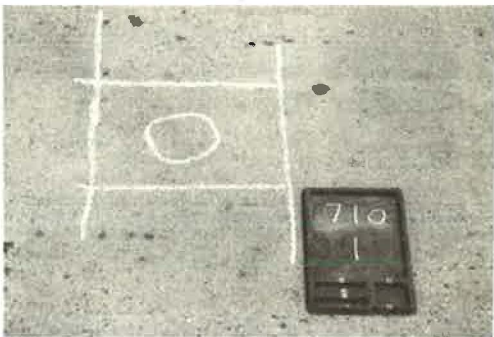
Interestingly, the interior polished surfaces of concrete cores from the so-called good areas of the northern project (Figure 10) showed exactly the same features as those from the scaled areas, the main difference between the concretes being the presence of surface scaling. These features are shown in Figures 11 and 12.

Figure 10. Core location on northern project showing healthy-looking pavement, apparently free of scaling and cracks.

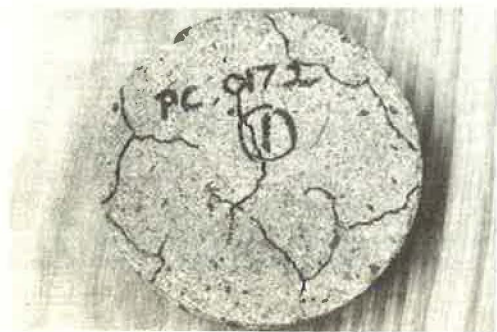
Figure 11. Core from location in Figure 10 showing system of hairline cracks outlined in black.

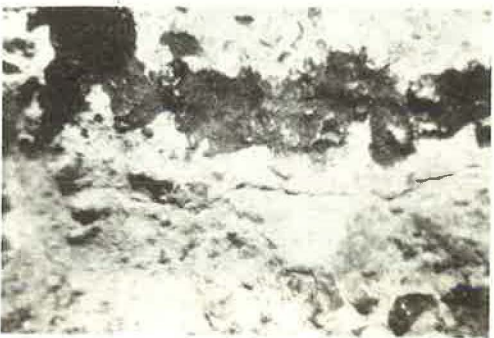
Figure 12. Detail view of crack in Figure 11.

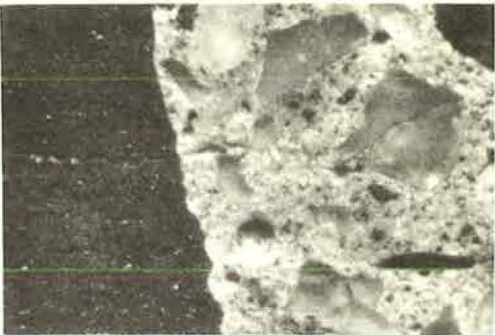
particles, extended into the paste (sometimes only a short distance), and dwindled to fine cracks or ended as radial cracks against other coarse aggregate particles. More often, the cracks extended through the paste a greater distance, transected coarse and fine aggregate particles, and ultimately connected with other cracks of similar origin (Figure 13).

Figure 13. Detail view of coarse aggregate particle from northern project showing internal crack extending into paste and through fine aggregate particle.

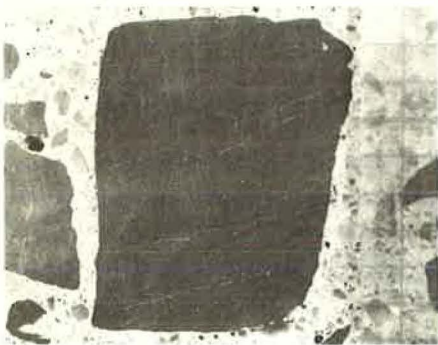
In any case, for the concrete of the northern project it was difficult, at best, to separate the distress due solely to reactivity from that due to freezing and thawing, but the general mechanism was almost certainly that internal fractures were produced within the aggregate (Figure 14), later extended to its edges (and eventually into the paste), propagated through the coarse and fine aggregate particles, and finally connected with cracks of a similar history.

Figure 14. Family of internal cracks in coarse aggregate particle in concrete from northern project; scale divisions are 0.1 in.

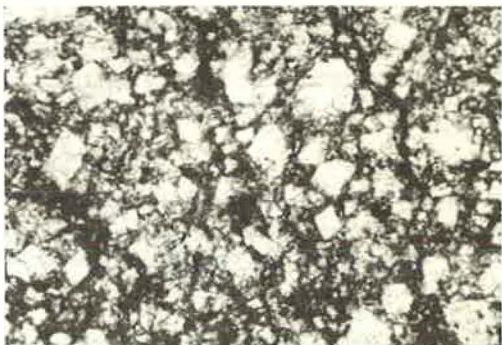
Petrographically, the coarse aggregate used in the northern project is very like the prototypical alkali-reactive carbonate rock (ASTM C 294). As seen in Figure 15, it is composed of isolated or "floating" dolomite euhedra and subhedra in a matrix of turbid, fine-grained, partially sparry but mainly micritic calcite and indistinct material that, on the basis of acid-insoluble residue determinations, is presumably clay.

Figure 15. Detail view of argillaceous dolomitic limestone from northern project showing interstitial clay and dolomite rhombs; field is 0.3 mm across, plane polarized light.

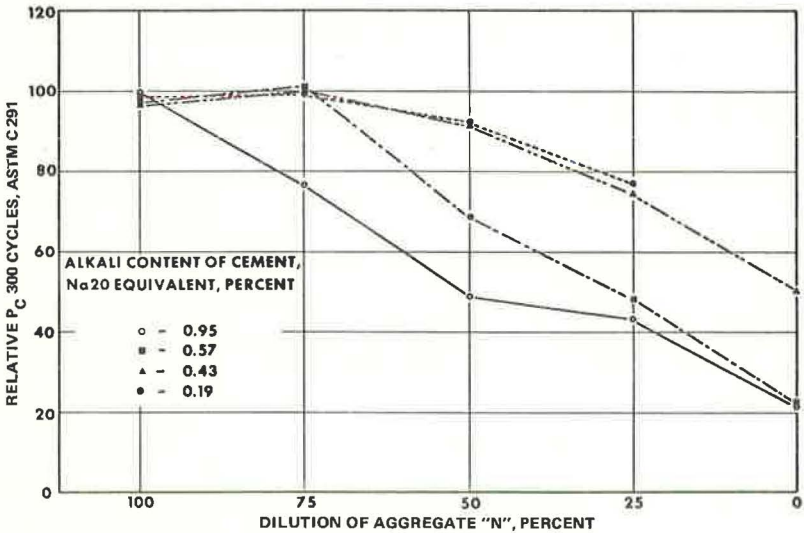
At the time the distress was observed it was not possible to obtain materials that would precisely represent the two aggregate sources involved. However, as part of a research program on potentially reactive carbonate aggregates, material from the quarry that supplied the northern project was extensively studied during the period that the decks were being constructed. No similar studies were made of the aggregate from the quarry that supplied the southern project because preliminary samplings of that quarry had indicated no potential reactivity. Thus direct experimental comparisons could not be made. Materials from the same vicinity and containing the same type of nearly pure "crystalline" dolomite were included in the testing program to determine resistance to freezing and thawing using ASTM procedure C 291 in concretes made with cements of varying alkali contents. The resistance to freezing and thawing of concrete with aggregate like that used in the southern project was good and unrelated to alkali content. The resistance to freezing and thawing of aggregate "1-8" was poorer and furthermore was shown to be a function of the alkali content of the cement. In that experiment the northern stone was diluted with a granite control aggregate and mixed with cements of varying alkali contents. The results of that experiment are shown in Figure 16.

Note that, after 300 cycles, for concrete with 100 percent reference aggregate, the relative dynamic modulus,  $P_r$ , is 100; but that, for instance, at 50 percent northern aggregate and high-alkali cement,  $P_r$  is about half of what it was before; and that, the lower the alkali content, the better was the performance in the freezing and thawing tests.

Apparently the resistance to freezing and thawing of the aggregate in concrete is related to the alkali content of the cement; the relation is that increased alkalies increase expansion from alkali-carbonate reaction and cause cracking, which in turn lowers the relative modulus.

Figure 16. Freeze-thaw durability of dolomitic limestone (aggregate N) with varying concentrations of granite reference aggregate and varying percentages of alkalis.

a lower resistance to freezing and thawing, results from freezing and thawing tests (with varying dilution of reactive stone versus alkali content) suggest that alkali-carbonate reactivity, due to increasing alkali content, was a strong determinant of performance, whatever freeze-thaw sensitivity the stone may have had.
