AN EVALUATION OF SIGNING TO WARN OF POTENTIALLY ICY BRIDGES

Fred R. Hanscom, BioTechnology, Inc., Falls Church, Virginia

This field study examined driver responses to a potentially slippery bridge during periods of possible preferential icing. Study objectives were to examine motorists' general awareness of the hazard and to assess the relative effectiveness of various warning sign treatments. Measures of signing effectiveness were motorists' speeds at critical bridge approach locations and questionnaire responses regarding motorists' observations and interpretations of the signs. Two bridge approaches were signed with combinations of activated and nonactivated signs at the bridge and 1,000 ft (305 m) before the bridge during periods of possible preferential icing. Significant speed reductions on the bridge and at the bridge entry were elicited by activated signing. The most effective signs were (a) activated, before the bridge and (b) activated, at the bridge during hours of darkness. Activated signing used at the bridge was observed to have a greater impact than activated signing used before the bridge. Drivers were more responsive to the signs during hazardous periods. Bridge-

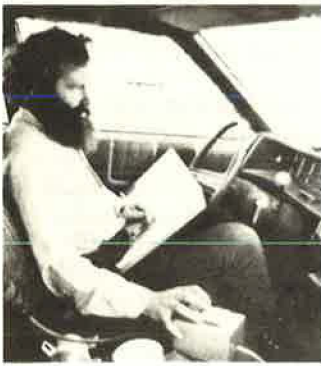
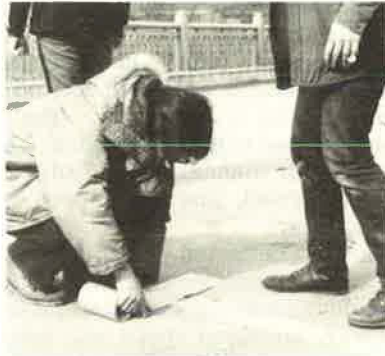
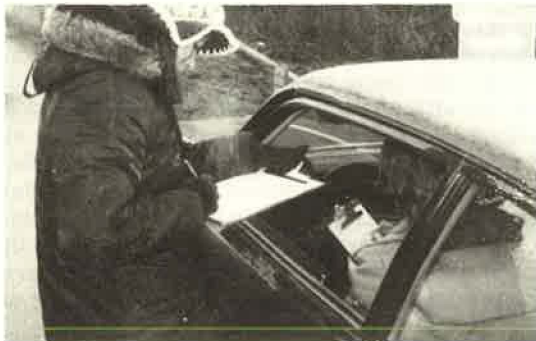
Figure 4. Traffic evaluator system and interviewing.

Two primary data collection techniques were employed. Vehicle performance data were gathered by using the traffic evaluator system, and driver characteristic data were obtained by questionnaire. Figure 4 shows each technique.

The traffic evaluator system consisted of road sensors, manual code switches, and a digital tape recorder. The equipment was small, portable, and easily concealed. The system was a powerful data collection technique that allowed precise measurements of driver-vehicle behavior over large areas of highway. The traffic sensors (tape switches) were extruded plastic devices about $\frac{1}{8}$ in. (3.2 mm) high by $\frac{1}{2}$ in. (12.7 mm) wide. The tape switch was an unobtrusive sensor that caused little vibration and noise to a vehicle when it crossed it. The system allowed monitoring of all vehicles in lanes instrumented with the sensors. Associated with the traffic evaluator system was provision for manual code inputs. Thus, randomly selected vehicles were coded to be interviewed, and their speed data were matched with appropriate questionnaire responses.

Interviewing of motorists was conducted during the testing of all experimental signing conditions. Speed data for each vehicle were matched to questionnaire responses for analysis. Interview locations were beyond driver sight-distances from the speed sensors. In this way, unbiased speed data were obtained. Vehicles selected for motorists' interviews were those with sufficient headways that their speeds were not influenced by others in the traffic stream. An interviewing strategy was adopted that permitted certain driver characteristics data to be obtained before the drivers knew that the study related to potential skid hazard. After a brief introduction that advised the motorists that a safety study was being conducted, general questions were asked to derive their familiarity with the site and the level of their driving practice. More specific questions were then asked regarding their assessment of safe speed during possible icing conditions and whether the bridge was always sanded when icy. By this time, the motorist knew the study pertained to potential skidding. The driver was then asked whether the bridge was a potential hazard and, if so, what their cue of the hazard was. In cases in which the experimental sign was not cited as the cue, the drivers were asked if they had seen a warning sign. If they had, they were asked to identify the sign by describing its appearance and message and to rate the sign as being helpful or not helpful.

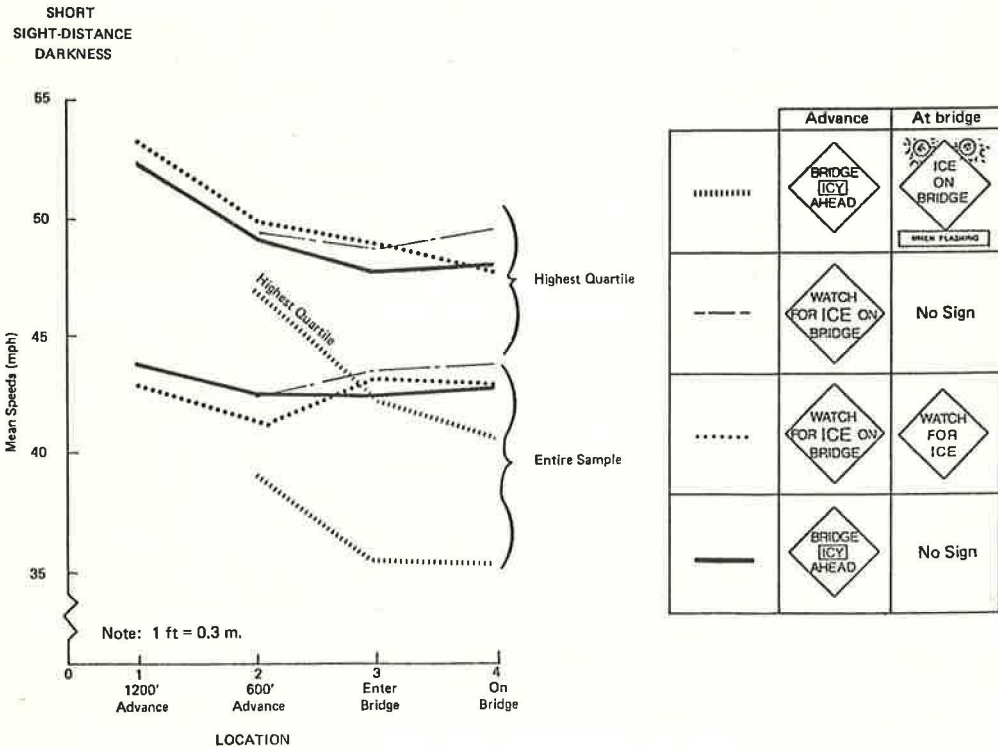
Figure 8. Mean speeds during hours of darkness on the short sight-distance approach.

conditions. The sharpest approach decelerations were observed in response to the activated sign located at the bridge during hours of darkness.

After comparing bridge approach speed data on an hour-for-hour basis, I noted 3 expected findings: (a) activated, before-the-bridge signing produced significantly greater speed reduction than did nonactivated, before-the-bridge signing; (b) 2 activated signs produced better results than did nonactivated signs; and (c) for activated and nonactivated signs used together, activation of the at-the-bridge sign produced better results than did activation of the before-the-bridge sign. Findings a and b were observed during conditions of darkness, and finding c was observed during daylight. These observations were based on mean speeds for the total vehicle sample. Keep in mind that the fastest motorists are most suitably designated as the target sample. Figures 8 and 9 provide mean speed plots for both the total and highest quartile samples. Data are somewhat incomplete because the 1,200-ft (365.8-m) before-the-bridge tape switch failed to adhere to the pavement on 1 morning. However, the lost data did not prove to be critical. Most notable in Figure 8 is the extreme speed reduction resulting from use of activated signs at both before-the-bridge and at-the-bridge positions. Ambient conditions were highly conducive to such a response to the

Relatively closer grouping of mean speeds was noted for the remainder of the sign conditions tested during hours of darkness; the nonactivated before-the-bridge sign afforded the lowest speed reduction. In fact, average speeds for the total sample increased at the bridge approach during use of both nonactivated signing schemes. The highest quartile motorists slowed slightly for the nonactivated advance sign, but then they increased speed. The combination of 2 nonactivated signs caused continual slowing on the part of the highest quartile motorists, yet speeds remained high. The activated before-the-bridge sign did cause motorists to slow down but to an insignificant degree compared to both nonactivated signs.
