# PRESTRESSED PAVEMENT DEMONSTRATION PROJECT

Raymond J. Brunner, Bureau of Materials, Testing and Research,  
Pennsylvania Department of Transportation

This report describes the installation of the first full-scale prestressed concrete pavement in Pennsylvania. A detailed account of the construction and placement methods used and pertinent cost data are included. The purpose of this project was to employ pavement prestressing techniques on a production basis. A variety of construction problems encountered provided valuable experience as to what can be expected on future projects of this nature. Some 23 post-tensioned slabs were placed on the main line, each with a nominal length of 600 ft (183 m). The concrete was placed with a slipform paver that also guided the prestressing strands into the pavement by feeding them through metal tubes on the paving equipment. A unique method was used to construct the joints where the slabs meet. During paving, a 3-ft (0.9-m) jacking space was provided between slabs. This space was later filled with concrete, which was prestressed by transferring the load from the strand anchors through the joint concrete. The slab ends were keyed together with

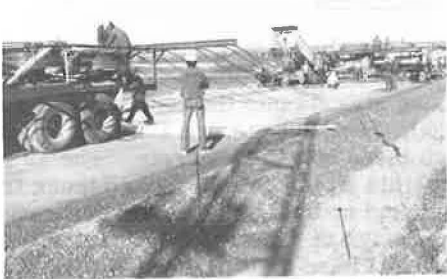
Figure 2. Paving operation.

Concrete placement was performed by a conventional CMI slipform paving train. Since no transverse reinforcing steel was used, a method was developed for feeding the prestressing strands into the concrete and positioning them at the design depth of 3.5 in. (89 mm). Steel tubes were attached to the spreader machine and the strands passed through these into the concrete. The 12 reels of strand were carried ahead of the paving train on a modified flatbed truck from which they were unwound onto the base, to be picked up by the placement tubes on the concrete spreader (Figures 2 and 3).

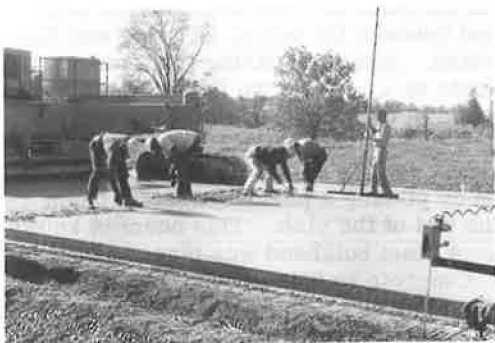
Figure 5. Preparing lifting ropes.

The continuous placement of prestressed pavement required that a jacking space of at least 3 ft (0.9 m) be left between slabs. A method of placing these joints was devised to prevent interruption to the slipform paving operation. The sequence of operations is shown in Figures 4 through 11 and is described in the following.

Blockouts, consisting of wooden boxes, 3 ft (0.9 m) in length, were staked out in a row on the base at the desired joint location. As the concrete spreader passed over the joint, the tubes that placed the strands passed between the boxes. Paving and finishing were then completed normally over the boxes. After the paving train passed the joint area, the boxes were lifted out of the concrete by a crane. To lift them out they were hooked onto a framework with ropes and lifted in unison. The remainder of the concrete in the joint void was removed by hand, leaving a void slightly longer than 3 ft (0.9 m).

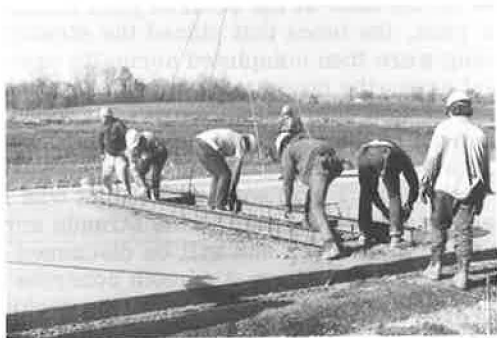
Figure 6. Hooking ropes on lifting frame.

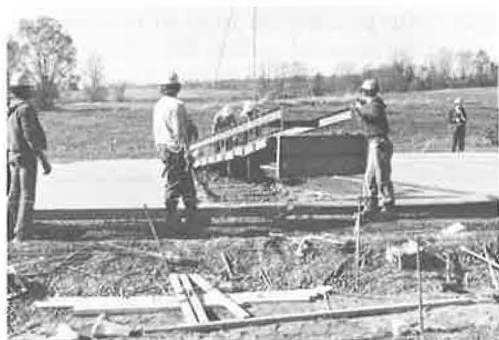
Figure 7. Lifting of blockout boxes.

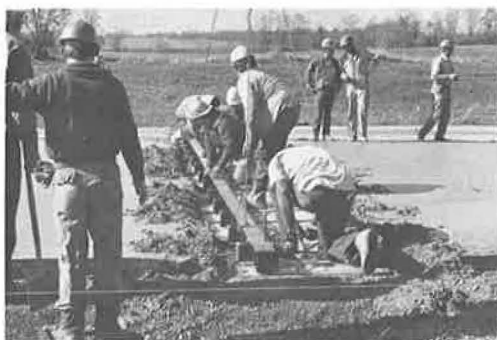
Figure 8. Placing female beam and bulkhead.

One of the 2 slab ends at the joint was formed by placing a permanent steel beam that distributes the load of the strands across the end of the slab. This beam is known as the female beam and will be discussed later. A steel bulkhead was placed at the other slab end to form a smooth concrete face. Concrete to fill the joint would later be poured against this face after the jacking was completed. The female beam and bulkhead were lowered in place by the crane and positioned properly, after which concrete was placed against them, vibrated, and finished. Slots in the female beam and bulkhead allowed them to be placed over the strands, which were not cut until the following day. This completed the joint-forming operation, and the crew moved ahead to repeat the sequence when the paving train reached the next joint.

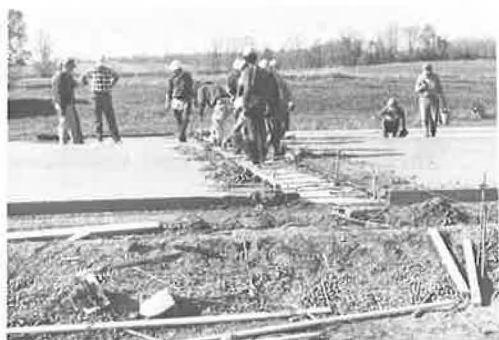
Figure 9. Placing concrete at joints.

A time limit was placed on the joint-forming operation to prevent the possibility of a cold joint when concrete was placed back against the bulkhead and female beam. The contractor was allowed 14 minutes after the paving train passed the joint to remove the wooden boxes and place the beam and bulkhead. Placing and screeding the concrete behind the beam and bulkhead were to be completed within another 6 minutes, or a total of 20 minutes after the paving had passed the joint.

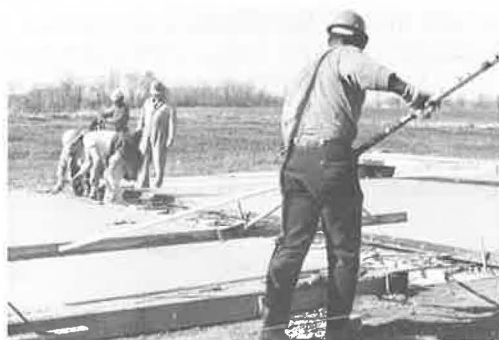
Figure 10. Finishing concrete at joint.

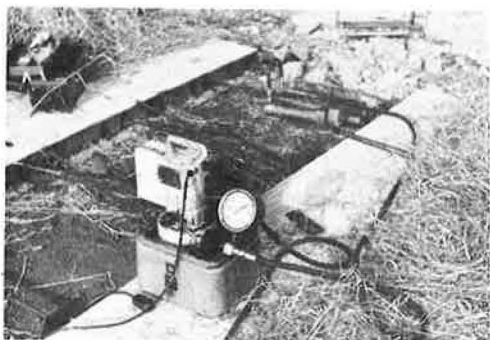
Figure 12. Hydraulic jack.

Jacking was done with portable hydraulic ram jacks capable of loading 1 strand at a time (Figures 12 and 13). The loading sequence used was to jack the center strands first and then jack on alternate sides out to the edges of the slab. The jack rams had a throw of only 10 in. (254 mm) and it was necessary to reposition the jack after each 10 in. (254 mm) of strand elongation was achieved. Jacking was done at both ends of each slab to reduce friction losses in the strands.

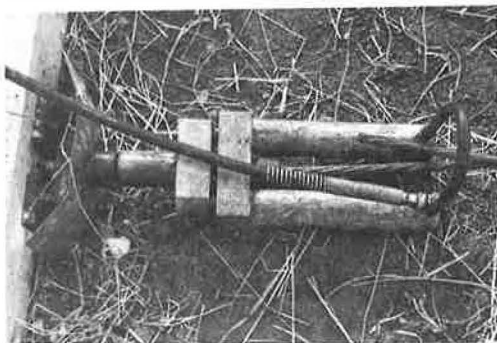
Figure 13. Jacking setup.

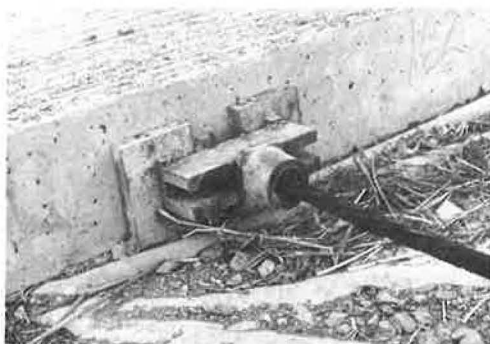
Figure 14. Jacking bridge.

After jacking was completed, the joints were prepared for concreting. A unique method was devised whereby the prestress would be applied to the joint concrete, resulting in movement only at 1 joint gap. To accomplish this, the load from the anchors at 1 end of the slab was transferred to permanent strand anchors cast into the joint concrete. The load transfer was accomplished by releasing the anchors at the end of the slab against which the joint concrete was placed. To release the load, a jacking bridge was used behind each strand anchor (Figure 14). This bridge was later cut after the joint concrete had cured sufficiently. The top and bottom horizontal bars were cut at one side of the strand to allow the load to transfer to the permanent anchor. To cut the jacking bridges, voids (Figure 15) had to be formed in the joint concrete. These were filled with concrete after the jacking bridges were removed.

The use of the jacking bridges to transfer the load on the strands through the joint concrete was successful, although several problems arose during construction that led to improvements in design and procedure. Shortly after final jacking began, the steel bars used as bridges were bending under the load of the anchors. The bending was more severe where the strand was not exactly perpendicular to the slab end. It appeared that adequate consideration had not been given to the relation between the span of the bridge and the strength of the materials. When a shorter span for the bridge was put into use, the problem was eliminated.

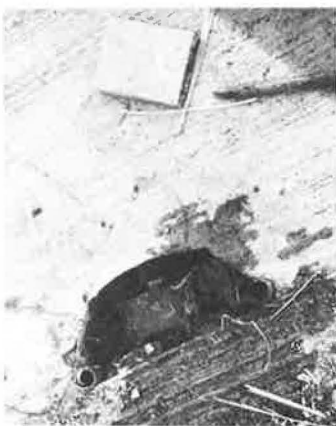
Figure 15. Jacking bridge after cutting.

The original plan for severing the jacking bridges to transfer the load through the joint specified flame cutting. This idea was abandoned in favor of cutting them with an electric arc welder. In this way, much less heat was applied to the strand because the total cutting time for each bridge was only about 15 seconds. The amount of heat on the strands was not even sufficient to melt the polypropylene conduit. A gradual release of the load on the temporary anchors occurred as the force was transmitted through the joint concrete to the permanent anchors. The temporary anchor moved approximately  $\frac{1}{4}$  in. (6.4 mm) toward the slab from its original position, due to elongation of the strand in the joint.

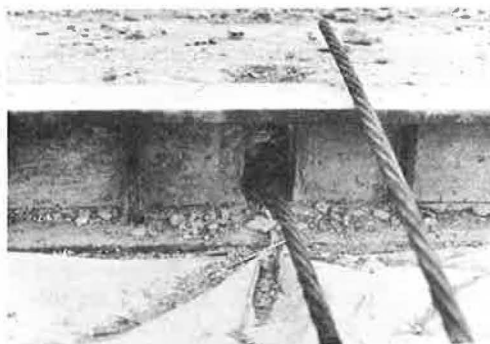
Figure 16. Anchor pocket in female beam.

The completed joint provides for movement of the slabs with an interlocking beam system at the joint. This system is a product of Pavement Systems Inc. and carries the trade name "PAJO". The female beam, placed during paving, becomes integral with the slab and is held to it by the force of the strands. Anchors in the female beam were set into anchor pockets so that they would not protrude from the beam. An anchor pocket is shown in Figure 16. These were filled with cement mortar after jacking.

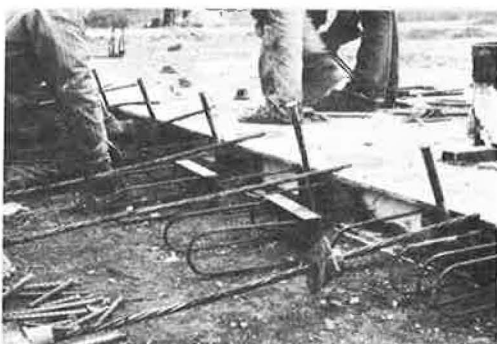
Figure 17. Placing male beams.

Male beams were placed inside each female beam prior to placing the joint concrete. It was necessary to fabricate the male beams in short sections due to the interference of the vertical ribs that are part of the female beam (Figure 17). When placing the male beams, a  $\frac{1}{4}$ -in. (6.4-mm) spacer of expanded foam sheeting was placed between each male beam and the female beam to allow for expansion of the slabs. A piece of foam was also clipped onto each vertical rib of the female beam to maintain the same spacing at this point. To prevent spalling when the joint closes, a hand-tooled edge was made where the joint concrete meets the top plate of the female beam.
