TRANSPORTATION RESEARCH RECORD

535

Concrete Pavement
Construction and
Joints and
Loader-Truck
Production Studies

8 reports prepared for the 54th Annual Meeting
of the Transportation Research Board

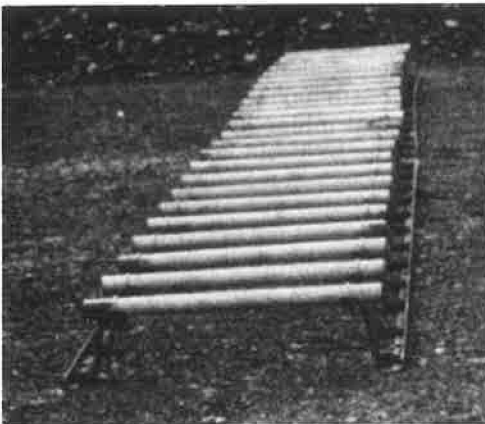
Figure 4. Bowed dowel assembly at Oneonta.

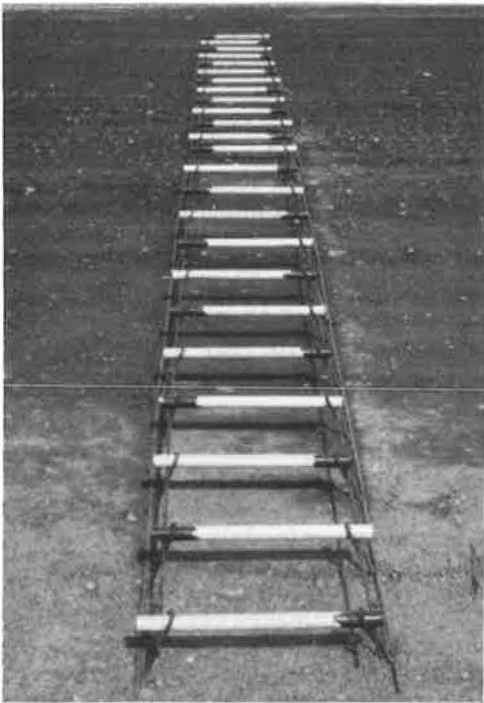
Figure 6. Bare dowel ends painted with red lead.

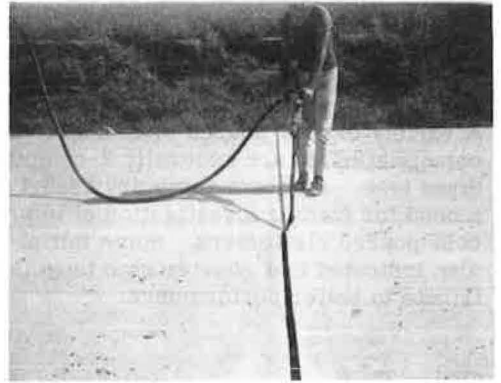
Figure 2. Sealing joint with rubberized asphalt.

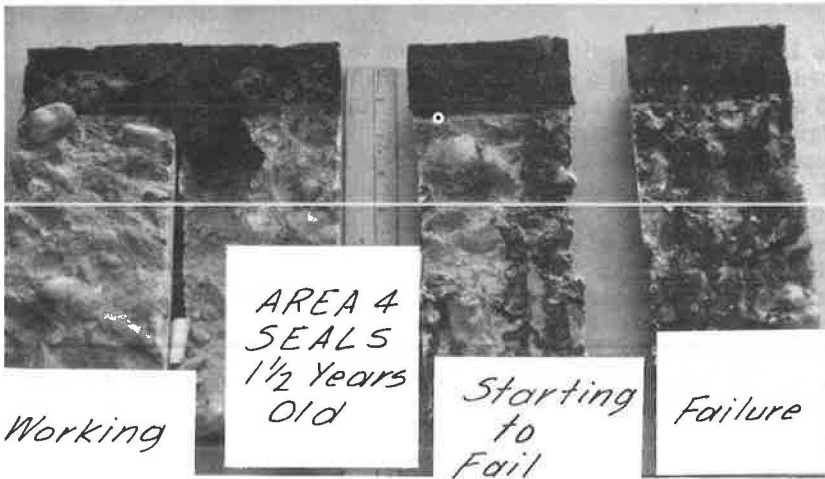
Figure 15. Cores from section 4.

fail (Figure 14). The cores revealed that some seals had failed where others had not. The 3 cores shown in Figure 15 are at different stages of failure. The core at the left contains a seal that has not failed, as evidenced by the absence of epoxy or other contaminants in the joint. The seal of the center core has started to fail as shown by the limited amount of epoxy that was able to pass the seal. The seal of the core at the right has failed, as shown by the epoxy and incompressibles found at the base of the core. In Figure 16 the problem of adhesion is apparent. The seal was adhering to the aggregate but not to the cement mortar. Cleaner joint walls may solve this type of adhesion problem.

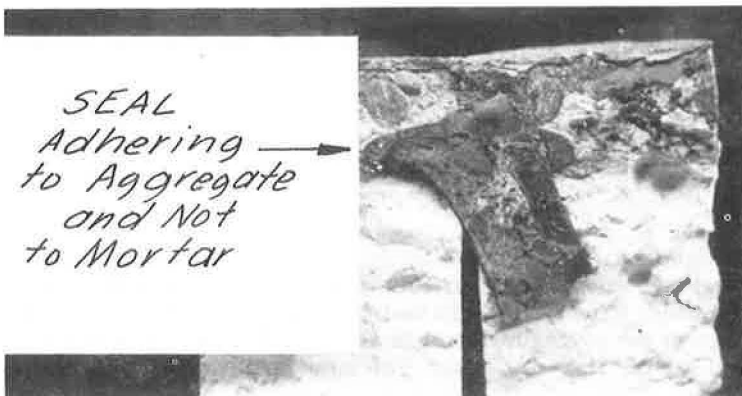
Figure 16. Seal failing in adhesion in section 4.

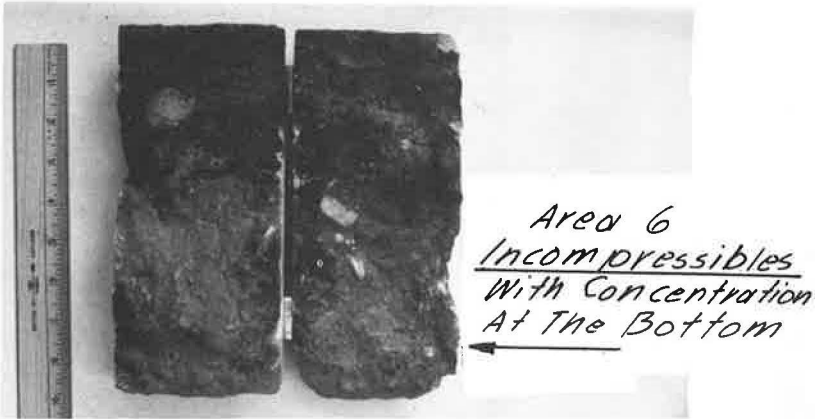
Figure 17. Core from section 6.

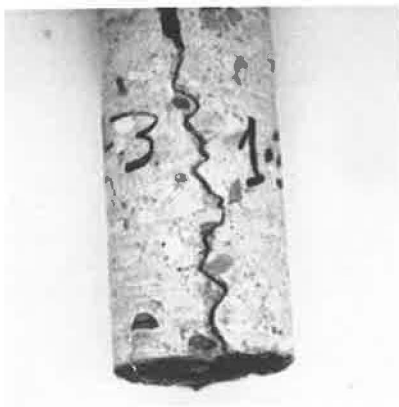
Figure 19. New pavement core with no spalling at the bottom.

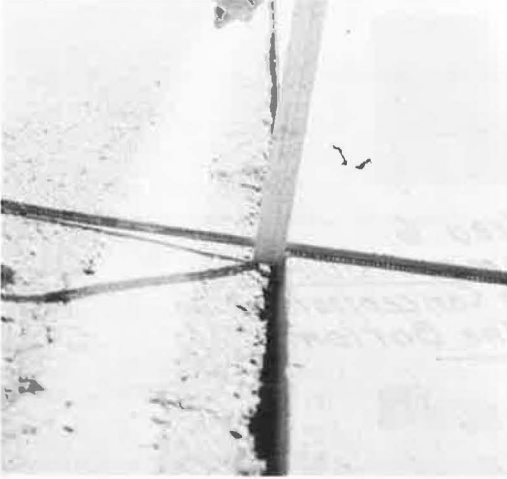
Figure 21. Trough formed between concrete pavement and asphalt shoulder.

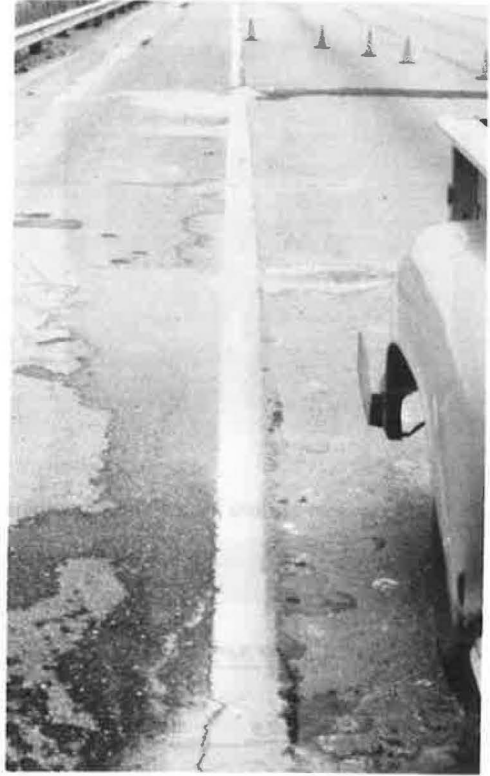
Figure 22. Water in depression between pavement and shoulder.

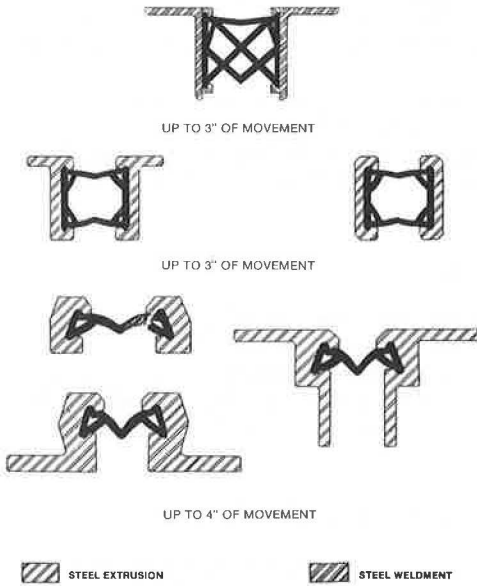
Figure 1. Typical mechanical locking of the seal element.

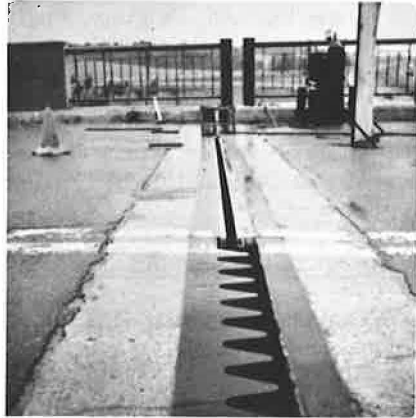
Figure 2. Seam-welded steel extrusion replacing old finger joint.

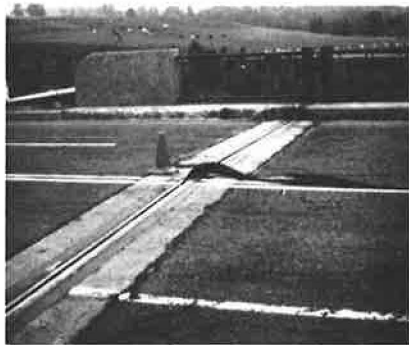
Figure 3. Installing strip seal element in one piece, a lane at a time, for 100 percent leakproofing.

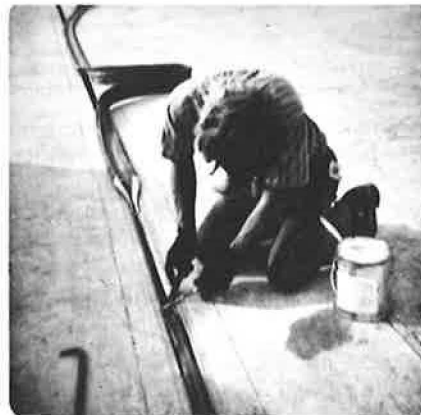
Figure 5. Field installation of strip seal gland.

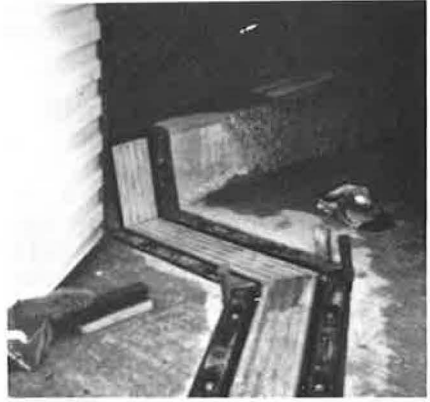
Figure 13. Factory-prefabricated unit incorporating vertical and horizontal bends.

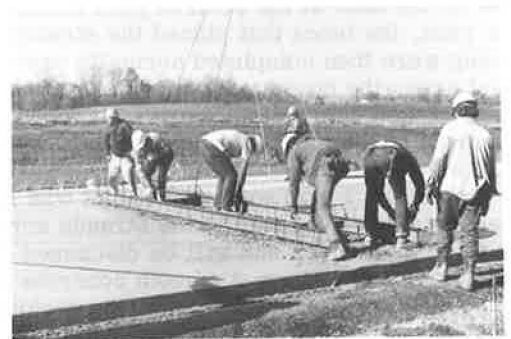
Figure 6. Hooking ropes on lifting frame.
