PERFORMANCE OF A LARGE CORRUGATED STEEL CULVERT

Ernest T. Selig, Department of Civil Engineering,
State University of New York at Buffalo; and
Salvatore J. Calabrese, Law Engineering Testing Company, McLean, Virginia

Because few published field data exist to help in the development and evaluation of design criteria for large buried structures, a construction project involving such a structure was instrumented in Thunder Bay, Ontario. The structure was a shallow-buried, elliptical, corrugated-steel pipe with a 16-ft (4.9-m) height and a 27-ft (8.2-m) span. A concrete relief slab was placed on the fill several feet (meters) over the crown to distribute the vehicle loads. Pressures around the structure and under the slab were measured by using embedded stress gauges. Horizontal and vertical extensometers measured strains in the backfill. Radial extensometers inside the structure provided the structural deformation pattern. Data were obtained during construction and during live load tests with heavy vehicles. The results provided information on the magnitudes and distribution of stresses and deformations, the influence of construction procedures, and the apparent moduli of the backfi

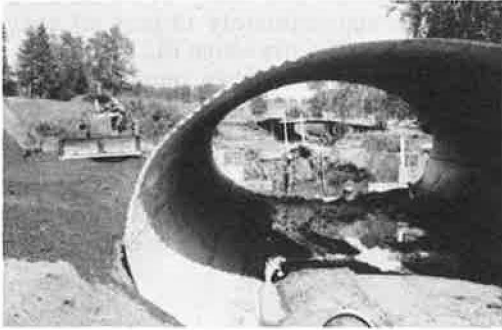
Figure 1. Structure under construction when backfill up to spring line.

The culvert was elliptical with a 27-ft (8.2-m) span, a 16-ft (4.9-m) height, and a shallow soil cover (Figures 1 and 2). It was fabricated from 5-gauge, 2 × 6-ft (0.6 × 1.8-m), rolled corrugated-steel plates. Because the design height of soil cover over the crown was initially only 10 percent of the span, the designers specified that a 1-ft-thick (0.3-m), reinforced-concrete slab be placed on top of the soil cover to distribute the concentrated vehicle loads. The structural backfill extending to about 13 ft (4 m) out from each side of the culvert consisted of a compacted granular glacial till.

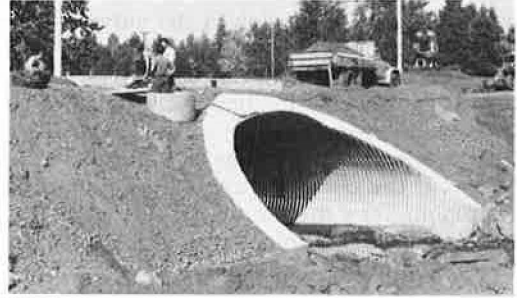
Figure 2. End view of completed structure with test load truck, readout station, and relief slab.

Most of the live load tests were conducted by using a gravel-filled dump truck with a gross weight of 32,800 lb (14 900 kg) (Figure 2). The load positions relative to the structure and the instrumented cross section are shown in Figure 10. The first load test consisted of positioning the truck successively in positions D, C, and E and then moving it off the slab to the starting position A. Residual deformations and net pressure increases were observed after the load was removed (Figure 11). The residual

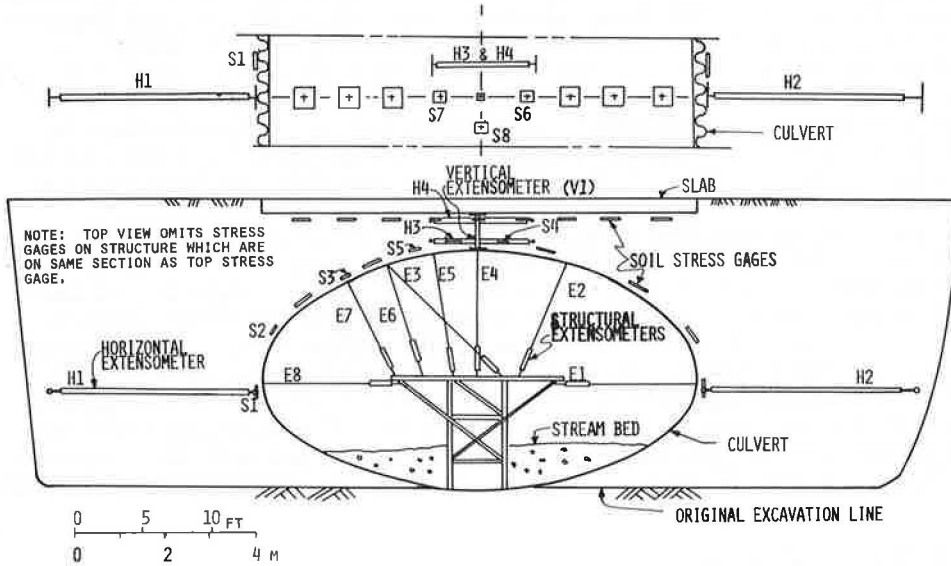
Figure 3. Top and end views of instrument layout.

The instrumentation layout is shown in Figure 3. Horizontal extensometers measured movements of the sides of the culvert relative to points approximately 13 ft (4 m) away from the structure, at the edge of the granular fill zone. The pressure distribution on the structure from the backfill was measured with embedded stress gauges. The pressure distribution under the slab was also measured with these stress gauges. Horizontal extensometers 6 ft (1.8 m) long were placed in the fill above the crown to help observe how this material deformed. Deflection of the slab relative to that of the crown of the culvert was measured with an embedded vertical extensometer. Radial extensometers inside the culvert gave the magnitude and pattern of deformation of the culvert under vehicle live loads. The instrumentation and installation procedures are described in another paper (1).

At the location of the structure, the original grade was above the prescribed culvert crown elevation. Therefore the excavation shown in Figure 3 was made first, and then the bottom was shaped to fit the culvert invert. Then assembly of the corrugated plates began, and fill was added to support them. After the entire structure was bolted together, the backfilling was resumed up to the spring line. At this stage (Figure 1), the first instruments were installed. Final bolt tightening with a torque wrench continued toward the crown as the fill elevation increased. By the time the fill reached 70 in. (1.8 m) above the spring line, the bolt tightening was complete, and about 3 ft (0.9 m) of gravel fill was spread, but not compacted, inside the structure to form the streambed. Pairs of heavy timber struts were then wedged upright at 6-ft (1.8-m) intervals along the length of the structure supporting the top plates and butting on the gravel base. The frame for the radial extensometers (Figure 3) was placed inside the culvert and bolted to the invert at the same time. Backfilling over the structure was then completed, and the concrete slab was constructed. The struts were removed after about 1 week of concrete curing. The live load testing of the structure was then conducted, and final grading of the road base over the slab was completed.

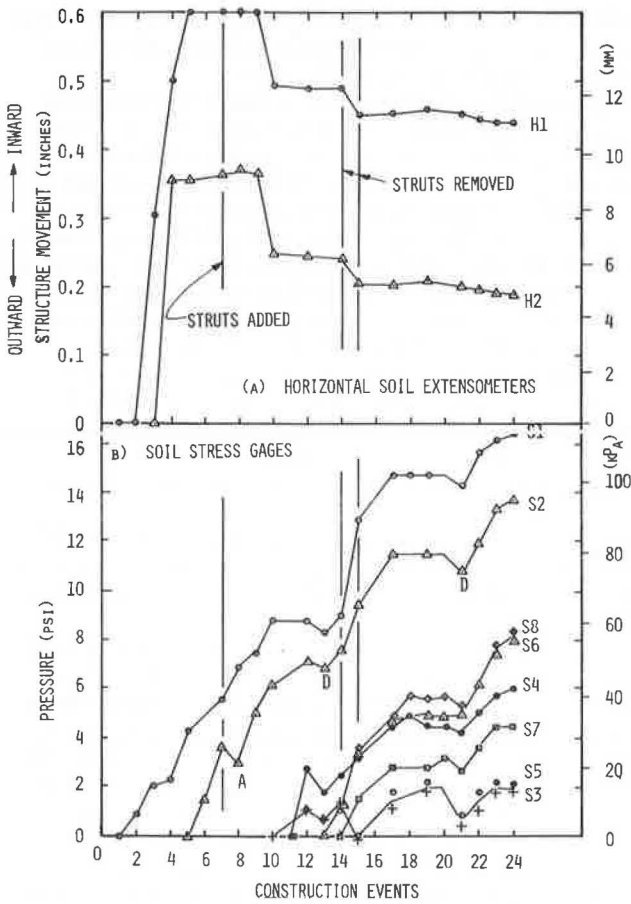
Figure 4. Measured pressures and deformations during construction.

The construction events corresponding to the measurements are given in Table 1. Figure 4a shows the change in the two spring-line soil extensometers during construction. The two sides show the same trends. Large inward movement of each side of the culvert [0.35 to 0.5 in. (8.9 to 12.7 mm)] occurred during the 3 ft (0.9 m) of backfilling above the spring-line elevation when the extensometers were placed. Additional fill caused another 0.1-in. (2.5-mm) inward movement on the H1 side but only caused 0.015 in. (0.38 mm) on the H2 side. These differences in magnitude probably resulted from the staging of construction because the filling on the H1 side was usually ahead of the H2 side, and bolt-tightening occurred simultaneously.

Inward movement was small on both sides during the last 2 to 3 ft (0.6 to 0.9 m) of filling up to about 1 to 2 ft (0.3 to 0.6 m) below the crown. Additional fill then caused a movement reversal, and both sides moved outward about 0.15 in. (3.8 mm) by the time the slab was added and the struts removed. During the load test process and final grading, variations within the range of ± 0.01 in. (± 0.25 mm) were observed. The net outward movement in this phase was a result of both the accumulation of residual strain from the load cycles and the addition of fill on top of the slab.

Figure 4b shows the trends for the pressures on the structure and under the slab during construction and subsequent static load testing. The horizontal stress, measured by gauge S1, at the spring line increased continuously as fill was added and sharply increased again when the slab was poured. A similar trend was observed higher on the pipe by stress gauge S2. The pressure reduction at point A for S2 may be a result of inward structure movement caused by the staging of backfilling. Gauges S1 and S2 showed the highest pressures of all the gauges. Gauges S4 and S5 showed an increase of 1 to 2 psi (6.9 to 14 kPa) as the trench above them was backfilled. Some of the pressure increase during the load-testing phase was caused by the addition of fill over the slab. The remainder was possibly caused by stress redistribution.

On two occasions for most gauges (Figure 4b, D, events 13 and 21) a noticeable pressure drop of up to 1 psi (6.9 kPa) was observed. This drop is believed to be a result of an overnight temperature decrease. Cooling of the steel structure would cause a slight shrinkage, and a pressure relief around the structure would result. Therefore, some of the other minor oscillations in the pressure graphs probably are influenced by temperature change.

All of the gauges showed a pressure increase under the first loading by the 32,800-lb (14 900-kg) truck (event 17) with only a small part of this pressure change generally eliminated after unloading. The additional load cycles during the remaining live load testing produced only a small additional net change in pressure.

The vertical extensometer V1 compressed 0.15 in. (3.8 mm), the upper horizontal extensometer H4 shortened by about 0.05 in. (1.3 mm), and the lower horizontal extensometer H3 extended about 0.03 in. (0.8 mm) from the time that these gauges were placed until the slab was poured and the struts removed. The subsequent movements of these extensometers during load testing were small by comparison (Figure 5a). The two horizontal extensometers exhibited approximately the same trends. The compression change in both when the slab was loaded by the truck indicates either (a) that the composite soil-steel-concrete structure deforms in a bending mode with the neutral axis next to the pipe or (b) that the system is deforming in compression like an arch.

The readings of the horizontal soil extensometer H measured outside the structure at the spring line are roughly consistent in trend with those for the horizontal structural extensometer E (Figures 4 and 6a). Outward movement of the structure would cause H compression and E extension, for example. However, the magnitudes of the H and E readings are different: Much smaller changes are indicated for H than for E on both sides of the structure. One possible explanation is that the zone of deformation in the soil extends well beyond 13 ft (4 m) from the structure. In addition, the cohesive soil beyond the backfill zone is most likely more compressible than the granular backfill.

The observed overnight deformation changes with the structural extensometers are shown in Figure 17 both with and without the 0.30-in. (7.6-mm) adjustment for the estimated temperature effect on the extensometers. The adjusted readings indicate a shrinkage of the structure. These readings are consistent with those for the observed pressure reductions (Figure 4).

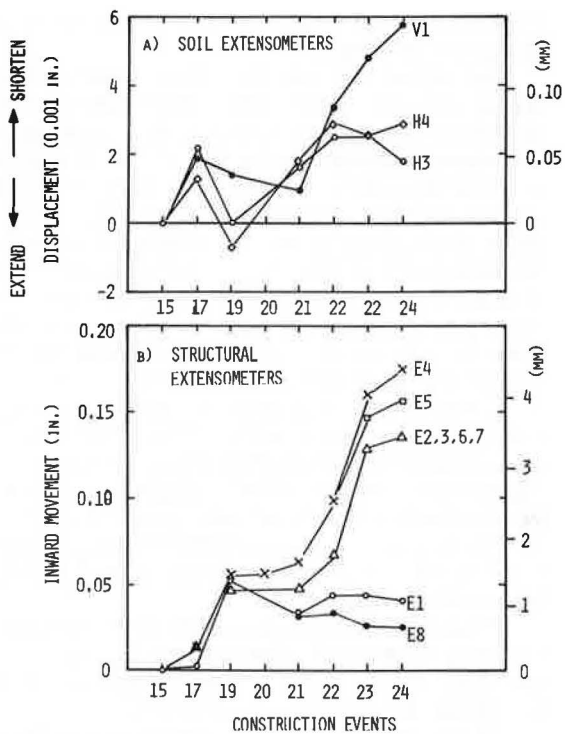
Figure 5. Movements after slab constructed and struts removed.

The structural extensometers were installed after the slab was constructed and the struts removed (event 15). Therefore no information was obtained on the magnitude of structure deflection caused by the construction phases. The measurements for the structural extensometers are shown in Figure 5b. The two horizontal structural extensometers showed little movement during the first loading with the 32,800-lb (14 900-kg) truck (change from event 15 to 17). All of the other extensometers moved about the same amount and generally indicated inward movement under load and a small amount of rebound on unloading. A much larger residual inward movement of about 0.05 in. (1.3 mm) occurred for all extensometers after many additional load cycles in event 18 were completed. The effect of the next series of live load tests (events 19 to 21) appeared to be small. Addition of fill on top of the slab (events 22 to 24) caused outward movement at E1 and E8 and inward movement at the other structural extensometers.

From the construction measurements for the vertical soil extensometer V1 and the vertical structural extensometer E4, it is apparent that the relative deflection between the slab and the structure is negligible compared with the deflection of the crown of the structure (Figures 5a and 5b).

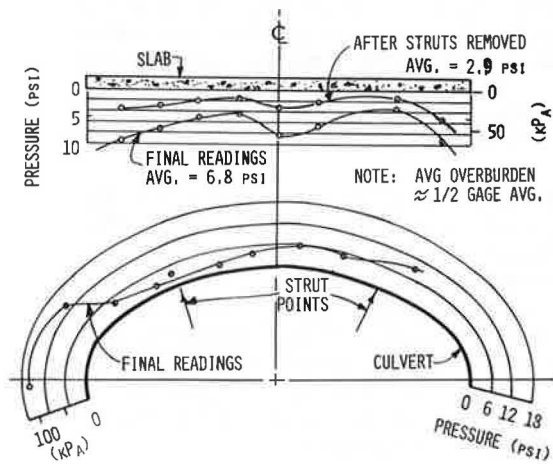
Figure 6. Final pressure distribution around structure and under slab.

The pairs of struts, installed at 6-ft (1.8-m) intervals along the length of the structure, supported the points shown in Figure 6. These struts were positioned prior to any backfilling over the top of the structure. The struts were removed after the slab was poured and partially cured. The nonuniform pressure distribution shown in Figure 6 was believed to be created under the slab and around the culvert as a result of the stress relief at the strut points when the struts were removed. This distribution did not change when additional fill was placed over the slab. The cross section on which the gauges were located was halfway between two strut cross sections. The average pressures under the slab of 2.9 to 6.8 psi (20 to 47 kPa) for the two situations shown in Figure 6 were about twice the average overburden stress. This indicates a longitudinal redistribution of stress accompanying strut removal, in which the stress

9. Considering the errors inherent in soil pressure measurements, the best estimate of the pressure distributions around the structure and under the slab at the completion of the tests is as shown in Figure 6. Under the slab, the average pressure was 6.8 psi (47 kPa), but it increased from about 8 psi (55 kPa) in the center, to 4 psi (28 kPa) at the quarter points, and to 10 psi (69 kPa) near the ends. The average pressure over the center of the structure was about 4.2 psi (29 kPa), and the maximum at the crown was 5.6 psi (39 kPa). These correspond to an overburden density of about 116 to 155 lb/ft³ (1860 to 2480 kg/m³) with a depth of 5.2 ft (1.6 m). This is in the range of the existing average density. The final crown pressure was about 5.6 psi (39 kPa). The pressure decreased to about 2.8 psi (19 kPa) at the strutting support point and increased again to 15.4 psi (106 kPa) at the spring line. The final horizontal pressure at the spring line was about equal to the vertical geostatic stress at that level.

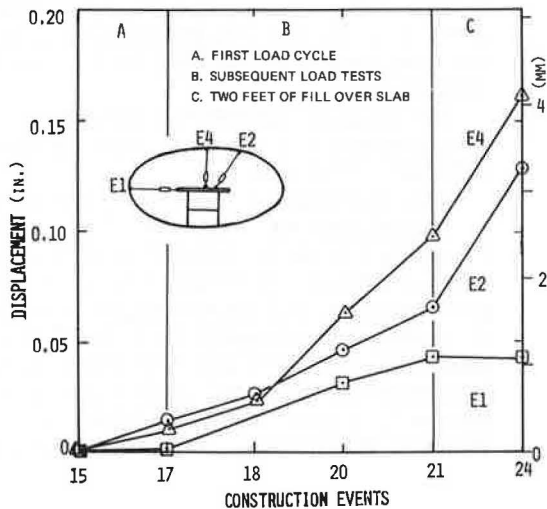
Figure 7. Inward movement of structure during load tests and final filling.

The residual structural deformation after the load tests and final grading was about 0.16 in. (4.1 mm) vertically downward and 0.04 in. (1.0 mm) horizontally inward on both sides (Figure 7).

For the five-gauge, 2 × 6-ft (0.6 × 1.8-m) corrugation, $A = 0.022$ ft²/ft (0.0068 m²/m). The average final backfill pressure on the culvert was about $p = 8 \times 144$ lb/ft² (55 kPa). The average diameter is $D = 22.5$ ft (6.9 m). Thus $\Delta P/P = 0.000135$. The corresponding average diameter change would thus be $\Delta D = 0.003$ ft (0.0009 m) or about 0.04 in. (1 mm). This diameter change is also large enough to account for the apparent residual inward movement at the spring line that resulted in permanent pressure increases around the pipe (Figure 7) after a series of live load tests.

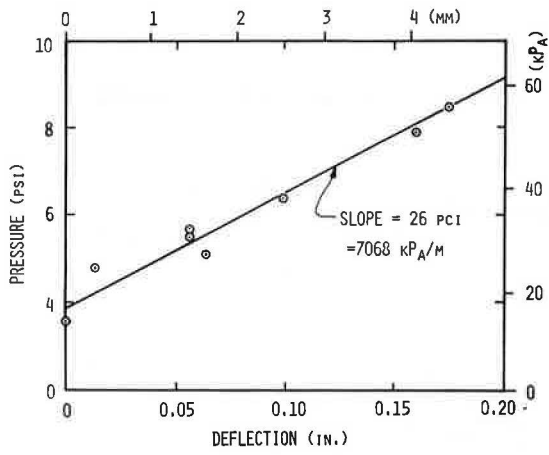
Figure 8. Pressure under slab S8 related to crown deflection E4.

The relationship between the pressure under the slab and the crown deflection from the construction process is shown in Figure 8. The average modulus is approximately 26 lb/in.³ (7070 kPa/m).

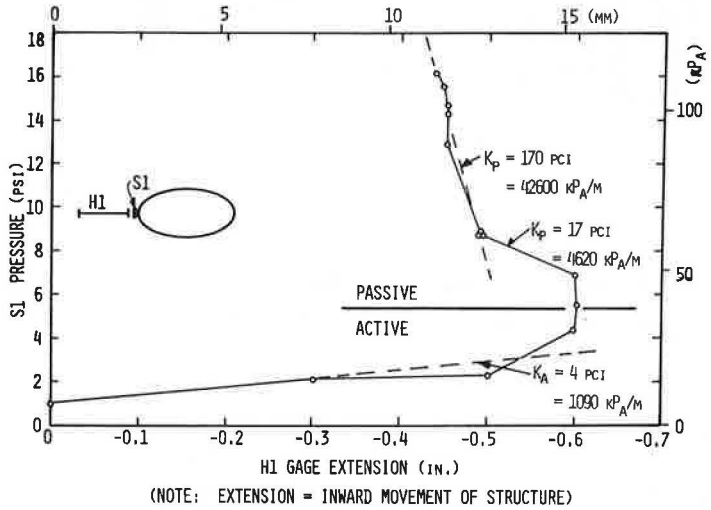
Figure 9. Relationship of spring-line pressure to deformation during construction.

Most commonly used design procedures for culverts require some measure of the horizontal passive resistance of the soil to outward movement of the structure. The dimensions of the associated modulus are pressure per unit deflection. An estimate of this modulus was obtained by plotting the spring-line pressure as a function of the corresponding soil extensometer movement (Figure 9). During the live load test phase, the modulus increased from 17 to 170 lb/in.³ (4620 to 46 200 kPa/m). However, because the structural extensometers showed larger lateral movement than the soil extensometers, the actual moduli are probably lower than those shown in Figure 9. During the initial stages of backfilling, the modulus was about 4 lb/in.³ (1090 kPa/m). This can be thought of as the active coefficient of backfill reaction.

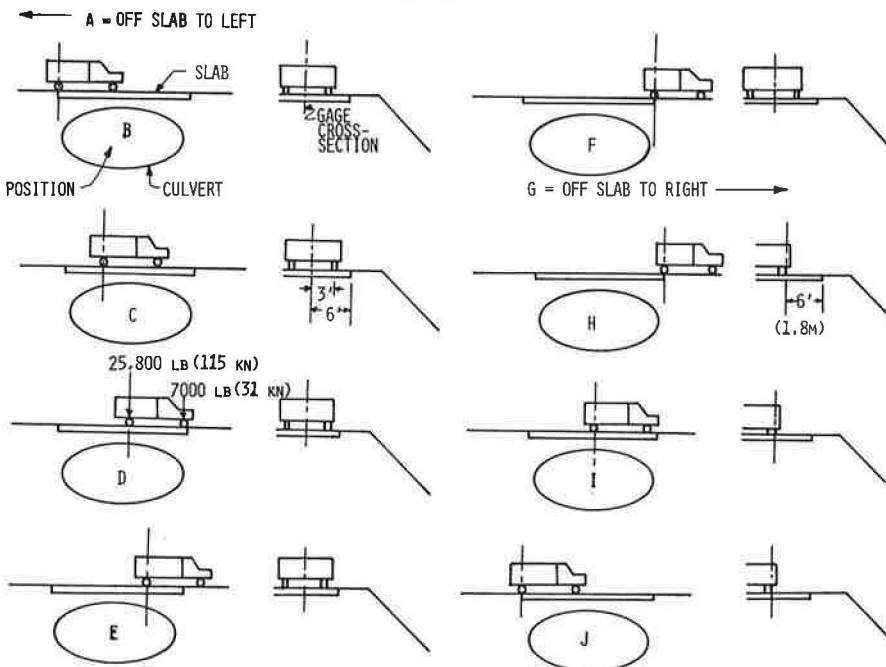
Figure 10. Load positions for 32,800-lb (14 900-kg) truck.

In the fourth live load test, the vehicle was positioned for a moment in each location in Figure 10. This test gave numerical results similar to those for the previous test with the continuously moving truck for positions A through G. For the reverse pass (positions H through J) in this case, the truck wheels on the right side passed over the gauge section rather than a straddle pass. The trends were similar, but the magnitudes of the peak readings were smaller by an average of 34 percent. The pressure distribution and deflection pattern produced by the truck in position D (center of slab) is shown in Figure 16. The maximum deflection under the 32,800-lb (14 900-kg) load was about 0.012 in. (0.3 mm) at the crown. The maximum pressure on the structure was 0.3 psi (2.1 kPa), and the maximum under the center of the slab was 0.8 psi (5.5 kPa).

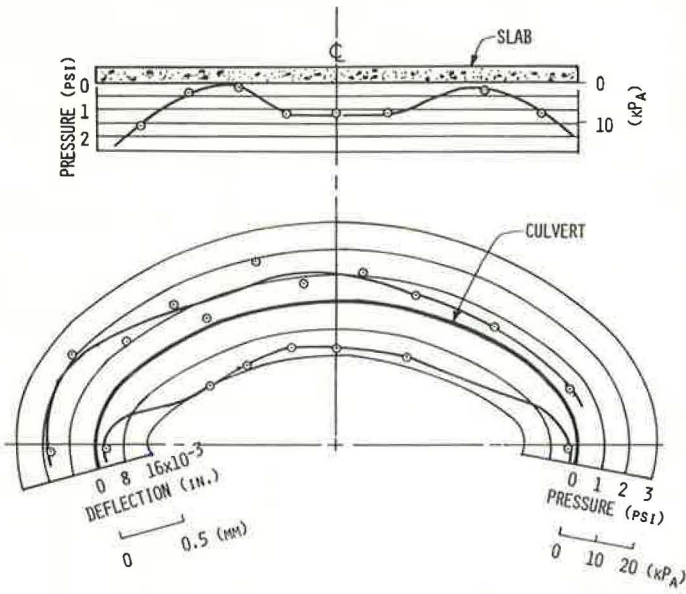
Figure 11. Residual pressures and deflections after first live load test.

radial deformations were all inward, amounting to 0.003 in. (0.008 mm) at the spring line and 0.014 in. (0.36 mm) at the crown. This pattern suggests slippage at the longitudinal bolted joints in the structure. At the same time residual pressure increases of about 0 to 2.2 psi (0 to 15 kPa) occurred on the structure.

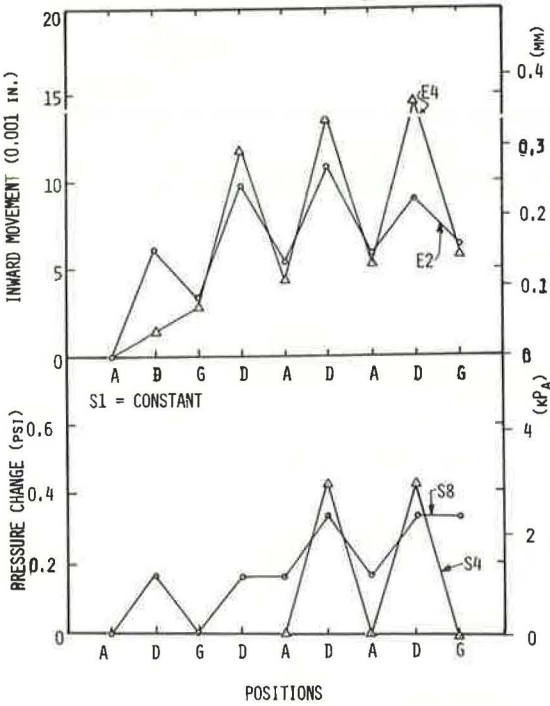
Figure 12. Results from second live load test.

In the second live load test, the truck made a series of passes on and off the slab. The observed elastic and residual pressures and deformations at several locations (Figure 10) are shown in Figure 12. The average ratio of pressure increase under the center of the slab to the crown deflection under the vehicle loading was approximately 47 lb/in.³ (12 800 kPa/m). Spring-line movements were less than 0.001 in. (0.025 mm).

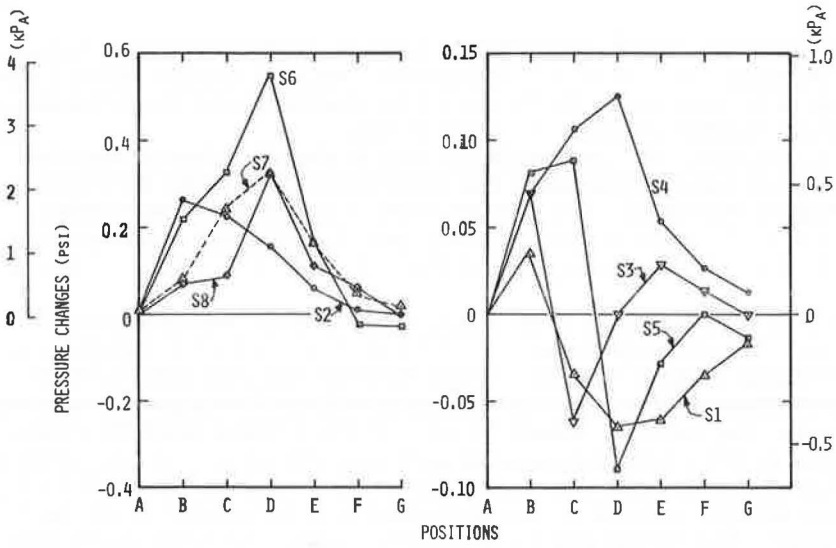
Figure 13. Soil stress changes during third live load test.

In the third live load test, the truck made a pass over the slab from position A to G at a constant speed of about 5 mph (8 km/h). The results are shown in Figures 13, 14, and 15. The residual readings are minor compared with the peak values; therefore, the response is essentially elastic. A reverse pass from G to A gave almost the same results; however, the curves in Figure 13 are not symmetrical about the center position D. The peak dynamic stress around the structure was about 0.15 psi (1.0 kPa) at the crown. The peak stress under the center of the slab was about 0.5 psi (3.4 kPa). The maximum crown deflection was 0.009 in. (0.23 mm), and deflections at all other locations were smaller. None of the soil extensometers changed by more than 0.0005 in. (0.013 mm). The ratio of pressure increase under the center of the slab to crown deflection was 34 lb/in.³ (9230 kPa/m).

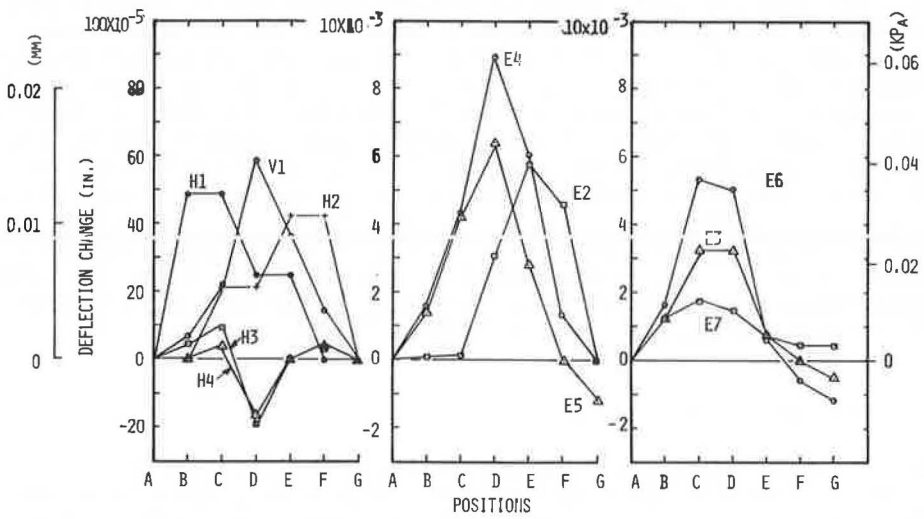
Figure 14. Extensometer changes during third live load test.

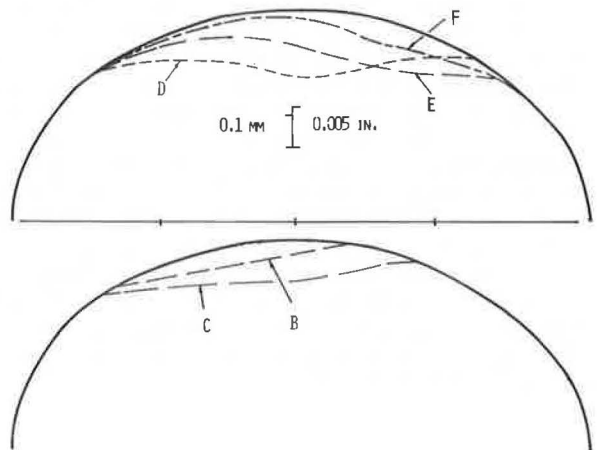
Figure 15. Culvert deflection pattern based on structural extensometers for truck moving over positions indicated.

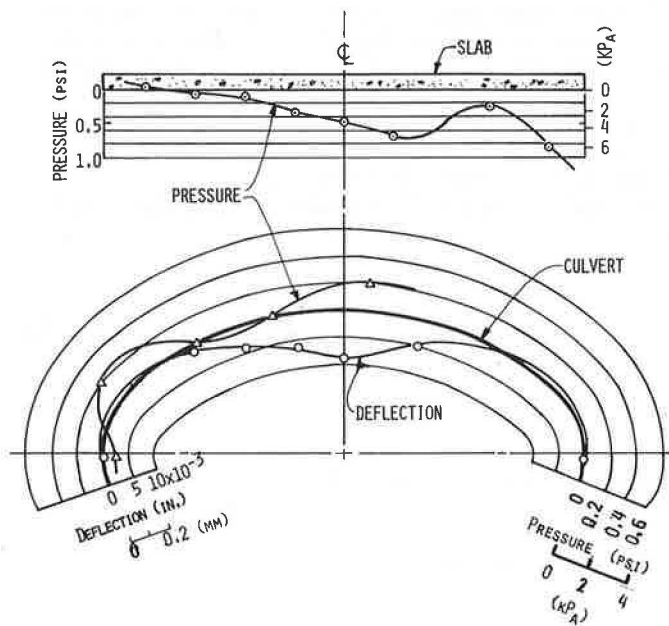
Figure 16. Pressures and deflections for 32,800-lb (14 900-kg) truck in position D.

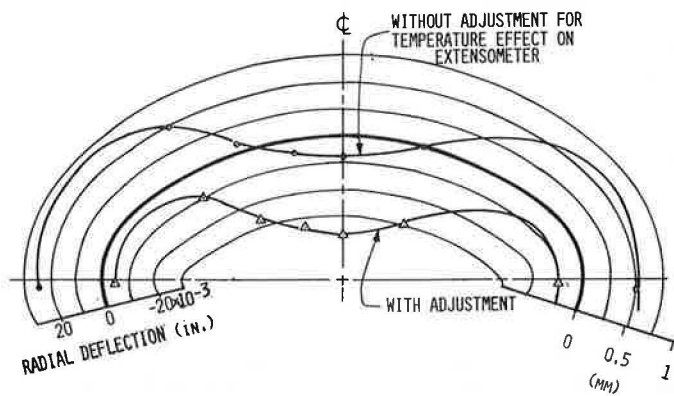
Figure 17. Radial deformations of structural extensometers caused by overnight temperature drop.

A decrease in temperature would cause the cables of the structural extensometers to shorten, which would move the sensing elements of the extensometer apart. The same decrease in temperature would also cause the perimeter of the structure to shorten, which would decrease the lengths of its axes. This will cause the sensing elements of the extensometers to move together so that essentially no net change in extensometer reading would be observed. However, the steel would not be likely to change in temperature as readily as would the structural extensometers because it is in contact with the backfill on one side. Thus air temperature decrease inside of the culvert would show an apparent increase in culvert diameter.
