**TRANSPORTATION RESEARCH RECORD**

**554**

# **Hazardous Materials Transportation and Highway Maintenance**

**8 reports prepared for the 54th Annual Meeting  
of the Transportation Research Board**

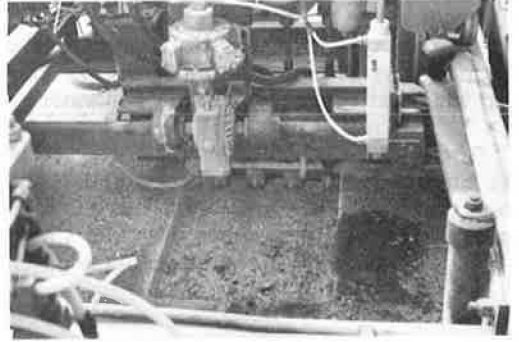
Figure 6. Smaller machine in hole-cutting operation.

In addition to the general purpose machine, a smaller machine designed exclusively for hole cutting was used. It required a compressor working at 250 ft<sup>3</sup> (7.1 m<sup>3</sup>)/min at 100 psi (689.5 kPa). Its operation is similar to that of the larger machine although it has only four cutting heads and can cut a maximum size hole of only 1.5 × 2 ft (0.46 × 0.61 m). Like the larger machine, its hole-cutting dimensions can be adjusted by taking cutting heads out of action. The larger machine is self-propelled, and the smaller one is not. This is a disadvantage because its weight is too great to allow ease of movement and setup by hand by the operator. In Table 1, all of the data under cutting heads are applicable to the smaller machine, except the data pertaining to the width of cut and the information in the footnotes. Figure 5 shows a rear view of the smaller machine with the four cutting heads visible, Figure 6 shows the machine in operation, and Figure 7 shows a hole prepared for patching.

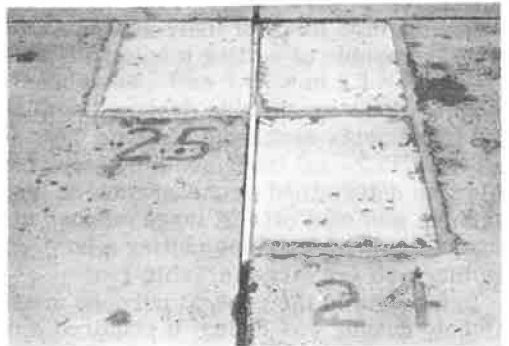
Figure 9. Patched area requiring more than one slab.

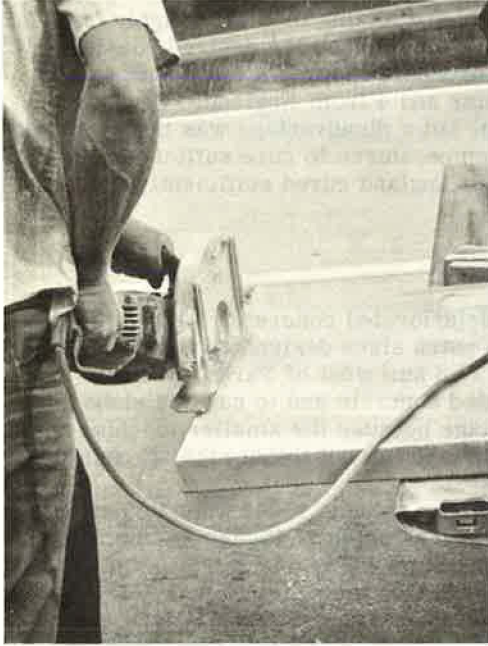
Figure 10. Precast slab being sawed to proper dimension.

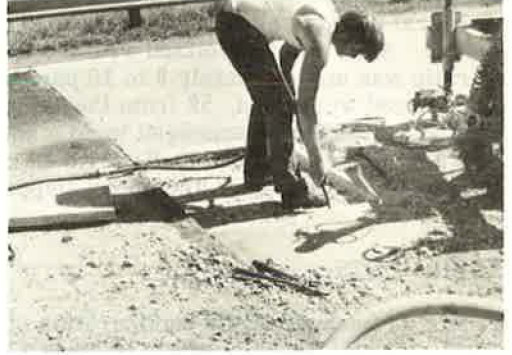
Figure 11. Steel mesh being removed from hole with hand tool.

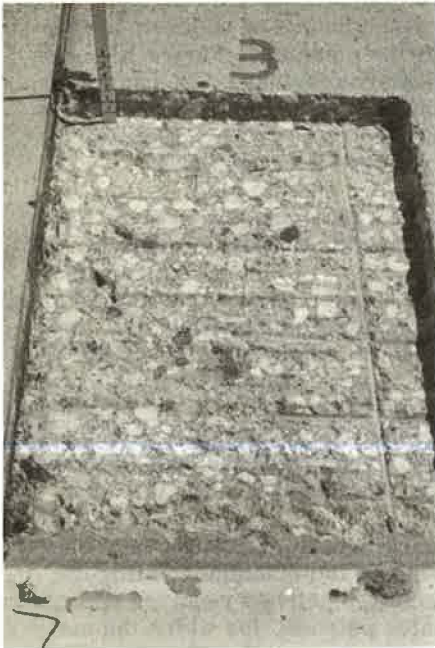
Figure 12. Grid pattern left after removal of steel mesh.
