FAILURE OF A CAST-IN-PLACE UNREINFORCED CONCRETE CONDUIT

Jerry C. Chang, Division of Construction and Research,
California Department of Transportation

A case history of the failure of a 72-in. (183-cm) cast-in-place, unreinforced concrete conduit constructed near the toe of a highway embankment is described. Theoretical analysis was conducted to predict the behavior of the conduit. It was concluded that the conduit had failed primarily because of the additional lateral load exerted by a 70-ft-high (21.3-m) embankment. The effectiveness of the theoretical analysis was demonstrated by using actual conduit failure.

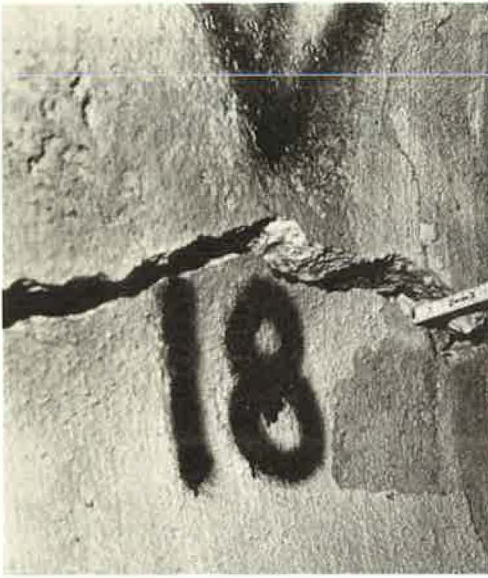
Figure 3. Cracks in conduit at spring line.

In January 1971, a third inspection of the conduit showed extensive cracking, particularly along the spring line of the conduit. The top half of the conduit was laterally displaced away from the embankment by as much as 3 in. (7.6 cm) relative to the bottom half.

Figures 3 and 4 show the crack in the conduit along the spring line and the crown respectively.

Visual inspection, backed by theoretical analysis, indicates that the failure of the conduit was primarily due to the additional lateral load exerted by the 70-ft-high (21.3-m) embankment located about 8.5 ft (2.6 m) away from the conduit. The conduit was cracked first at the inner face along the spring line (also the location of the construction joint). The upper half of the conduit was then sheared off and displaced by as much as 3 in. (7.6 cm) away from the embankment by the lateral earth pressure exerted from the embankment load. Since the lower half of the conduit was cast neatly in the excavated, semicircular-shaped trench, which was mostly composed of sandy soil with shale fragments and was more rigid than the clayey backfill material surrounding the top of the conduit, it was held in place without appreciable movement.

There was no circumferential crack observed on the conduit wall. Therefore, it can be concluded that there was no appreciable uneven settlement along the axis of the conduit. This conduit was replaced with a class 4, double-caged, reinforced concrete pipe after the conclusion of this study in June 1971.

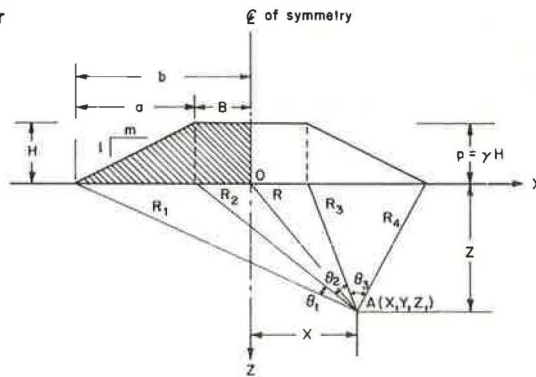
Figure 5. Subsoil stresses under symmetrical trapezoidal load.

The stresses under a symmetrical trapezoidal load are shown in Figure 5. The loading of the external soil pressure [pounds/foot² (pascal)] on the conduit is shown in Figure 6.

The earth pressure on the conduit due to the embankment load was estimated for computing subsoil stress at any point A in the foundation soil due to a trapezoidal embankment loading. This pressure was estimated from the equation given by Chang (3), where γ = unit weight of the embankment soil and horizontal stress is

$$\sigma_x = \frac{P}{\pi a} \left[a(\theta_1 + \theta_2 + \theta_3) + B(\theta_1 + \theta_3) + X(\theta_1 - \theta_3) - 2Z \log_e \frac{R_1 R_4}{R_2 R_3} \right] \quad (4)$$

$$\sigma_z = \frac{P}{\pi a} \left[a(\theta_1 + \theta_2 + \theta_3) + B(\theta_1 + \theta_3) + X(\theta_1 - \theta_3) \right] \quad (5)$$

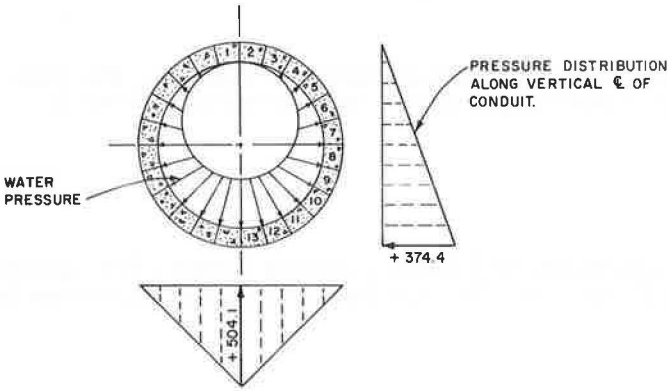
Figure 7. Hydrostatic pressure on internal face of conduit.

When the conduit is flowing full with water, hydrostatic pressure [pounds/foot² (pascal)] would act on the internal face of the conduit. The distribution of the water pressure is shown in Figure 7.
