DEVELOPMENT OF A NEW COLLAPSING-RING BRIDGE RAIL SYSTEM

C. E. Kimball, M. E. Bronstad, and J. D. Michie, Southwest Research Institute; and J. A. Wentworth and J. G. Viner, Federal Highway Administration

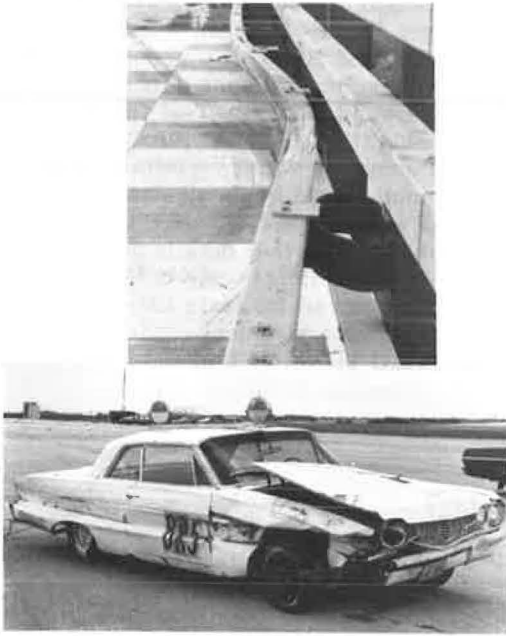
Figure 3. Condition of vehicle and collapsing-ring bridge rail after impact in test BR-5.

The 3,910-lb (1773-kg) 1964 Chevrolet Impala sedan impacted the front rail at post 5 with a speed of 56 mph (90 km/h) and an impact angle of 24 deg and was smoothly redirected as shown in Figure 2. Figure 3 shows the condition of the vehicle and the rail barrier after the impact. The design goal of complete collapse of one ring without excessive vehicle contact with other elements of the system with the given impact conditions was met with the $\frac{3}{8}$ -in.-thick (9.5-mm) rings. The comparison of predicted and experimental results is shown in Figure 4.

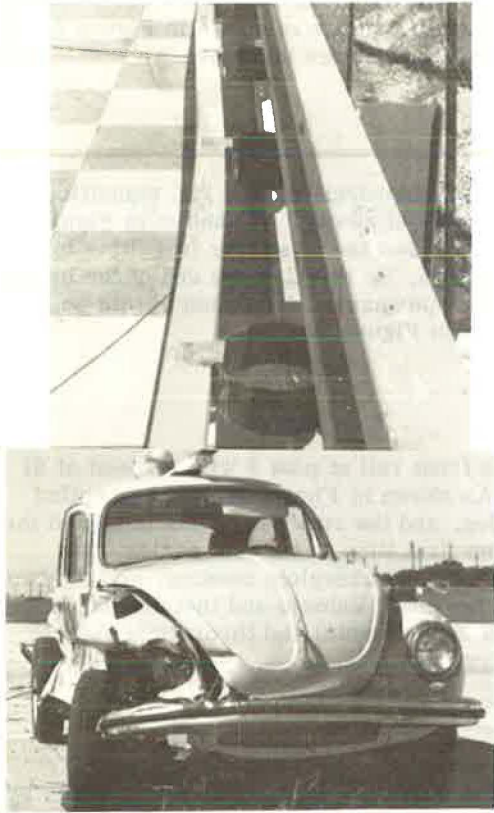
Figure 6. Condition of vehicle and collapsing-ring bridge rail after impact in test BR-6.

5 and 6 with a speed of 56 mph (90 km/h) and an impact angle of 24 deg and was smoothly redirected as shown in Figure 5. Vehicle and barrier damage is shown in Figure 6, and the comparison of predicted and experimental results is shown in Figure 7.

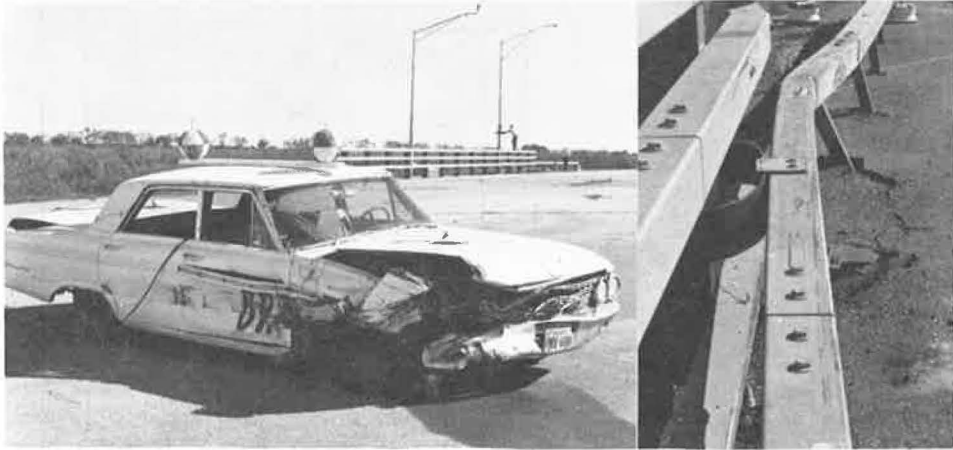
Figure 9. Condition of vehicle and collapsing-ring bridge rail after impact in test BR-7.

The 4,230-lb (1018-kg) sedan impacted the approach guardrail-bridge rail transition with a speed of 57 mph (92 km/h) and an impact angle of 29 deg. As shown in Figure 8, the vehicle impacted the guardrail, completely collapsed the first ring (resulting in backup rail translation of the soil), mounted posts A, B, and C at the end of the bridge rail, and was then smoothly redirected. Maximum permanent deflection of this post was 22.9 in. Vehicle and barrier damage is shown in Figure 9.

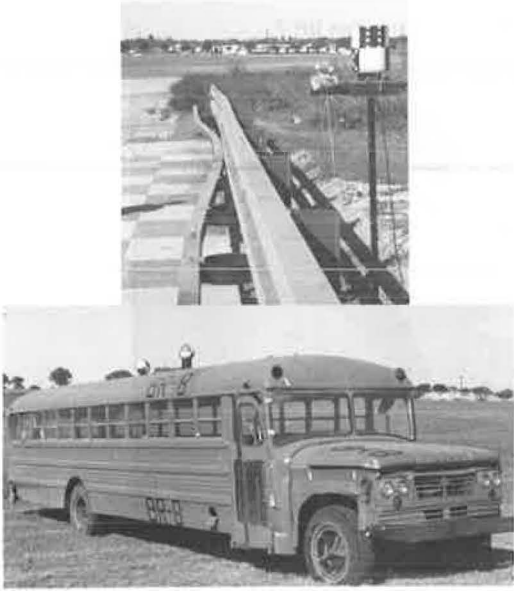
Figure 11. Condition of vehicle and collapsing-ring bridge rail after impact in test BR-8.

The 19,000-lb (8618-kg) school bus impacted the front rail at post 8 with a speed of 61 mph (98 km/h) and an impact angle of 14 deg. As shown in Figure 10, the bus rolled toward the rail to a maximum roll angle of 15 deg, and the rear of the bus impacted the two upper rails before being redirected. For the first time in the test series, two bridge posts sustained damage: Posts 7 and 8 sustained baseplate bending, and the two bolts nearest the bridge deck in post 8 failed in tension. Vehicle and installation damage are shown in Figure 11. The comparison of experimental and theoretical vehicle dynamics is shown in Figure 12.

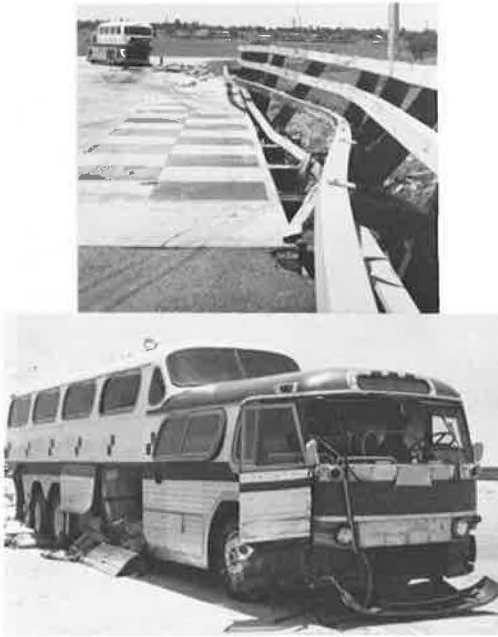
Figure 14. Condition of vehicle and collapsing-ring bridge rail after impact in test BR-9.

The scenicruiser intercity bus ballasted to 40,000 lb (18 144 kg) with 10,200 lb (4627 kg) of sand bags in the baggage compartment impacted the front rail at post 2 with a speed of 54 mph (87 km/h) and an impact angle of 19 deg. As shown in Figure 13 and Figure 14, the bus completely collapsed rings in the impact zone, rolled toward the rail, and the rear of the bus impacted the three-rail system. The redirected bus reached a maximum roll angle of 20 deg (toward the rail) before returning to an upright position. The significance of the vehicle's c.g. being lowered by the ballast and of the ballast spilling free of the vehicle is not clearly defined. In the extreme case, had the vehicle been redirected in a manner that raised the c.g., a rollover might have occurred.

The bottom rail (rub rail) failed completely. Considerable post damage was sustained: Posts 2 through 5 failed in bending and torsion with all four baseplate bolts fractured; posts 1, 6, and 7 sustained baseplate bending, and the two bolts nearest the bridge deck failed in tension. In addition, all three soil-mounted posts upstream of the bridge deck were displaced laterally with a maximum permanent displacement of approximately 26 in. (660 mm). The comparison of experimental and theoretical vehicle dynamics is shown in Figure 15.
