# FIELD TESTING OF AGUASABON RIVER BRIDGE IN ONTARIO

J. Peter C. King and Paul F. Csagoly,  
Ontario Ministry of Transportation and Communications; and  
John W. Fisher, Lehigh University

This paper describes the field testing of the Aguasabon River bridge in Ontario, a three-span, continuous, steel girder bridge with parabolic haunches of composite concrete slab construction. As part of the 1973 bridge testing program, the structure was tested both statically and dynamically with two load-testing vehicles. Because this structure had a history of failures of the haunch weld detail and because it was one of several similarly designed structures, it was decided to determine the actual bridge behavior under load as well as its structural adequacy. Outlined are the grid type and other analytical procedures followed to predict stresses and deflections, which are then compared with those values recorded during the static loading. An estimate of the fatigue life of the weld details is made by using the dynamic strain data obtained. General aspects of the behavior of the structure are discussed, and conclusions are drawn on the structural adequacy of the test bridge and the methods used

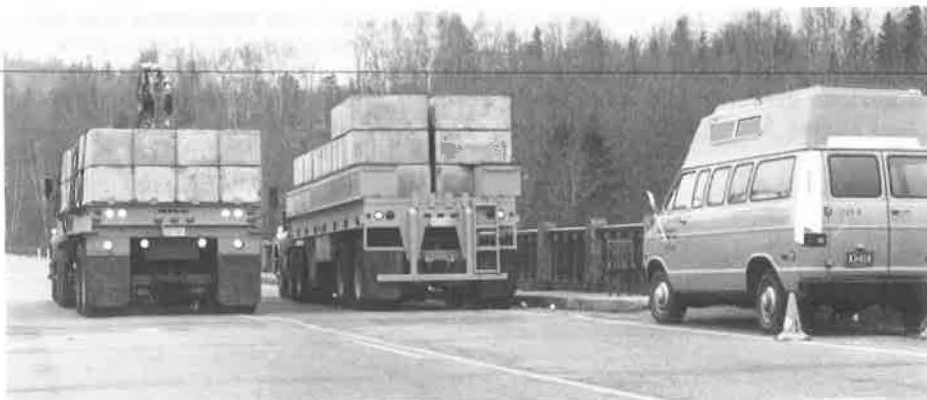
**Figure 9. Test 1B-48 maximum moment at east end span.**

To clarify the questionable results from this splice plate, an additional strain gauge was attached near the first and was monitored throughout the second day of testing. When the load was increased to 147,000 lb (66 680 kg) on each vehicle (48 test series) a similar situation was encountered. The explosive sound was heard, louder than before, and plate stresses this time reached 38 ksi (262.0 MPa) or 1,095  $\mu\text{in./in.}$  with a permanent offset of 940  $\mu\text{in./in.}$  The second strain gauge confirmed the readings obtained from the original one. A number of repeated loadings were made with plate movements measured by precision dial gauges, and a similar elastic strain was recorded with increasing permanent set each time. This confirmed suspicions that the splice plate had undergone considerable yielding. The remainder of the tests were completed at this load value, but test series 60 and 72 were abandoned because there was fear that serious structural damage would result. Figure 9 shows a typical loading condition of test series 48.

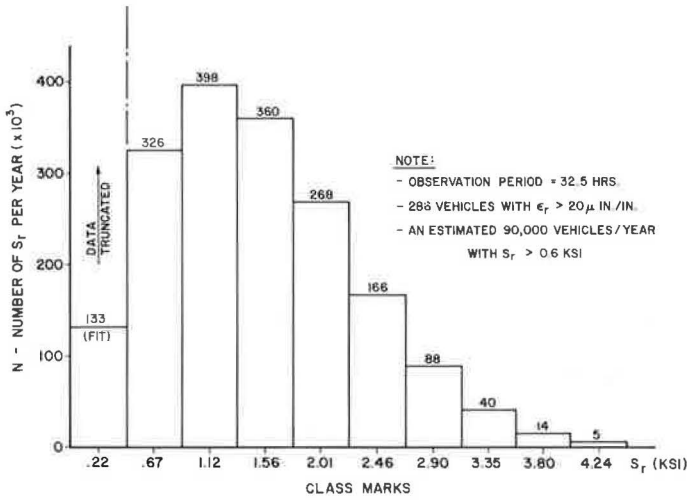
Figure 12. Stress range histogram (smoothed).

Figure 11 shows three typical strain records made when the test vehicle was traveling at 45 mph (72 km/h) in the eastbound lane. These and other traces were examined, and a representative histogram of stress range ( $S_r$ ) was determined (Figure 12). The service life of the welded details of the Aguasabon River bridge was estimated from the measured stress range histogram and the estimated fabricated flaw conditions that existed in the structure.

The stress range histogram was used to estimate the root mean square stress range  $S_{rRMS}$  for various minimum stress range conditions. When all stress range levels greater than 0.85 ksi (5.9 MPa) were considered, this resulted in  $S_{rRMS} = 1.92$  ksi (13.2 MPa) at an annual rate of 1,340,000 cycles. This also provided a lower life estimate than when smaller stress range levels were considered.

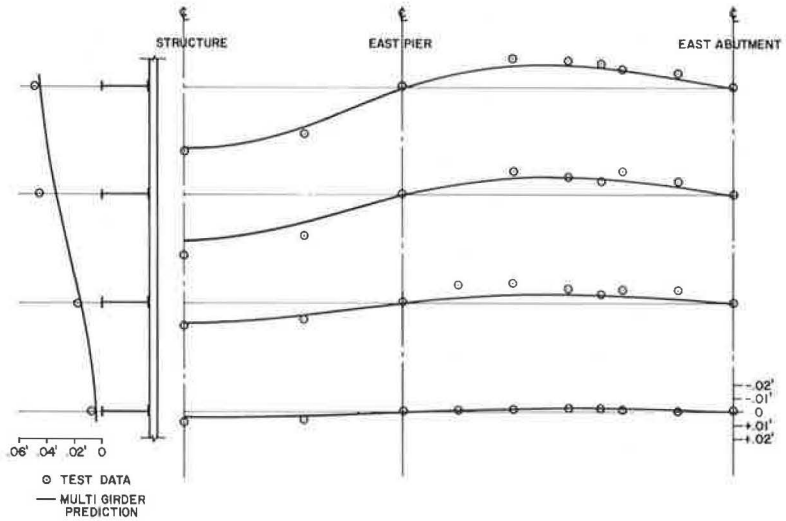
Figure 14. Deflected shape.

The use of triangulation techniques to reduce all deflection data resulted in the deflected shape of the structure under load. Measured deflections were compared to revised deflection results from the multigirder computer program by using loading conditions identical to those used in the field. The maximum recorded deflection was 0.756 in. (19.2 mm) at the center span with a 244,000-lb (110 680-kg) live load on the structure in comparison with the revised calculated deflection of 0.732 in. (18.6 mm). Pier and abutment displacements were negligible. Deflection distribution factors similar to the AASHTO load distribution factors, in terms of girder spacing (2), are given in Table 3.

The multigirder program requires inertia, torsional stiffness of the exterior girders, and diaphragm stiffness values as input to mathematically describe the structure. As might be expected, any variation in these parameters makes a significant change in computed deflections and moments. The first trial using inertias suggested by AASHTO provided poor agreement with the experimental deflected shape. However, by increasing the inertias in the negative dead load bending moment region, the computed deflections approached the experimental cross-sectional average. The final inertias used corresponded to a fully composite deck throughout the length of the bridge, with 80 percent of the slab width effective. Further variation of the floor beam stiffnesses and the torsional stiffness of the exterior girder would provide better transverse agreement. Correlation between experimental and theoretical moments was not consistent. Good agreement was obtained at midspan, and poor to fair agreement was obtained elsewhere. Figures 14 and 15 show the agreement obtained for test 5A-36 for both deflection and moment respectively.
