Sediment Trapping Efficiency of Straw and Hay Bale Barriers and Gabions

David J. Poché, Virginia Highway and Transportation Research Council
W. Cullen Sherwood, Virginia Highway and Transportation Research Council
and Madison College

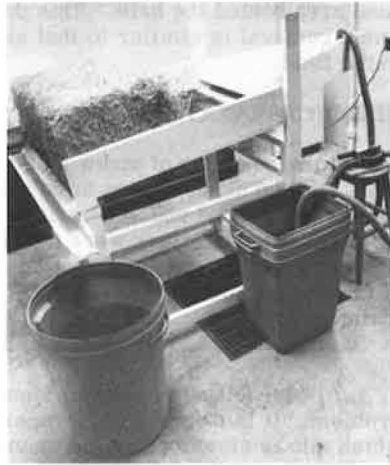
Figure 1. Apparatus for testing the trapping efficiency of a bale.

A test flume was designed so that sediment-laden water could be filtered through either one or two bales. The flume was constructed of 1.9-cm-thick ($\frac{3}{4}$ -in-thick) plywood and coated with a waterproof paint (Figure 1). For most of the comparative tests, only a single bale was used. The test followed a set procedure.

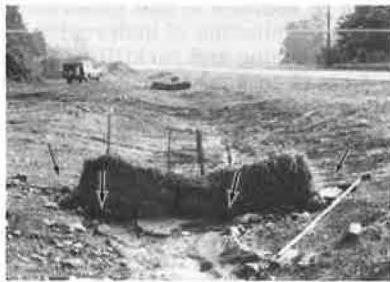
Figure 2. Improperly constructed and maintained filter barrier.

1. Undercutting, shown in Figure 2, is a placement problem. It is caused by improper bale-to-soil contact, which allows storm water to run under the bale. The resulting concentrated flow tends to cut a channel under the bale. The process of channelization mobilizes sediment in addition to that generated upstream from the bale. Elimination of undercutting can be accomplished by entrenching and backfilling the bales to a depth of 5 to 8 cm (2 to 3 in) before staking or by wedging loose straw from a broken bale under the bale after staking.

2. End flow, also shown in Figure 2, occurs when storm waters flow around the end of the barrier. As in the case of undercutting, end flow can result in a higher concentration of suspended sediment downstream from a barrier than that reaching the barrier from upstream. Elimination of end flow can best be ensured by extending the barrier where possible so that the bottoms of the end bales are higher than the top of the lowest center bale. This placement forces water to pond and flow over rather than around the lower bale or bales.

The efficiency measurements given in the tabulation on contractor-placed straw barriers were taken on a series of unmodified barriers placed on the project by the contractor. Figure 2 shows a barrier located on this project. Before the experimental barriers were placed, all of the old barriers were removed.

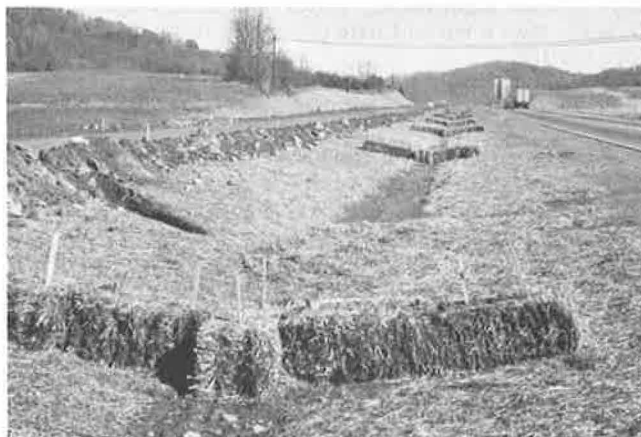
Figure 4. Experimental barriers in place.

The number of experimental barriers to be placed per 30.5 m (100 ft) of roadway was determined by using a computer program developed by Poché and based on the soil loss equation (2). Each barrier was placed by using the criteria discussed in the section on field observations. That is, (a) straw was wedged under each bale after staking (subsequent field investigations in Virginia have indicated that a small amount of loose soil placed by shovel and lightly compacted along the upstream edge of a bale barrier eliminates undercutting and significantly aids barrier efficiency), and (b) the bottoms of the end bales were higher than the top of the lowest center bale. In addition, loose straw was scattered on the upstream side of each barrier to provide an increased filter travel length. Field observations indicate that subsequent movement of the loose straw tends to seal any undetected openings in the barrier. A typical experimental barrier is shown in Figure 4. The following tabulation gives percentage figures for trapping efficiency of barriers for storm events subsequent to placement of the experimental barriers:

Flow was from barrier I to barrier A in the ditch line. Barriers were 30.5 m (100 ft) apart and were constructed of wheat straw. The data from the storm of November 6 clearly indicate that the sediment-trapping efficiency of field barriers can approximate that obtained under laboratory conditions. Unfortunately, the average trapping efficiency for the storm of December 1 dropped significantly because of the failures of barriers A, C, and H. These failures vividly point out the need for constant surveillance and close attention to maintenance.
