Photogrammetry,  
Water Quality,  
Safety  
Appurtenances,  
and Shoulder  
Design

*TRANSPORTATION RESEARCH BOARD*

**Transportation Research Record 594**  
Price \$2.80  
Edited for TRB by Marianne Cox Wilburn

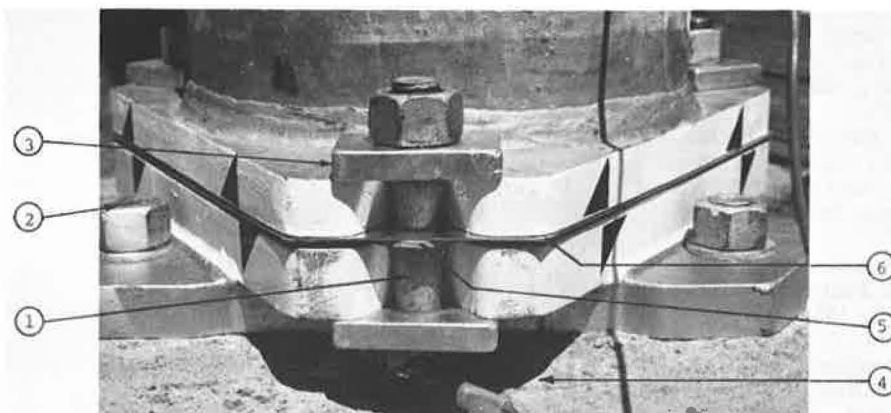
Figure 1. Slip base used with type 31 lighting standard in crash tests 311 and 312.

1. 22.2-mm diameter ASTM A325 galvanized clamping bolts (total 3 per slip base) instrumented with strain gages.
  2. 22.2-mm diameter HS anchor bolts (total 3 per slip base) cut flush with top of ASTM A564 Grade 2H galvanized nuts to allow top base plate to slip.
  3. 12.7-mm thick steel plate washers (2 per clamping bolt, total 6 per slip base).
  4. Surface of foundation beneath slip base clamping bolt heads relieved to provide minimum 3.2-mm clearance.
  5. Hardened flat washers (1 per clamping bolt - 1 per anchor bolt, total 6 per slip base).
  6. .102-mm galvanized steel keeper plate (one per slip base).
- Note: 1mm = .0394 in.
