Differential Friction: A Potential Skid Hazard

John C. Burns, Arizona Department of Transportation

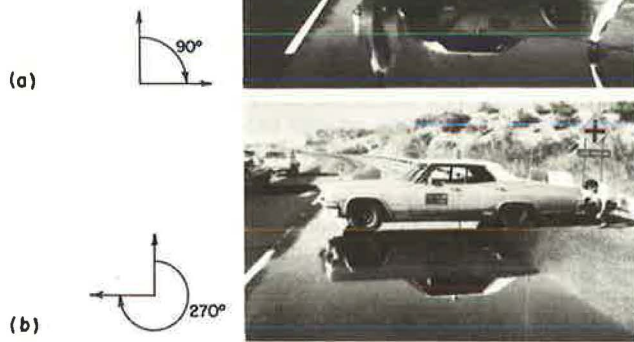
Figure 1. Effects of differential friction.

Figure 1 is a case used to portray what might happen if one wheel path was flushing and the other was not. Although both wheel paths have a satisfactory level of friction, a hazardous condition exists because of their difference. As the speed increases, the effects of differential friction increase dramatically. The problem is serious because the average driver tends to remove his or her foot from the brake as the car begins to rotate. When this is done, the car is propelled in the direction that the vehicle is facing. This could be off the road or into oncoming traffic. Because of national concern about the potential hazard that this condition might cause, a special research project was initiated to study this and other frictional problems (1). The remainder of this paper will discuss some of the findings of the research project.

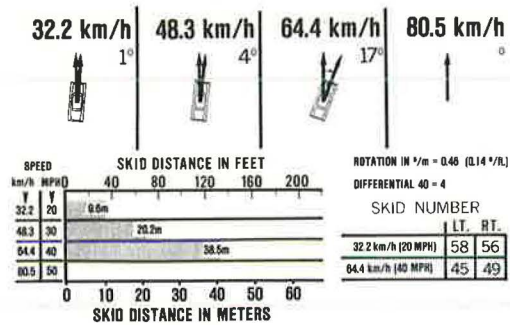
Figure 2. Rotation test, site 12.

Several of the actual test results are shown in Figures 2 through 5. From these diagrams, it can be seen that, as the differential friction level increases, the amount of rotation in degrees per meter of skid also increases. This indicates that good but unequal coefficients of friction in both wheel paths, may cause a more hazardous condition than low but uniform coefficients of friction. Similar findings were reported by Zuk (4). In the bottom right corner of these figures is the SDN recorded for the individual wheel paths at 32.2 and 64.4 km/h (20 and 40 mph). The differential friction at 64.4 km/h (40 mph) is obtained by calculating the absolute difference between the SDN for each wheel path recorded at 64.4 km/h (40 mph). To calculate the rotation in degrees per meter, divide the actual rotation at a particular speed (center of the figure) by the stopping distance (bottom left) recorded at that speed. The rotation shown in the right corner is for 64.4 km/h (40 mph).

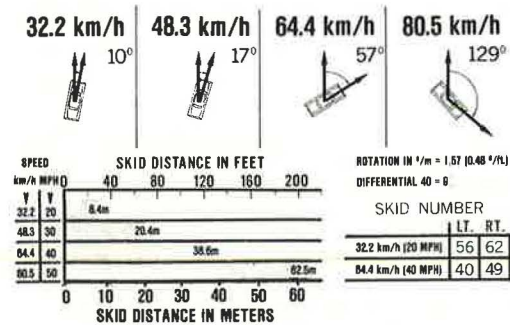
Figure 3. Rotation test, site 4.

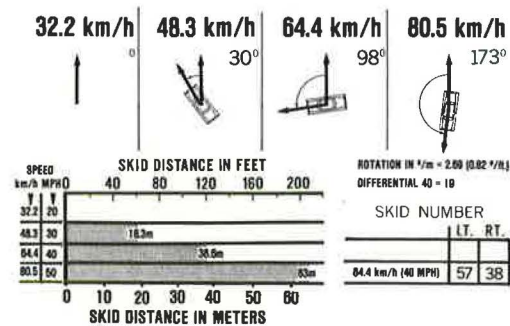
Figure 4. Rotation test, site 15.

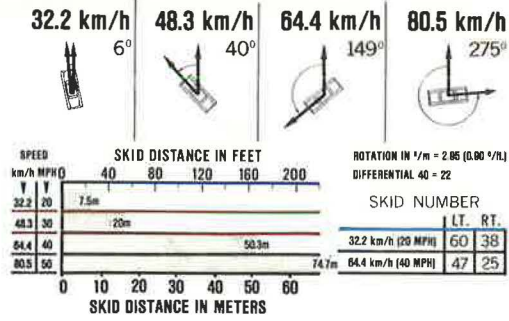
Figure 5. Rotation test, site 9.

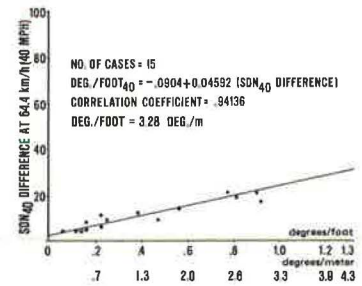
Figure 6. Rotation at 64.4 km/h (40 mph) versus SDN_{40} differential.

Equations for 48.3, 64.4, and 80.5 km/h (30, 40, and 50 mph) were obtained by relating the degrees per meter rotation to the DFN recorded at 64.4 km/h (40 mph). Correlation coefficients ranged between 0.93 and 0.94, and reliable equations were derived as can be seen in Figure 6. Figure 7 shows all three equations plotted on the same graph. Site 6 was not used in the derivation of these equations because it contained a portland cement concrete (PCC) and asphalt concrete (AC) surface differential. The degree of rotation was high, but lower than expected. This may have been due to the longitudinal burlap drag texture on the PCC pavement, which would impart a higher side force and thus inhibit rotation. If this is the case, grooving or grinding might be used to correct a differential friction problem.

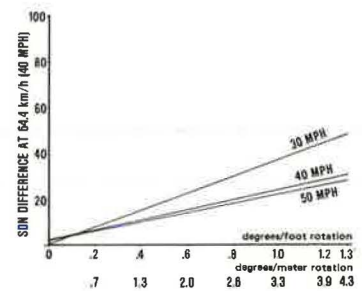
Figure 7. Rotation versus SDN_{40} differential.

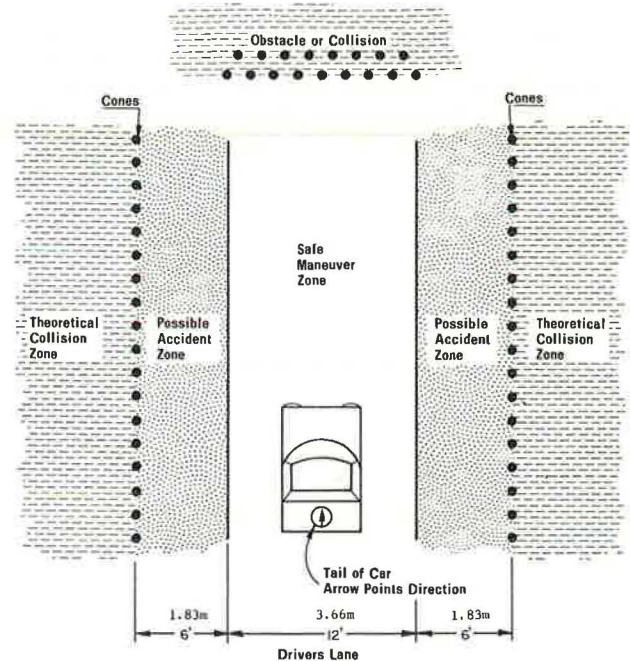
Figure 8. Vehicle control tests.

The second part of the evaluation was concerned with the maneuvering problems associated with the differential friction surface. A driver tends to release the brake after he or she begins to spin; at the same time, the driver tries to regain control of the vehicle. Therefore, a similar condition was reconstructed in two phases. The first phase was an experiment to determine how many degrees a car could rotate before it could not be safely corrected by the driver. Figure 8 shows the schematic of the system that was used in the test. The premise of the test was that a vehicle would have a 3.7-m-wide (12-ft-wide) lane in which it could safely maneuver. If the vehicle moved out of its lane for a distance

of up to 1.8 m (6 ft) on either side, it was considered to be in another lane and thus in a potential accident zone for oncoming or parallel traffic. The test vehicle was given additional maneuvering space because other traffic was assumed to be able to move 1.8 m (6 ft) and avoid the spinning car. If the car moved any further into another lane, a collision with other traffic was assumed to occur because an oncoming vehicle would not be able to avoid the spinning car. Traffic cones were placed along the imaginary collision zone, which allowed our vehicle a width of 7.3 m (24 ft) in which to maneuver. During each test, the driver was instructed to avoid these cones because they represented oncoming cars.

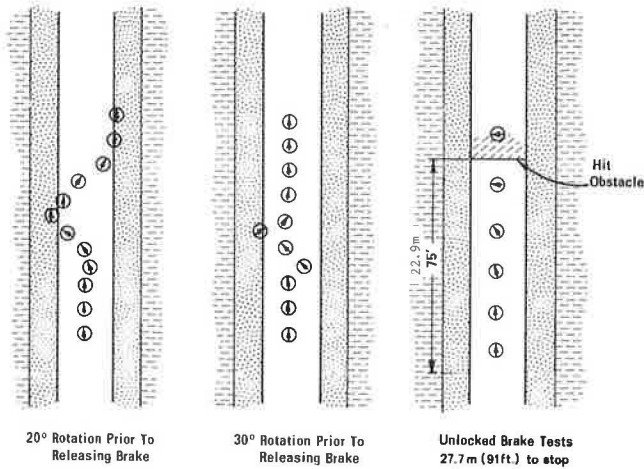
Figure 9. Vehicle control tests at 48.3 km/h (30 mph) where DFN = 17.

Films were made of all tests. Figures 9 through 11 show the trajectory of the vehicle recorded on film for various test speeds. In these figures, a circle was used

to represent the position of the rear end of the vehicle. The arrow inside the circle indicates the direction that the front of the car was facing at that moment.

Figure 9 shows the trajectory of the vehicle during tests

at 48.3 km/h (30 mph). When the vehicle was allowed to rotate 20 deg before releasing the brake, the vehicle moved into the possible accident zone, but did not enter the collision zone. In these tests, the vehicle had almost come to a complete halt before the brakes were released. When an obstacle was placed in the highway, the driver was able to stay in his or her lane but unable to stop before reaching the object.

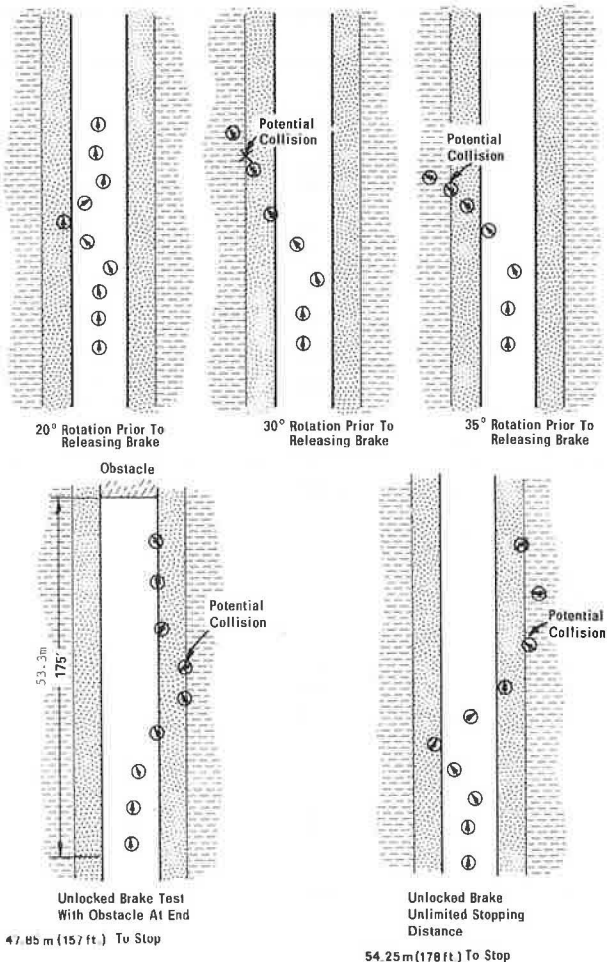
Figure 10. Vehicle control tests at 64.4 km/h (40 mph) where DFN = 17.

Figure 10 shows the results of the 64.4-km/h (40-mph) tests. The figure shows that the only case in which the vehicle did not move into the collision zone was the 20-deg rotation test. In this case it only moved into the

possible accident zone. The car was basically uncontrollable after rotating 30 deg or more. When an obstacle was placed in the road, the driver avoided it at 64.4 km/h (40 mph); however, to do this, the car moved into the collision zone and spun out of control. When the obstacle was removed and the driver was given unlimited stopping distance, the driver was still unable to prevent the car from spinning out of control and entering the collision zone.

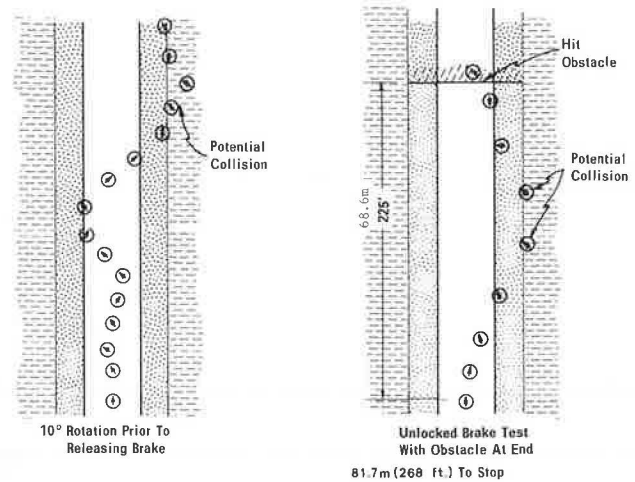
Figure 11. Vehicle control tests at 80.5 km/h (50 mph) where DFN = 17.

Figure 11 shows the results of the 80.5-km/h (50-mph) tests. In this case, the driver was unable to control the vehicle after 10-deg rotation and moved into the collision zone. When an obstacle was placed in the road, the vehicle not only moved into the collision zone but also spun into the obstacle.

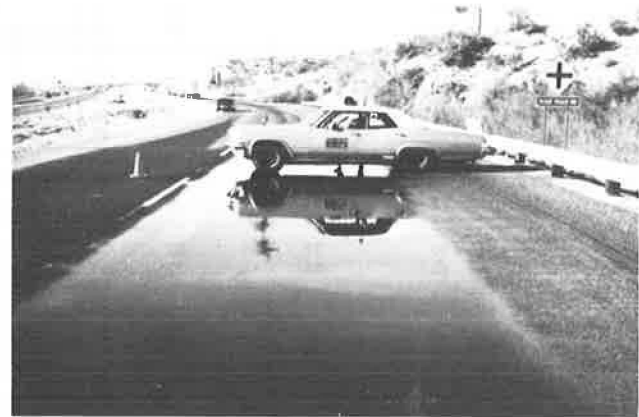
Figure 12. Differential flushing or bleeding.

Differential flushing or bleeding (Figure 12) is created when a portion of the lane is flushing or bleeding while the rest is not. Such a condition can also occur when full-lane-width repairs are not made.

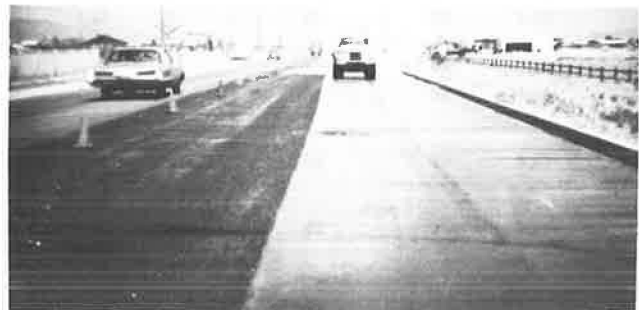
Figure 13. Chip or slurry seal occupying only a portion of a lane.

When a chip or slurry seal is placed across only a portion of the lane width (Figure 13) a major differential friction condition may exist. Maintenance forces may create such a problem while attempting to reduce costs; however, it only creates a more expensive and hazardous condition. This problem is greatly magnified if the seal bleeds.

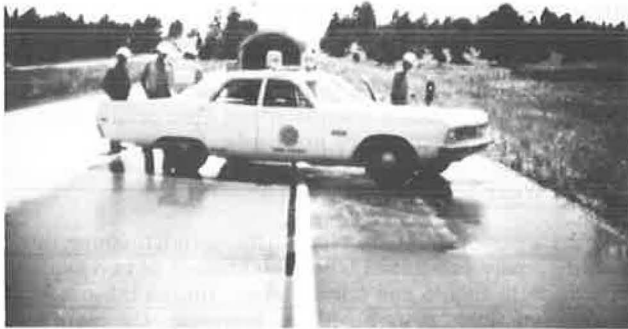
Figure 14. PCC pavement travel lane with AC distress lane.

When a distress or shoulder lane has a dissimilar surface texture different from the travel lane (Figure 14), a differential friction condition may exist. An example of this may be the use of a chip seal shoulder and an AC travel lane or an AC shoulder and a concrete travel lane. A recent preliminary report (5) has shown that 65 percent of truck traffic may ride with one wheel on the shoulder. This indicates that differential friction should be of concern.

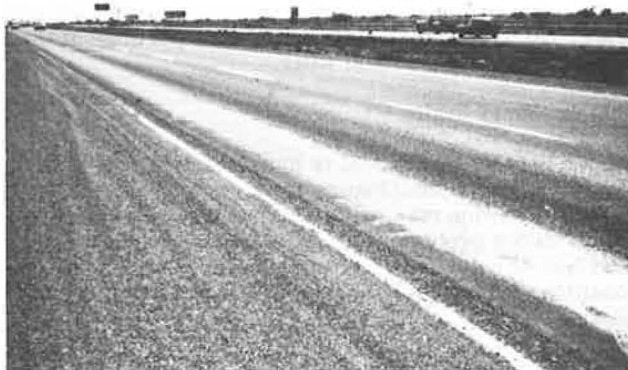
Figure 15. Maintenance crack patching.

Maintenance crack patching can be a major problem when the rate of crack patching in one wheel track is much greater than in the other (Figure 15). When this problem

exists, it is almost impossible to cure without major corrective action.

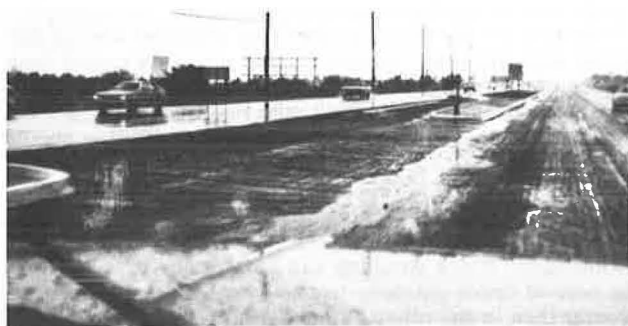
Figure 16. Unequal drainage properties.

When surface drainage characteristics are different, a differential friction condition may exist (Figure 16). An example of this might be a chip seal in combination with an AC surface.
