INFLUENCE OF TREAD DEPTH ON WET SKID RESISTANCE OF TIRES

Albert Dijks, Delft University of Technology,
The Netherlands

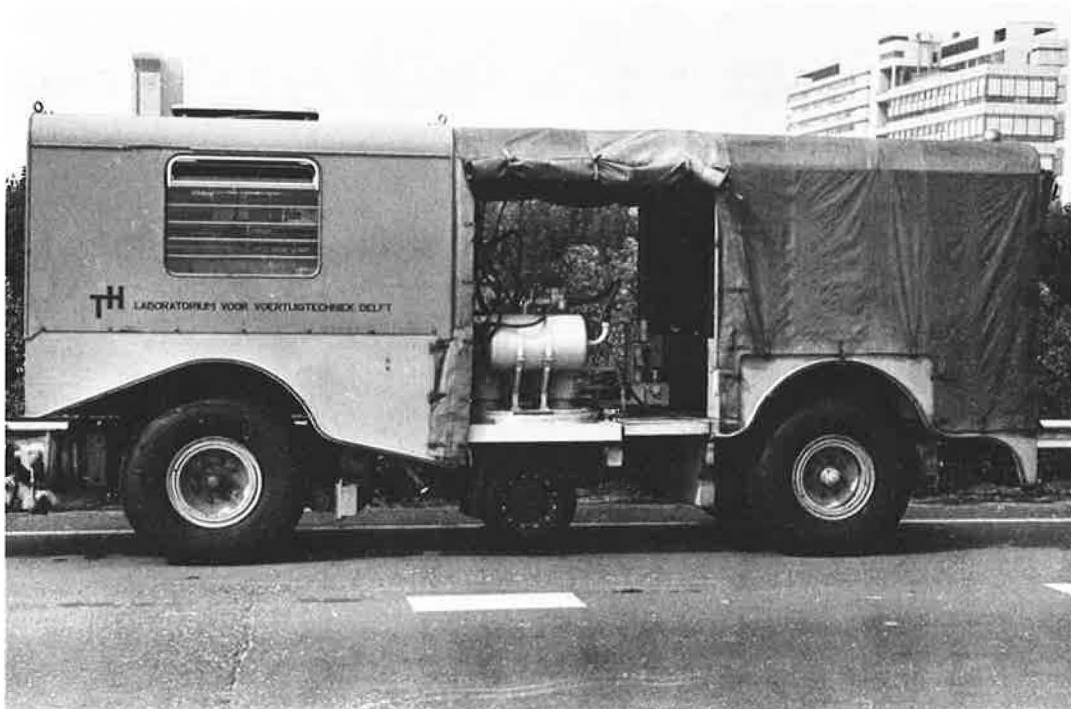
Figure 4. The VRL measuring trailer.

Measurements of braking force coefficients as well as cornering force coefficients have been carried out by the Vehicle Research Laboratory of the Delft University (VRL). The VRL has a test trailer specially built for measuring tire traction characteristics (figure 4).

This trailer can steer, camber and brake the test tire. The tire to be measured is mounted on a five component measuring hub, placed in a frame (figure 5).

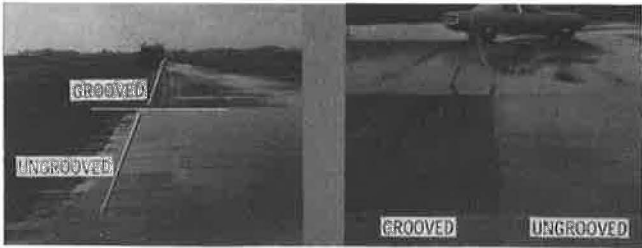
Figure 8. Water drainage from grooved and ungrooved asphalt. Grooving pattern, 38 x 6 x 6 mm (1-1/2 x 1/4 x 1/4 in.).

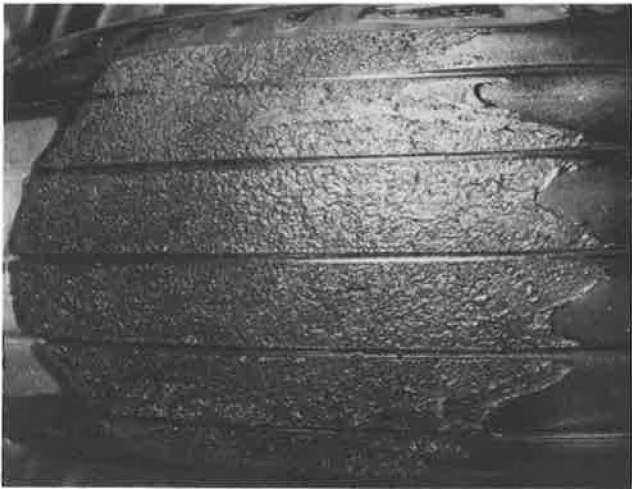
Figure 10. B-737 tire reverted rubber skid patch after 1.8 km (6000 ft) locked-wheel skid on wet smooth concrete.

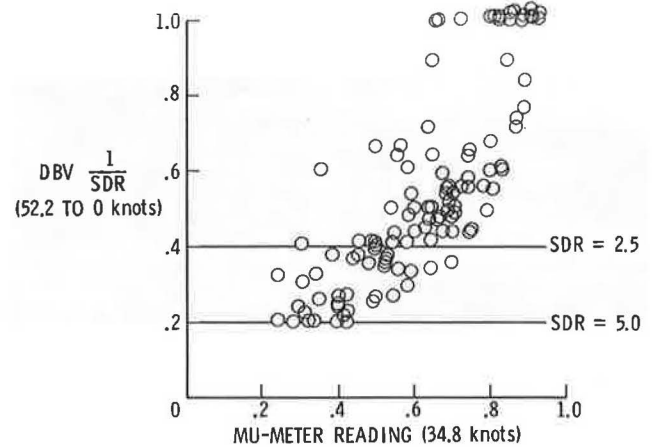
Figure 17. DBV/Mu-Meter relationship found by USAF tests (ref. 28).

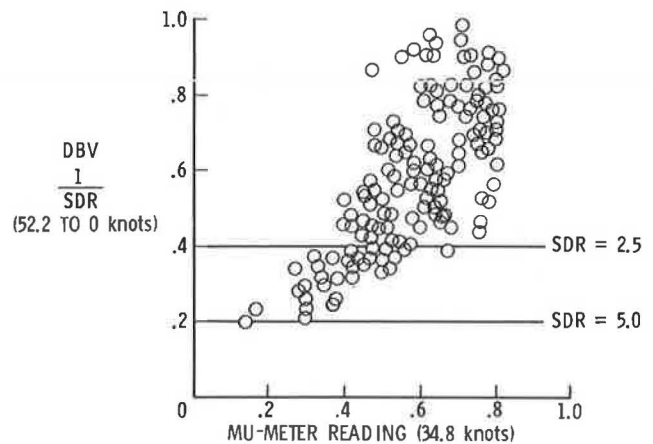
Figure 18. DBV/Mu-Meter relationship found by FAA tests on 31 runways.

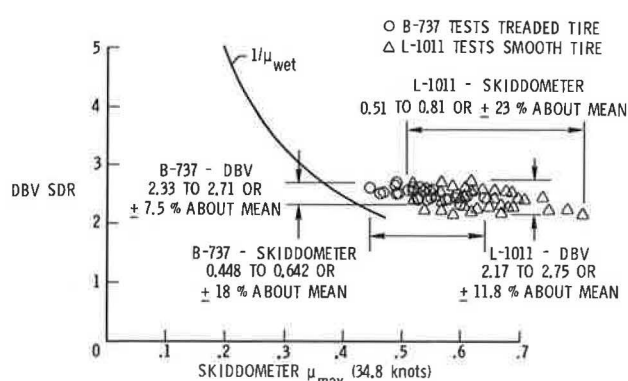
Figure 20. Comparison of NASA DBV with skiddometer.

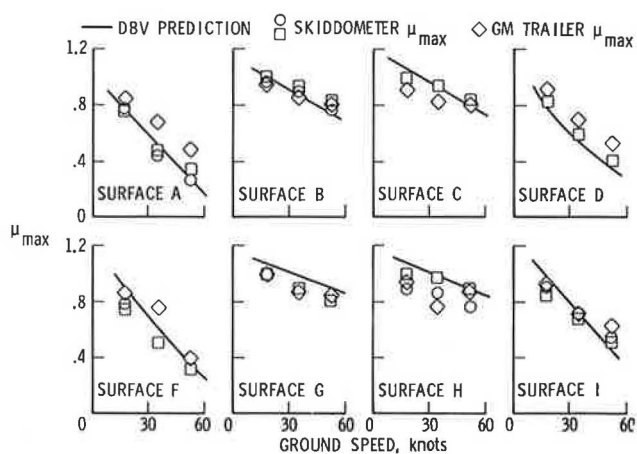
Figure 24. Prediction of skiddometer and GM trailer μ_{max} from DBV μ_{skid} data. Data from references 21, 22, and 30.

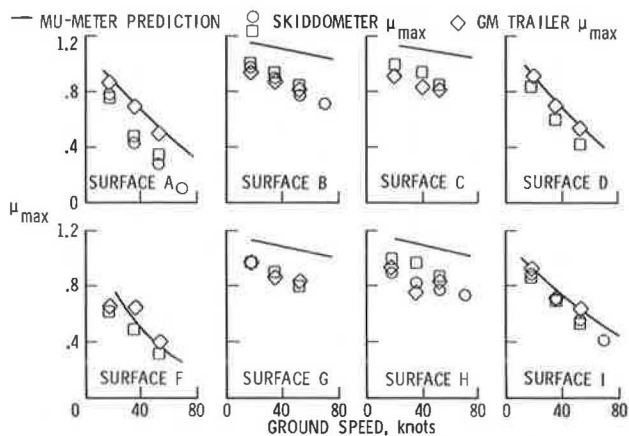
Figure 25. Prediction of skiddometer and GM trailer μ_{\max} from Mu-Meter friction reading ($\psi = 7.5^\circ$). Data from references 21, 22, and 30.

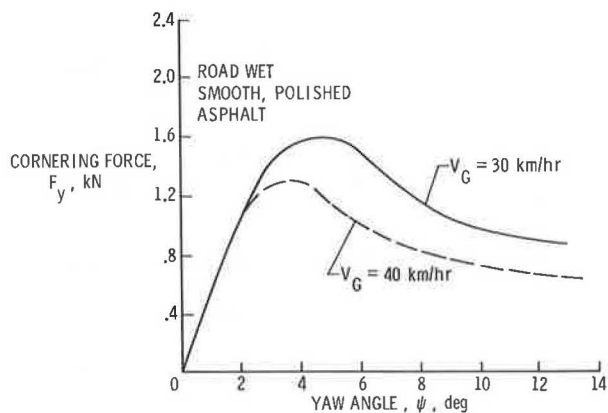
Figure 26. Effect of ground speed on cornering-force-yaw-angle relationships for 5.60-13 automobile tire. $F_z = 2.70$ kN; $p = 167$ kPa; from reference 31.

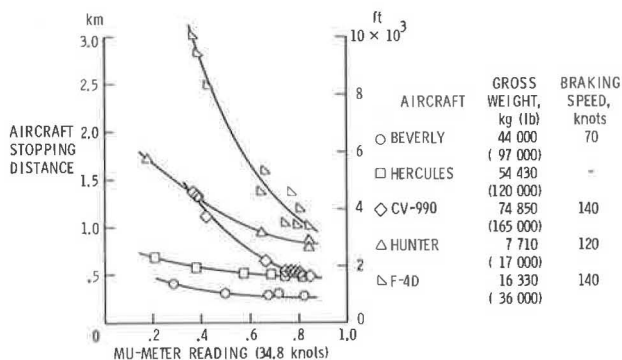
Figure 27. Mu-Meter correlation with aircraft stopping distances on wet surfaces.

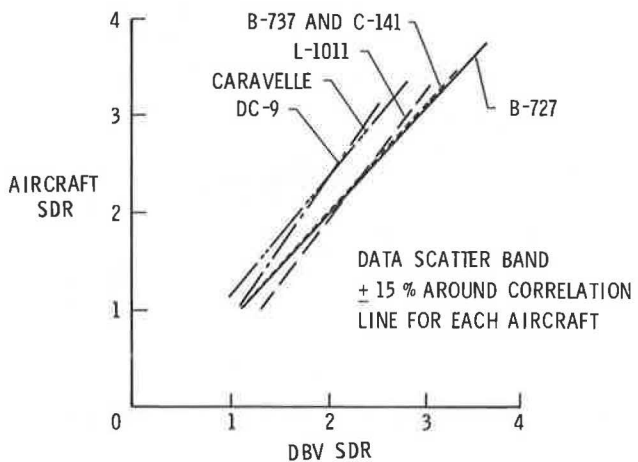
Figure 28. Aircraft/DBV correlation on wet runways for different jet transports.
