# Road Test to Determine Implications of Preventing Thermal Reflection Cracking in Asphalt Overlays

Ramesh Kher, Research and Development Division, Ontario Ministry of Transportation and Communications

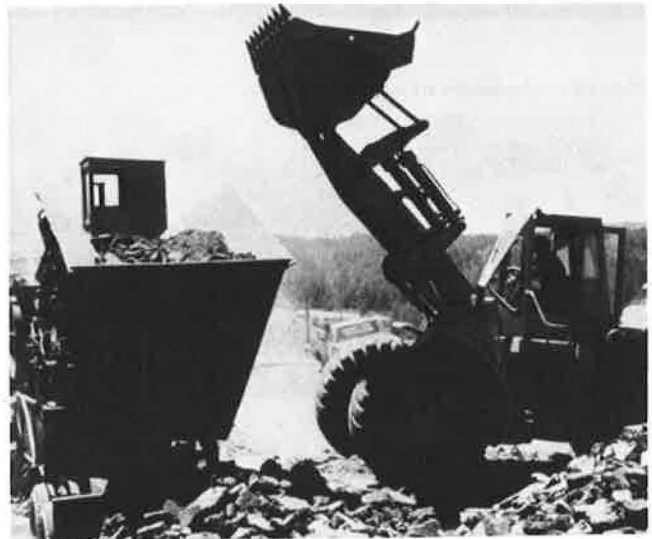
Figure 6. Pulverization by using a crusher.

crusher, crushed to a minus 2.54-cm (1-in) size, then hauled back to the road and relaid. The production rate obtained was about 457 m (1500 ft) of two lanes/d. Figure 6 shows the hauling and the crushing operations.

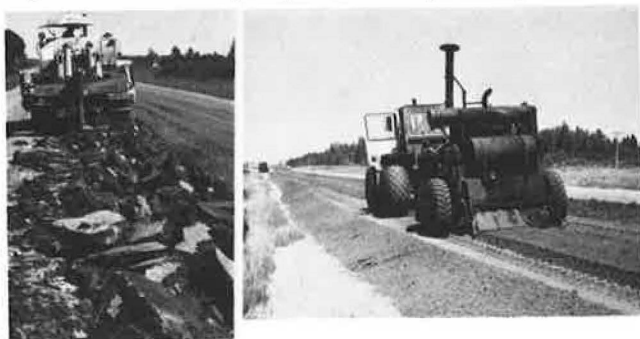
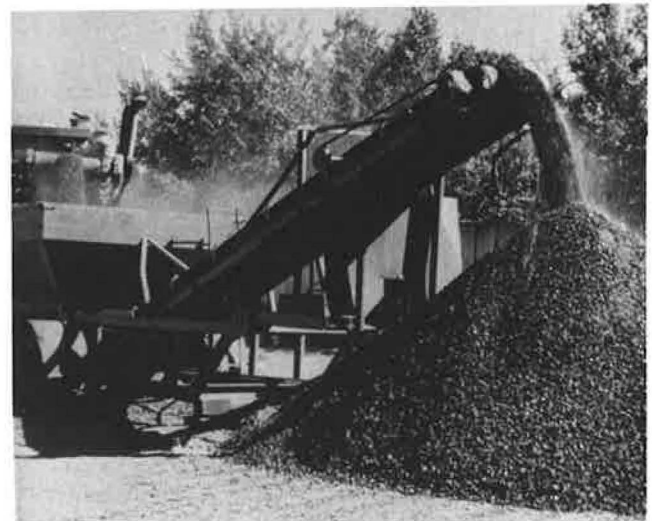
Figure 7. Pulverization by using a Hammermill pulverizer.

a minimum thickness of 11.4 cm (4.5 in) was ripped one lane at a time and windrowed to the shoulder. This material was then brought inside the lane in small windrows and pulverized. Two or three passes of the pulverizer were generally required to pulverize the material to required size. A production rate of about 213 m (700 ft) of two lanes/d was obtained. Figure 7 shows pavement ripping and pulverization of the pavement.

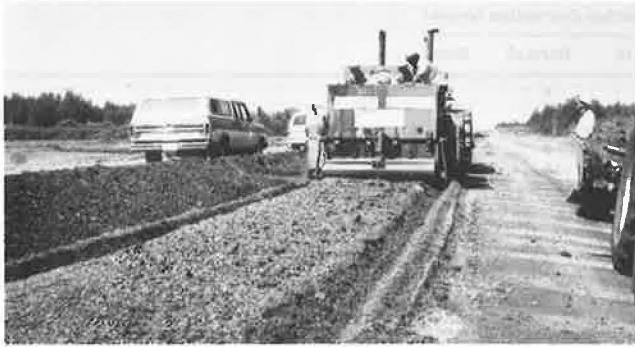
Approximately 6.4 km (4 miles) of this project were pulverized by using a heavy-duty Hammermill pulverizer. This pulverization was often followed by one pass in the smaller pulverizer, mentioned above, to obtain the required maximum size. Ripping of the pavement was not

Figure 8. Pulverization by using a heavy duty Hammermill pulverizer.

needed with this equipment. A production rate of about 610 m (2000 ft) of two lanes/d was obtained. Figure 8 shows this equipment in operation.

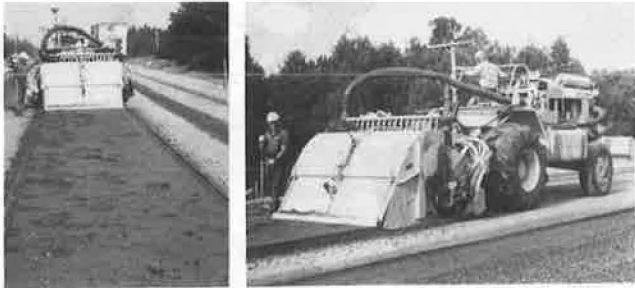
Figure 9. Pulverization by using a pulvimixer.

The pavement, 7.3 m (24 ft) wide and 7.6 cm (3 in) thick, was pulverized by a pulvimixer. It was not necessary to rip the pavement because this equipment was used. One to two passes of the pulvimixer were required to pulverize the material to a minus 2.54-cm (1-in) size. A production rate of about 366 m (1200 ft) of 2 lanes/d was obtained. Figure 9 shows this equipment in operation.
