*TRANSPORTATION RESEARCH RECORD 632*

**Design and  
Performance of  
Pavement  
Overlays**

*TRANSPORTATION RESEARCH BOARD*

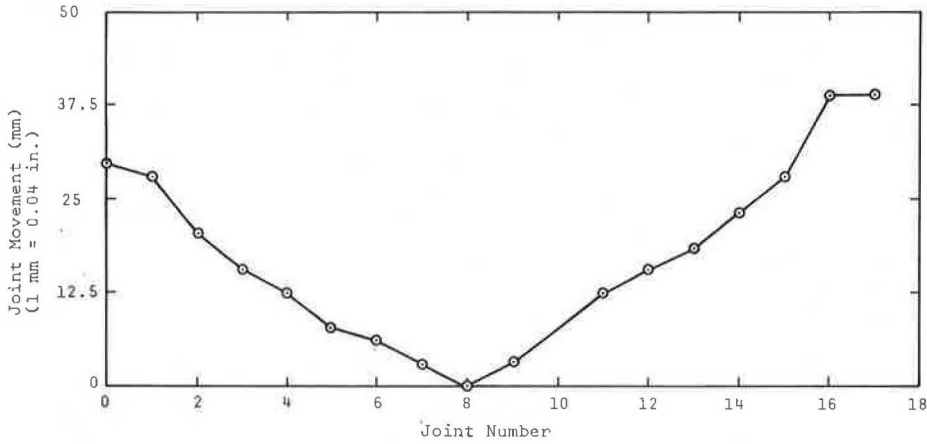
Figure 2. Joint shift between pressure-relief joints.

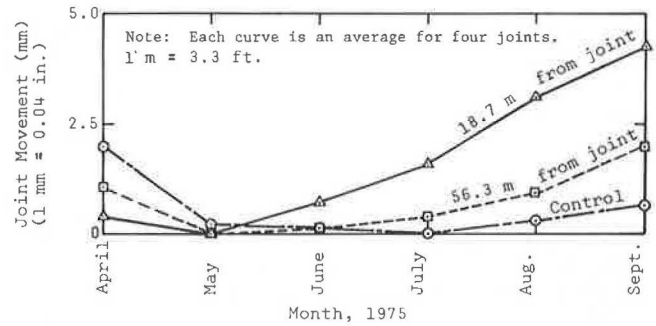
and 93.8 m (307.5 ft) from the pressure-relief joints. The pavements contrasted in this figure are also discussed in an earlier report (3) in which the behaviors of pavements that are prone to blowups were compared with those pavements of the control section that had no history of blowups.

Figure 5. Comparison of pavements with and without pressure-relief joints.

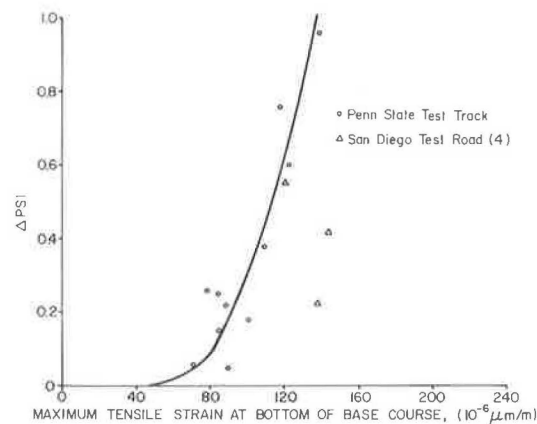
Figure 6. Correlation between ΔPSI and maximum tensile strain at bottom of base course.

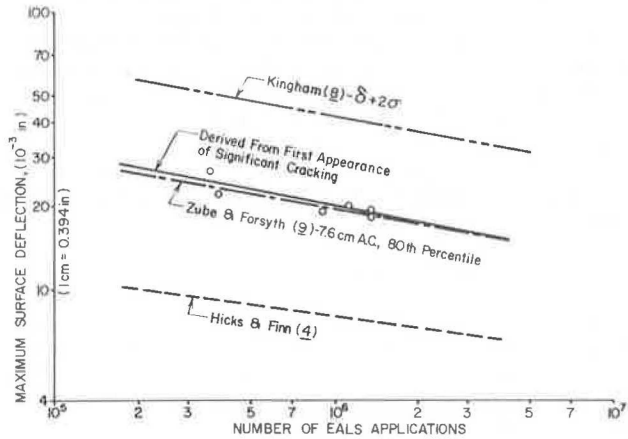
Figure 8. Correlation between surface deflection and number of 8165-kg equivalent axle-load applications.

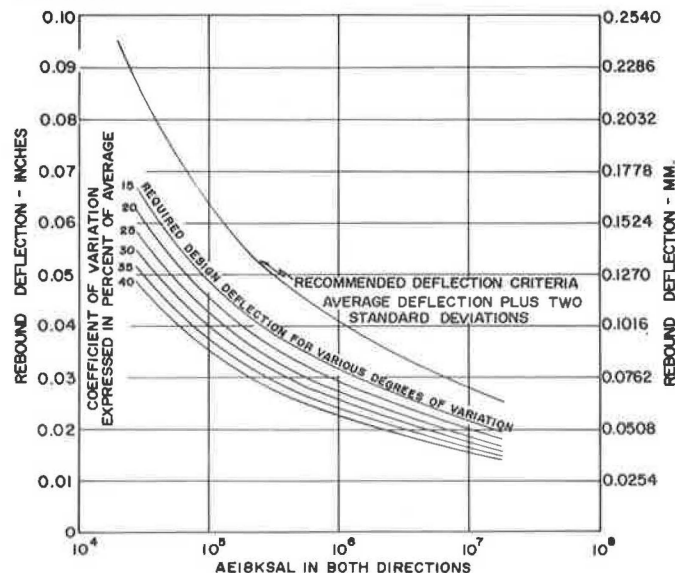
Figure 2. Relation between design deflection and traffic for practical range of coefficients of variation.

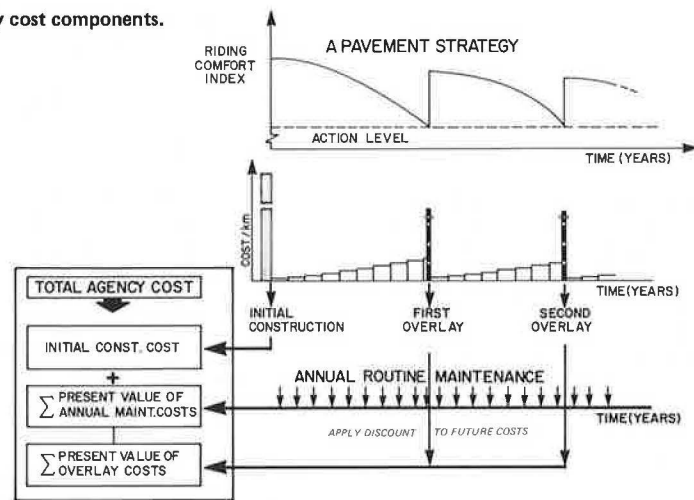
Figure 4. Schematic representation of agency cost components.

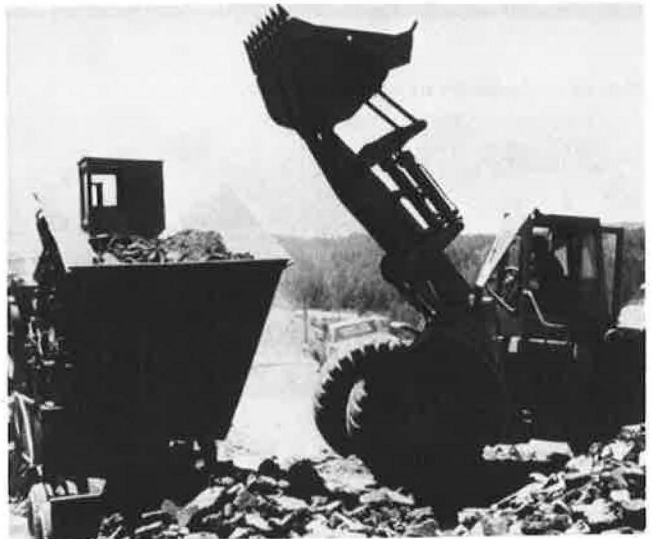
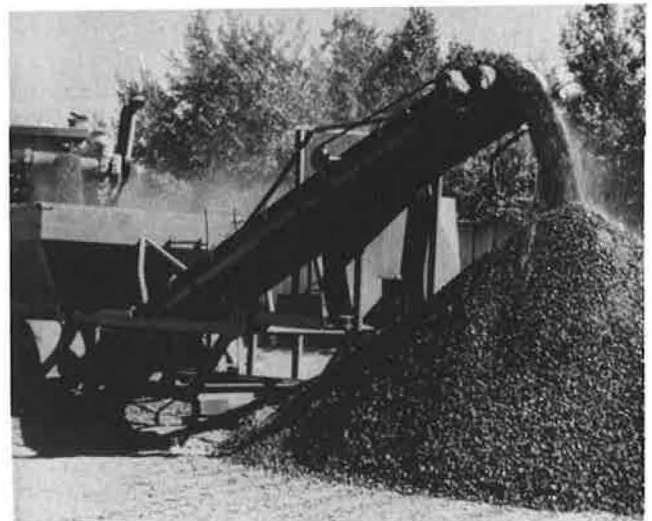
Figure 6. Pulverization by using a crusher.

crusher, crushed to a minus 2.54-cm (1-in) size, then hauled back to the road and relaid. The production rate obtained was about 457 m (1500 ft) of two lanes/d. Figure 6 shows the hauling and the crushing operations.

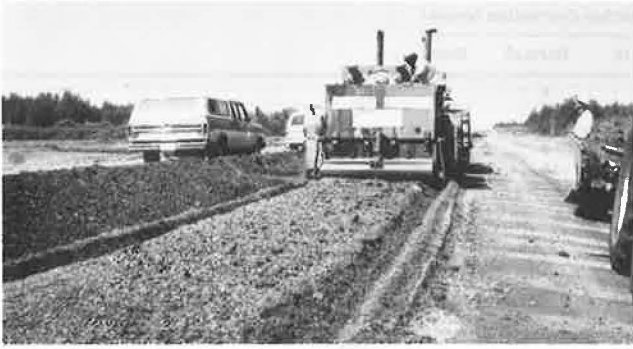
Figure 8. Pulverization by using a heavy duty Hammermill pulverizer.

needed with this equipment. A production rate of about 610 m (2000 ft) of two lanes/d was obtained. Figure 8 shows this equipment in operation.

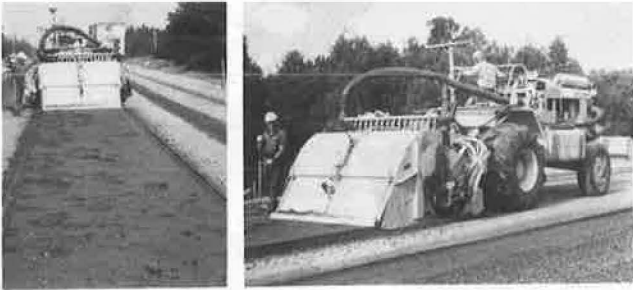
Figure 9. Pulverization by using a pulvimixer.

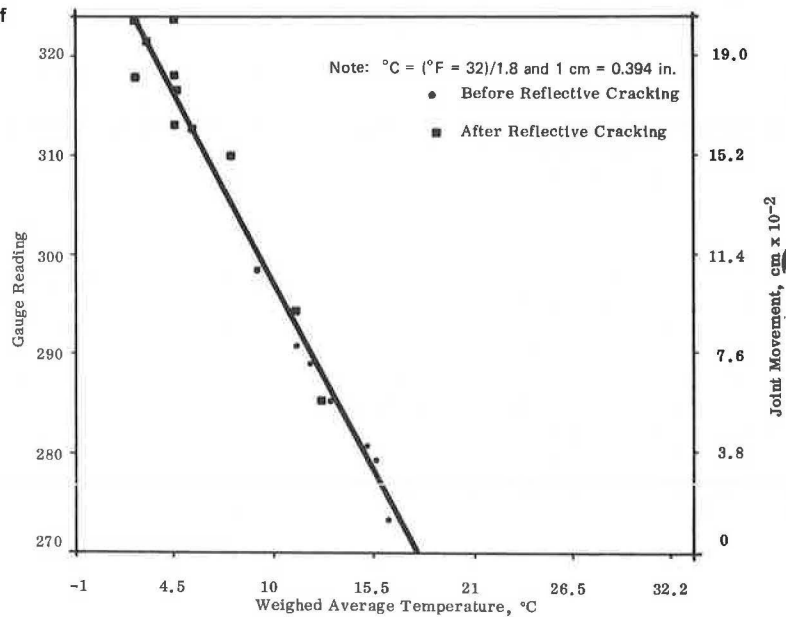
**Figure 2. Horizontal movement because of temperature change.**
